MINERALS PROGRAM INSPECTION REPORT
PHONE: (303) 866-3567

MINE NAME: Montoya Pit	MINE/PROSPECTING ID#: M-1980-146	MINERAL: Sand and gravel	COUNTY: La Plata
INSPECTION TYPE: Multi Person Inspection	INSPECTOR(S): Lucas West	INSP. DATE: August 25, 2021	INSP. TIME: 12:50
OPERATOR: C & J Gravel Products, Inc.	OPERATOR REPRESENTATIVE: Hank Boschert, Cesar Valenzuela	TYPE OF OPERATION: 112c - Construction Regular Operation	
REASON FOR INSPECTION: Normal I&E Program	BOND CALCULATION TYPE: Complete Bond	BOND AMOUNT: \$421,358.00	
DATE OF COMPLAINT: NA	POST INSP. CONTACTS: None	JOINT INSP. AGENCY: None	
WEATHER: Clear	INSPECTOR'S SIGNATURE:

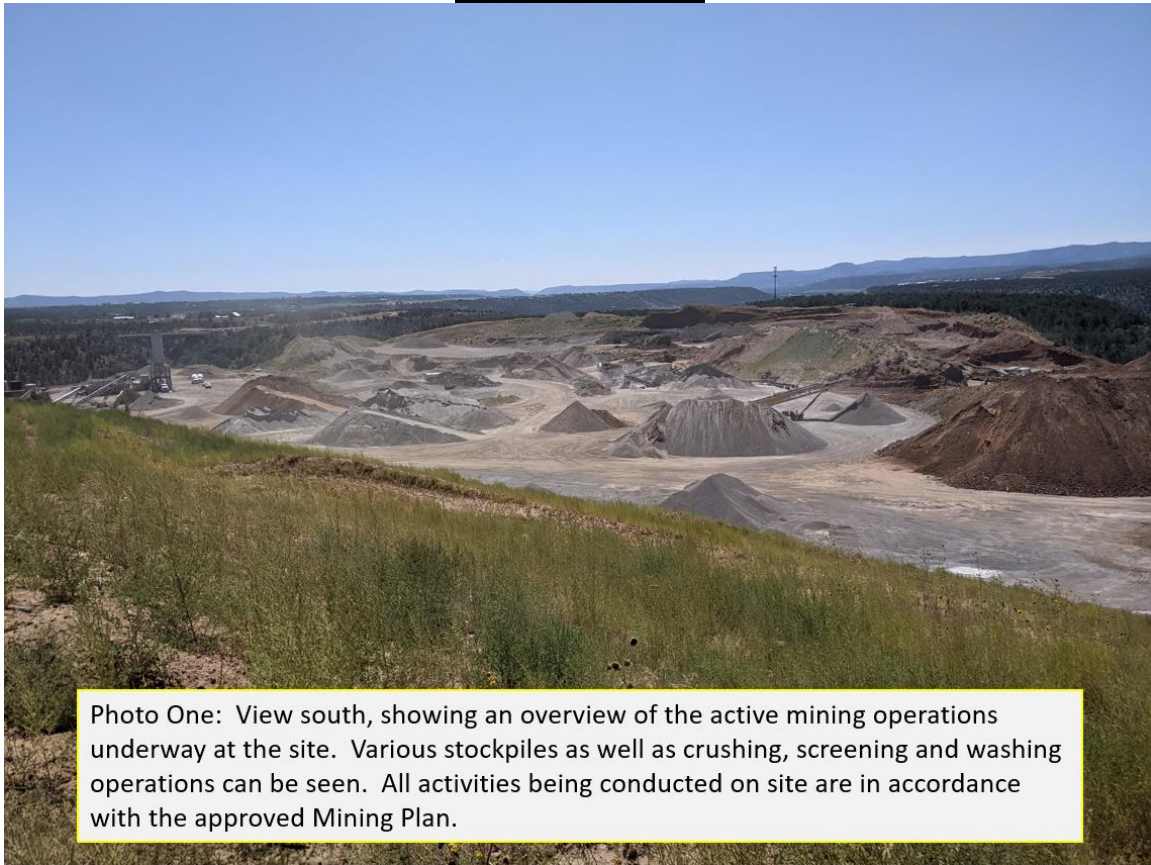
The proper mine identification signage was posted and all boundary markers were clearly identifiable. The site was active at the time of the inspection. Several areas of active mining were identified, as well as crushing, screening, washing and stockpile activities. An overview of the active area can be seen in Photo One. The active mining areas included a small section near the south end of the permitted area, as well as a larger area located to the west end of the affected lands boundary. All observed highwalls were less than 20 feet in height and appeared to stable at the time of the inspection. The mining area to south of the permit boundary, abuts the Crader Pit, held by La Plata County. This area can be seen in Photo Two. The boundary has been mined through in accordance with the written agreement and no problems were noted in this area. The second area of active mining lies in the expansion area detailed in AM-5 shown in Photo Three. This area contains a small highwall and areas of active excavation. On site discussions with the Operator indicate that the amount of useable material is almost gone in this area. Potential expansions of the area were discussed with the Operator and the BLM. Expanding into this area should be addressed through the Division's Technical Revision process to update the mining and reclamation plans for this area.

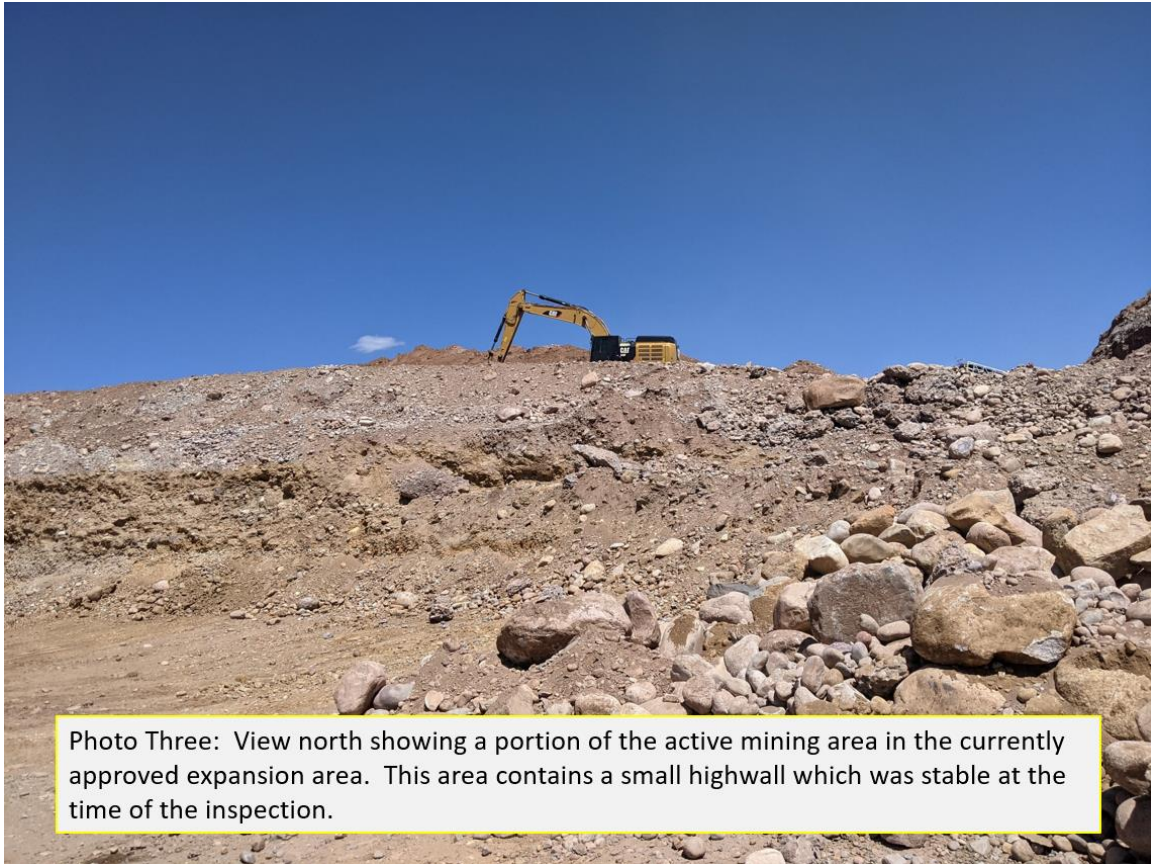
Photo Three: View north showing a portion of the active mining area in the currently approved expansion area. This area contains a small highwall which was stable at the time of the inspection.

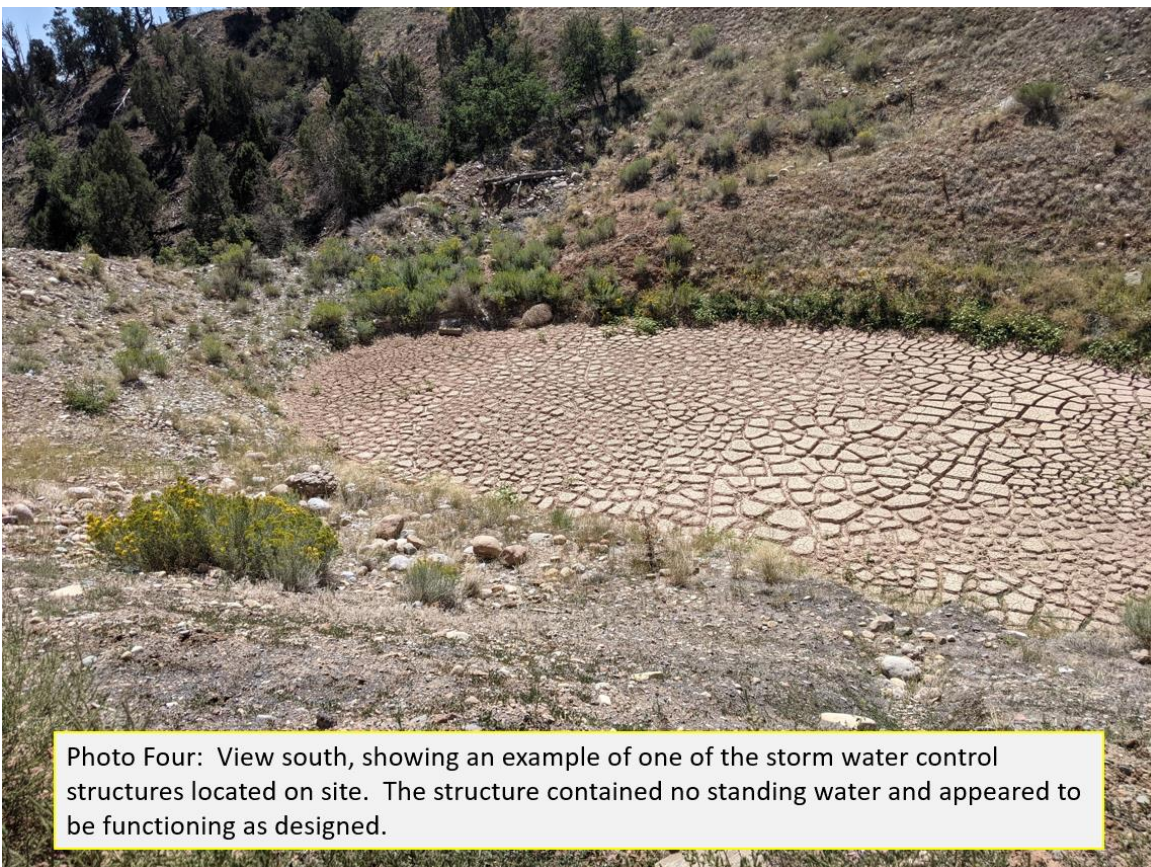
In the stockpile and processing areas, multiple stockpiles of various materials were observed. All stockpiles are stable and in good condition. Material was actively being stockpiled and hauled during the inspection. Despite the high level of activity on site, fugitive dust was almost non-existent and constant dust control operations were noted. Also, throughout the site, various storm water control features were noted. All storm water control features appeared to be functioning as designed, and none of the observed features contained standing water at the time of the inspection. An example of one of the storm water control features can be seen in Photo Four.

Photo Four: View south, showing an example of one of the storm water control structures located on site. The structure contained no standing water and appeared to be functioning as designed.

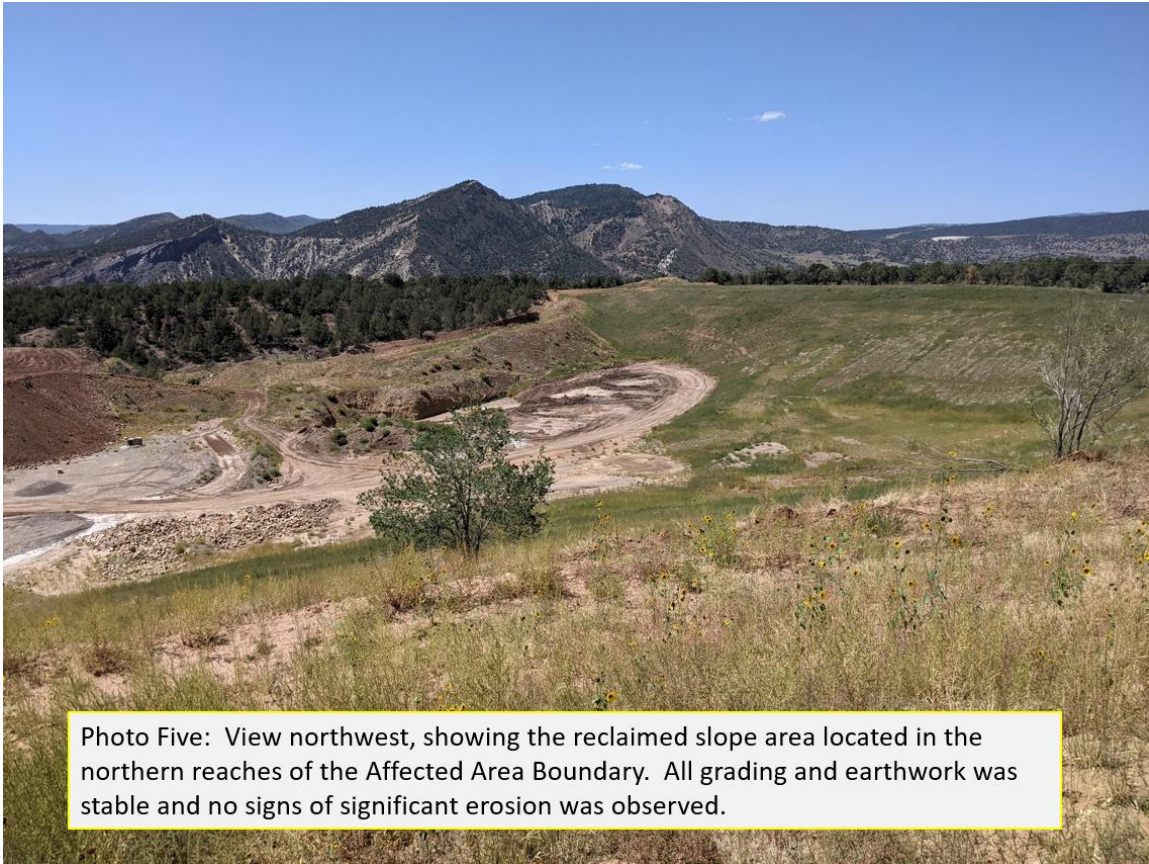
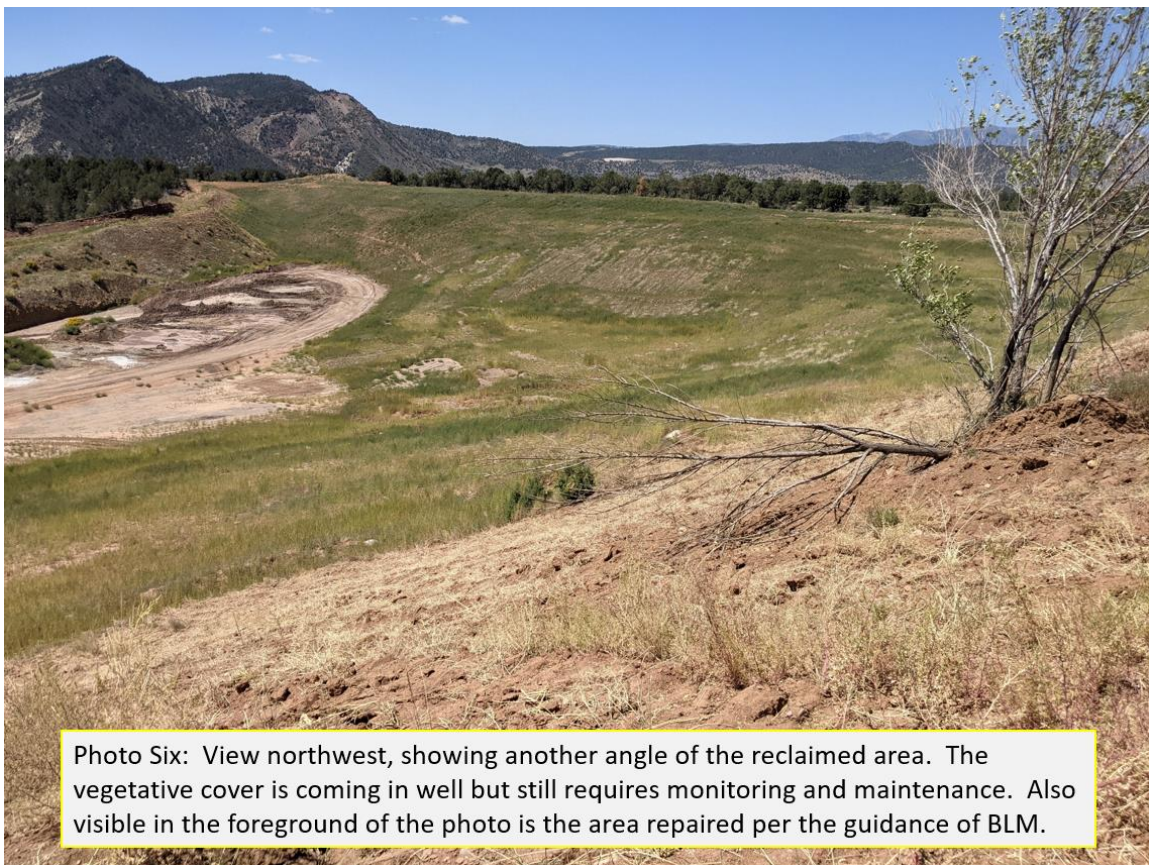
Significant reclamation has been undertaken in the northern section of the disturbed area. This area can be seen in Photos Five and Six. Slope reduction, grading and shaping has all been conducted in this area. No evidence of settling, slumping or erosion was noted in the reclaimed area. The reclaimed area consists of approximately 15 acres. Recently, some erosion repair was conducted at the guidance of BLM. A portion of the repair work can also be seen in Photo Six. All areas appear to be stable and in good condition. The area has been revegetated and will continue to be monitored and maintained until sufficient cover is achieved.
