**MINERALS PROGRAM INSPECTION REPORT**  
**PHONE: (303) 866-3567**

<b>MINE NAME:</b> Overlook Mine	<b>MINE/PROSPECTING ID#:</b> M-2006-075	<b>MINERAL:</b> Sand and gravel	<b>COUNTY:</b> Grand
<b>INSPECTION TYPE:</b> Monitoring	<b>INSPECTOR(S):</b> Peter Hays	<b>INSP. DATE:</b> August 30, 2021	<b>INSP. TIME:</b> 12:30
<b>OPERATOR:</b> GRCO LLC	<b>OPERATOR REPRESENTATIVE:</b> None	<b>TYPE OF OPERATION:</b> 112c - Construction Regular Operation

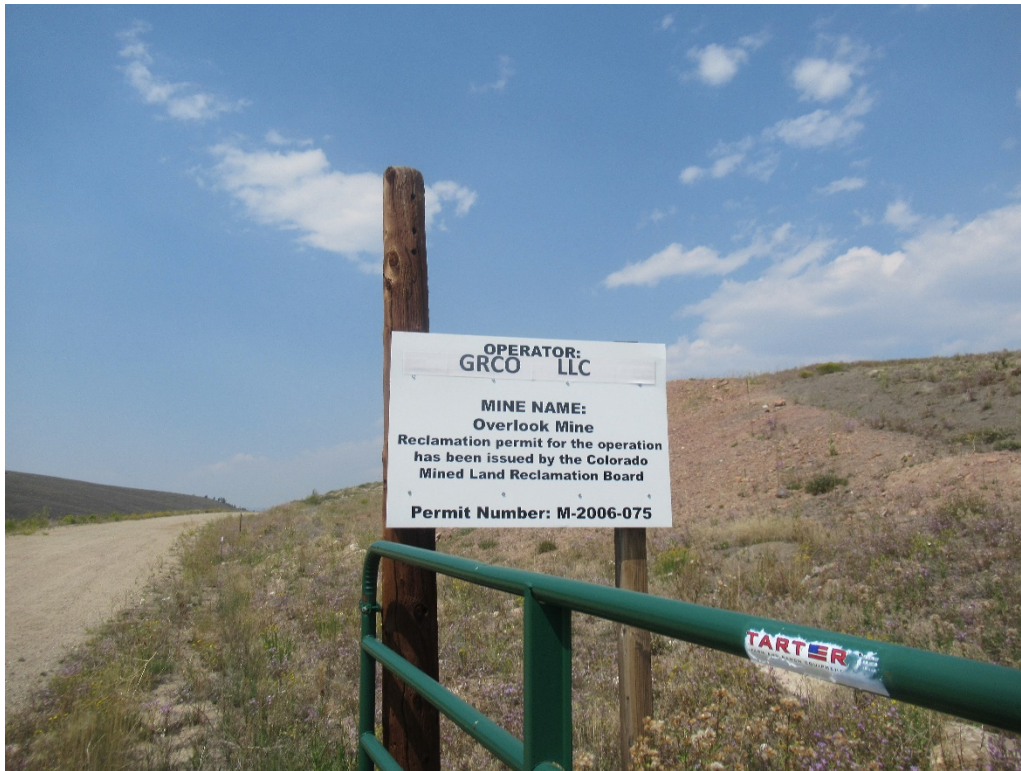
Overlook Mine mine sign

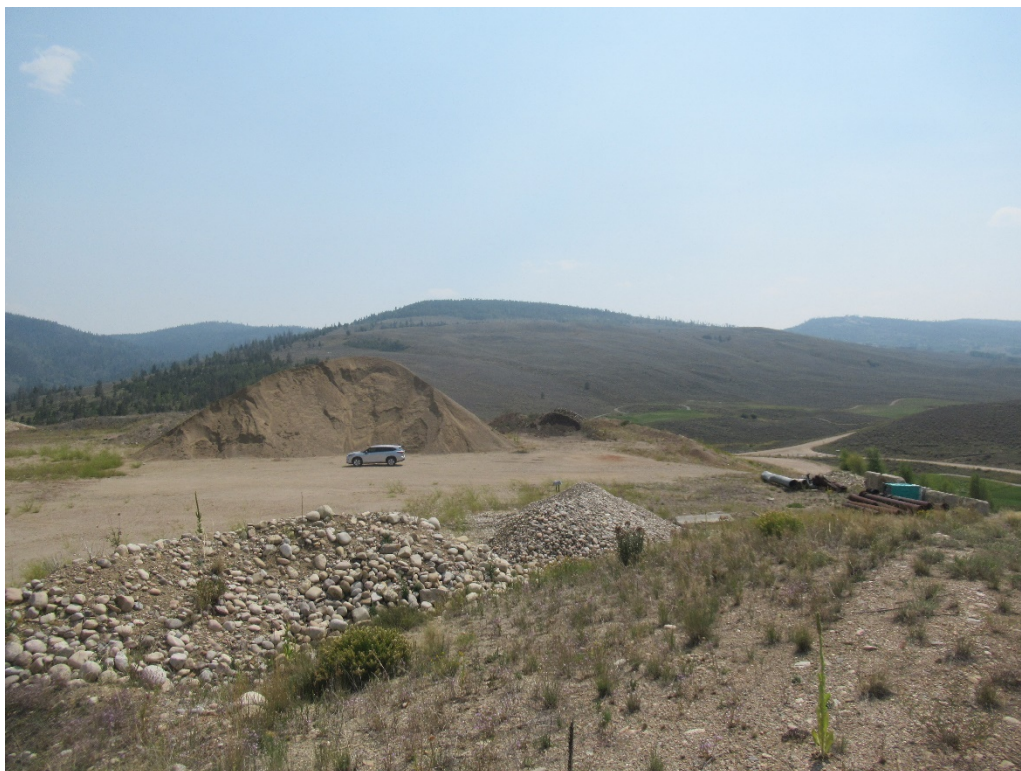
View of the pit floor looking south

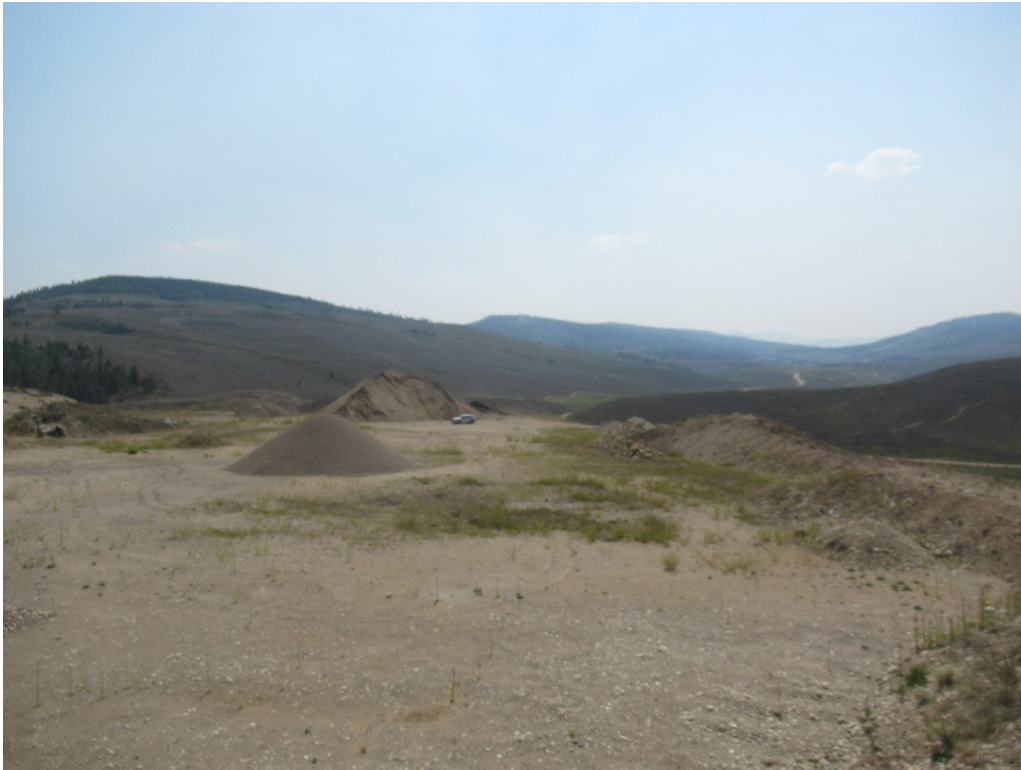
View of the site from the north highwall looking southwest

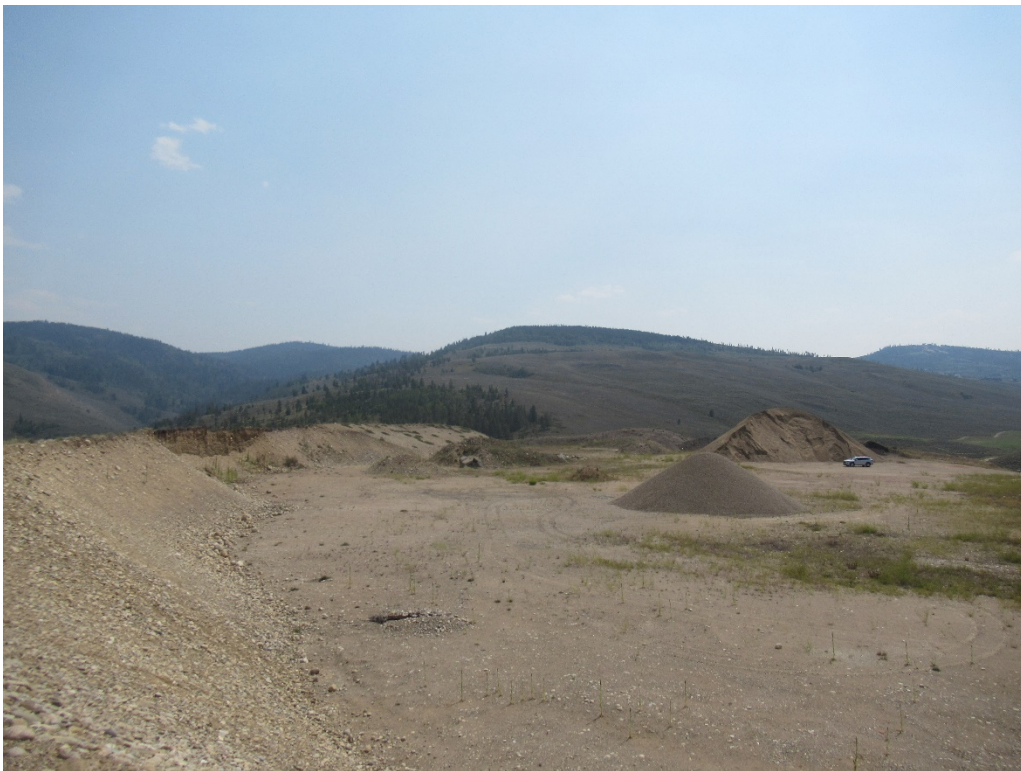
View of the site from the north highwall looking southeast
