Re: King II Mine
Pond Annual Inspection
3rd Quarter 2021

Re: King Coal II - Annual Water Quality Improvements Inspection

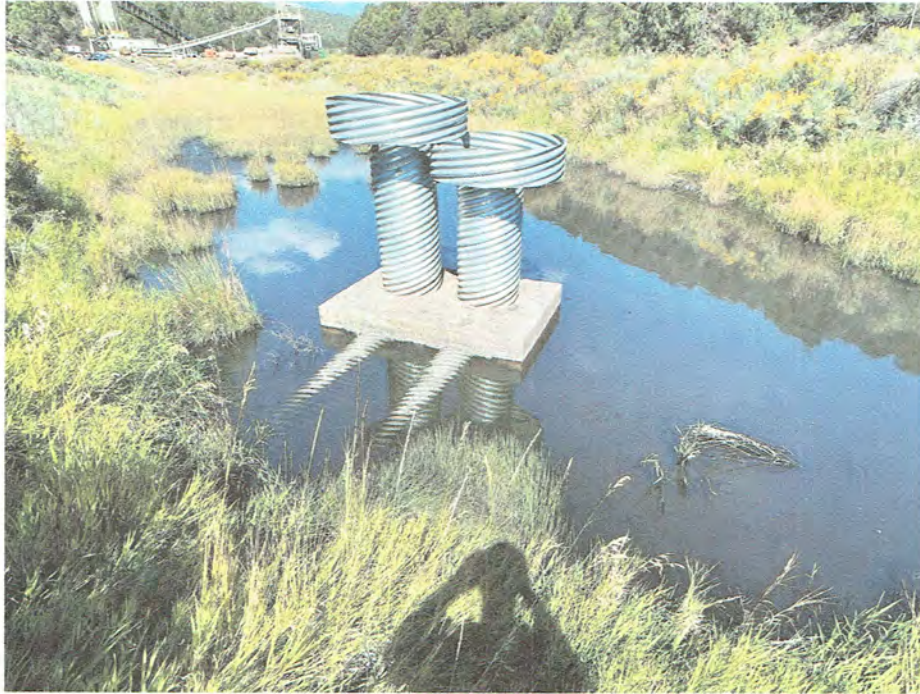
The vegetation both inside and out of the pond is well established to minimize the erosion impacts of storm runoff. The outlet structure shows no signs of damage and was functioning as designed at the time of the inspection. The water quality pond appears to be in generally good condition. There were no signs of weakness or distress to either the outlet structure or the embankment material though the vegetative cover made observation extremely difficult. The water quality pond has the storage capacity to function as designed.

Pic. 1 – Detention Pond outlet in good condition.

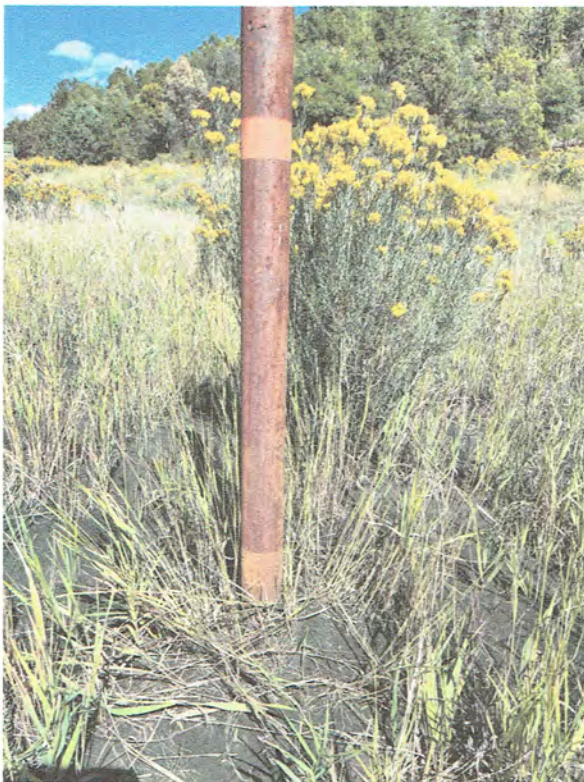
The water quality pond was mostly dry at the time of the inspection. The elevation at the bottom of the pond was estimated to be at an elevation of 7227.3, approximately 12-inches below the concrete of the outlet structure. The sedimentation level at the pond outlet and the sedimentation gage have only risen slightly since the 2020 inspection (see Pic. 1). Removal of sediment from the ponds was anticipated this year and is currently ongoing at the King I site. The sediment was approximately one (1) foot below the cleanout level during the 2018 inspection, eight (8) inches below the cleanout level during the 2019 inspection, four (4) inches below the cleanout level during the 2020 inspection and only slightly less for the detention pond during the current inspection (see Pic. 2). This represents an elevation of 7229. The 60% cleanout level is at an elevation of 7229.25. The current sediment level in the detention pond is less than the allowable 1.57 [ac-ft] of sediment which is the 60% cleanout level as shown in the Sediment Pond Stage Discharge Curve prepared by EIS Environmental & Engineering Consulting dated 12/18/08. It is anticipated that the excess sediment will be removed from the detention pond once the King I sediment ponds have been completed.

Pic. 2 – Sedimentation gage in pond.

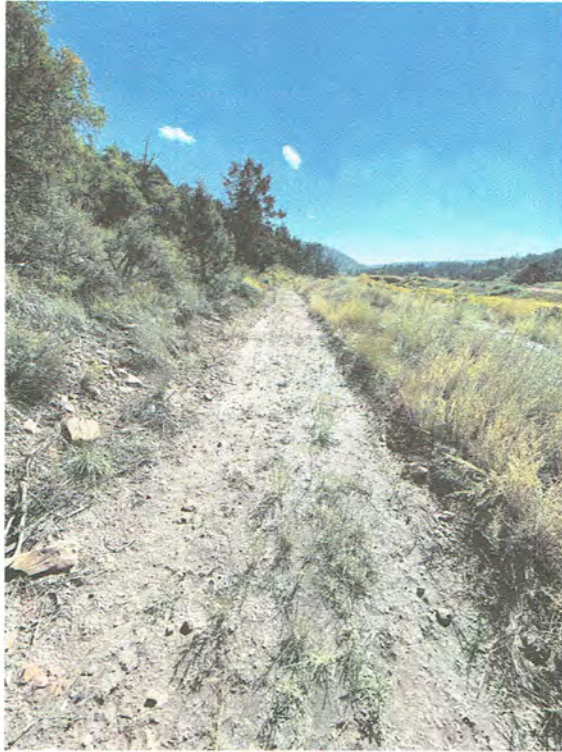
The east clear water ditch, the lower west clear water ditch (east of the driveway access) and the main drainage ditch (combined clear water ditches) were found to be in generally good condition and clean of debris (see Pic. 2). The east clear water ditch should have the weeds removed from the portion of the channel upstream from the air-jig as the channel is section is overgrown (see Pic. 3). There was some limited sedimentation of the clear water ditch west of the scale house. If additional sedimentation occurs at this location, it will require maintenance. All ditches should be inspected and repaired as necessary, especially after storm events.

Pic. 3 East clear water ditch downstream from air-jig.

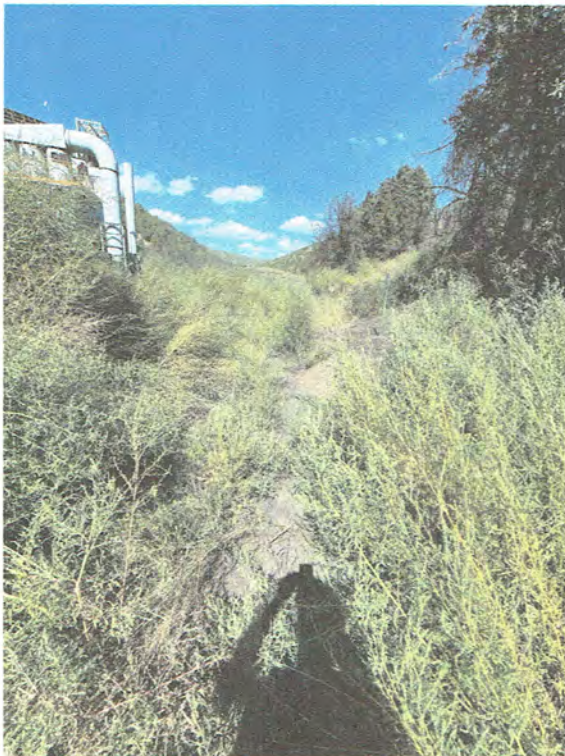
Pic. 4 –East clear water ditch upstream from air-jig.
