Re: GCC Energy, LLC, King II Mine  
CDRMS Permit # C-1981-035  
Stoner Engineering: Quarterly Inspection: Refuse Pile  
3rd Quarter 2021

Date: September 21, 2021

Re: King Coal I – Quarterly Waste Pile/Embankment Inspection

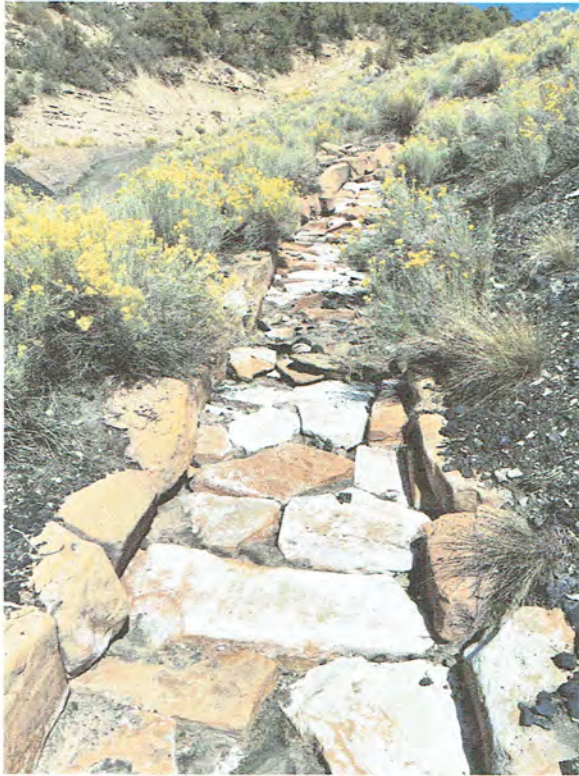
The south treated water ditch (Reach 10) and the south clear water ditch (Reach 1) appeared to be in generally good condition (see Pic. 1). There was some erosion from the recent storms at the northwest corner of the lower embankment pile along the east side of the haul road. If not addressed, this could result in excessive erosion, instability, sloughing or weakness (see Pic. 2). There was also erosion located at the southwest corner of the main waste embankment pile at the seam between the waste pile and the existing mountain (see Pic. 3). The erosion control measures at this location have been covered with sediment as a result of the erosion in this location. The erosion control measures should be re-established to prevent excessive erosion at this location.

Pic. 1 –Reach 10 treated water channel in good condition.

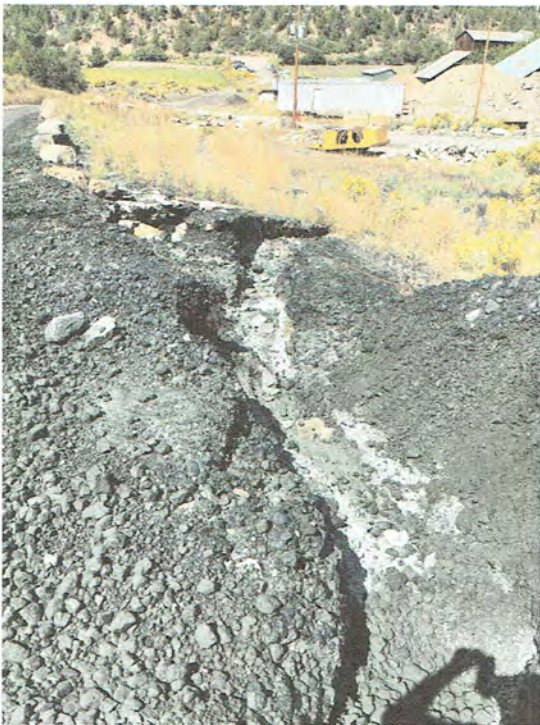
Pic. 2 – Erosion between haul road/NW corner of lower waste pile.

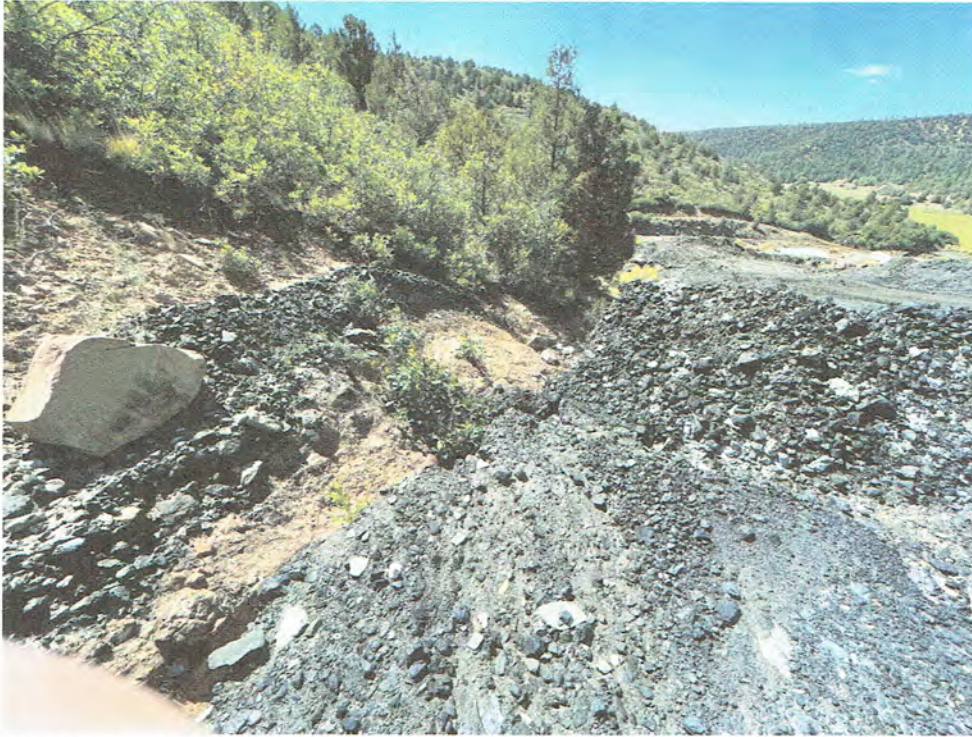
Pic. 3 – Erosion at SW corner of main waste pile at top.

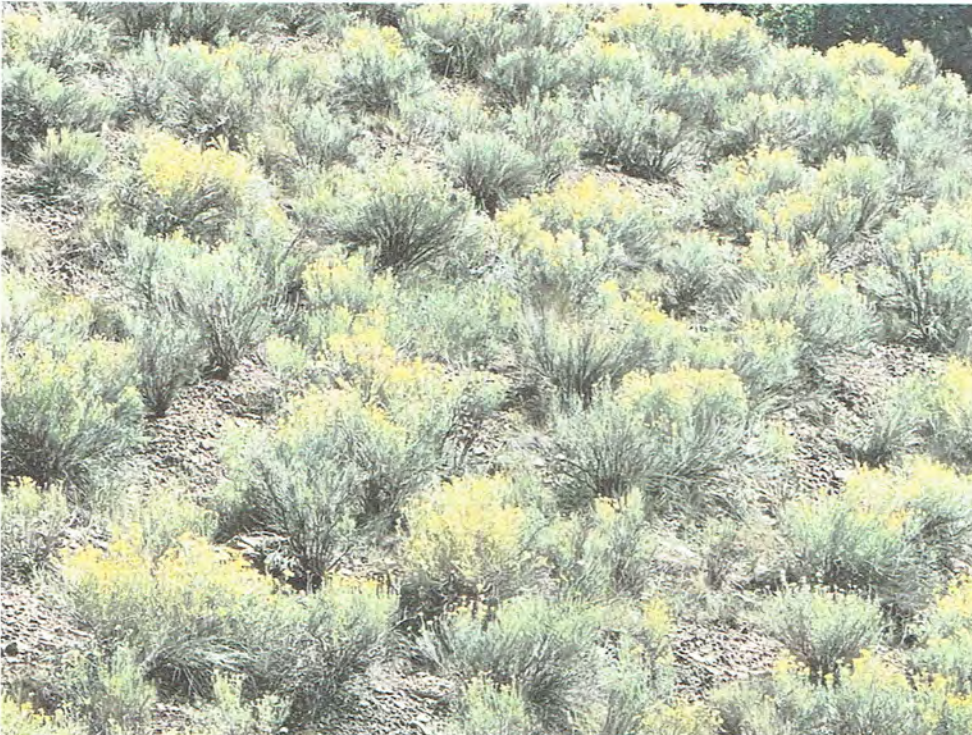
The face of the embankment appeared to be in generally good condition. There were no signs of excessive erosion, instability, sloughing or weakness observed on the face of the embankment of either of the waste embankment piles at the time of the inspection (see Pic. 4).

Pic 4 – Face of the main waste pile in good condition.
