Re: GCC Energy, LLC, King II Mine
CDRMS Permit # C-1981-035
Stoner Engineering: Quarterly Inspection: Water Quality Improvements
3rd Quarter 2021

Date: September 21, 2021

Re: King Coal I – Quarterly Water Quality Improvements Inspection

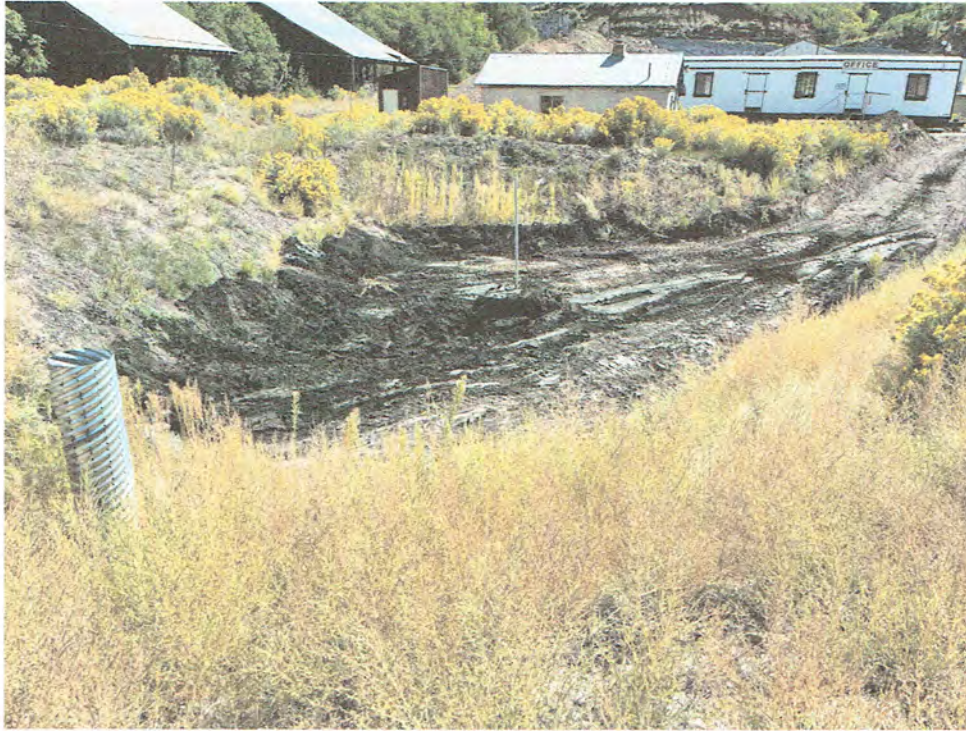
Both ponds were dry at the time of the inspection. Pond maintenance has begun in that the excess sediment is being removed from the storm water detention ponds (see Pic. 1 & 2). The material removed from the detention ponds is currently being stockpiled near the southwest corner of the lower waste embankment pile (see Pic. 3). The ponds should continue to be monitored after storm events to ensure that excess sediment does not reduce the required storage capacity available for storm water runoff.

Pic. 1 – Sediment removal, East pond.

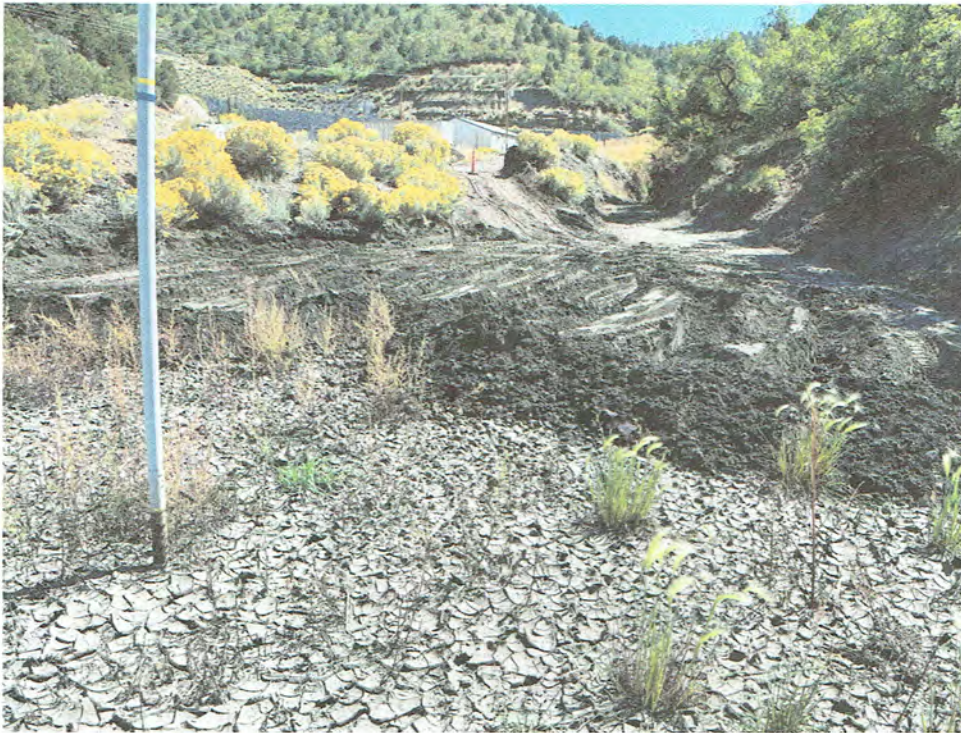
Pic. 2 – Sediment removal, West pond.

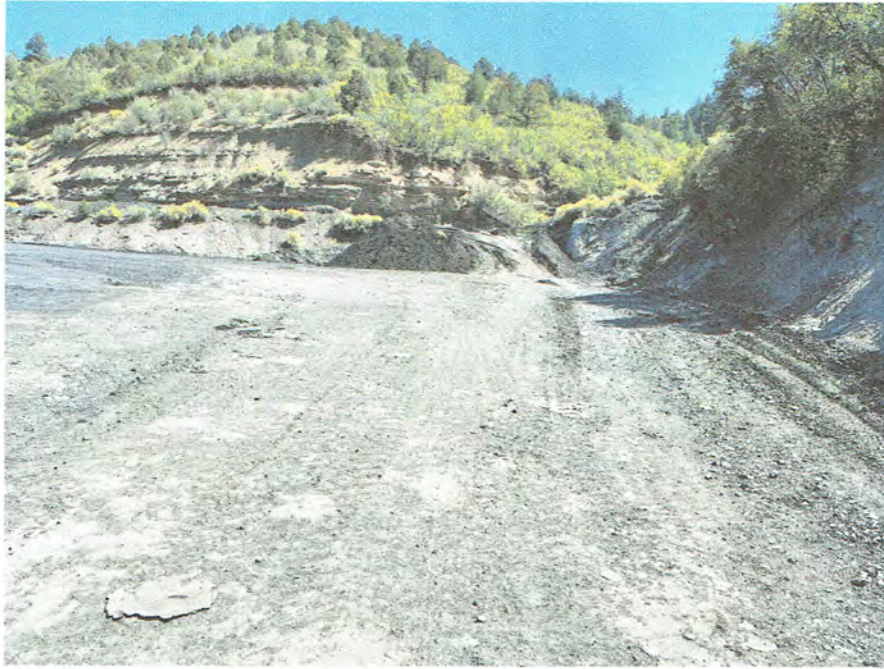
Pic. 3 – Pond sediment stockpile SW corner of lower waste pile.

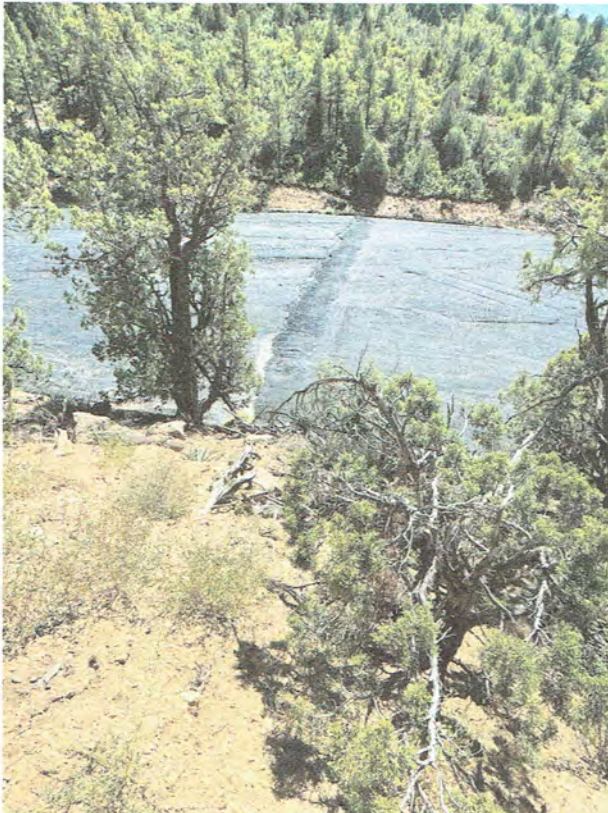
The sedimentation traps at the entrance to the site are generally in good condition. A limited amount of waste material appears to have been placed on the upper waste pile since the previous inspection (see Pic. 4). The grading of the lower waste embankment pile generally directs surface runoff generally to the south and west as required in the design documents. The small portion of the northeast corner that drains towards the front of the pile is still present. This grading situation needs to be correcting by adding some additional fill material along the front of the lower waste pile at this location to ensure runoff is directed south and west as specified in the design documents. While this was a minor concern noted during the previous inspection, temporary fuel storage tanks have been added below the lower waste pile at this location (see Pic. 5). A portion of the lower site, south of the storm water detention ponds, is currently being utilized by a contractor (Weeminuche Construction Authority) as a field office (see Pic. 6). While the potential for washing out the fuel storage tanks and containment pad is minimal, a localized, high intensity storm event could result in localized erosion in and around the fuel storage area.

Pic. 4 – Upper waste embankment pile with additional waste material.

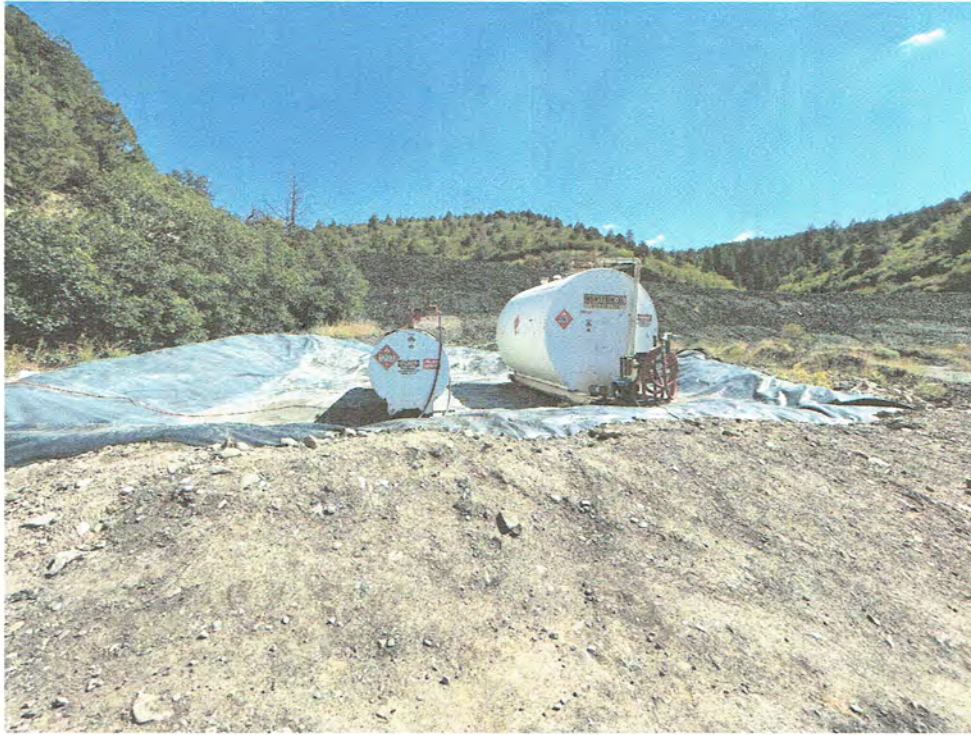
Pic. 5 – Fuel storage tanks/containment pad NE corner of lower waste pile.

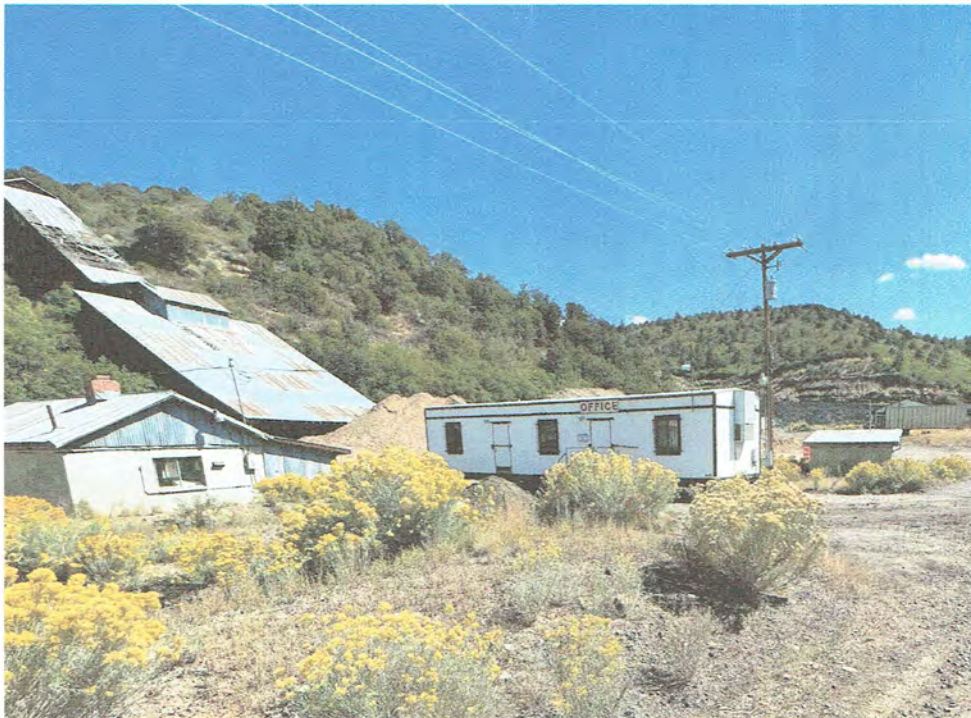
Pic. 6 –Temporary construction office south of east pond.
