MINERALS PROGRAM INSPECTION REPORT
PHONE: (303) 866-3567

MINE NAME: Cresson Project	MINE/PROSPECTING ID#: M-1980-244	MINERAL: Gold	COUNTY: Teller
INSPECTION TYPE: Monitoring	INSPECTOR(S): Brock Bowles	INSP. DATE: September 22, 2021	INSP. TIME: 09:00
OPERATOR: Cripple Creek & Victor Gold Mining Company	OPERATOR REPRESENTATIVE: Jeana Ratcliff	TYPE OF OPERATION: 112d-3 - Designated Mining Operation	
REASON FOR INSPECTION: Normal I&E Program	BOND CALCULATION TYPE:	BOND AMOUNT: \$209,491,188.00	
DATE OF COMPLAINT: NA	POST INSP. CONTACTS: None	JOINT INSP. AGENCY: None	
WEATHER: Clear	INSPECTOR'S SIGNATURE:

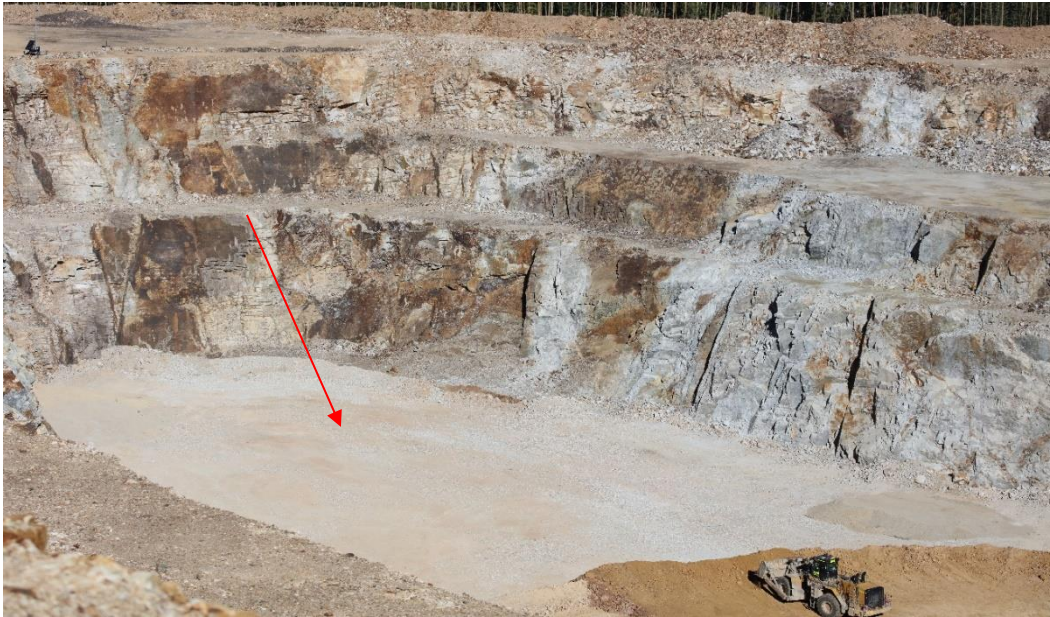
Two lifts of the low compaction backfill have been completed. The first lift was 20 feet thick and the second was 15 feet thick. This brought the backfill up to the level of the next bench (photo 1). On the south side of the bench area, additional work is need to plug some old mine workings. The concrete is on order but a delivery date has not been set. A rock larger than 5 feet was in the area of the old shaft (photo 2). It is left over from mining and will be removed during shaft remediation.

Photo 1 – Pit backfilled up to first bench level

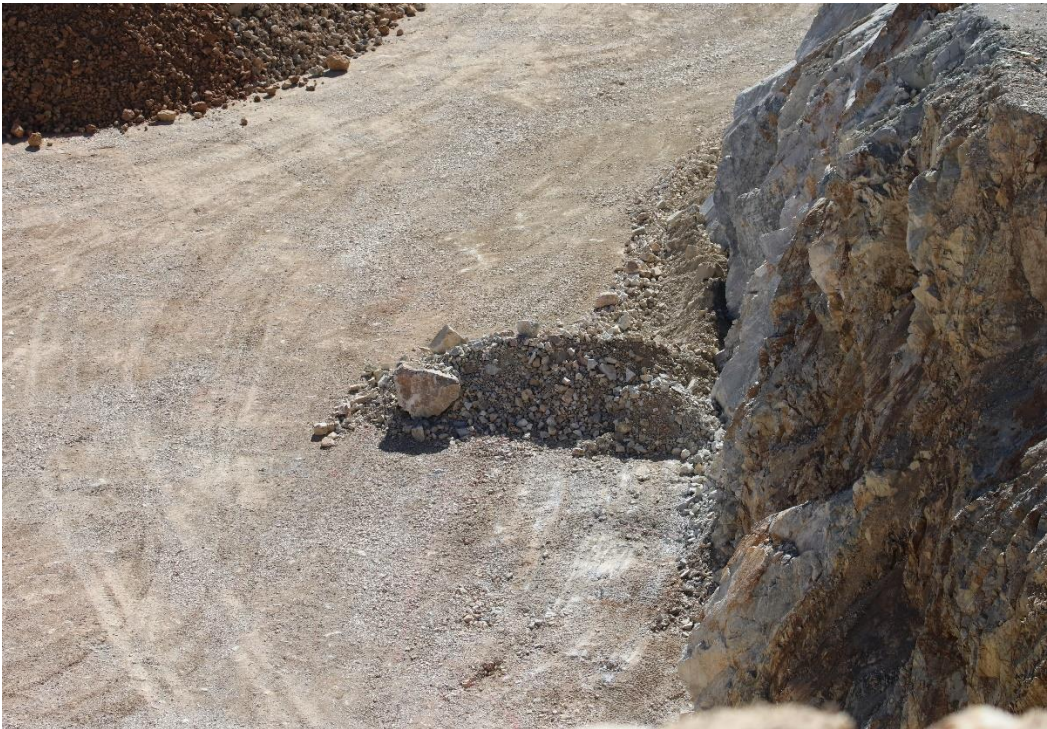
Photo 2 – Rock left over from mining, will be removed during shaft remediation

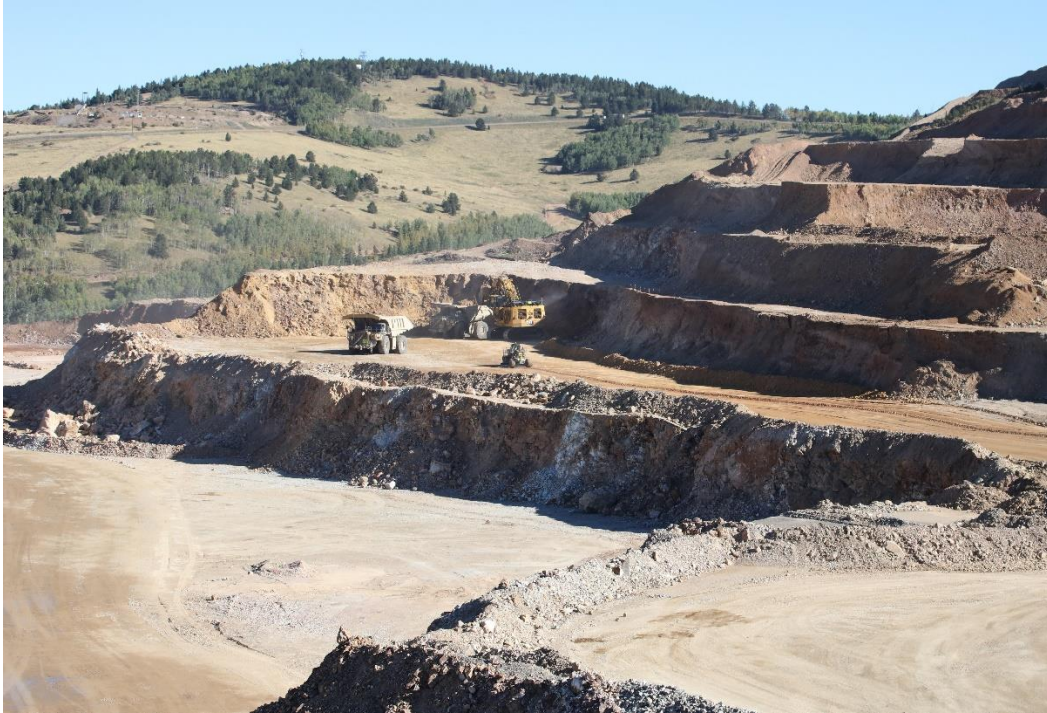
The 3rd lift construction was observed during this inspection. It is 20 feet thick. The lift was being constructed from the southeast side of the pit to the west and north. The backfill material was coming from the Schist Island phase 2 area today (photo 3). Several cycles of haul trucks (photo 4) were observed. No rocks greater than 5 feet in size were seen in the backfill material (photo 5). When a lift is completed, a fully loaded haul truck or water truck is assigned to drive over the entire lift to compact the lift. The truck drives between the previous tire tracks in a north/ south orientation and then east/west.

Photo 3- Schist Island Phase 2 area being used for backfill material

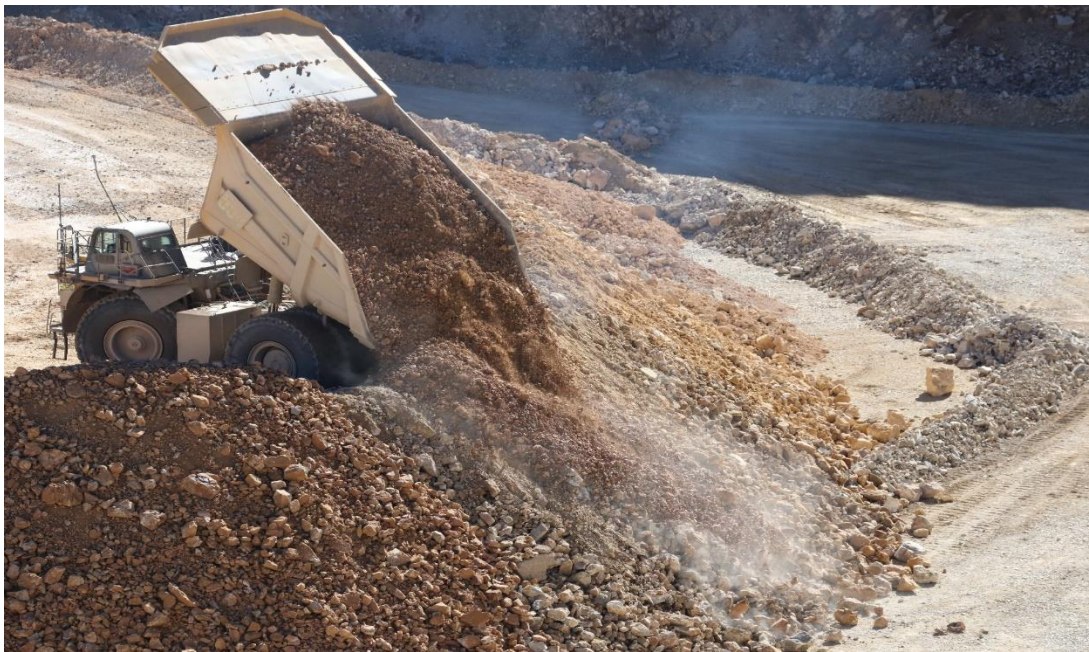
Photo 4 – Back fill material from Schist Island Phase 2 area

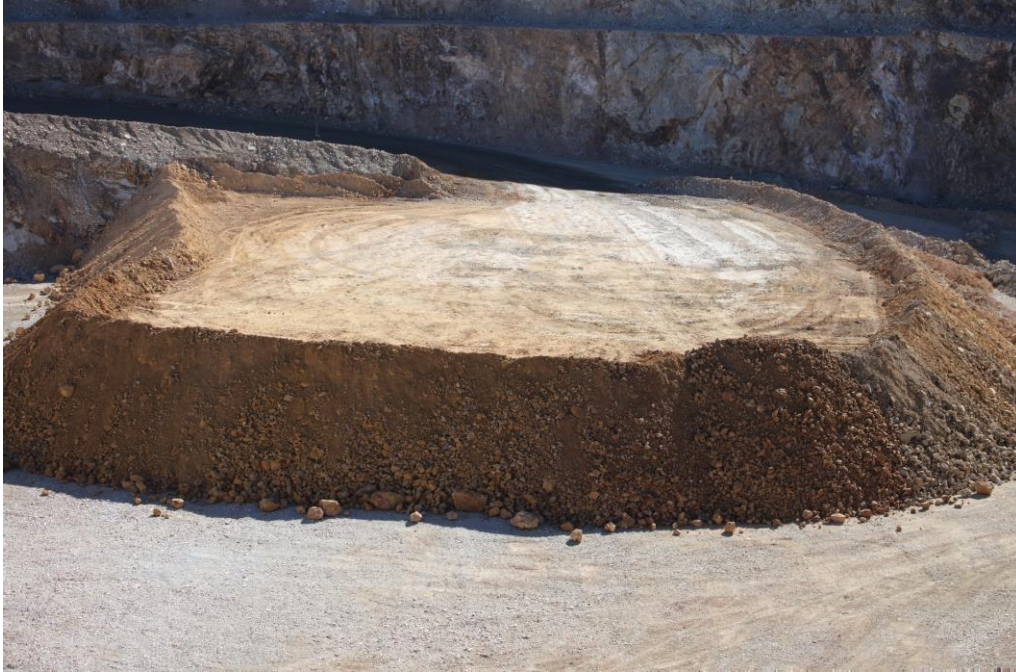
Photo 5 – Third lift construction, 20 foot lift, rocks all smaller than 5 feet
