MINERALS PROGRAM INSPECTION REPORT
PHONE: (303) 866-3567

MINE NAME: Tucson South Resource	MINE/PROSPECTING ID#: M-2004-044	MINERAL: Sand and gravel	COUNTY: Adams
INSPECTION TYPE: Surety-Related Inspection	INSPECTOR(S): Patrick Lennberg	INSP. DATE: September 23, 2021	INSP. TIME: 09:00
OPERATOR: Aggregate Industries - WCR, Inc.	OPERATOR REPRESENTATIVE: Gary Linden	TYPE OF OPERATION: 112c - Construction Regular Operation	
REASON FOR INSPECTION: Surety Related	BOND CALCULATION TYPE: None	BOND AMOUNT: \$3,505,000.00	
DATE OF COMPLAINT: NA	POST INSP. CONTACTS: None	JOINT INSP. AGENCY: None	
WEATHER: Clear	INSPECTOR'S SIGNATURE:

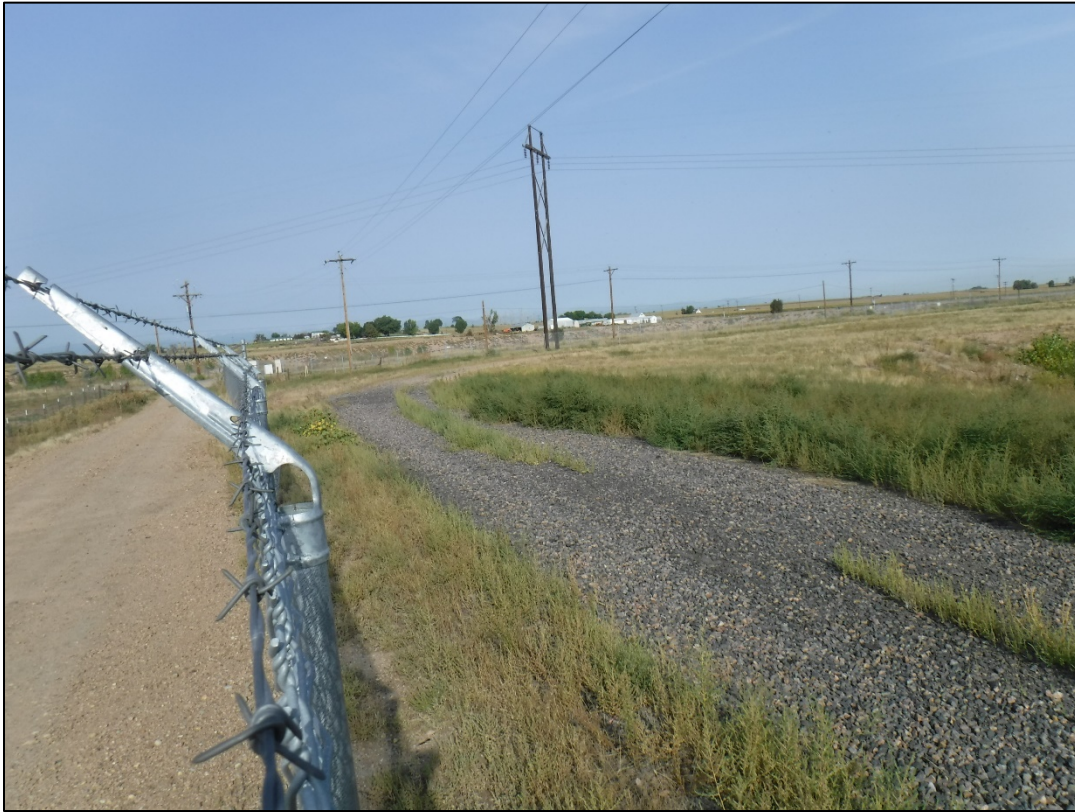
Photo 1: Looking west along the southern most area to be released

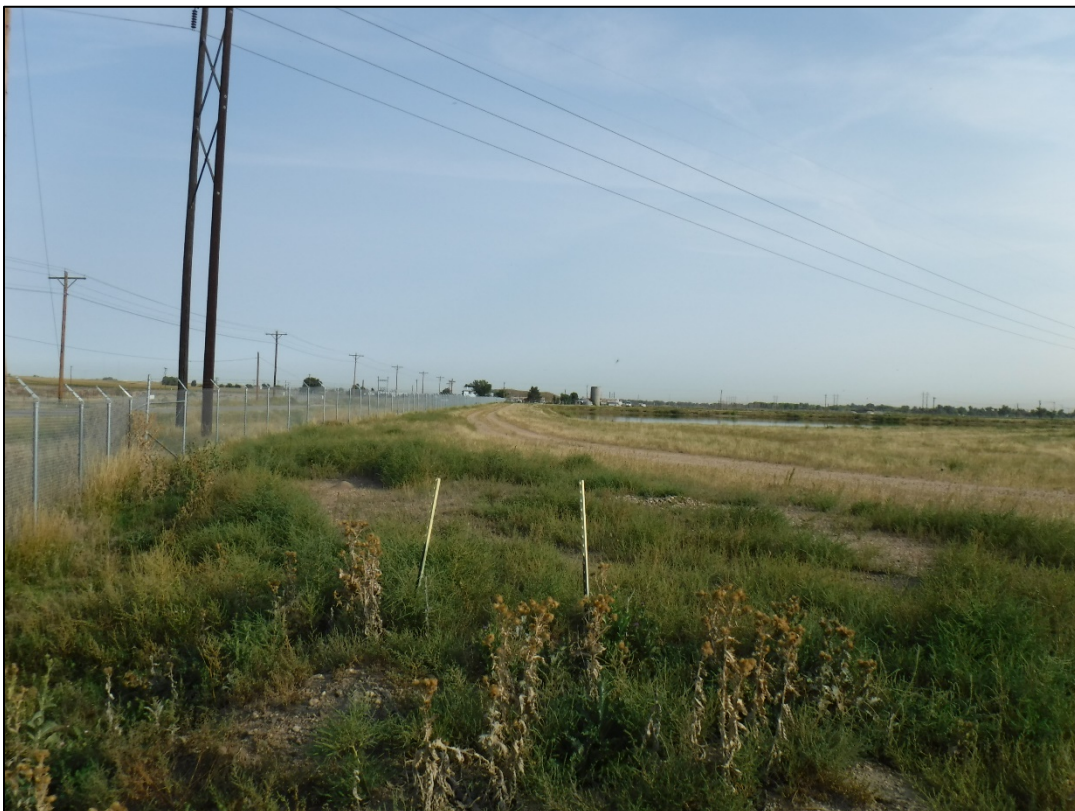
Photo 2: Looking north along the axis of conveyor corridor, the belt would have been within the fenced area

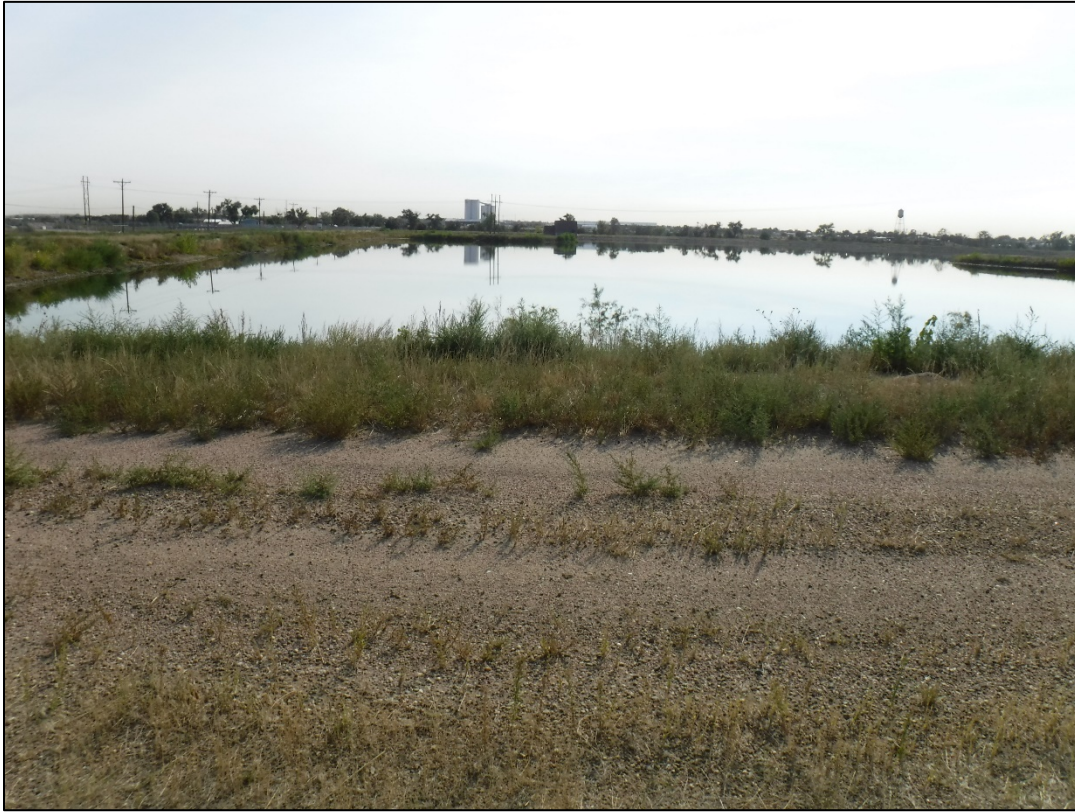
Photo 3: Maintenance road that would have been the base for the belt

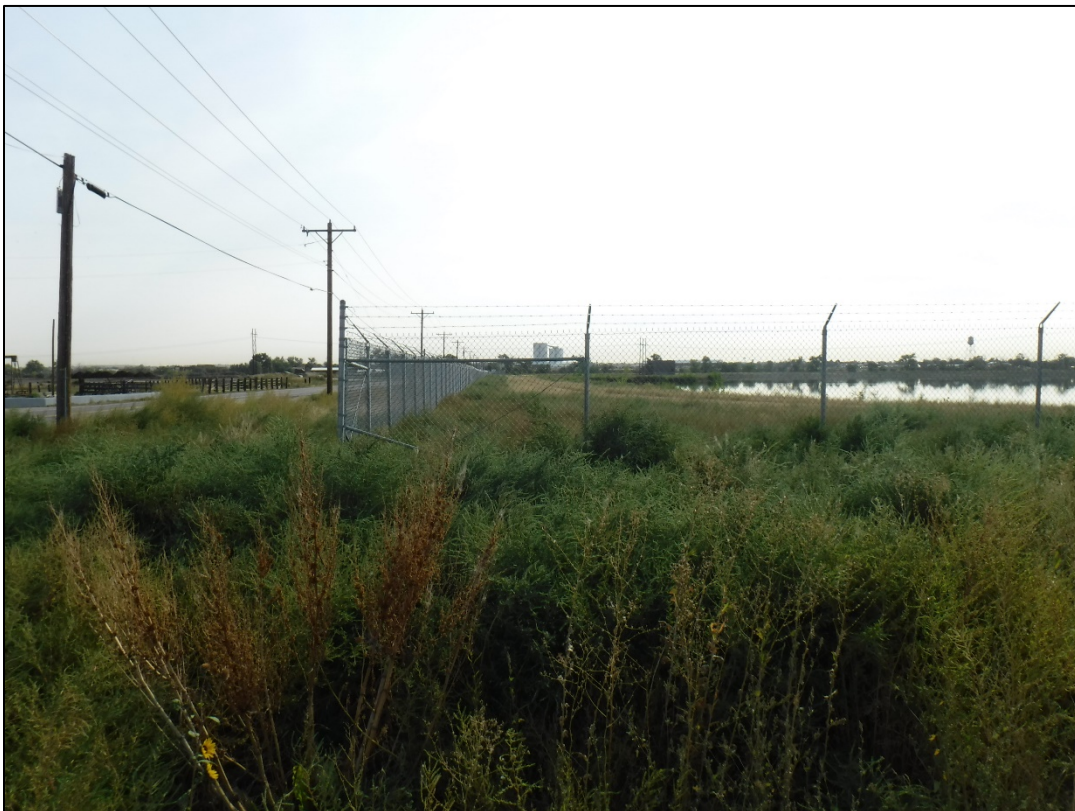
Photo 4: Looking east from the corner of Tucson and 168th Streets

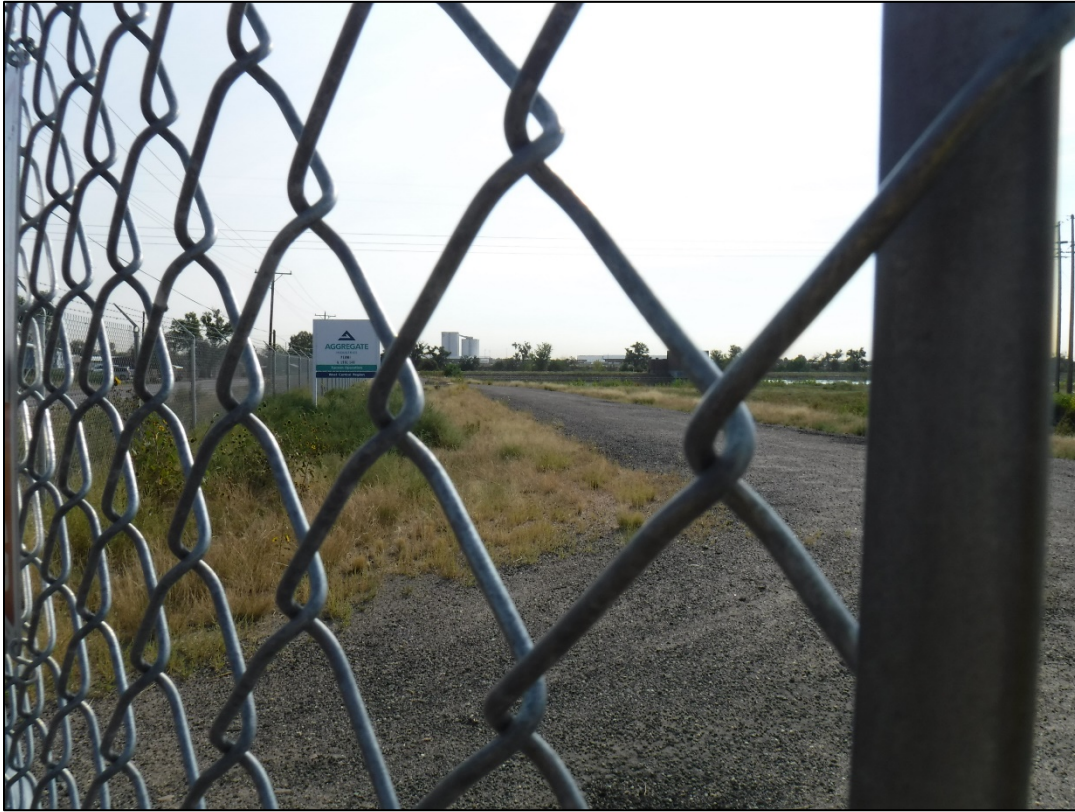
Photo 5: Looking east near the eastern end of the corridor

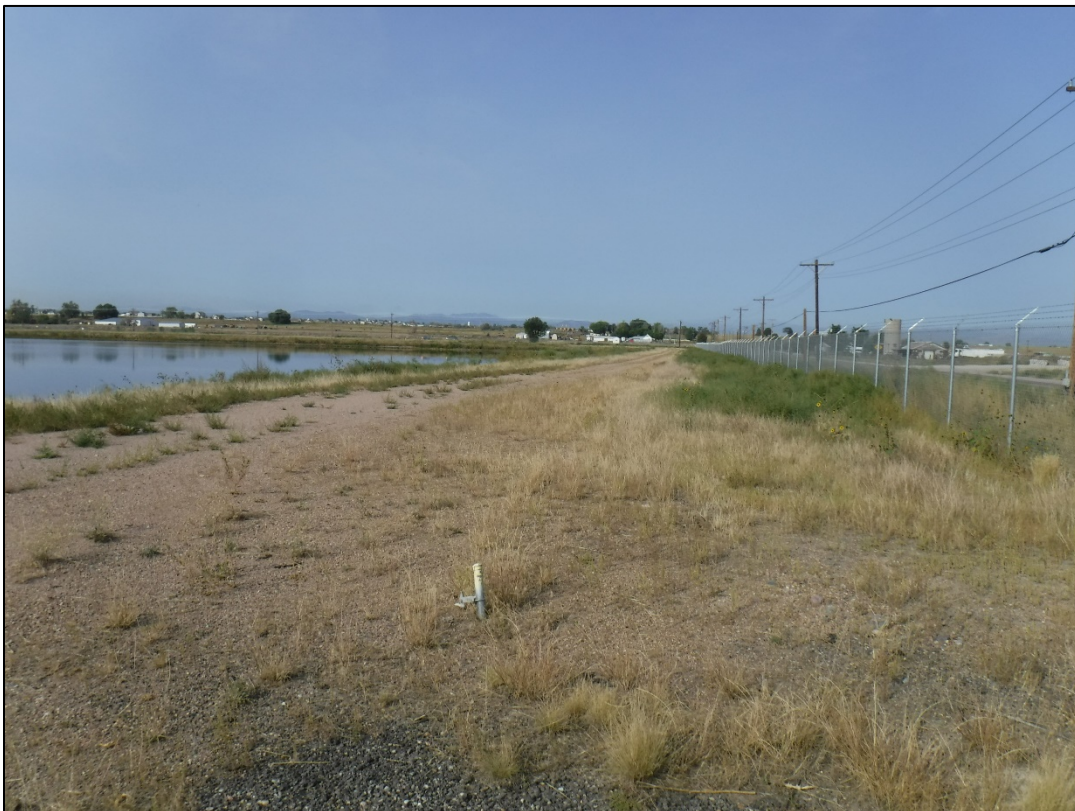
Photo 6: Looking west from the eastern portion of the corridor.
