COLORADO
Division of Reclamation,
Mining and Safety
Department of Natural Resources

Permit Number: C-1981-018 Mine Name: Deserado Mine Operator: Blue Mountain Energy, Inc. Operator Address: Mr. Kurtis Blunt 3607 County Road 65 Rangely, CO, 81648	County: Moffat, Rio Blanco Operation Type: Underground Permit Status: Active Ownership: Private
	Operator Representative Present: Kurt Blunt
Operator Representative Signature: (Field Issuance Only)

Inspection Start Date: September 23, 2021 Inspection Start Time: 09:58 Inspection End Date: September 23, 2021 Inspection End Time: 13:00		Inspection Type: Coal Complete Inspection Inspection Reason: Normal I&E Program Weather: Clear	
Joint Inspection Agency: None		Joint Inspection Contacts: None	
Post Inspection Agency: None		Post Inspection Contacts: None	
Inspector(s): Clayton Wein Travis Marshall	Inspector's Signature: <i>Clayton Wein</i>		Signature Date: 9/28/2021

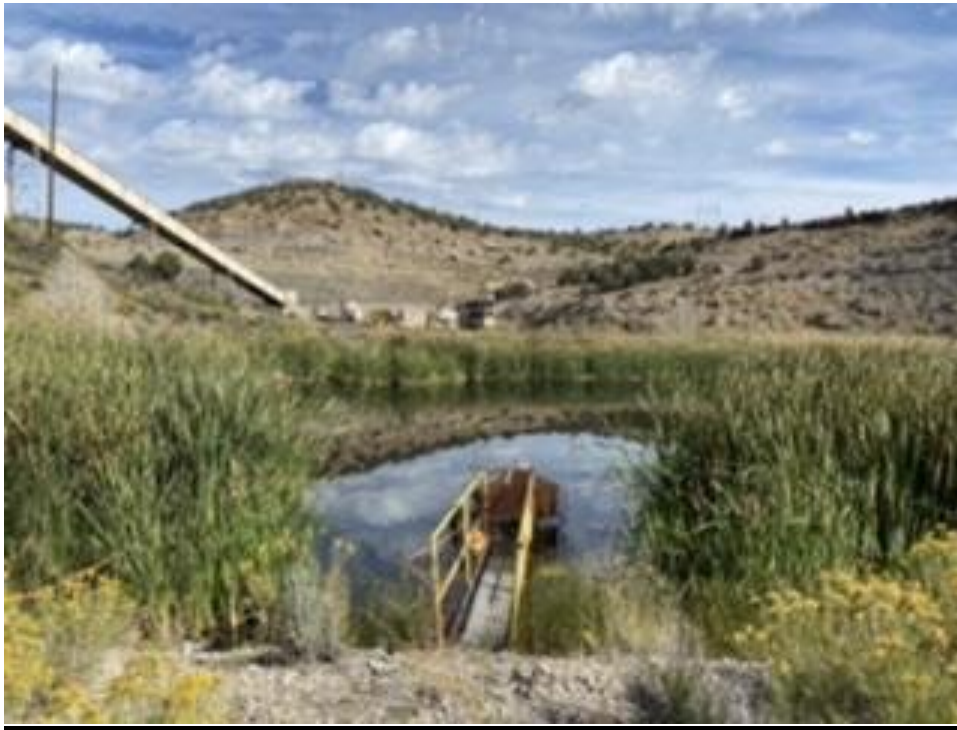
There are three ponds located at the main facilities area; the DP-1 pond, the PP-1 pond and the PP-2 pond. The DP-1 pond is located on the lower bench of the facilities area. The pond was impounding water during the inspection. Discharge through the primary spillway was occurring (Photo 1). The spillway was clear of debris and functional. The embankment for the pond was vegetated and stable. There were no observed erosional features. The PP-1 pond is located on the middle bench next to the prep plant. The pond was being cleaned during the inspection. There was no discharge from the pond. The embankment was stable with no erosion. The

Photo 1: The outlet of the DP-1 Pond.

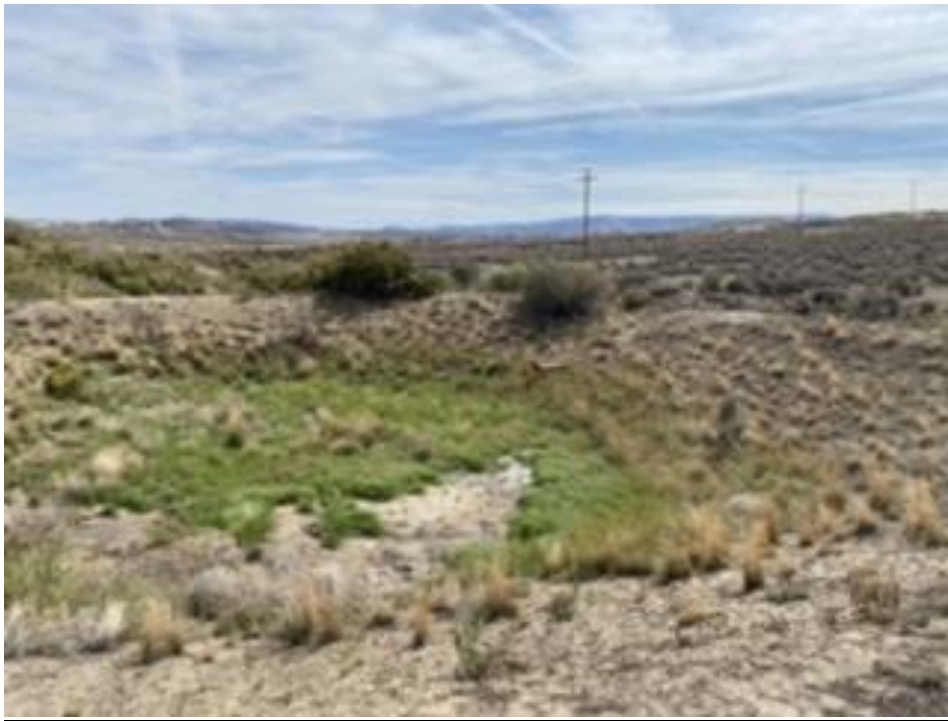
On the south side of the rail loadout, there is one pond (RR-1) and one sump (RS-1). The RR-1 pond was dry (Photo 2). The outlet for the pond was clear of debris. The embankment was vegetated and stable. No indications of erosion were noted. The RS-1 sump was also dry. The outlet was clear. The sump's embankments were stable with vegetative cover. There were no erosional issues observed. The Ditch along the south side of the loadout connected to the sump and pond was dry. Vegetation is becoming dense within the ditch. The Ditch may need to be cleaned in the future.

Photo 2: The embankment of the RR-1 pond.

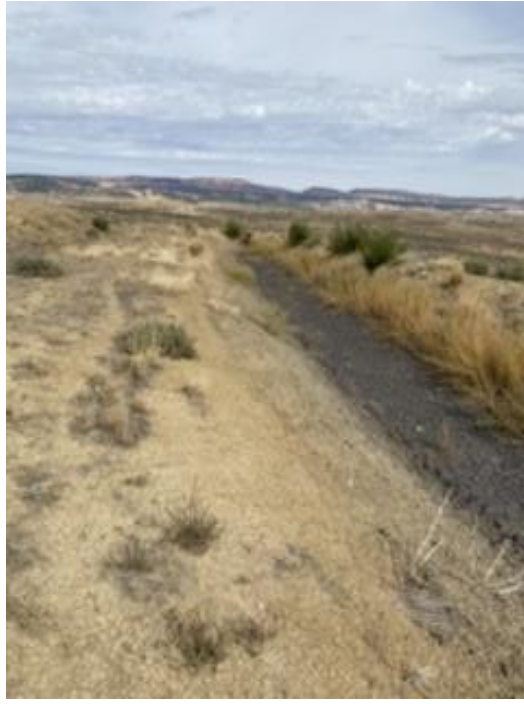
The B Seam Dewatering System No. 2 was inactive during the inspection. Both the upper (Photo 3) and middle cell of the system were dry. The Lower cell off the system is not used even when the system is active. The embankments for the cells had no indications of instability or erosion. There is sufficient vegetative cover on the cells' embankments. No obstructions were observed in the cells' outlets.

Photo 3: The first cell of the B Seam Dewatering System No. 2.

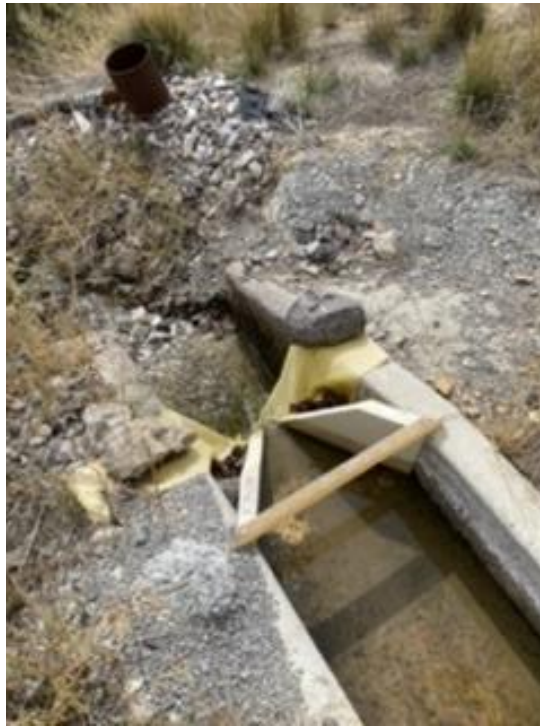
The B Seam Dewatering System No. 1 was impounding water in all of the cells in the system. The outlet at the last Chance pond was discharging to Red Wash. The outlet was clear and functional (Photo 4). The embankments of the system were stable with vegetative cover. There were no indications of erosional features.

Photo 4: The outlet of the Last Chance Pond.

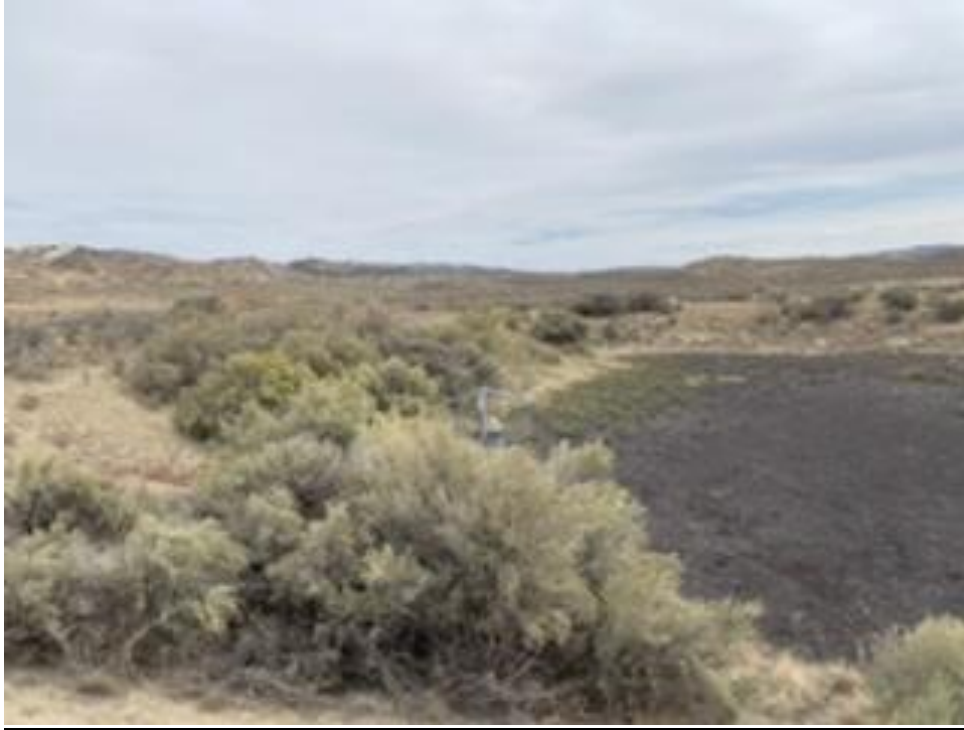
One pond is associated with the RP-1 refuse pile. The RP-1 pond was dry during the inspection (Photo 5). The embankment was stable and vegetated. The outlet was unobstructed.

Photo 5: The embankment of the RP-1 pond.

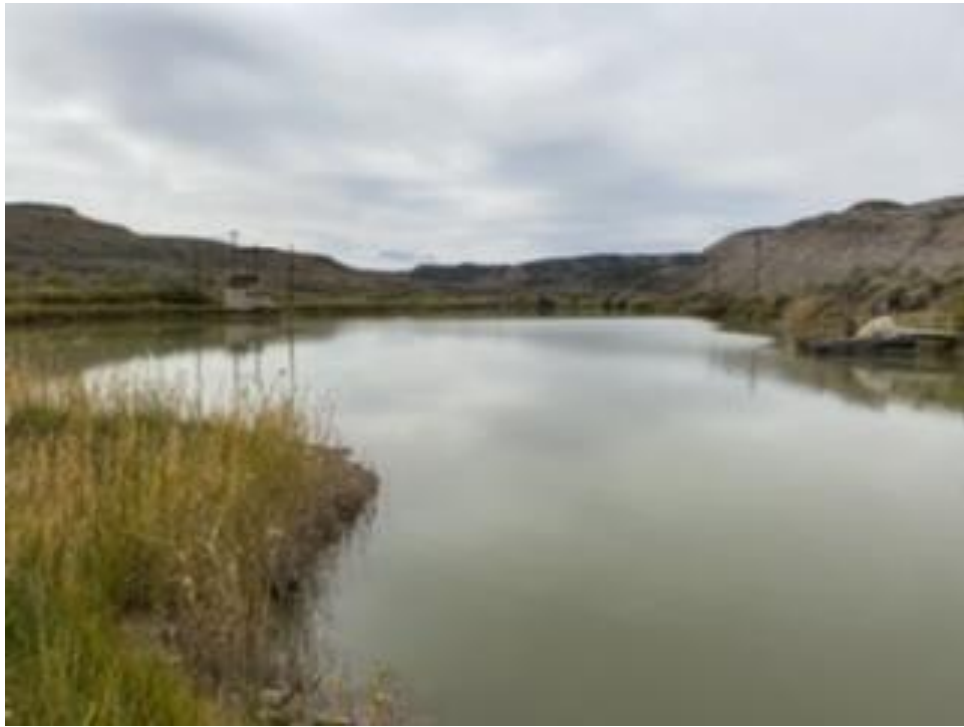
The Raw Water Lagoon was holding water (Photo 6). The embankment was vegetated and stable. There were no erosional issues observed.

Photo 6: The Raw Water Lagoon.

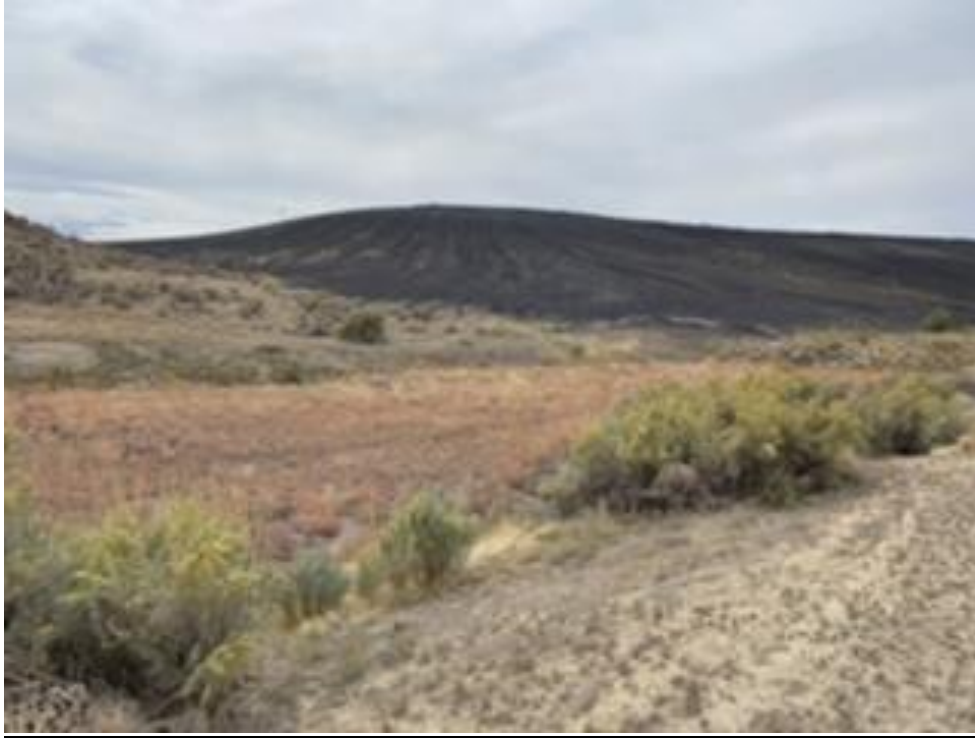
The RP2/3/4 and RP-5a (Photo 7) refuse piles were stable with no erosional concerns. The slopes of the piles had no major rills or gullies on them. The perimeter ditches were dry and stable. No erosional features were observed.

Photo 7: The north slope of the RP-5a refuse pile.

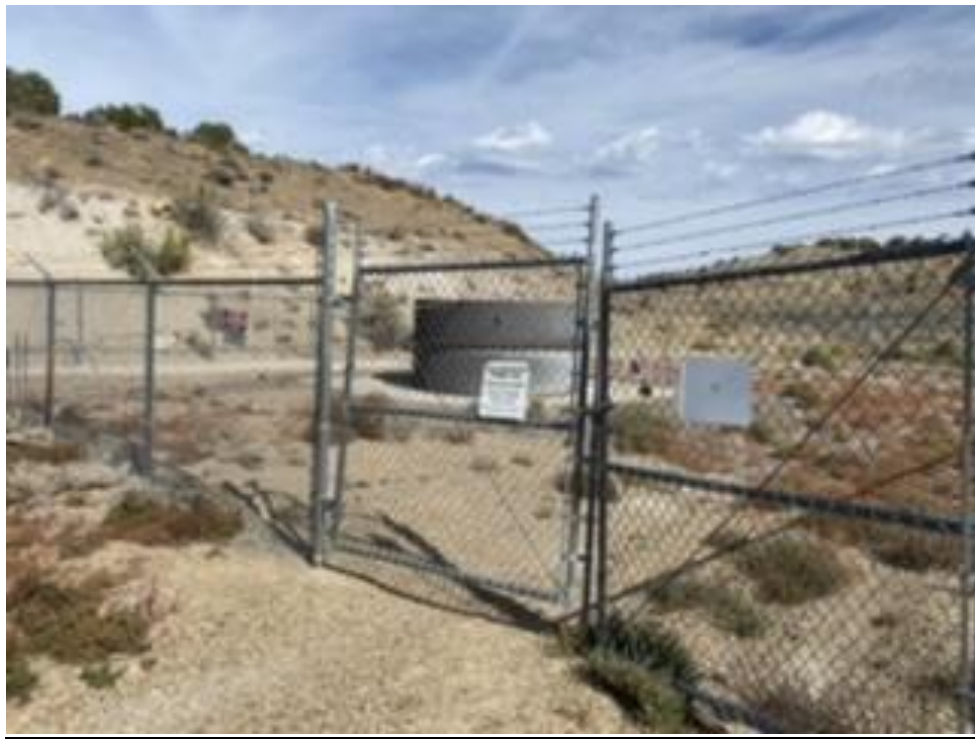
All Support Facilities inspected had stable pads with no erosional issues. The berms on the pads were intact and vegetated. No off site impacts were observed.

Photo 8: The B Seam Vent Shaft No. 1.
