To: Jerald Schnabel  
Continental Materials Corp.  
File: August 2021 Monitoring Summary

**Reference: August 2021 Geotechnical Monitoring Summary Pikeview Quarry**

Client/Project  
**CONTINENTAL MATERIALS  
 CORP.  
 PIKEVIEW QUARRY SLOPE  
 MONITORING**

Title  
OBSERVATIONS FROM  
SEPTEMBER INSPECTION

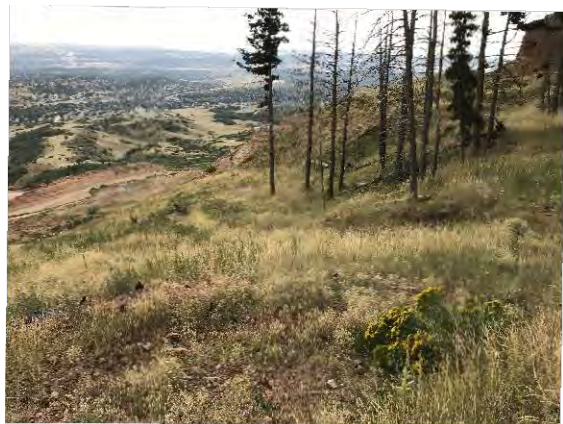
6. HUMMOCKS AREA ON SOUTH END OF SITE

- Crack Free: No cracking was observed on the native granite slopes above the extents of the disturbed area. The hummocky field in the area immediately above the southern extent of the slide shows evidence of cracking but they are not fresh or active. No new or open cracks were found immediately inside or next to the slide area.

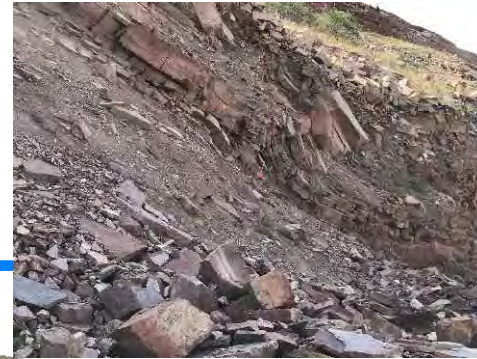
4. PRISM NEAR ROCK FALL AREA

- Prisms: Several prisms were passed along the walking route and appeared to be in their original position and operating normally. Control points and most of the monitoring points are permanently cemented into the ground while some of the monitoring points are cemented into 5-gal buckets to be portable as needed (Photo 4).

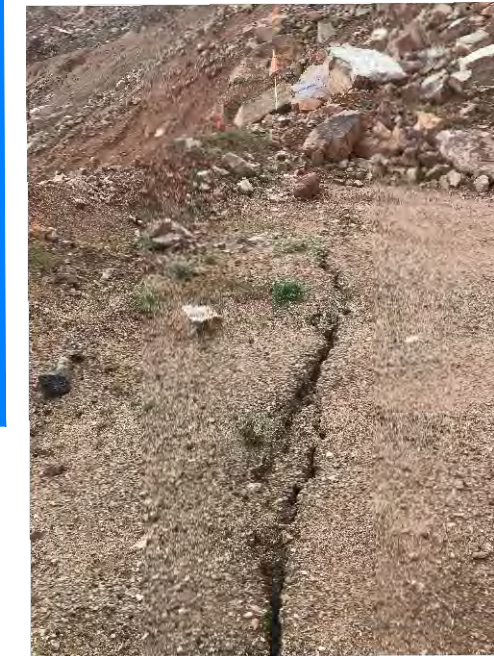
2. CRACKING NEAR PRODUCTION FLOOR

- Previously Observed Cracks: Previously observed tension cracks remain on the production floor and at the crest of fill slopes. These cracks were observed following the period of heavy rain. The cracks are not believed to be a problem, they are likely due to the recent heavy rain saturating the area (Photo 2).

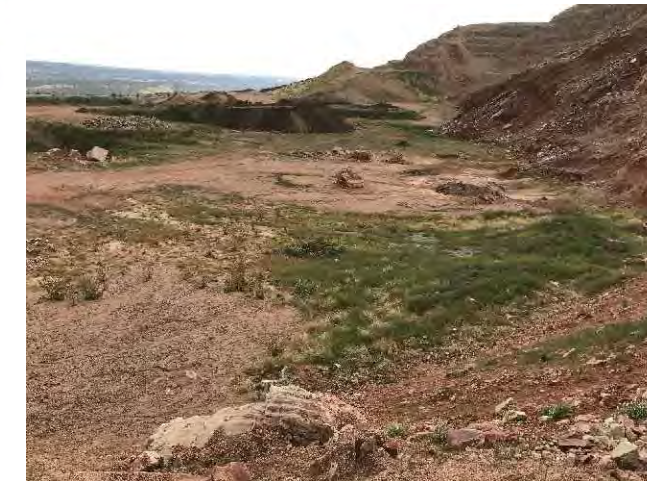
1. PRODUCTION FLOOR

- Fill: Material is being imported and temporarily placed on the "production floor". During the visit, different types of material including mulch and general fill were being deposited here for future placement.

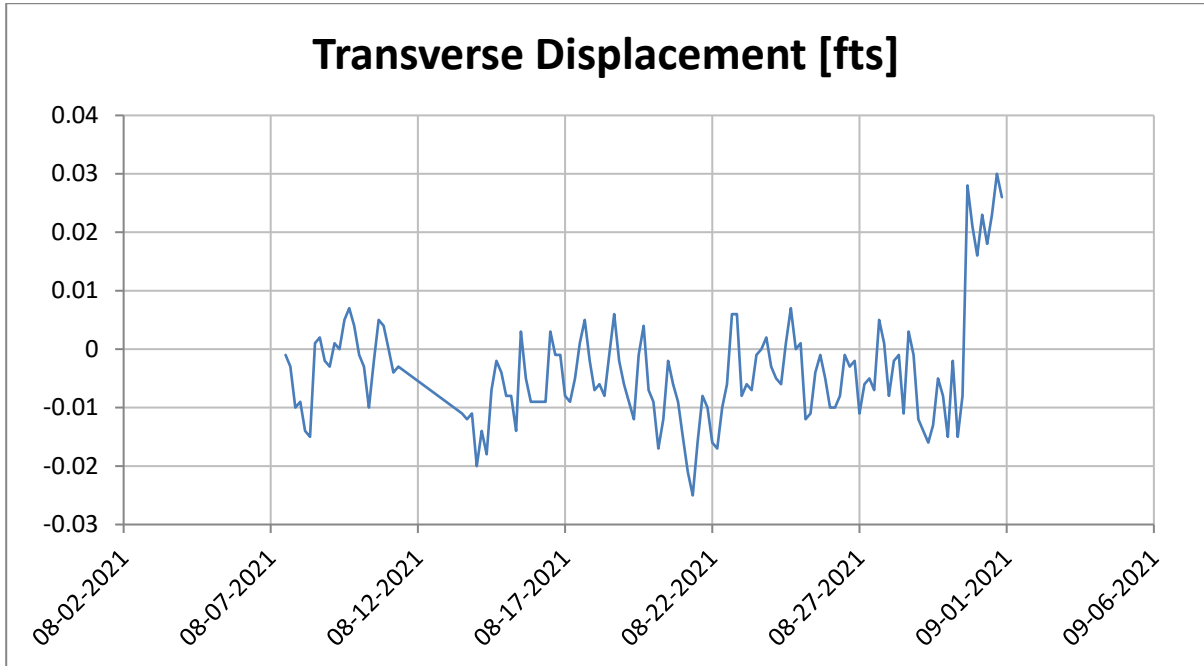
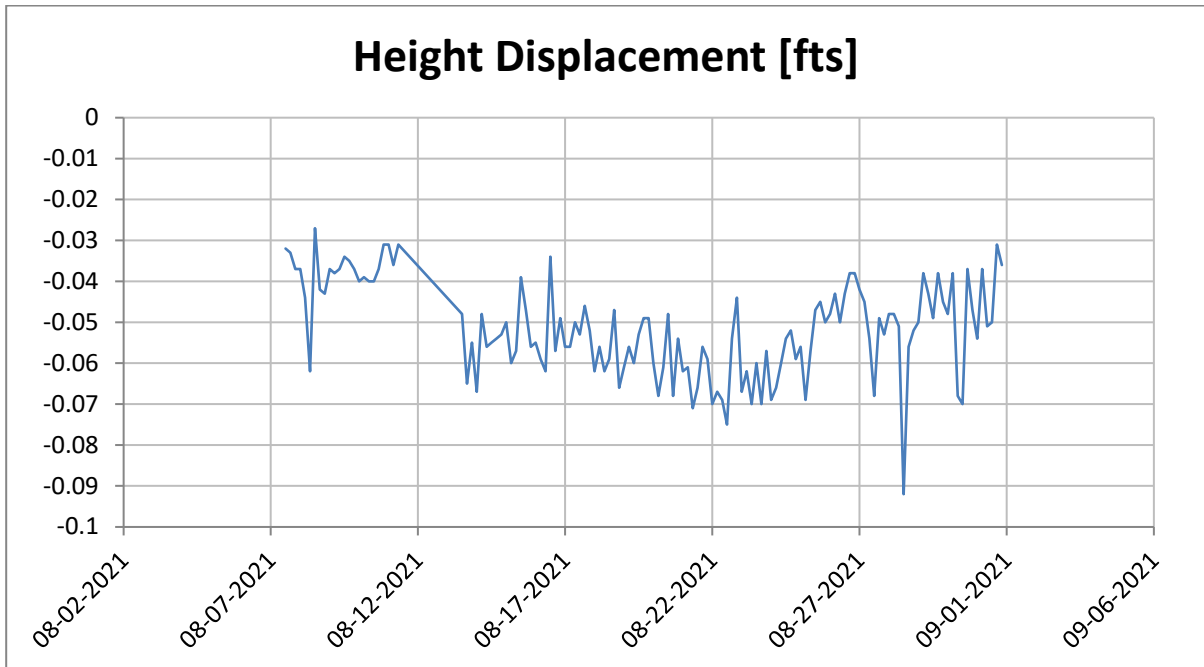
## Prism P69

1. Survey accuracy is +/-0.016 feet.
2. Alarm threshold is +/-0.35 feet.
3. Transverse displacement is in the horizontal direction. Positive direction means closer to the robotic station.
4. Height displacement is in the vertical direction. Positive direction means higher in elevation.
5. Prism P69 was moved due to erosion and placed approximately in its original position.

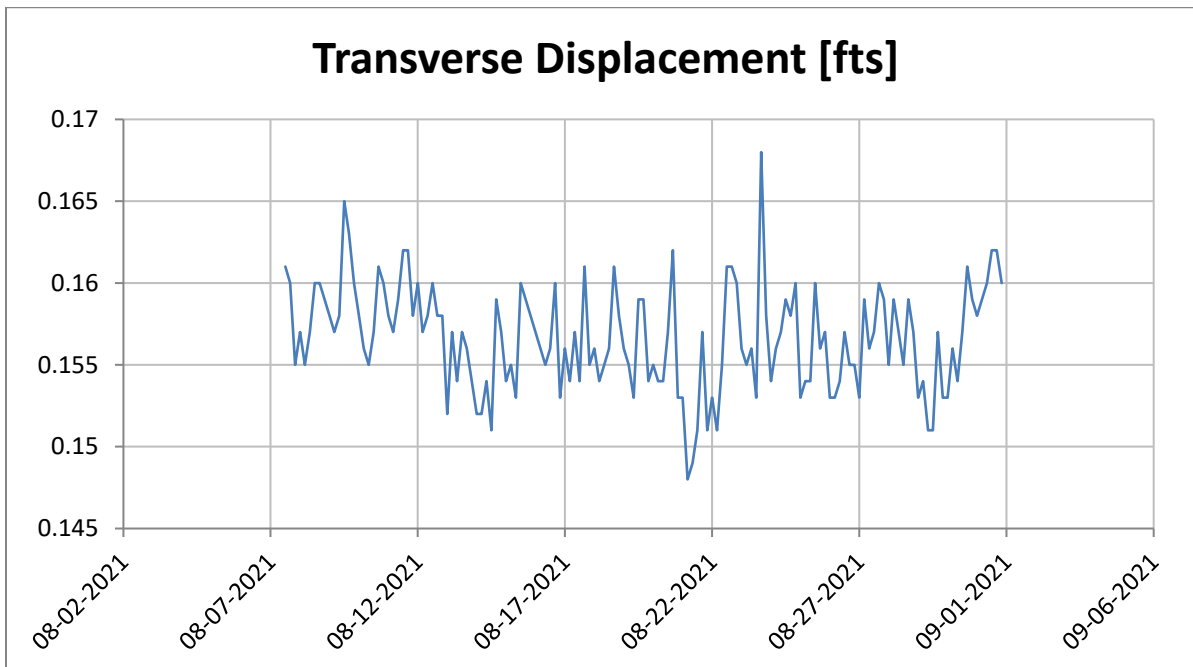
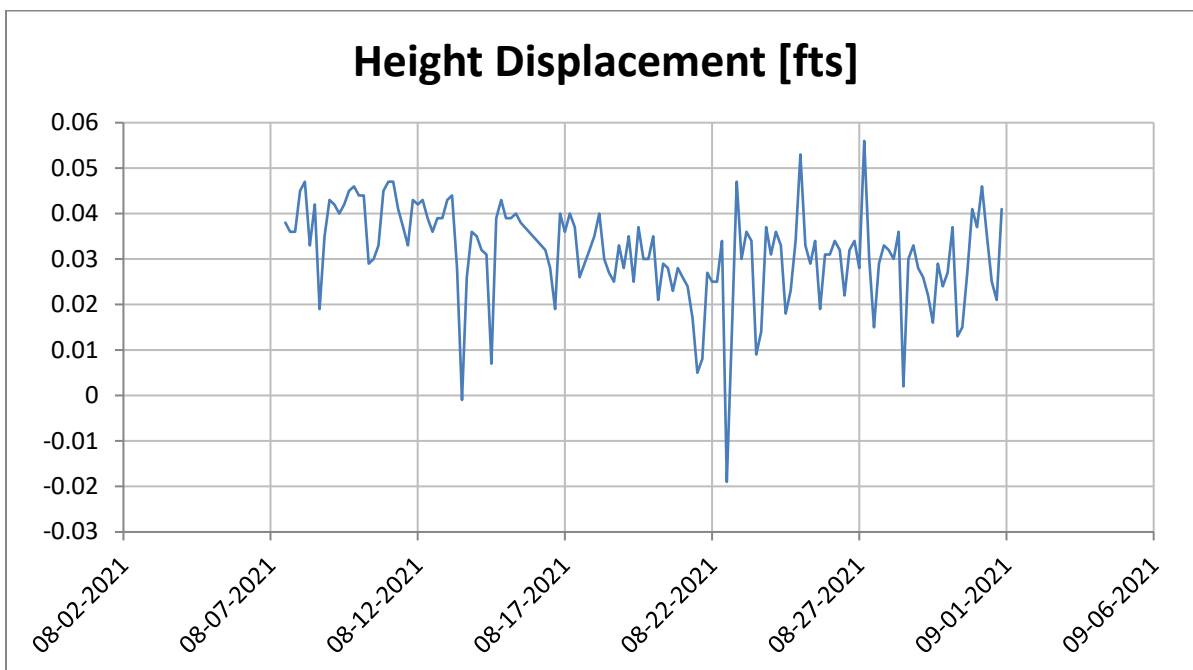
# Prism TOE1

1. Survey accuracy is +/-0.016 feet.
2. Alarm threshold is +/-0.35 feet.
3. Transverse displacement is in the horizontal direction. Positive direction means closer to the robotic station.
4. Height displacement is in the vertical direction. Positive direction means higher in elevation.
5. Prism TOE1 was moved by wildlife on 8/15.

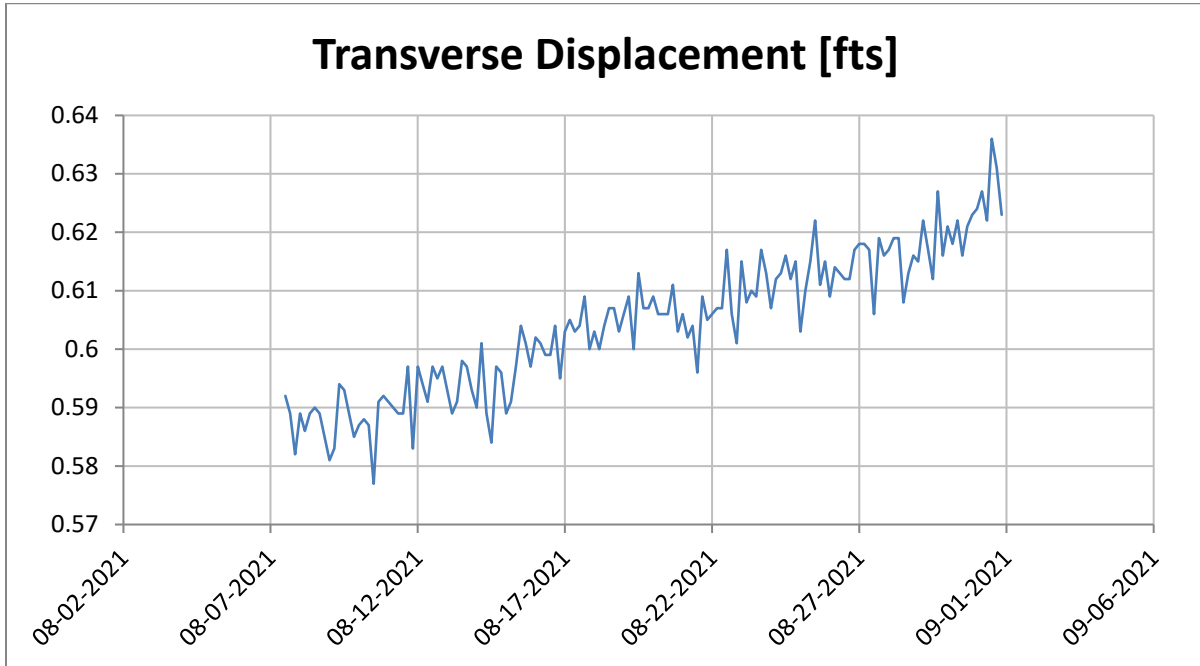
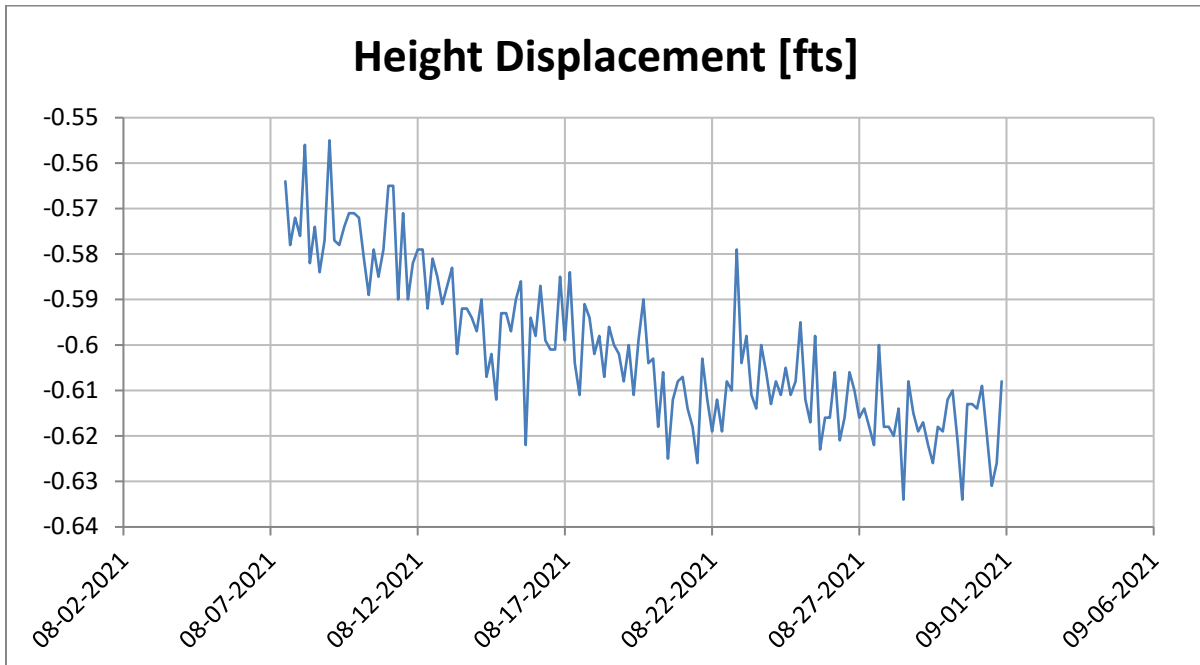
## Prism TOE2

1. Survey accuracy is +/-0.016 feet.
2. Alarm threshold is +/-0.35 feet.
3. Transverse displacement is in the horizontal direction. Positive direction means closer to the robotic station.
4. Height displacement is in the vertical direction. Positive direction means higher in elevation.
5. Prism TOE2 is located at the toe of the landslide. This location showed slope creep movements at slow velocities.

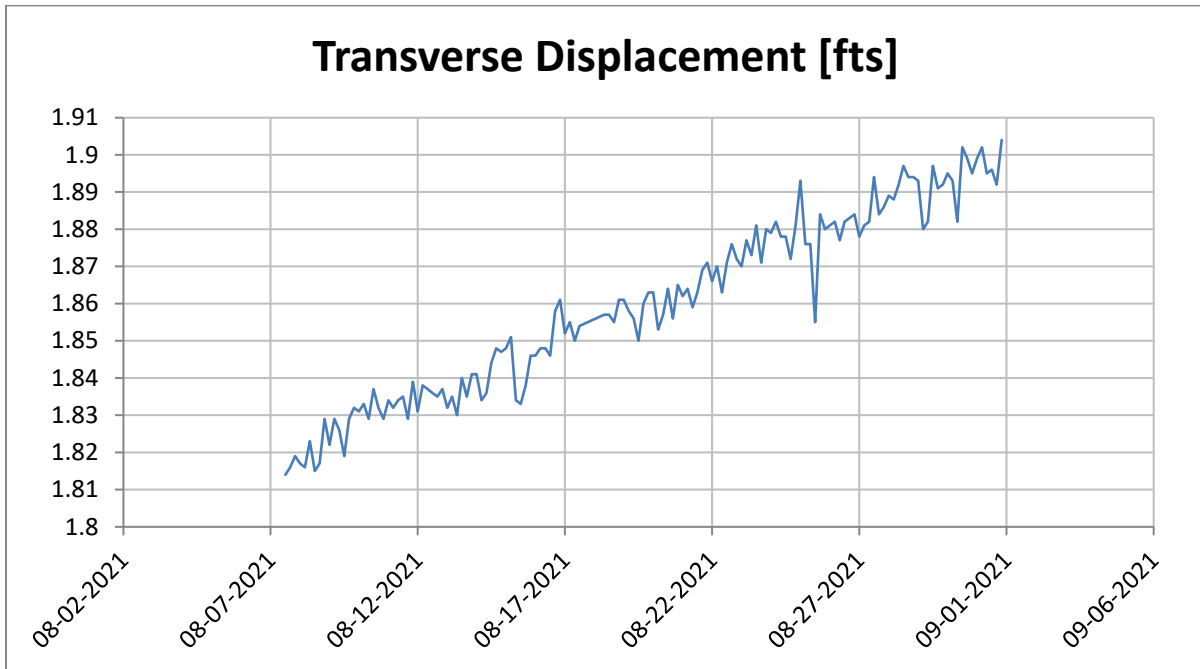
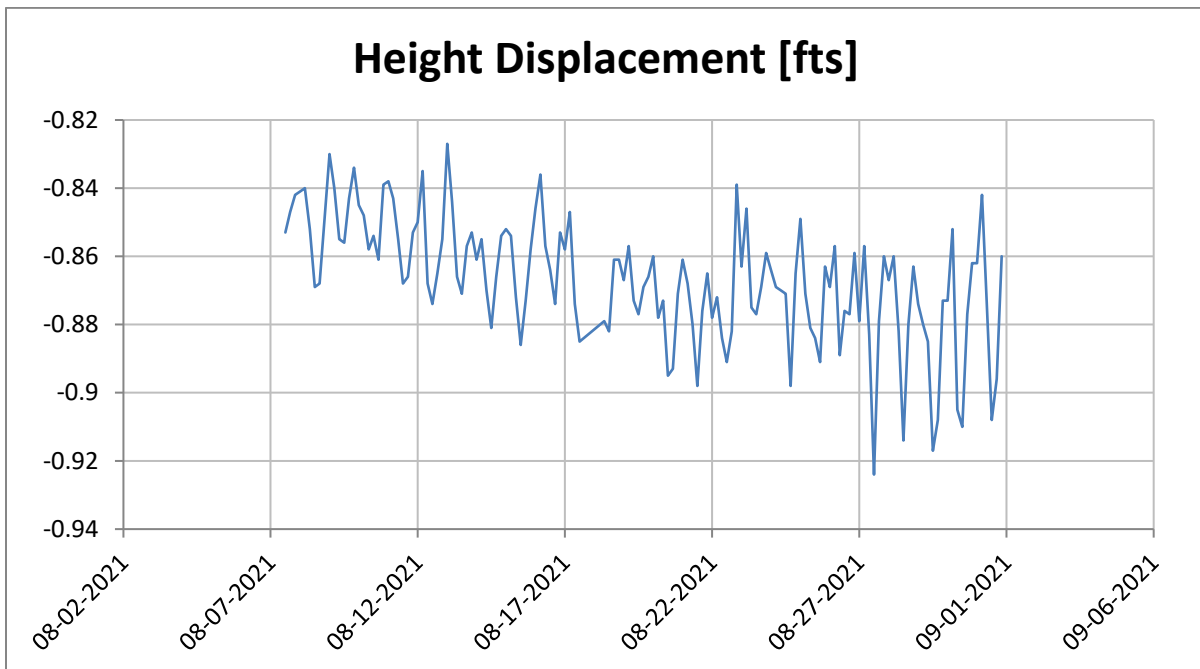
## Prism TOE3

1. Survey accuracy is +/-0.016 feet.
2. Alarm threshold is +/-0.35 feet.
3. Transverse displacement is in the horizontal direction. Positive direction means closer to the robotic station.
4. Height displacement is in the vertical direction. Positive direction means higher in elevation.
5. Prism TOE3 was moved by wildlife on 8/17.

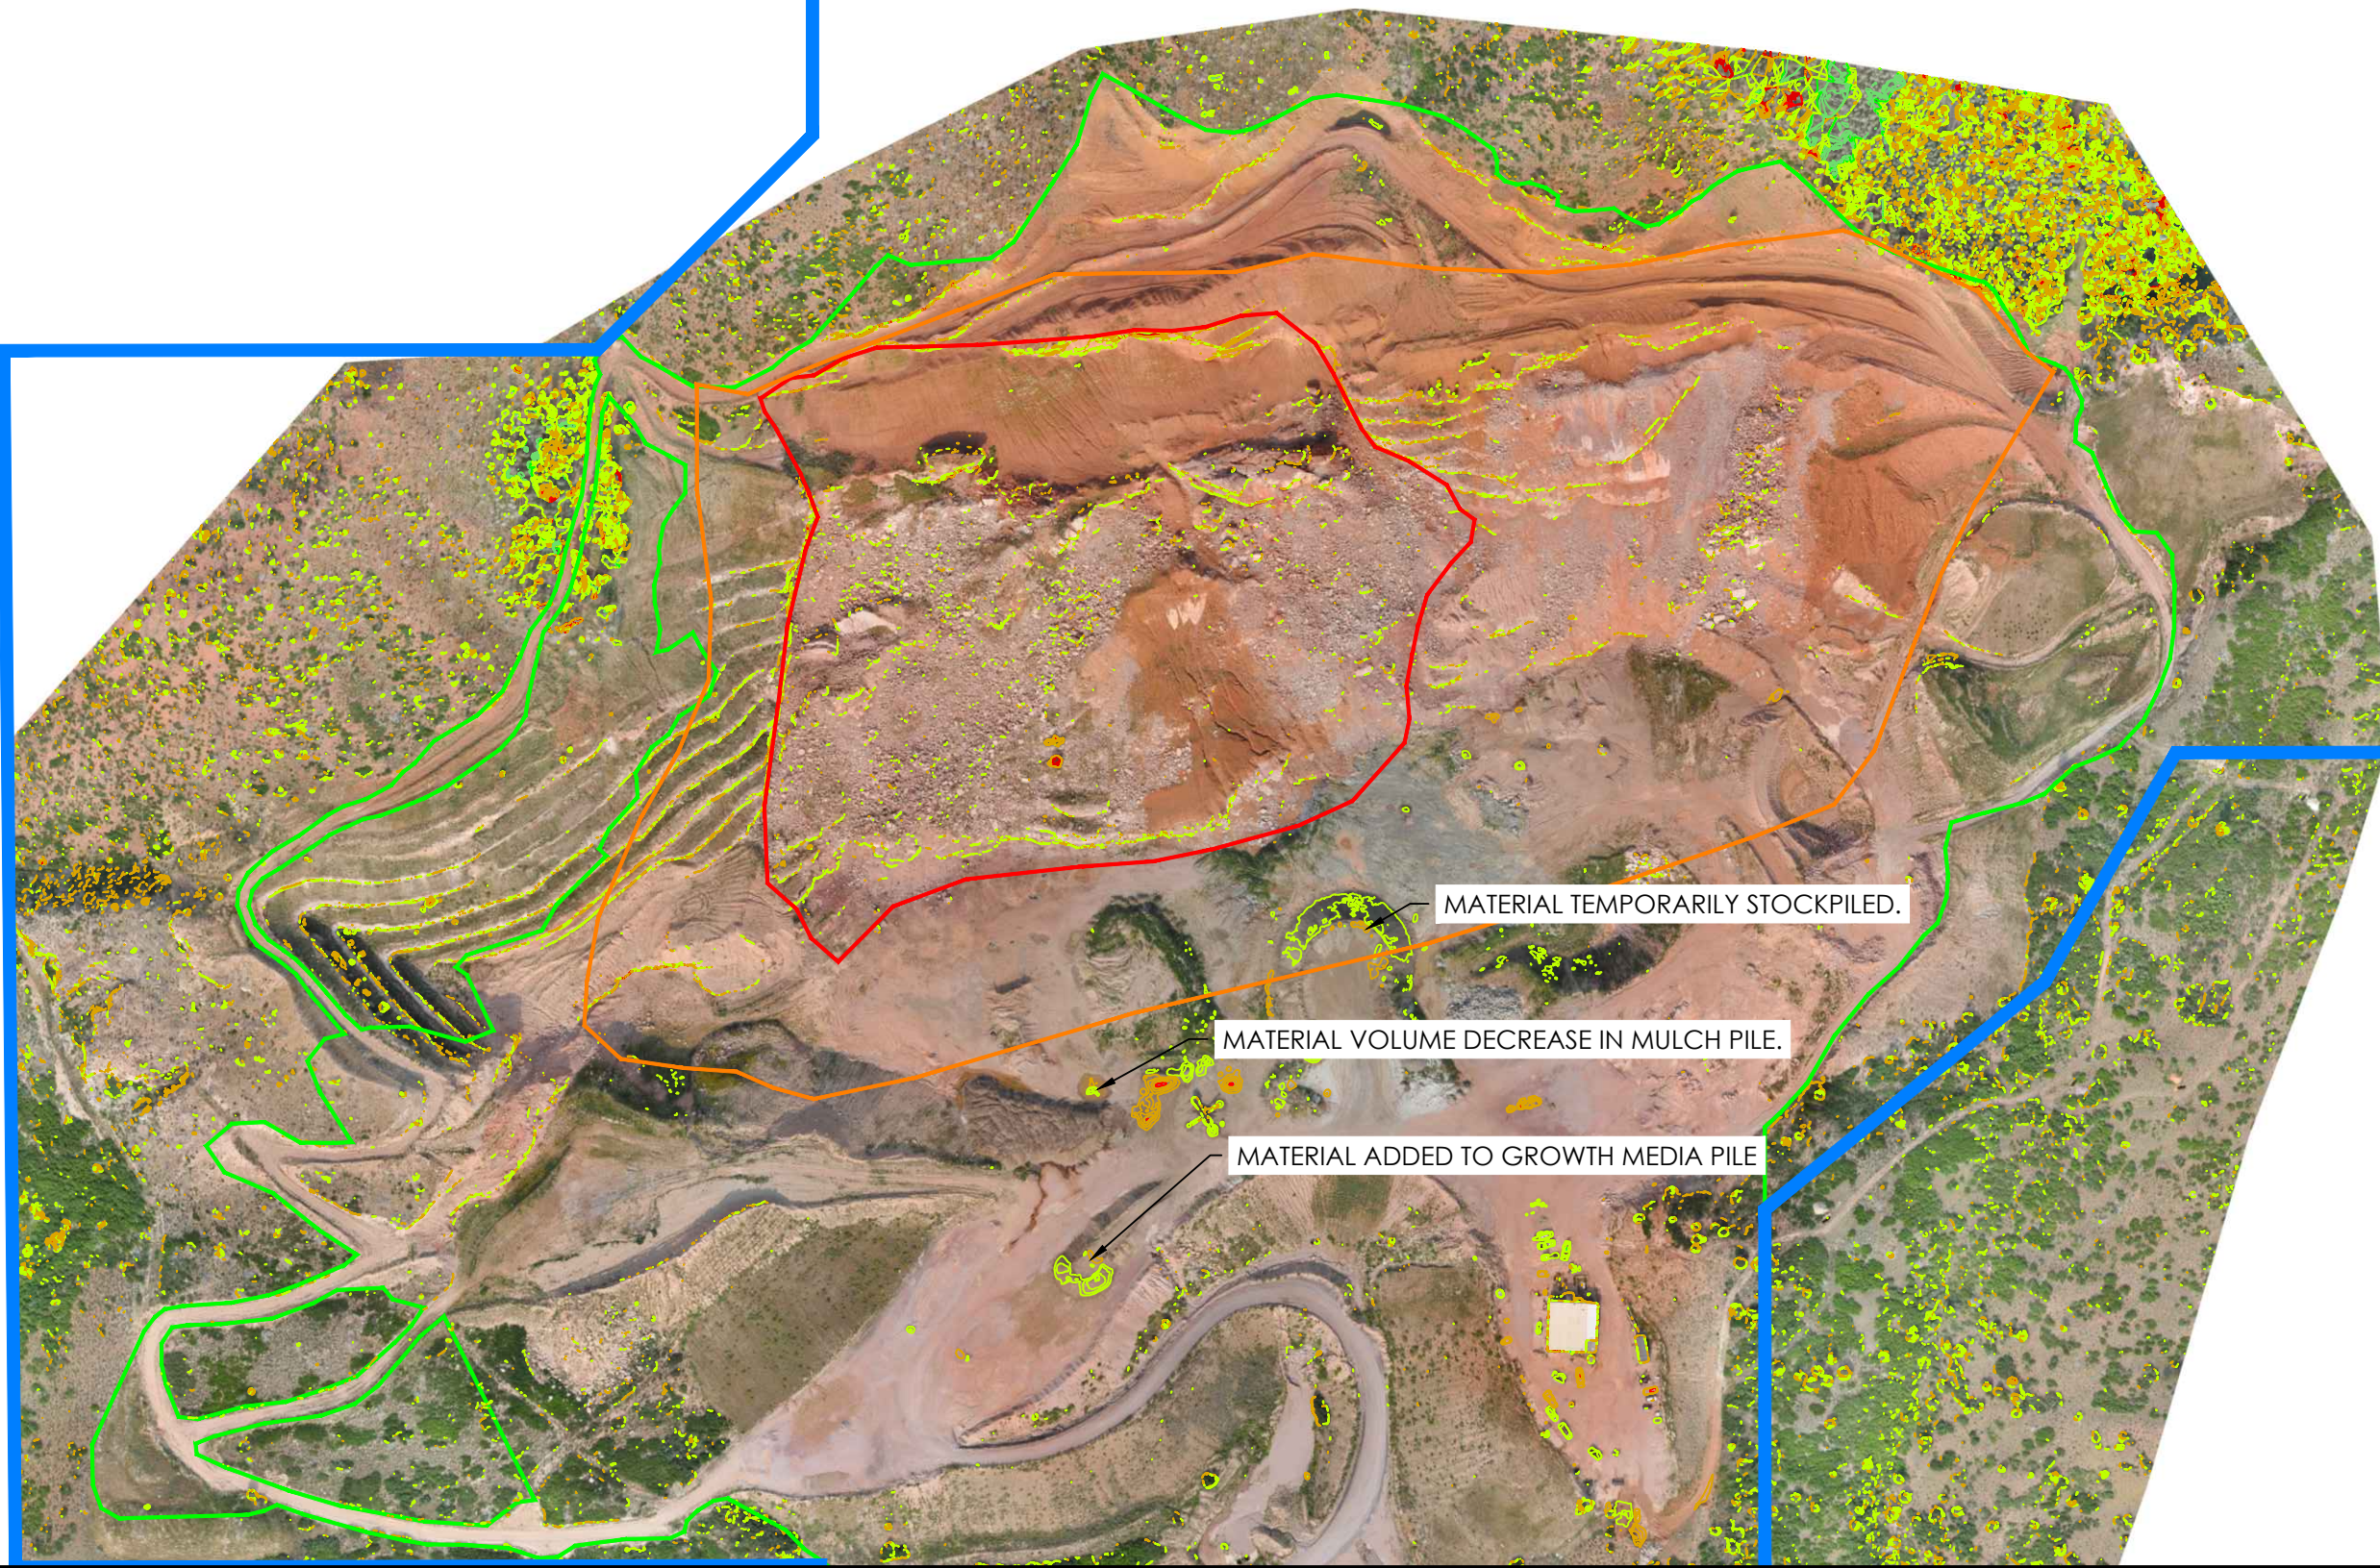
Revision #	Date
	2021.09.30
Drawn By PK	Figure No. 5

The July topography was also compared to the August topography to identify changes in the site topography. Comparison of the two surveys showed that approximately 3,120 yd<sup>3</sup> of fill had been imported and temporarily placed. No slope movements or other changes in topography were identified. The current imagery and topography are included in Figures 1 and 3, and the comparison surface is included as Figure 5 in Appendix C.

As previously reported in the September 2020 monitoring report, there are limitations with the method of comparing drone surveys from different months. The drone data indicate changes in the slopes along each of the reclamation benches, buildings, and areas with trees or shrubs. These areas are stable, and the changes are the result of survey limitations on or near vertical slopes.
