## QUARTERLY SEDIMENTATION POND INSPECTION REPORT

Mine: New Elk

Inspection Period: Third Quarter 2021

Inspection Date: 9/20/2021

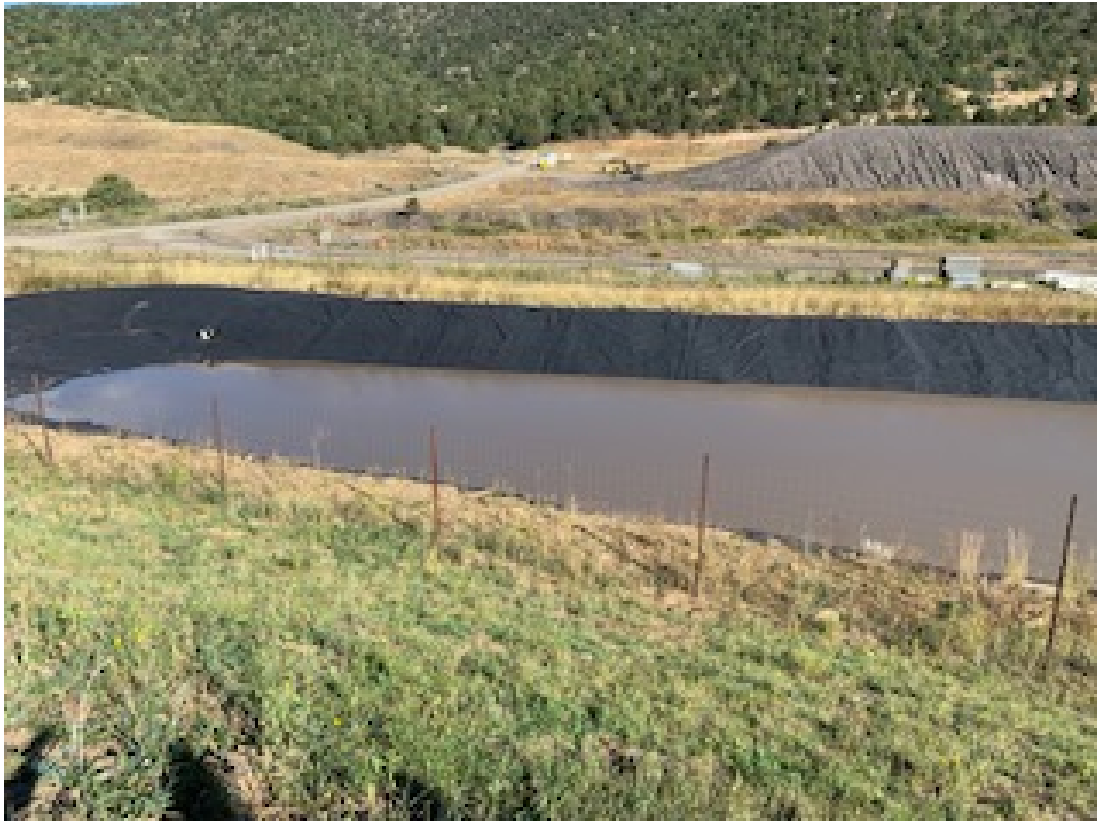
**Pond 1**

Pond liner is in good working condition at time of inspection. Pond was holding water at time of  
inspection. The mine is putting water into the pond. Water level has not raised much since mining  
began in late May.

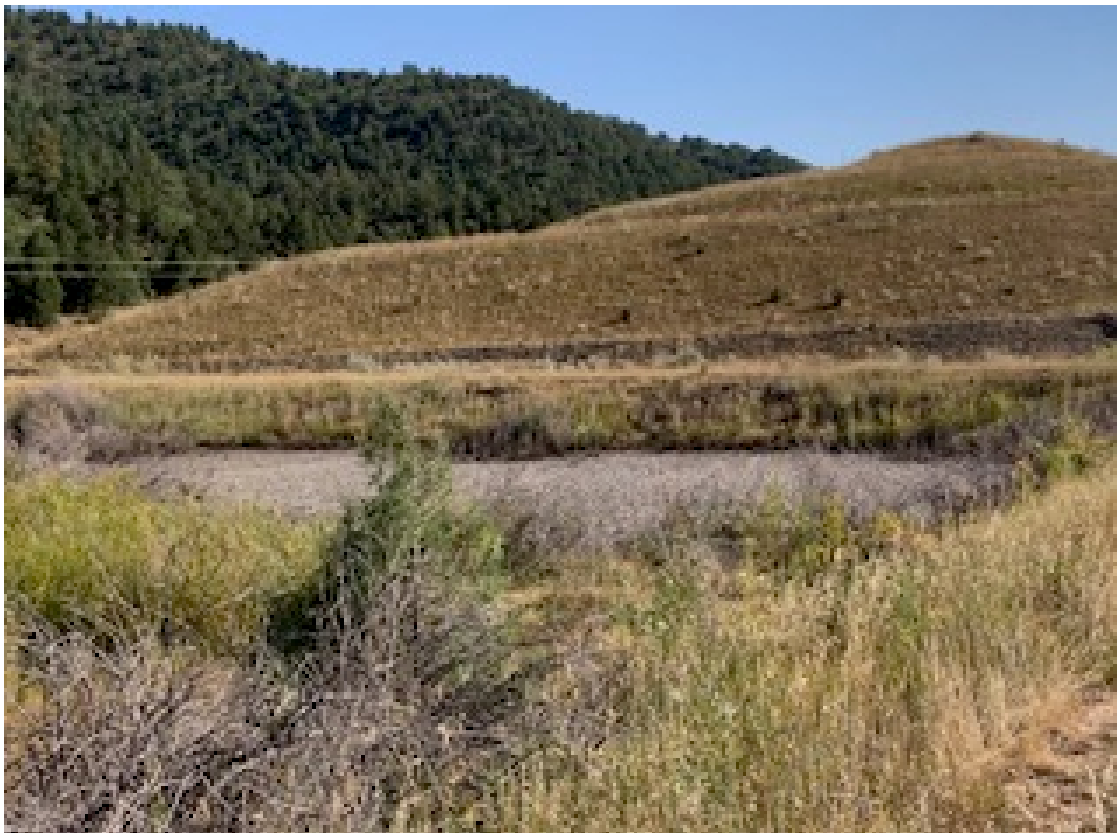
**Pond 4**

Pond is holding a very little amount water and is not close to discharging. Area around decant

needs to be cleaned of vegetation.

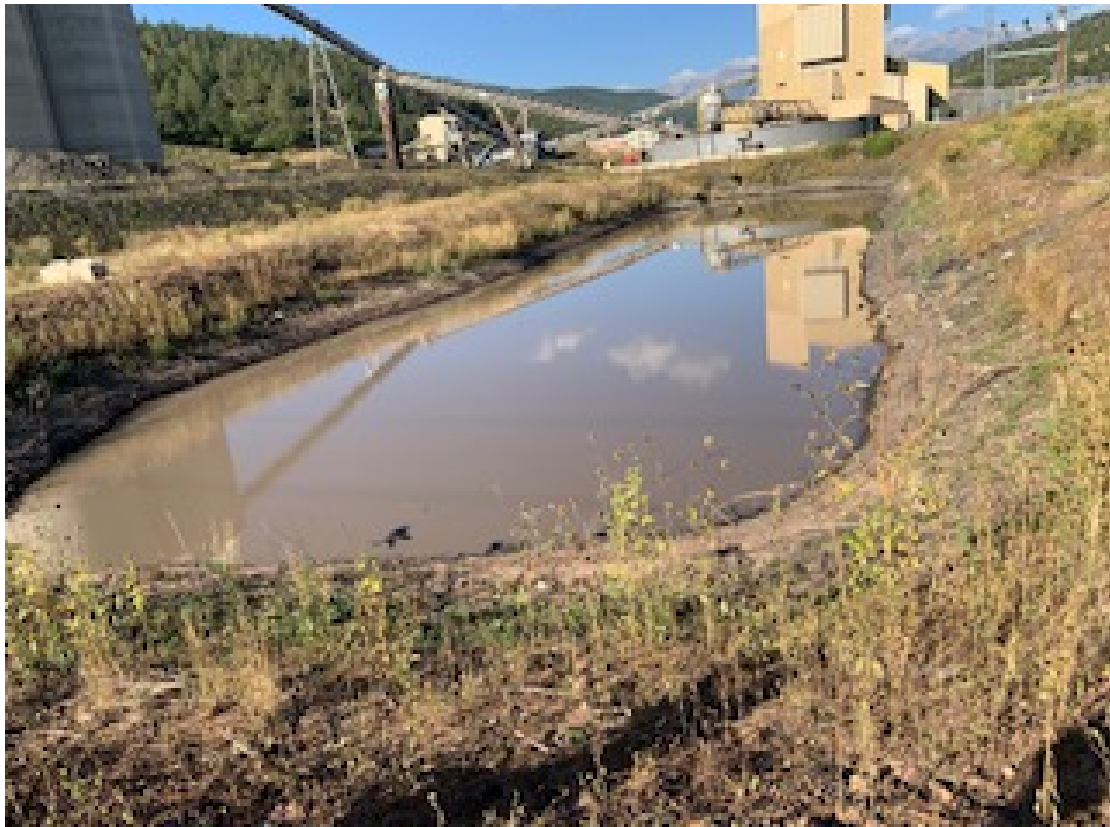
**Pond 6**

Pond is holding water, but it is not close to full.

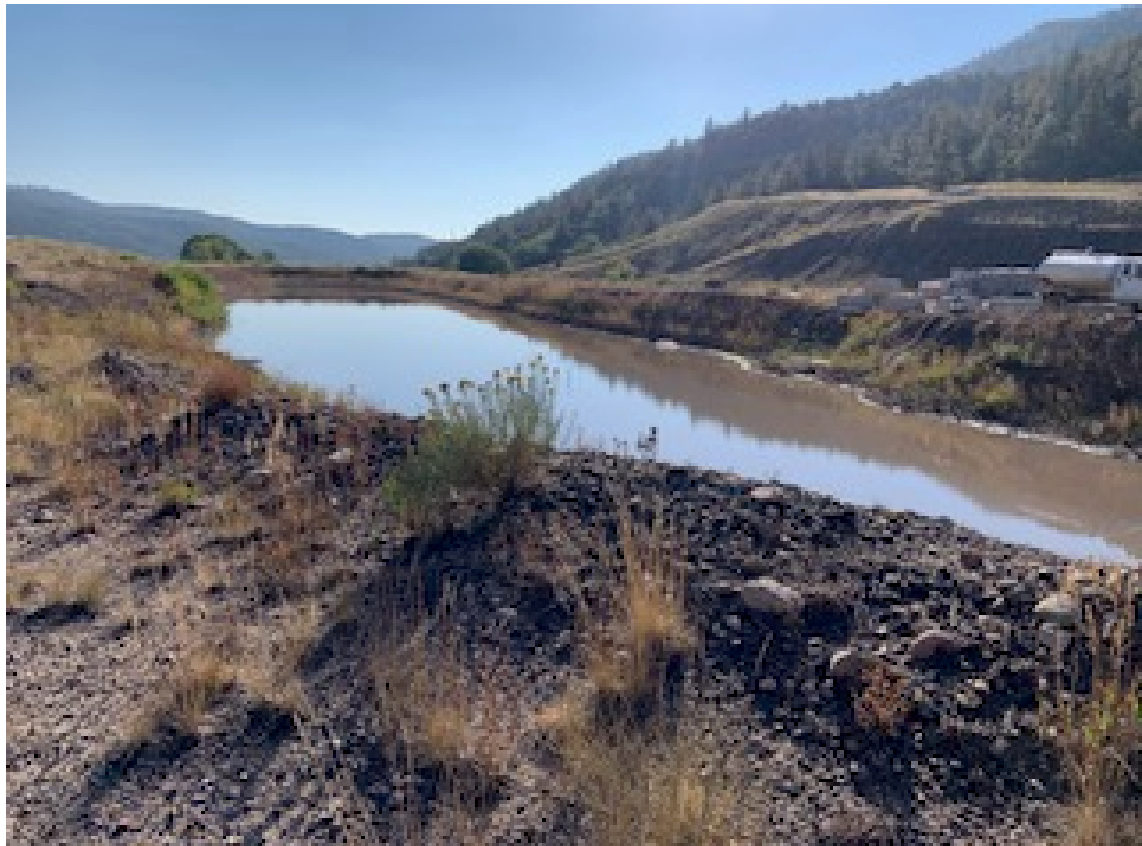
**Pond 7**

Pond is holding water, not near the decant level. The pond is in good working condition.

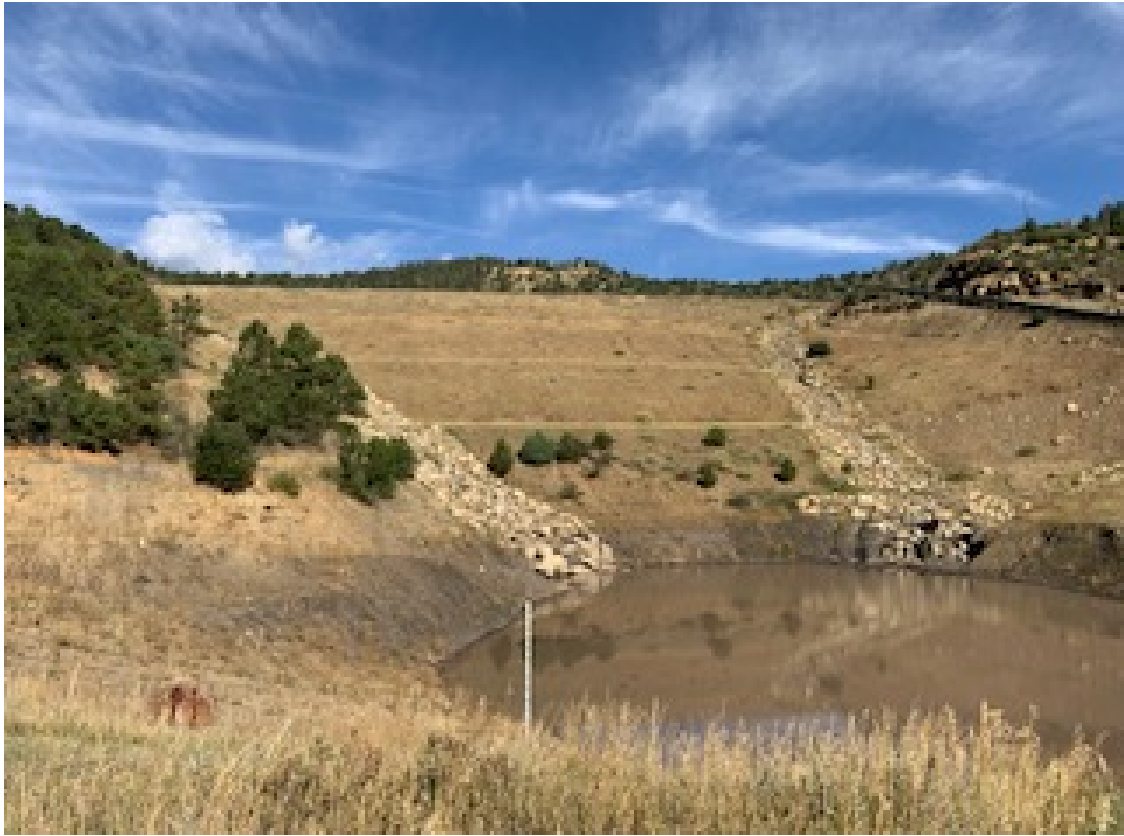
**Pond 8**

Pond is holding water, not near the decant level. No new sediment has been deposited.

There is very little sediment in the pond.

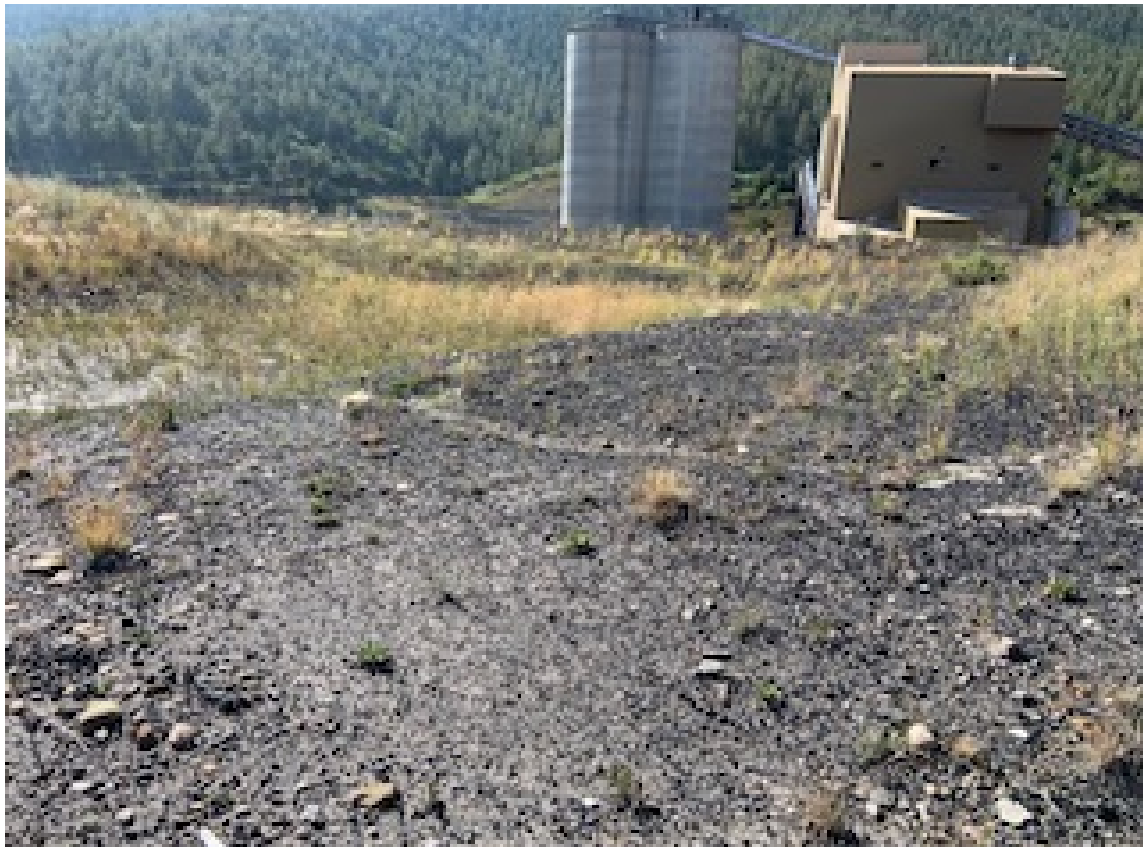
**Containment Area #3**

Containment Area was dry at time of inspection.

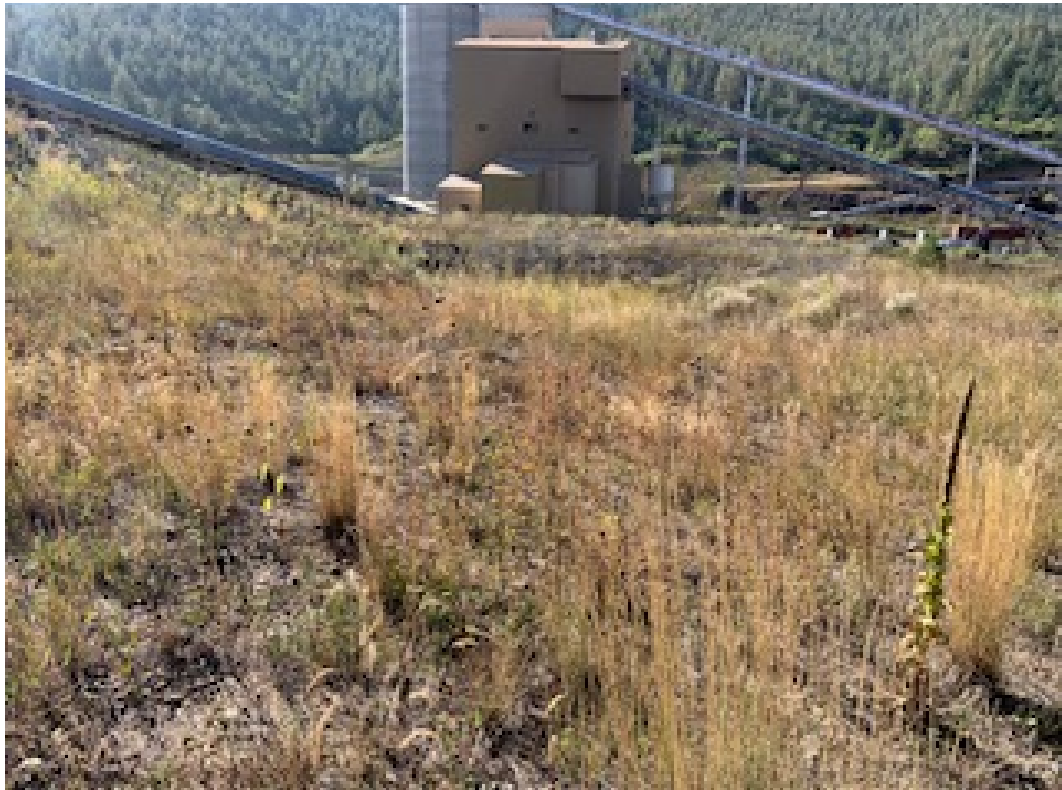
**Containment Area #4**

Containment Area was dry at time of inspection.

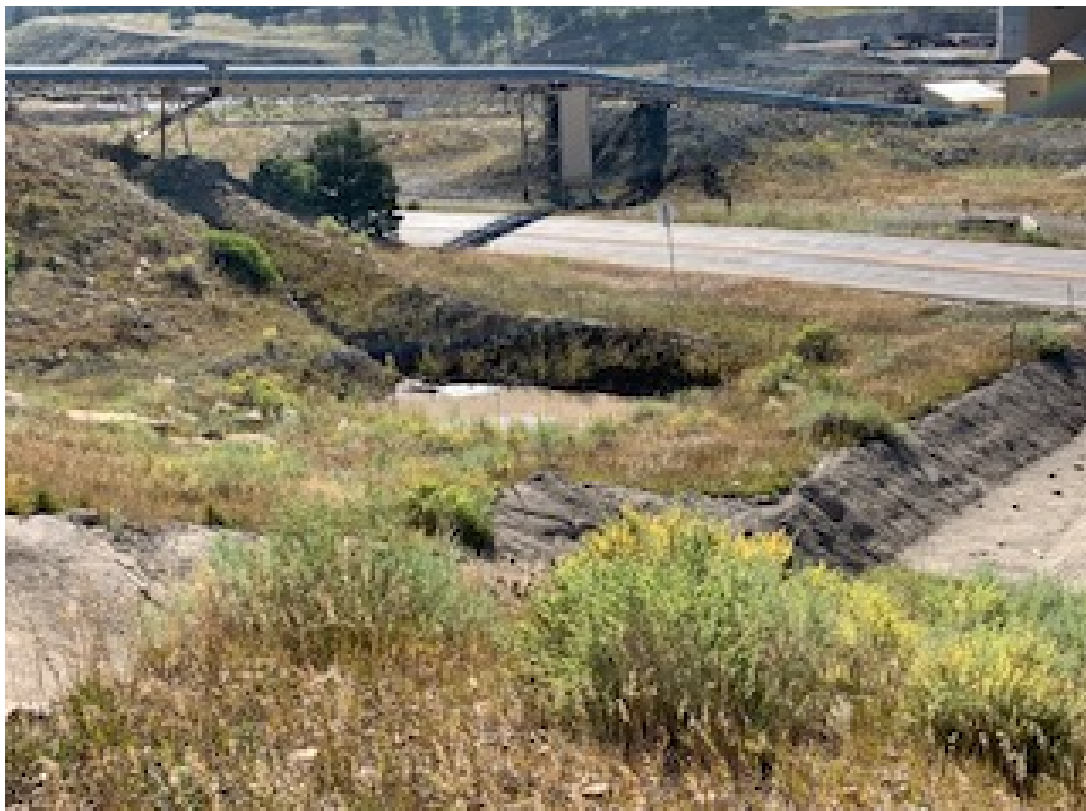
**Containment Area #5**

Containment Area was holding water. Sediment was cleaned in quarter 2 of 2020.
