## QUARTERLY SEDIMENTATION POND INSPECTION REPORT

Mine: Lorencito

Inspection Period: Third Quarter 2021

**QUARTERLY SEDIMENTATION POND INSPECTION REPORT**  
**Lorencito Canyon Mine- September 20, 2021**

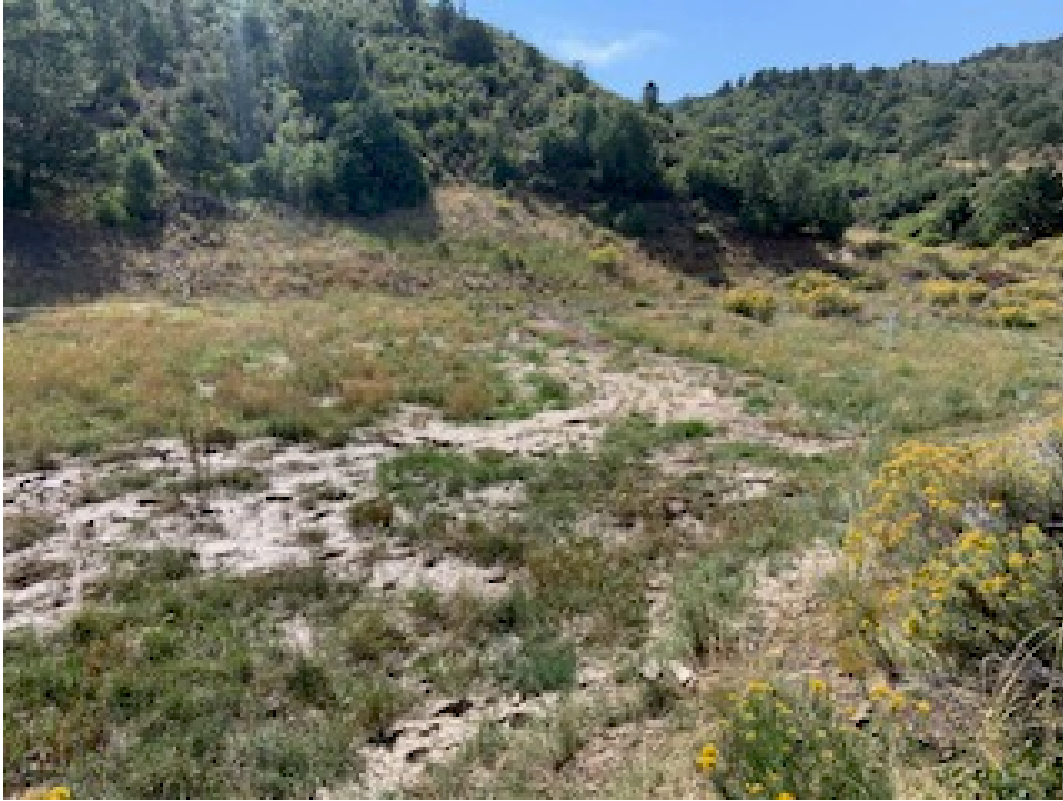
**Pond 5**

Explain: Sediment in pond does not appear to be over capacity by visual inspection.

Pond was empty at time of inspection. Recent rain events have put some water in the pond, but

it has since dried.

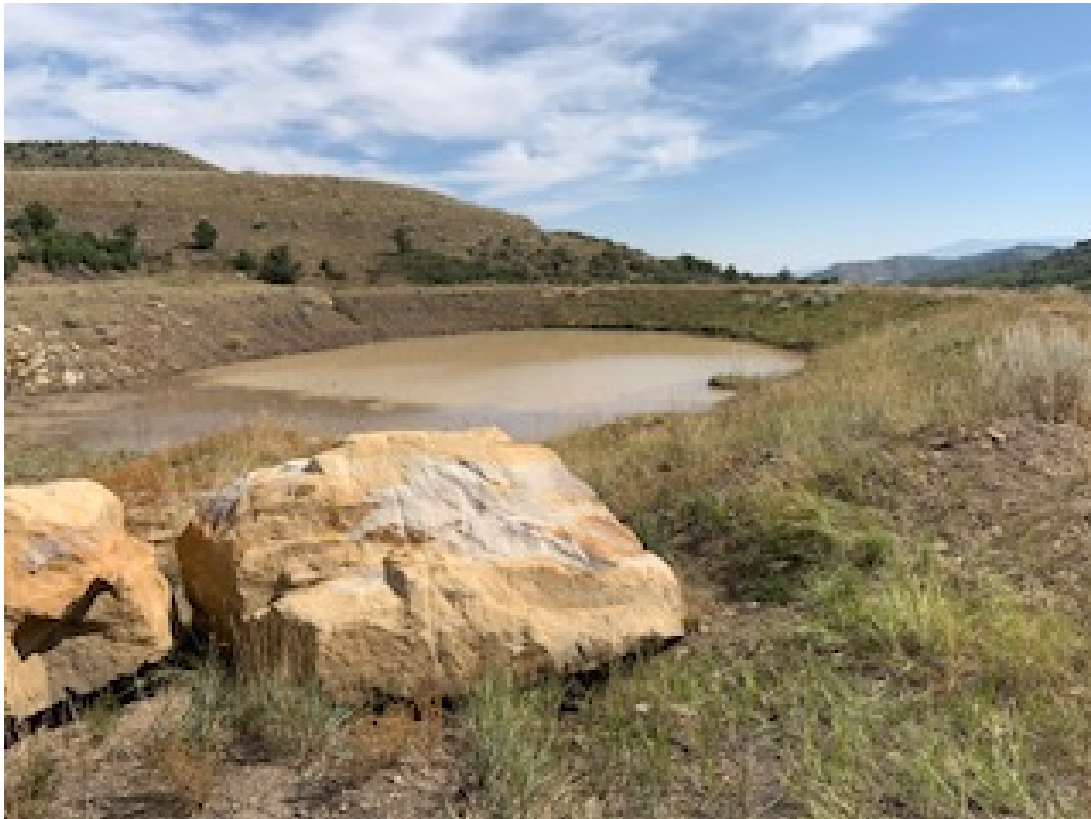
**Pond 6**

Pond was holding water but not near the level of the decant.

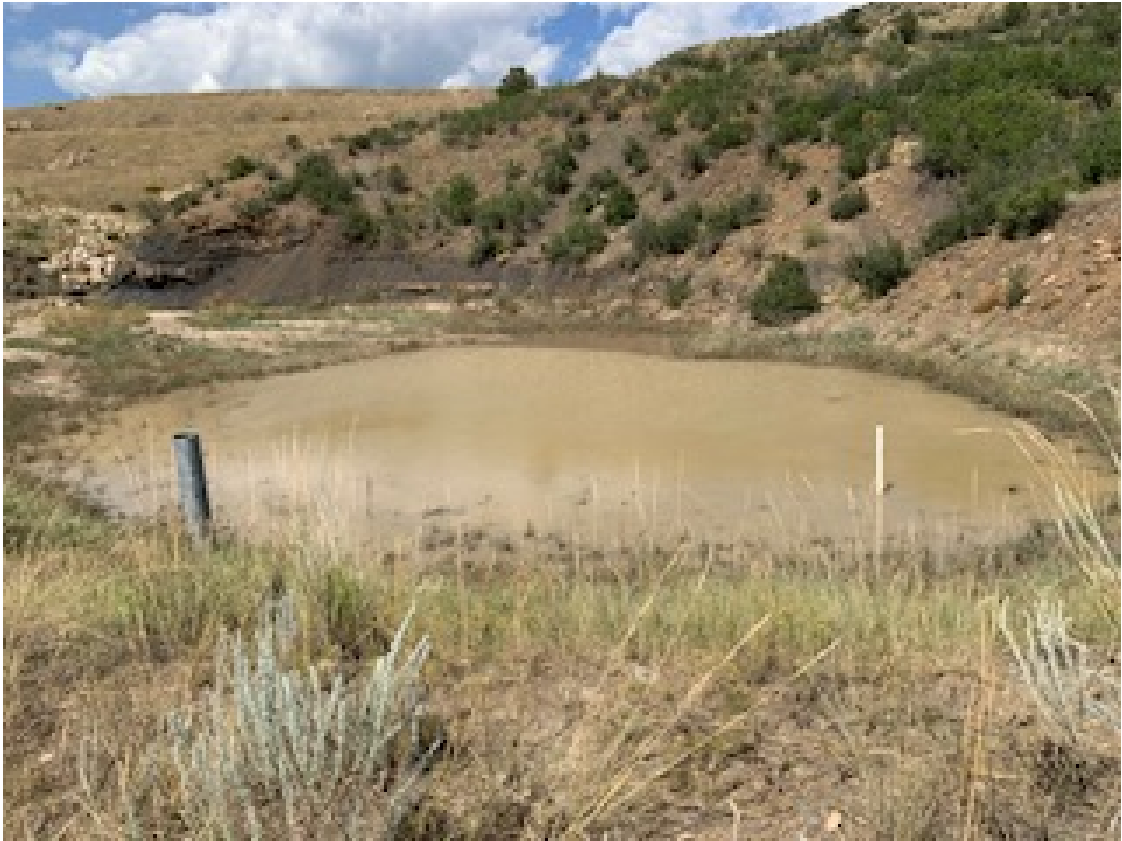
**Pond 7**

Pond was holding some water but not near the level of the decant.

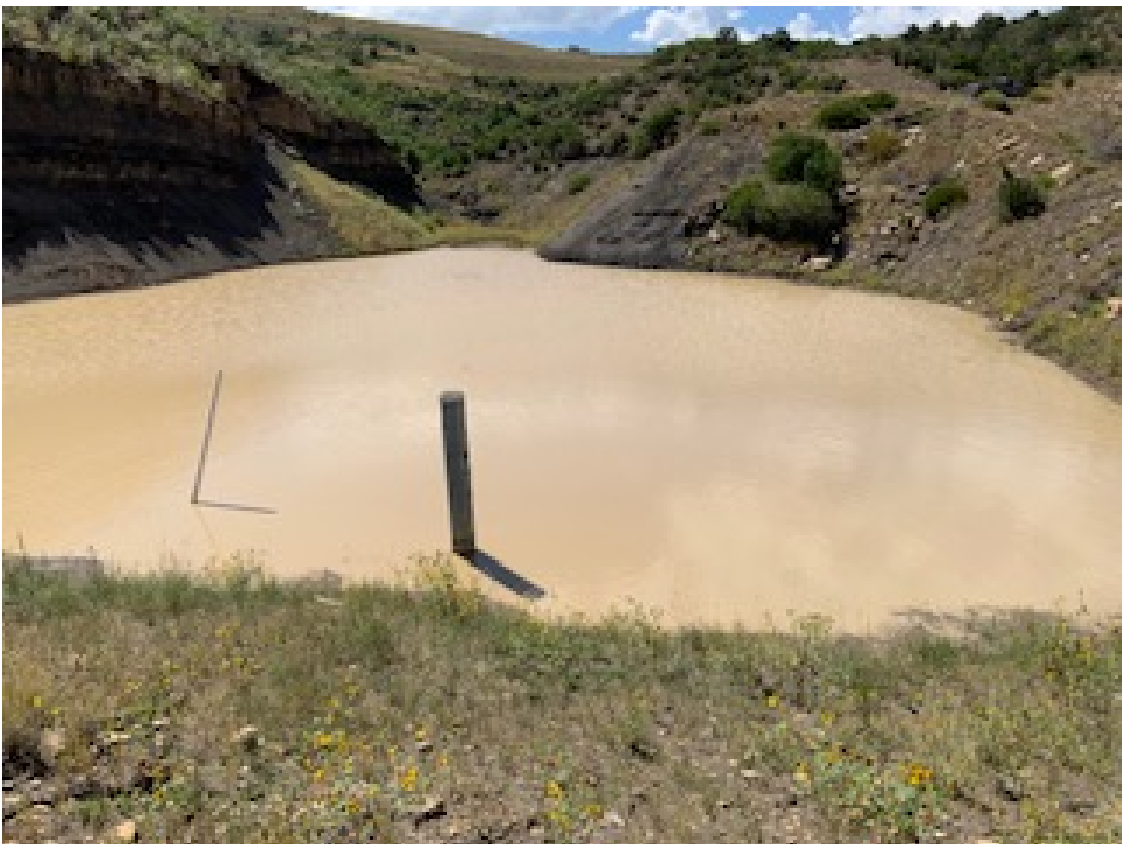
**Pond 8**

Pond was holding water to the decant level, but the pond was not discharging at the time of

inspection.

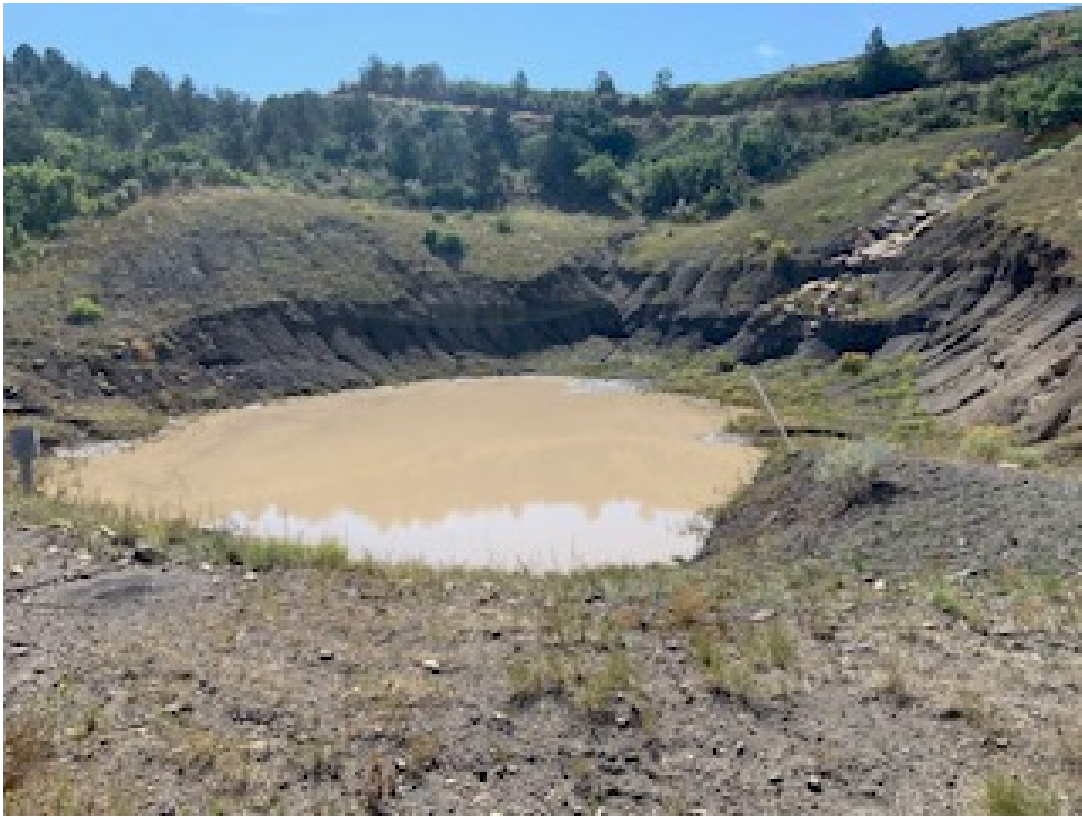
**Pond 9**

Pond was holding water but not near discharging at time of inspection.

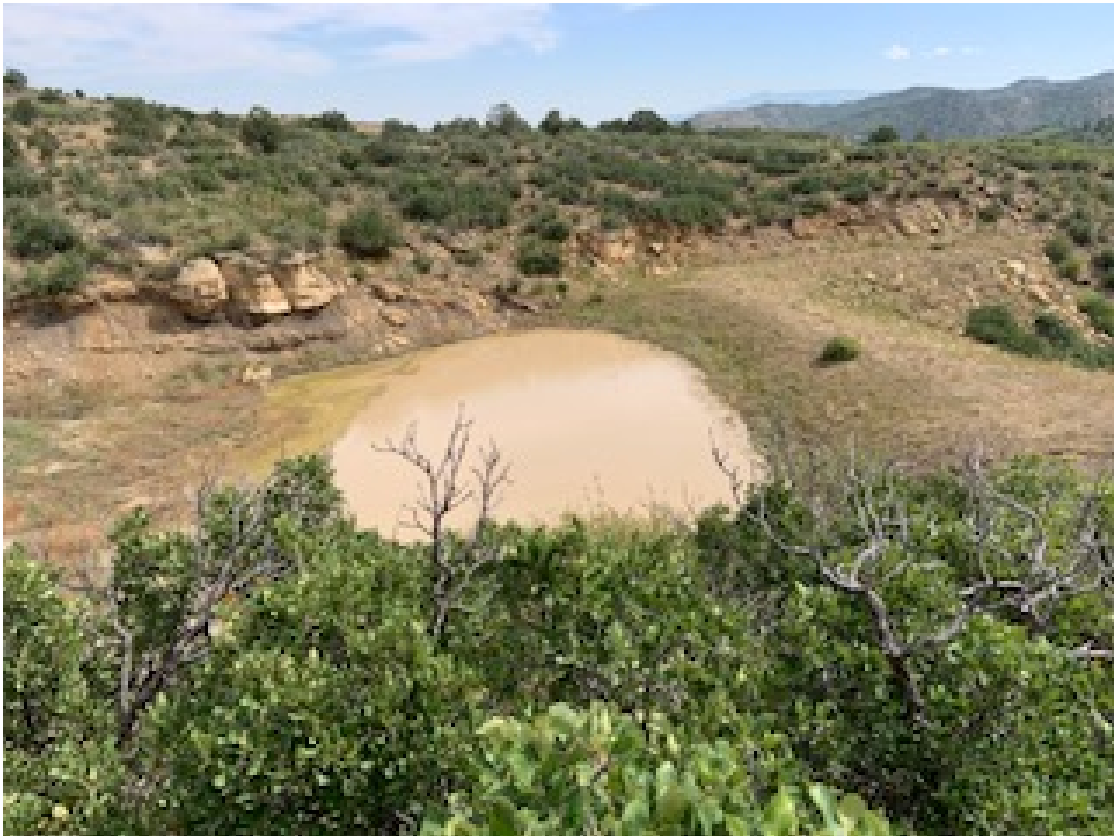
**Pond 9a**

Pond was holding water but not near discharging at time of inspection.
