NEW ELK MINE
Permit No. C-1981-012

QUARTERLY COAL WASTE BANK INSPECTION REPORT
September 20, 2021

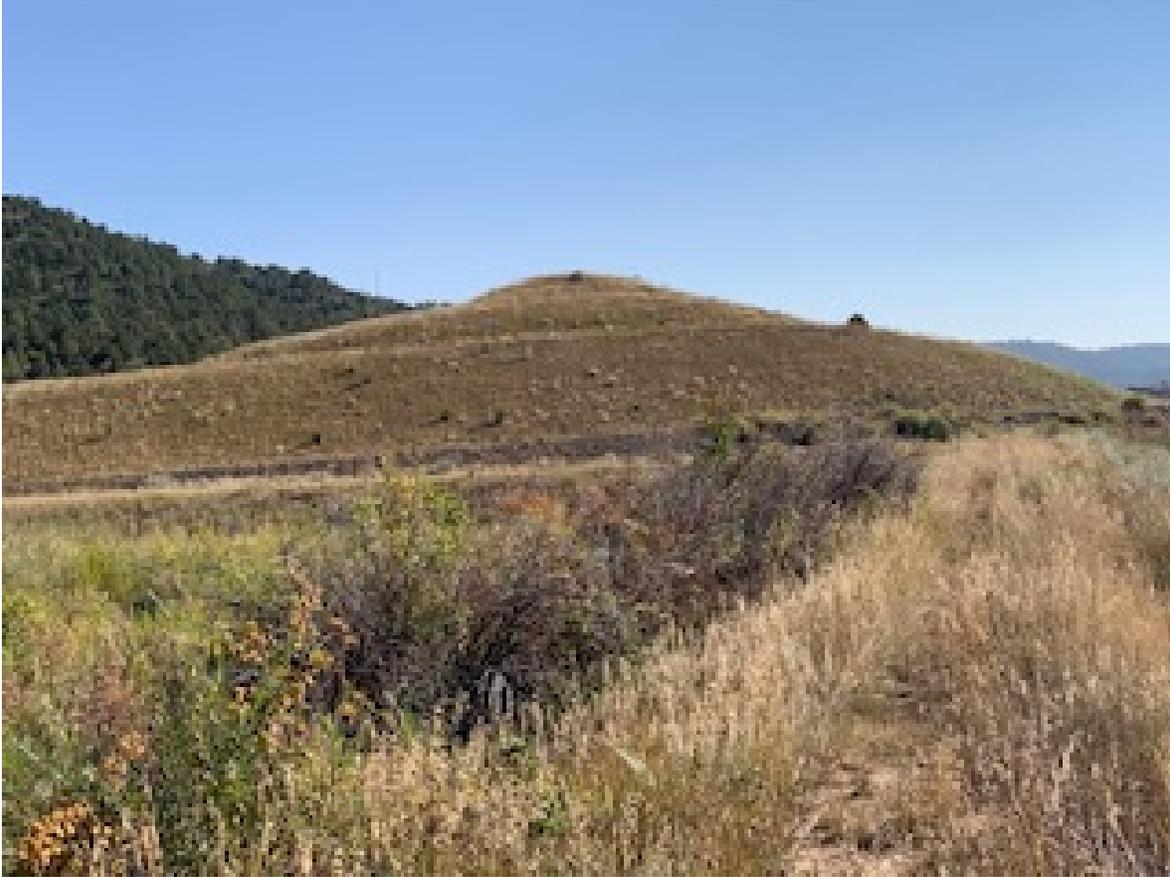
Surface and out slopes of the pile were inspected for visible signs of potential failure or instability. None were observed.

Overall the disposal area is in good condition.

DWDA #1 – West Facing Slope

None at this time.

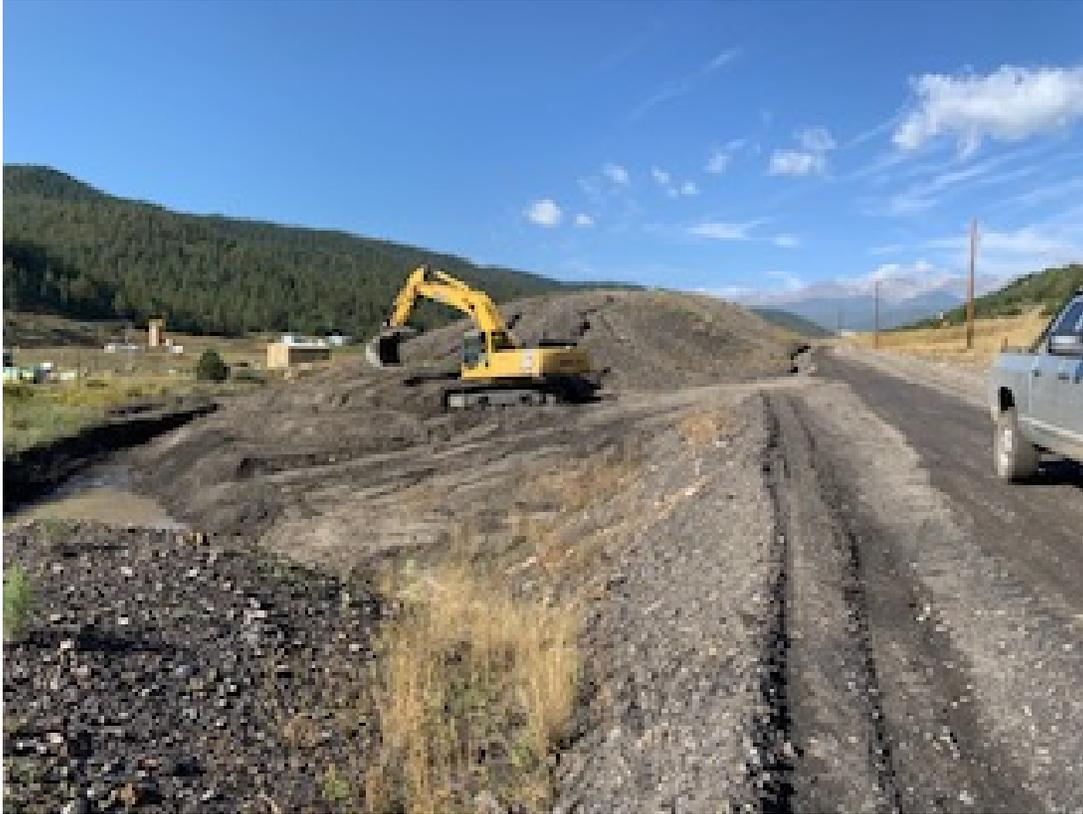
Positive Drainage is maintained on the surface of the DWDA. Sump on East end of pile was being cleaned at time of inspection. Rills on the disposal area are being monitored. No evidence of springs nor seeps were observed.

Surface and out slopes of the pile were inspected for visible signs of potential failure or instability. There was some surface erosion but not enough to make the area unstable. In all no signs of failure or instability were observed.

Overall the disposal area is in good condition. The sign with the name of the area was recently replaced.

DWDA #2 – East Facing Slope

The Rills are being monitored and have not gotten any bigger and there is no sediment loading. Operator is evaluating either reclamation of the area or permitting alternative uses of the land north of the Purgatoire River and south of Highway 12. The sump at the end of the area was being cleaned as annual maintenance.

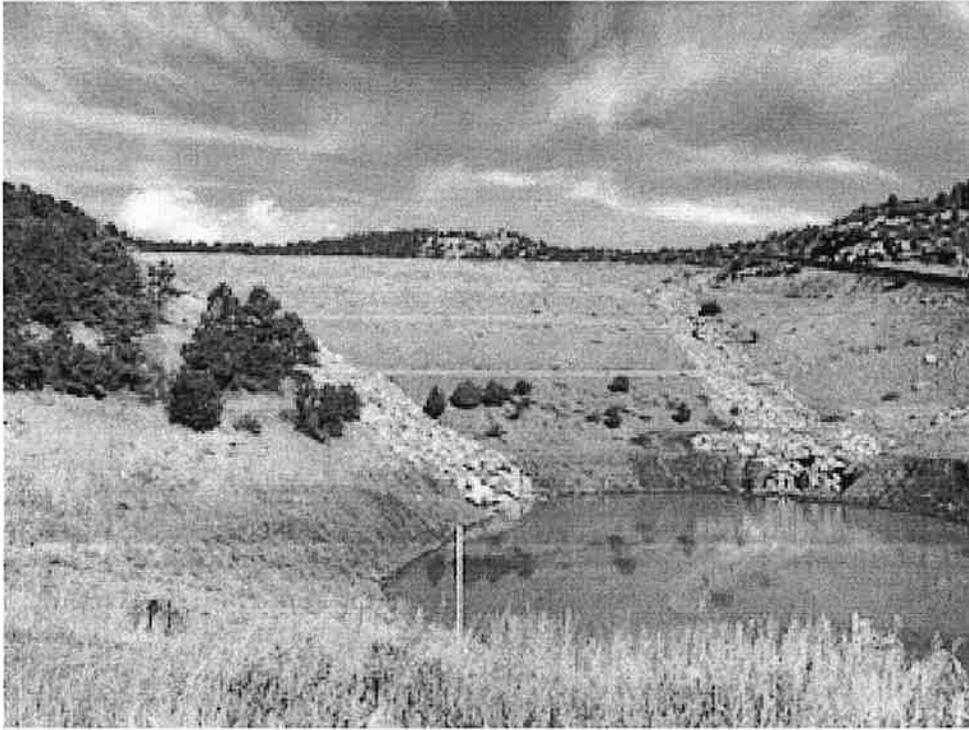
Overall the site is in good condition.

Face of Refuse Disposal Area

None required at this time.
