MINERALS PROGRAM INSPECTION REPORT

MINE NAME: Cresson Project	MINE/PROSPECTING ID#: M-1980-244	MINERAL: Gold	COUNTY: Teller
INSPECTION TYPE: Monitoring	INSPECTOR(S): Elliott Russell	INSP. DATE: August 10, 2021	INSP. TIME: 10:00
OPERATOR: Cripple Creek & Victor Gold Mining Company	OPERATOR REPRESENTATIVE: Justin Raglin	TYPE OF OPERATION: 112d-3 - Designated Mining Operation	
REASON FOR INSPECTION: Priority	BOND CALCULATION TYPE: None	BOND AMOUNT: \$209,491,188.00	
DATE OF COMPLAINT: NA	POST INSP. CONTACTS: None	JOINT INSP. AGENCY: None	
WEATHER: Clear	INSPECTOR'S SIGNATURE:

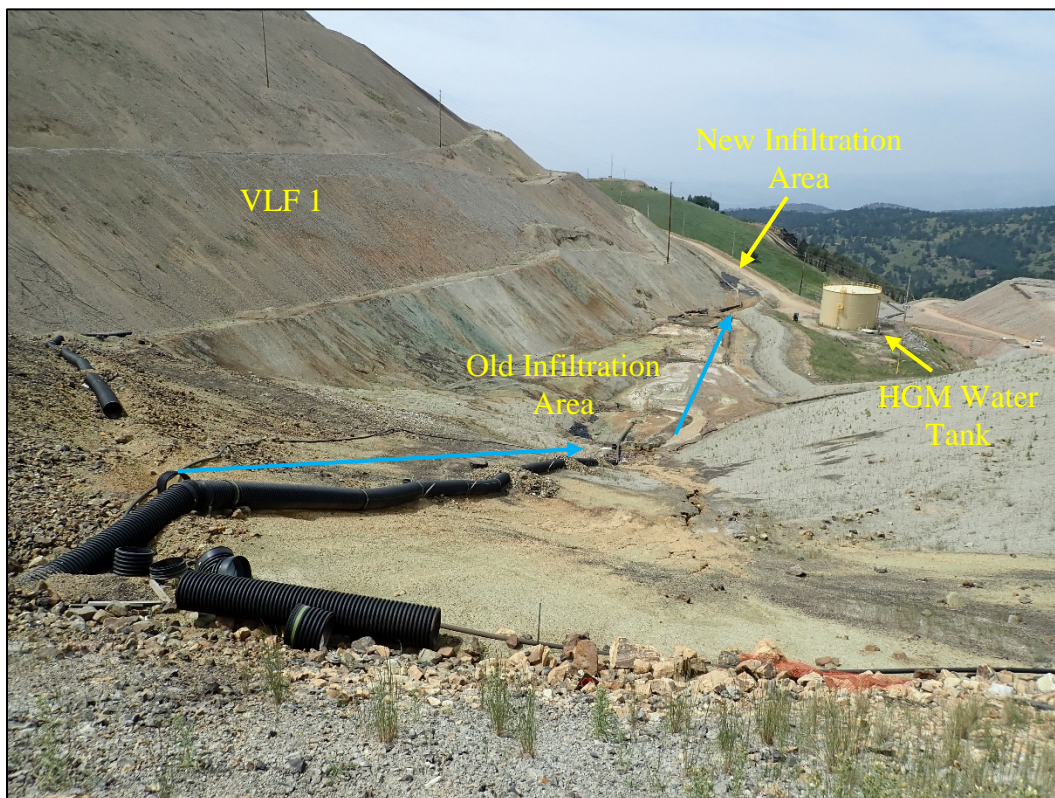
Photo 1. Path of stormwater in the area between HGM and VLF 1; looking west.

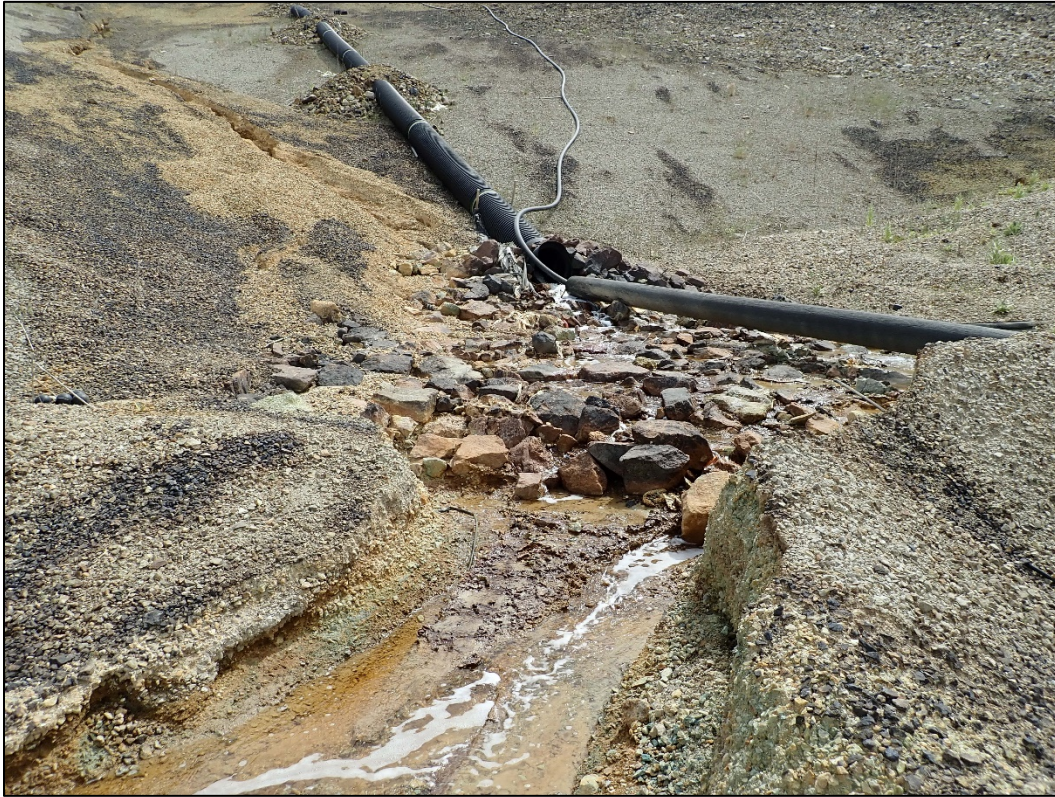
Photo 2. Stormwater pipe discharge; looking east.

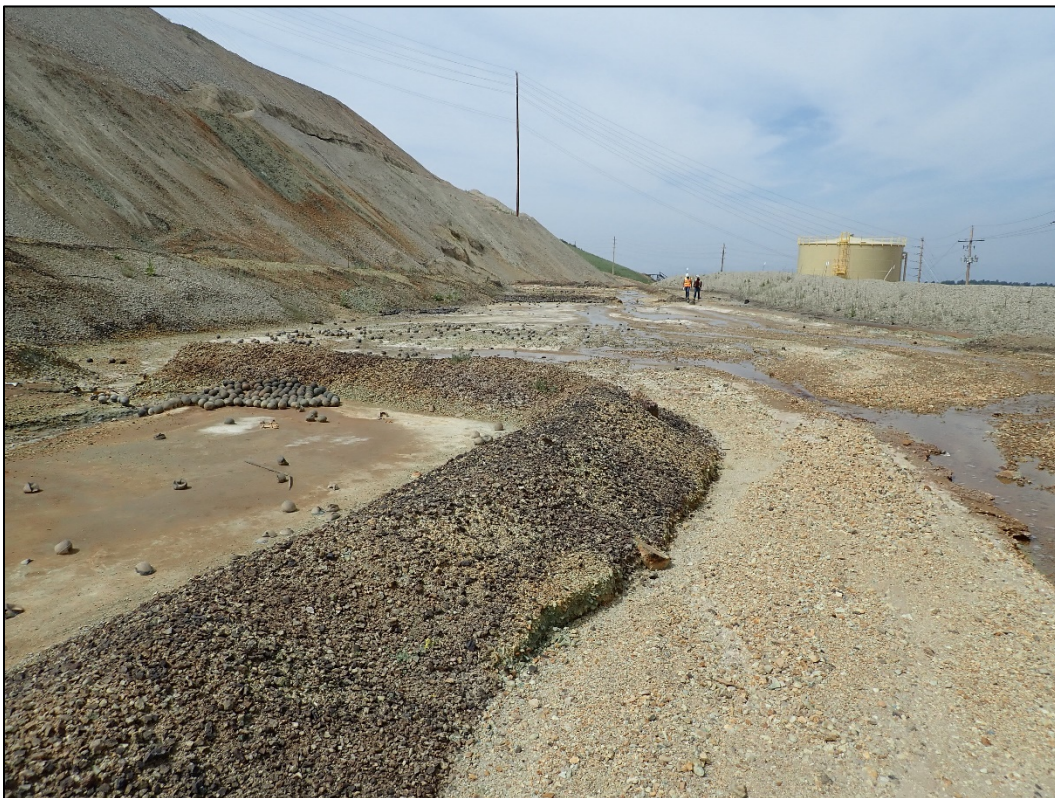
Photo 3. Remnants of an old infiltration area (left), and current stormwater flows (right); looking west.

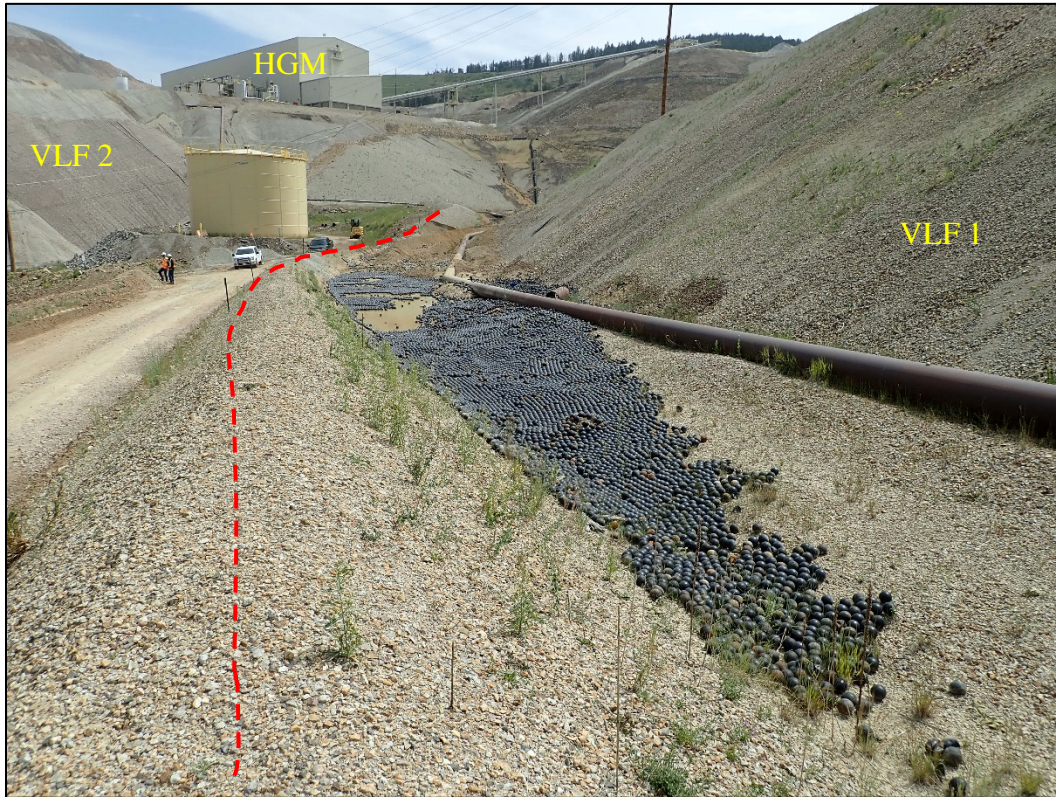
Additionally, the Division is citing Compliance Problem #2 regarding the current stormwater controls associated with the High Grade Mill liner. The stormwater management associated with the HGM platform will need to be revised to ensure containment of impacted stormwater. The use of an infiltration pond on VLF 1 immediately adjacent to the edge of liner is inappropriate. If the Operator intends to relocate the infiltration pond farther upgradient away from the edge of liner, potentially where original infiltration activities occurred,

Photo 4. Infiltration pond and Edge of Liner (red); looking northeast.

then the Operator will need to submit a detailed plan and suitable designs with adequate overflow protection and a secondary emergency infiltration area. The Operator will need submit a plan to address the accumulation of precipices and fines to ensure adequate infiltration through time. As discussed with the Operator during the inspection, the Operator may want to consider an alternative plan to handle this stormwater, such as removing a portion of the western HGM liner berm near the southwest corner of the HGM area to allow intercepted stormwater to flow freely onto VLF 2 and eliminating the need to pump the water into the concrete sumps and infiltrating ponded water into VLF 1.

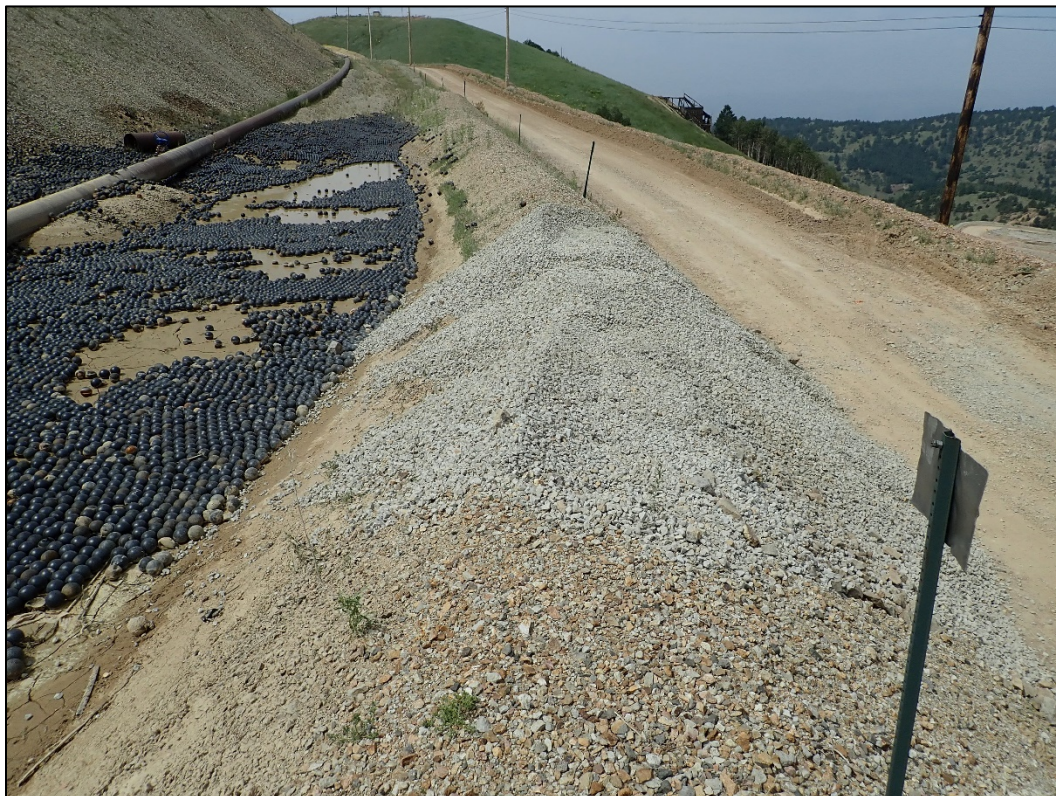
Photo 5. Repaired edge of liner berm where one overtopping occurred; looking southwest.

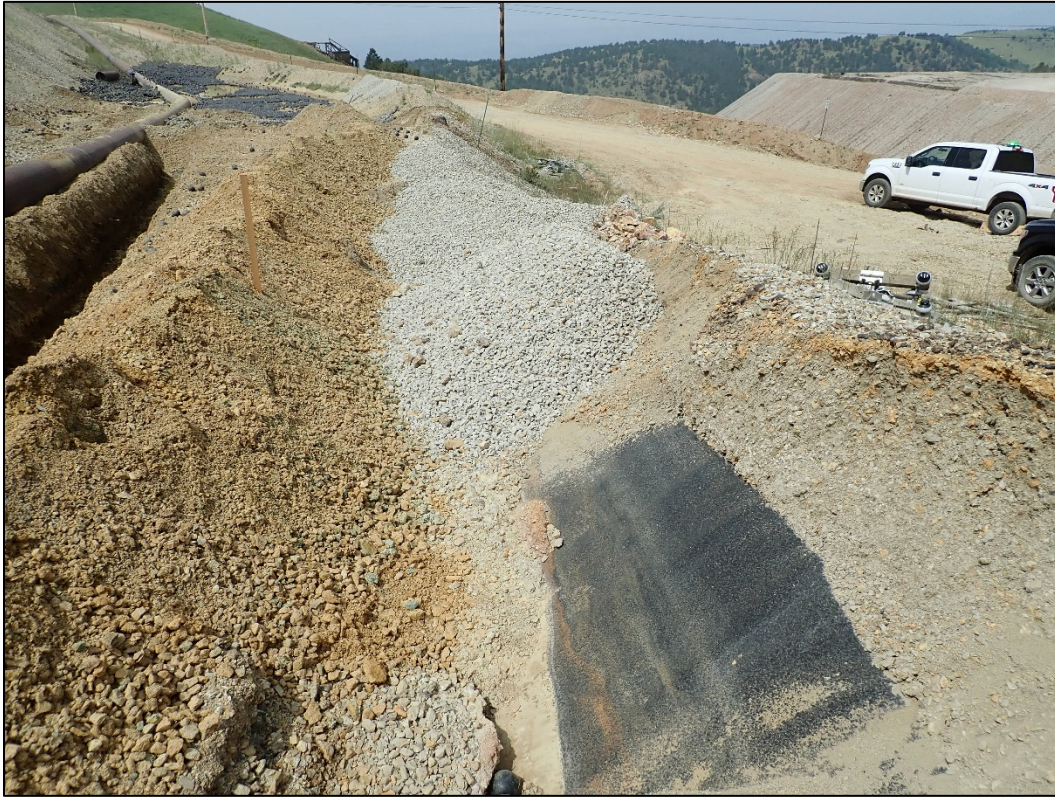
Photo 6. Repaired edge of liner berm where one overtopping occurred; looking southwest.

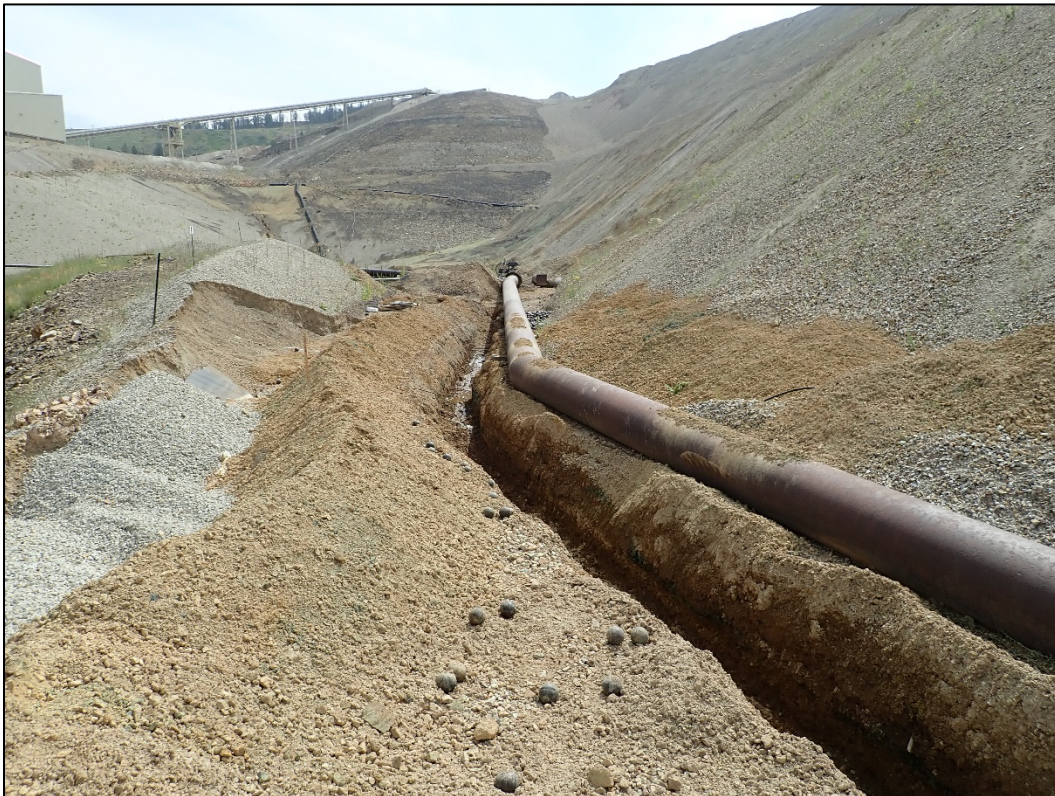
Photo 7. Excavated channel to direct flows away from edge of liner in the pinch-point area; looking northeast.

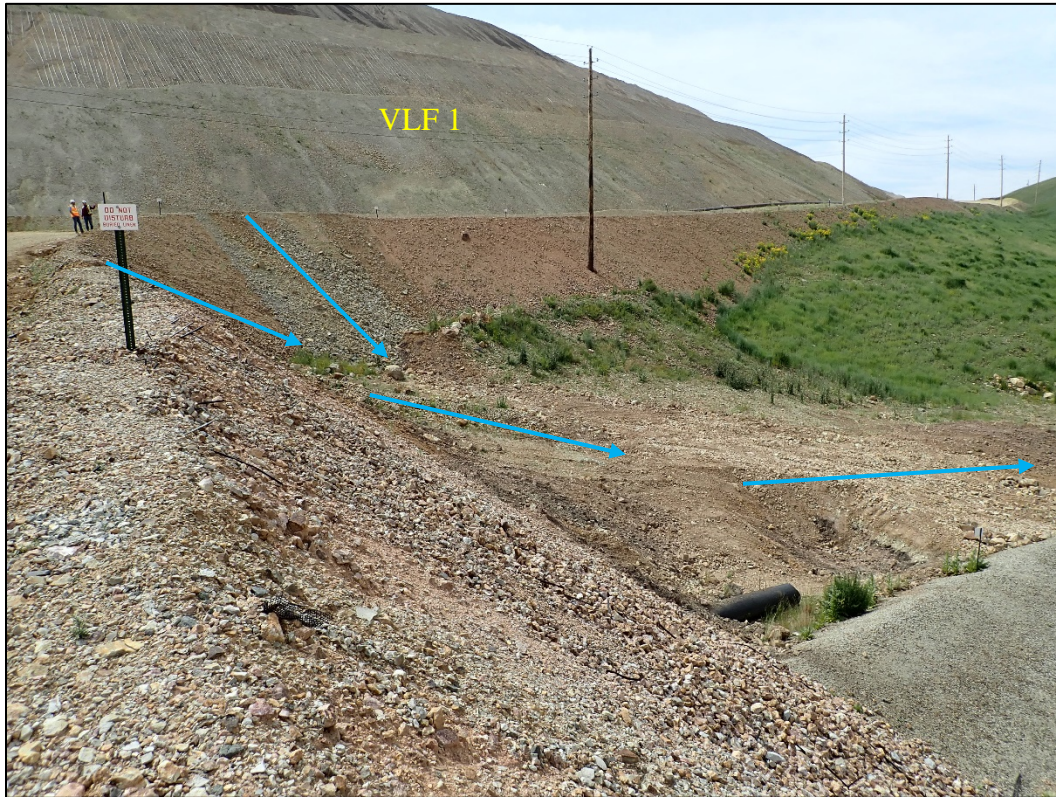
Photo 8. Path of stormwater after overtopping occurred; looking south.

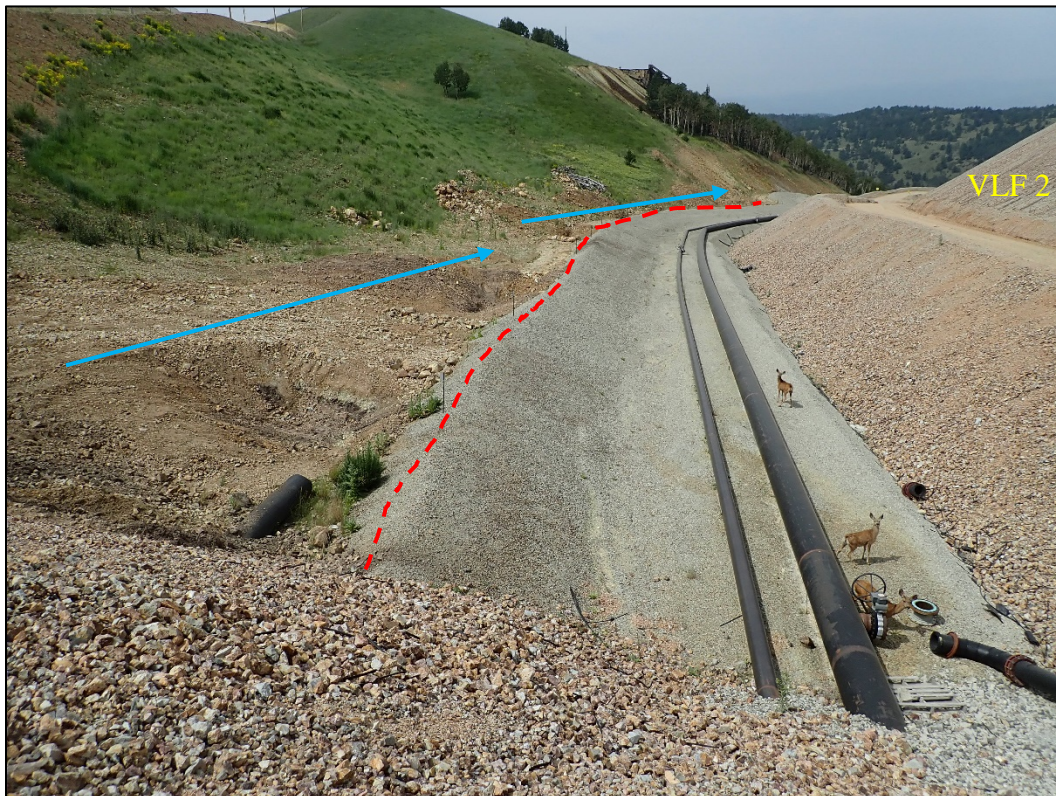
Photo 9. Path of stormwater adjacent to the southern edge of VLF 2; looking west.

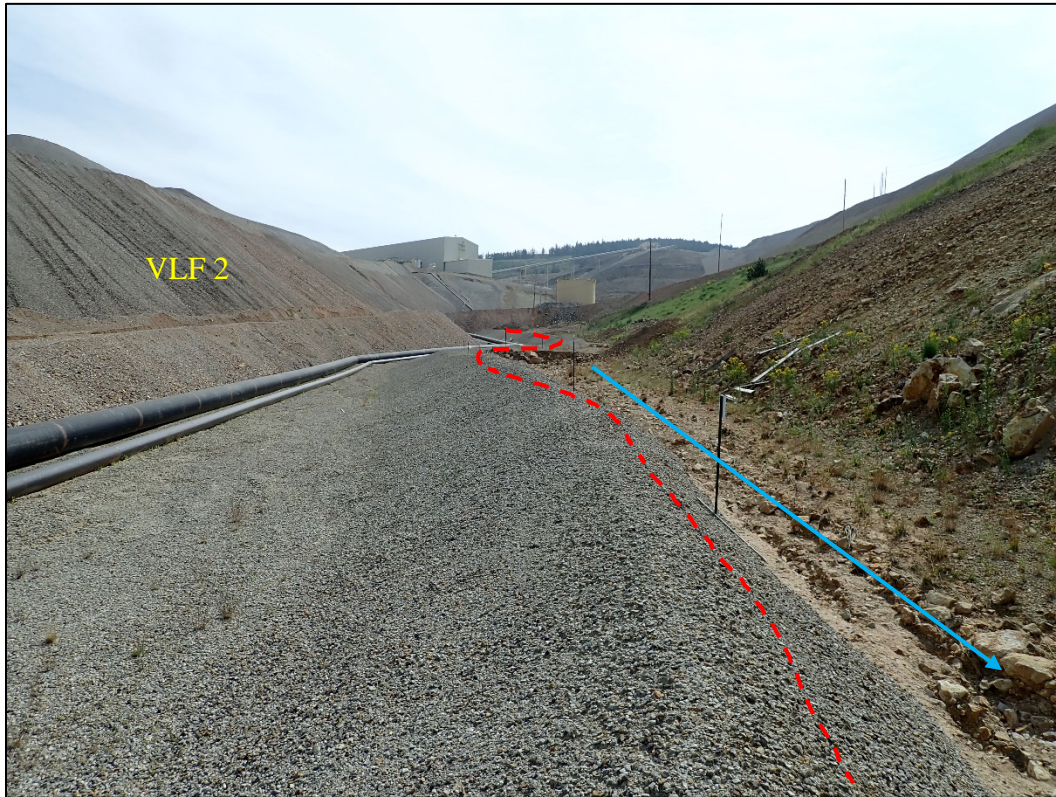
Photo 10. Path of stormwater adjacent to the southern edge of VLF 2; looking east.

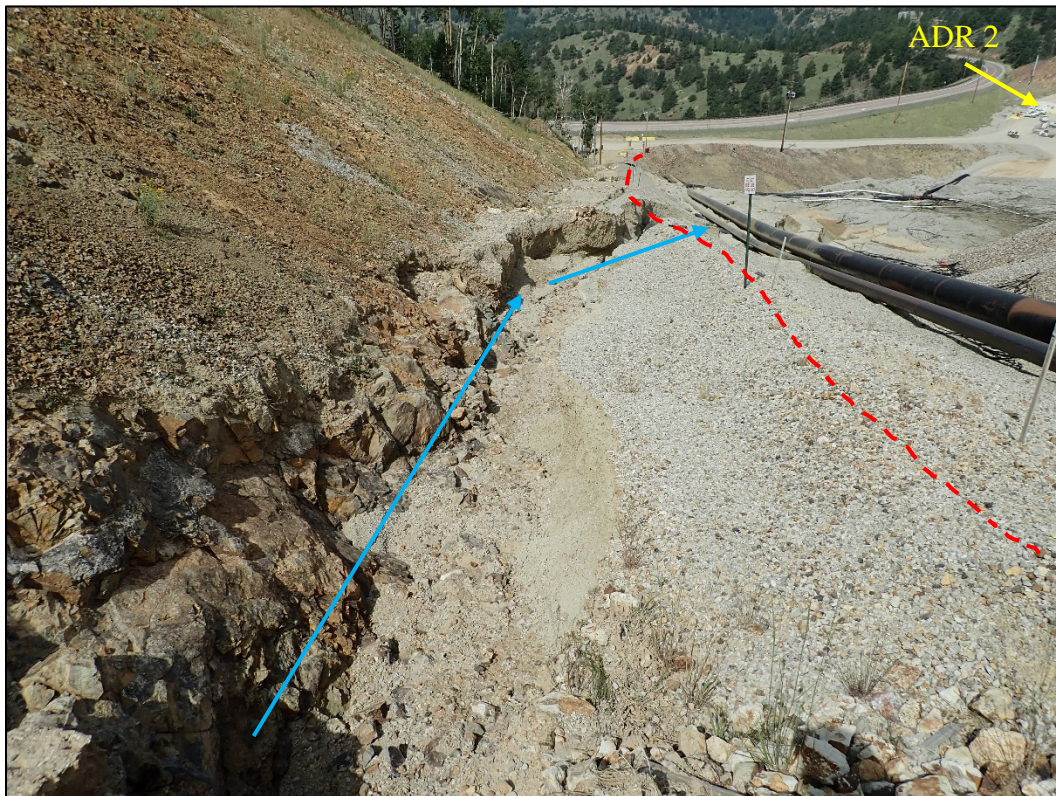
Photo 11. Area where stormwater reentered containment onto VLF 2; looking west.

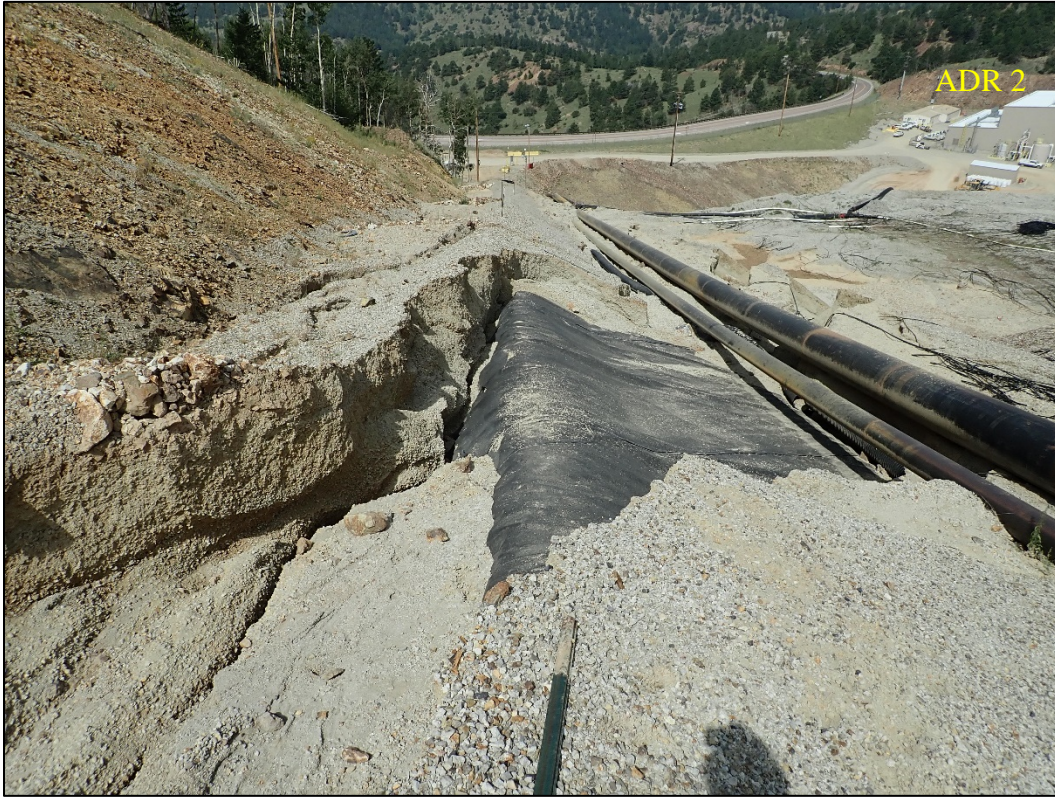
Photo 12. Area where stormwater reentered containment, exposing edge of liner and anchor trench; looking west.

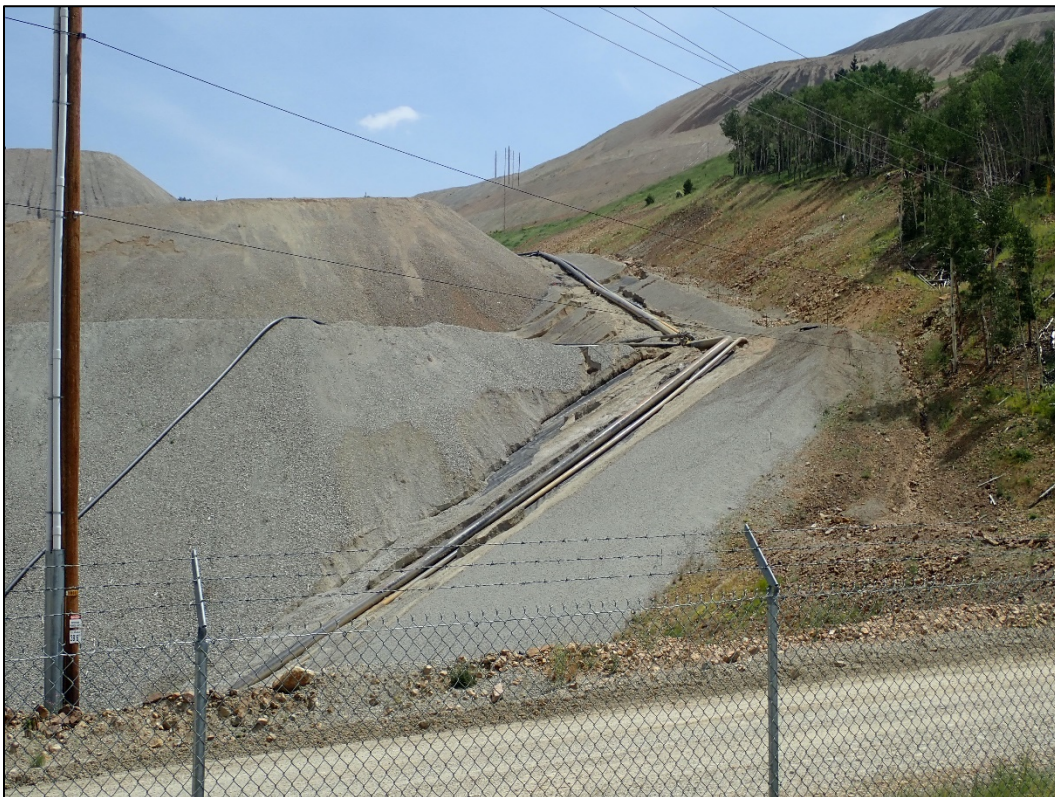
Photo 13. Path of stormwater approaching the ADR 2 area; looking east.

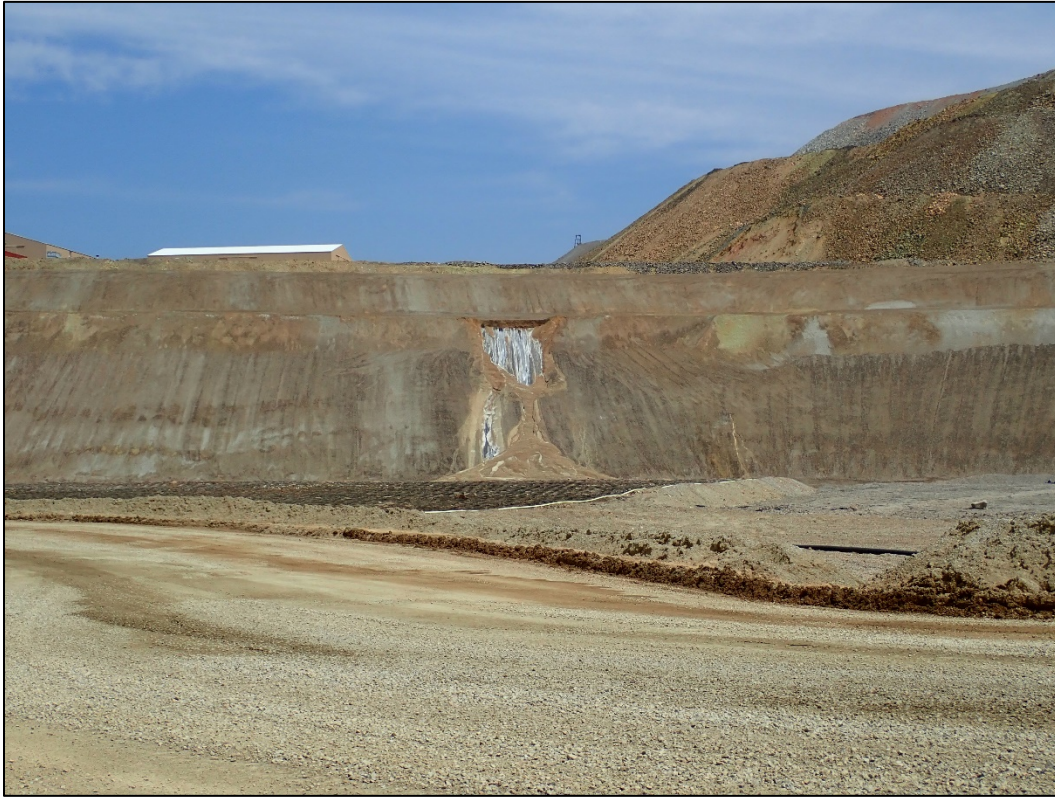
COMPLIANCE PROBLEM #1: A storm event caused Drain Cover Fill to washout in several areas of the Valley Leach Facility 2. The Drain Cover Fill was previously certified as a part of the Environmental Protection Facility and therefore these areas need to be repaired and recertified in accordance with Rule 7.3 and 7.4.

The Division also observed the area where stormwater caused DCF to washout and expose the liner on the north end of VLF 2 (see **Photo 14**). This washout was approximately 100 feet in length and appears to originate from a cross-contour light utility truck access road constructed on the DCF. The Operator indicated this washout was between 10,150' and 10,050'.

Photo 14. Additional washout of DCF within VLF 2; looking north.

CORRECTIVE ACTIONS: The Operator shall repair and recertify the areas damaged by the storm event within the Valley Leach Facility 2 Environmental Protection Facility by the corrective action date.

As discussed with the Operator during the inspection and further discussed in an email from the Division on August 19, 2021, the Operator will need to have the areas which were damaged by stormwater on VLF 2 recertified. This has been cited as Compliance Problem #1. Recertification, in accordance with Rule 7.3 and 7.4, will need to be completed by appropriate quality assurance and control on the repair work to meet the approved specifications and the submittal of a final recertification report is required. In accordance with the approved specifications, DCF will need to be replaced in the areas where the stormwater caused the originally-certified material to washout. Additionally, an evaluation of the exposed liner and anchor trench, recertifying their integrity, will need to be included within the final recertification report.
