August 19, 2021

**Re: Permit No. M-1980-244; Cripple Creek & Victor Gold Mining Company ("CC&V");  
Cresson Project– Significant Stormwater Event – August 3, 2021**

**Project Name: Cripple Creek/Victor Water and Soil 2021**

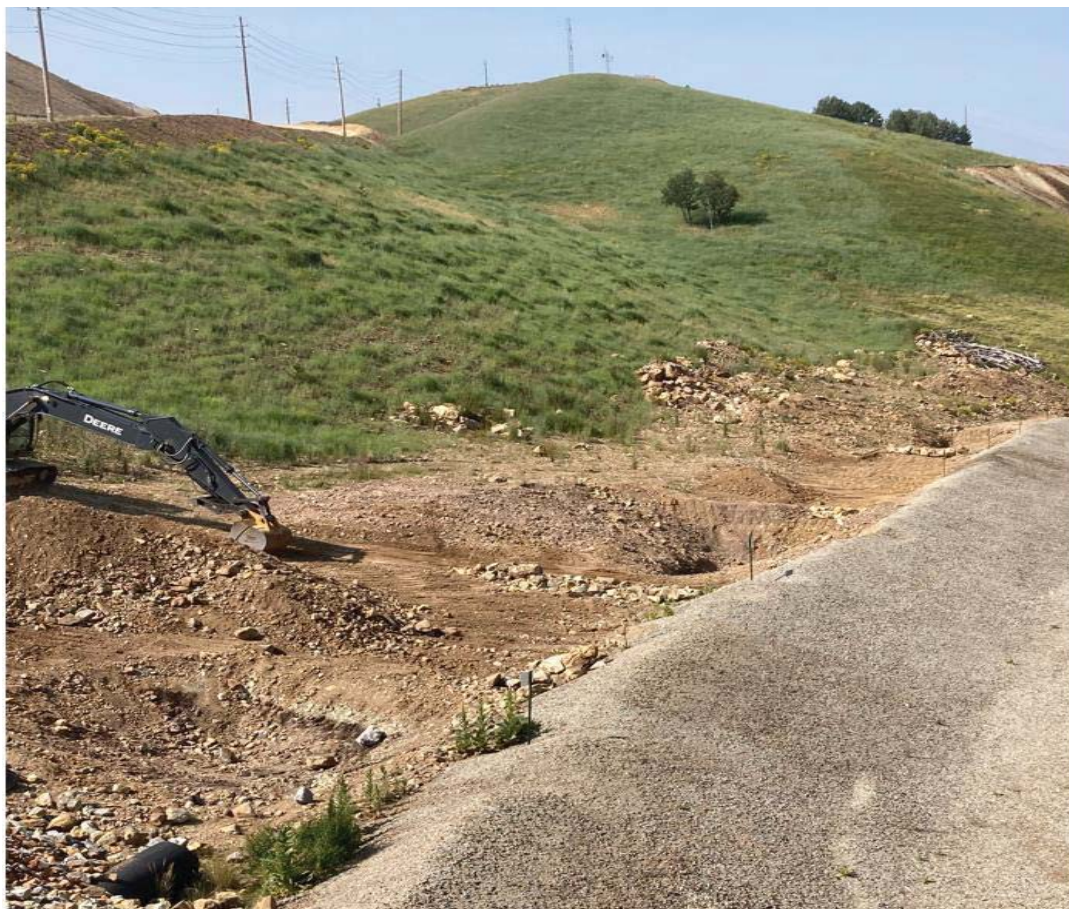
All leach material which discharged outside of lined containment has been excavated and replaced back onto lined areas. This work was completed on August 17, 2021. Please see photo 1 below documenting cleanup activities.

Photo 1: Excavator removing leach material from impacted area for placement on lined areas.
