MINERALS PROGRAM INSPECTION REPORT
PHONE: (303) 866-3567

MINE NAME: Henderson Mine	MINE/PROSPECTING ID#: M-1977-342	MINERAL: Molybdenum	COUNTY: Clear Creek, Grand
INSPECTION TYPE: Monitoring	INSPECTOR(S): Peter Hays	INSP. DATE: August 30, 2021	INSP. TIME: 09:30
OPERATOR: Climax Molybdenum Company	OPERATOR REPRESENTATIVE: Geoff Niggeler	TYPE OF OPERATION: 112d-3 - Designated Mining Operation	
REASON FOR INSPECTION: Normal I&E Program	BOND CALCULATION TYPE: None	BOND AMOUNT: \$134,155,028.00	
DATE OF COMPLAINT: NA	POST INSP. CONTACTS: None	JOINT INSP. AGENCY: None	
WEATHER: Clear	INSPECTOR'S SIGNATURE:

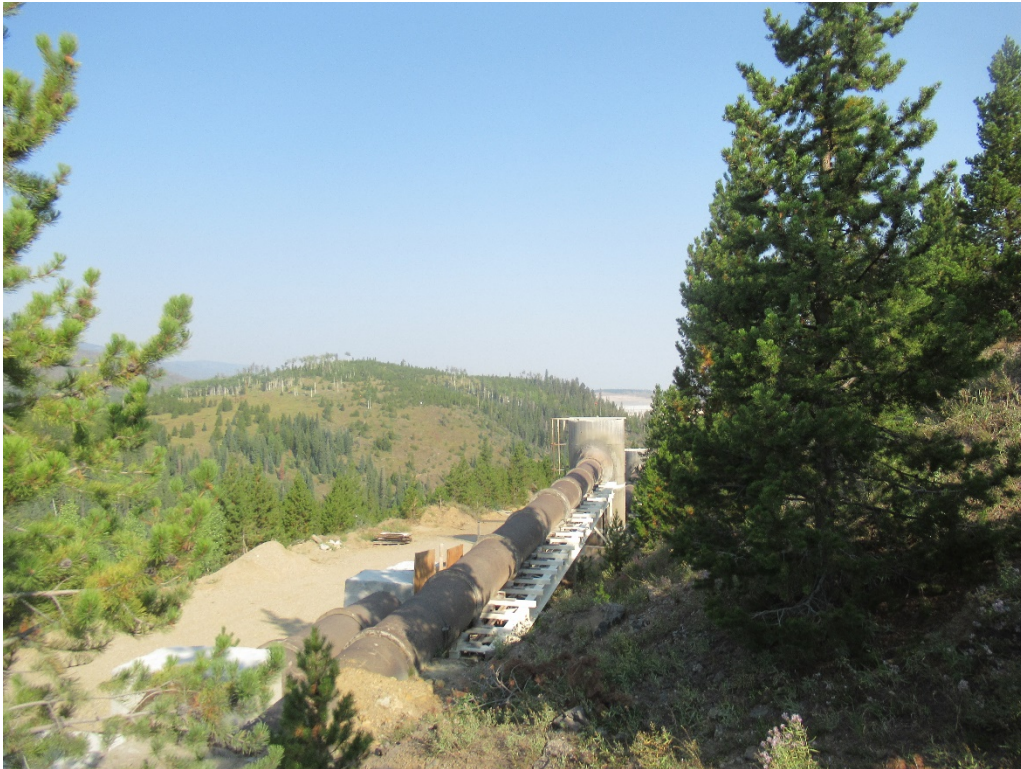
View of the TDL from the drop box

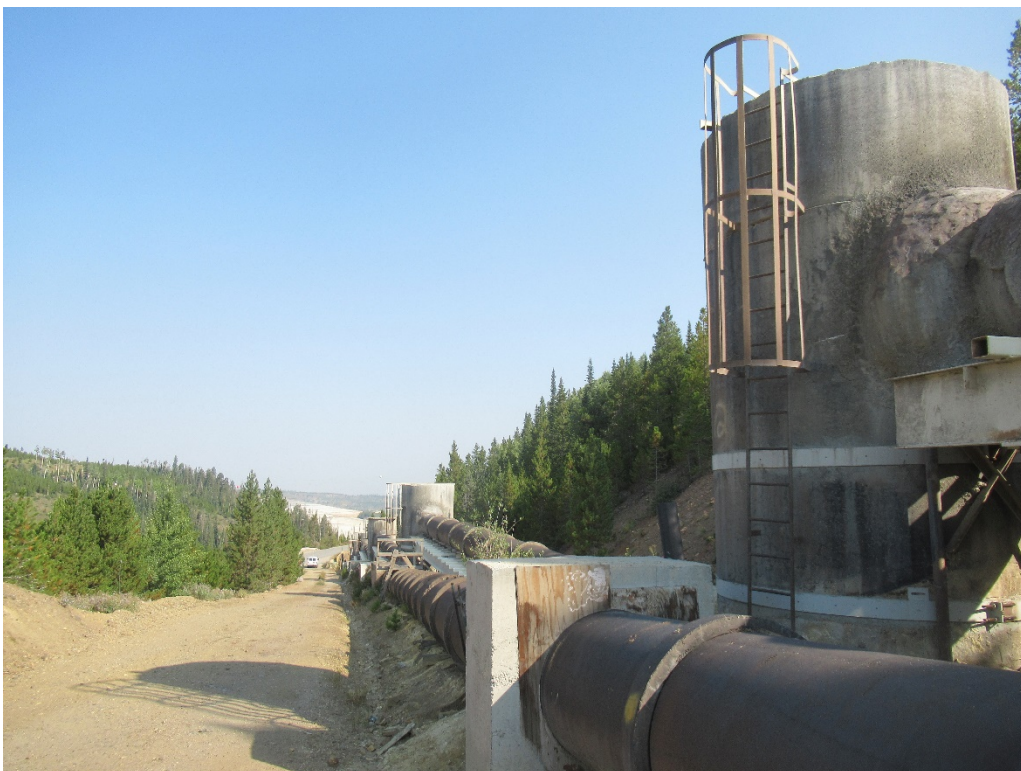
Evidence of the routine maintenance on drop tower 4 including the replacement of the splash curtain was observed during the inspection.

View of the drop tower 4, the ECO and the TDL

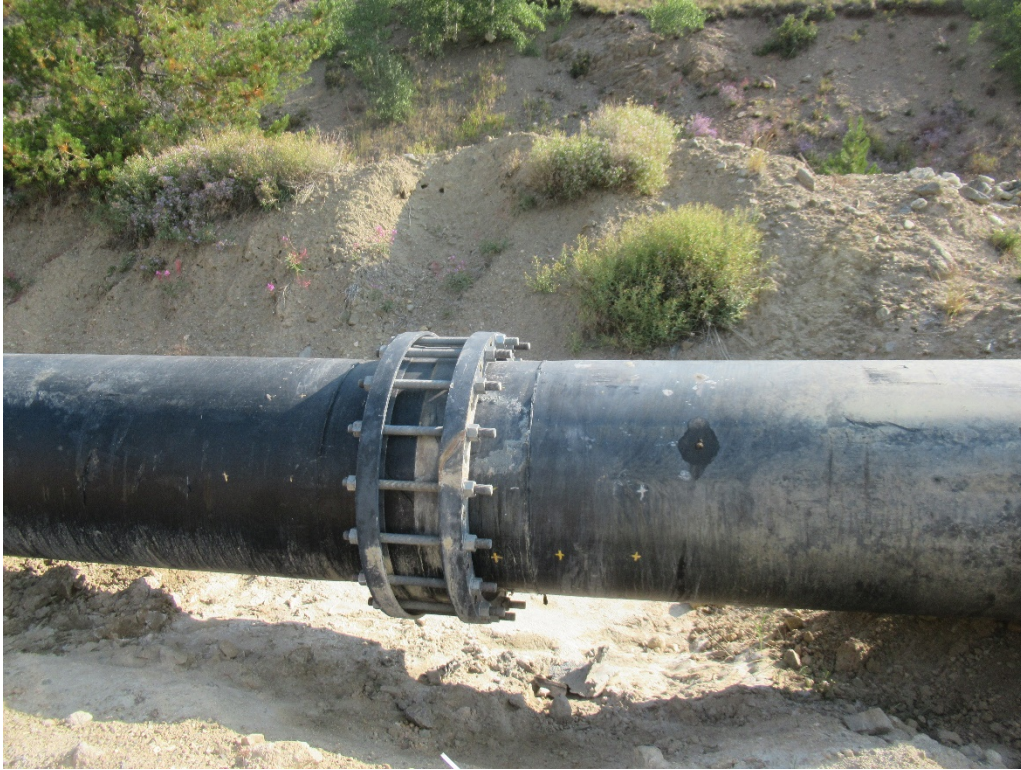
On August 12, 2021, the Division received the required written follow-up notice for a Mill TDL leak. The notice stated on August 6, 2021 a leak in the HDPE section of the TDL was discovered during a routine inspection. Henderson staff estimated approximately 150 to 200 gallons of tailings leaked out of the TDL and onto the TSF access road between the No. 1 Cutout and the 3-Dam crest. The leaked tailings were fully contained on the TSF access road. A small hole near a fused joint in the HDPE was patched with epoxy after the tailings flow was diverted to the No. 1 Cutout. The repaired section of TDL is scheduled to be replaced as part of the 3-Dam crest raise.

View of the repaired HDPE section of the TDL

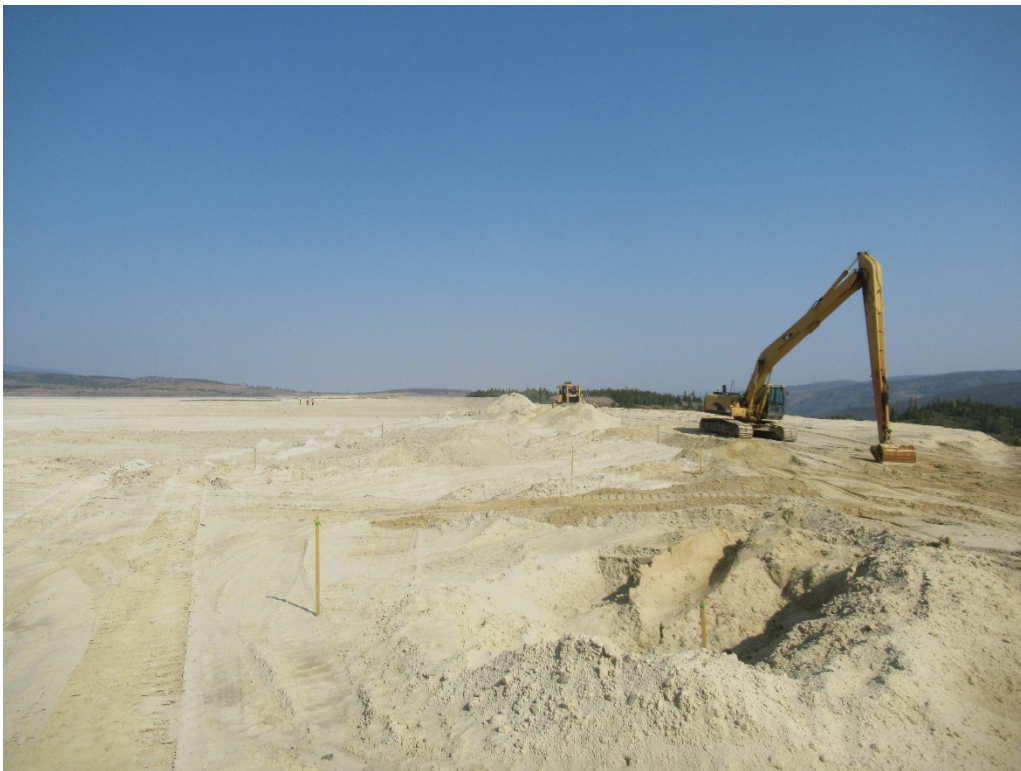
The 3-Dam crest raise construction was observed during the inspection. Two engineers from AECOM were on-site observing the 3-Dam crest raise and performing the monthly tailings impoundment inspection. The crest raise was estimated at a ninety (90) foot offset from the previous face and six (6) feet in height. The 3-Dam crest raise will be completed to allow leadoff deposition on 3-Dam through the winter. The 1-Dam crest raise is schedule to occur over next summer.

View of the southern portion of the 3-Dam crest raise

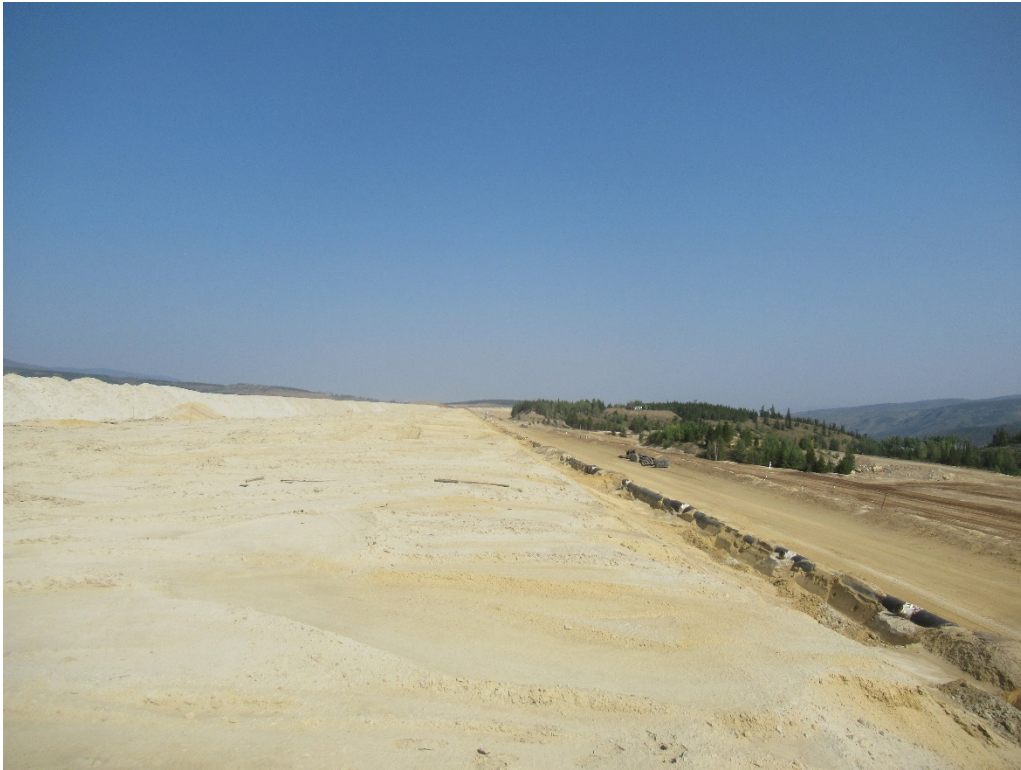
View of the new setback created by the 3-Dam crest raise

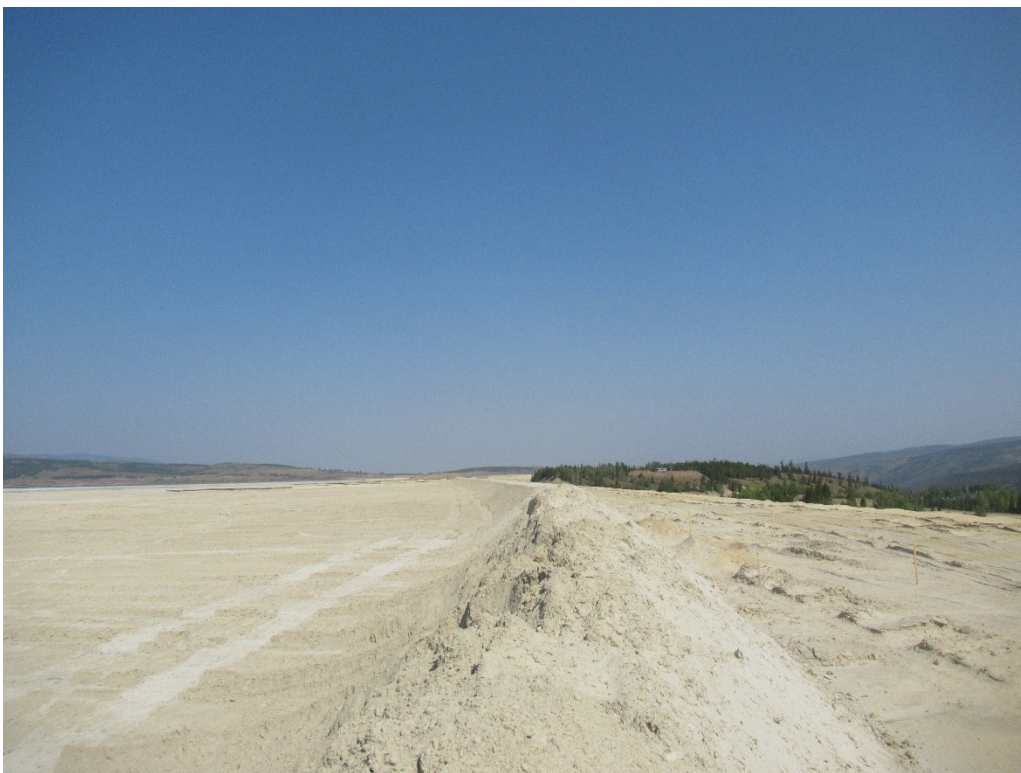
View of the 3-Dam crest raise construction looking north

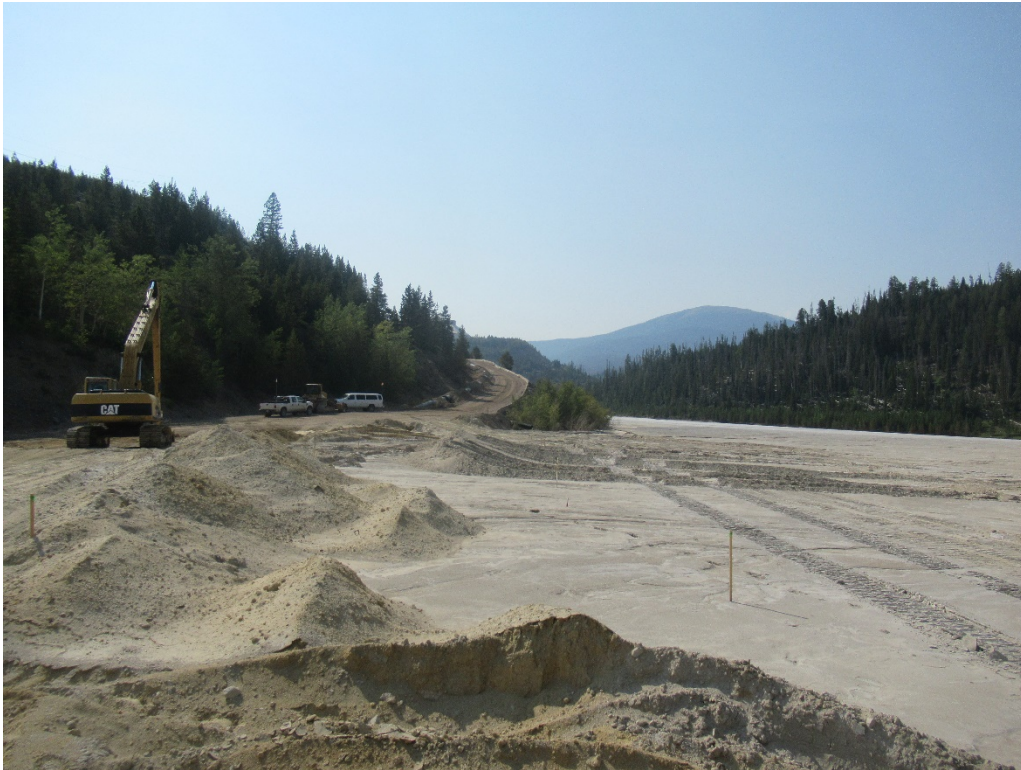
View of the 3-Dam crest raise looking south toward the TSF access road

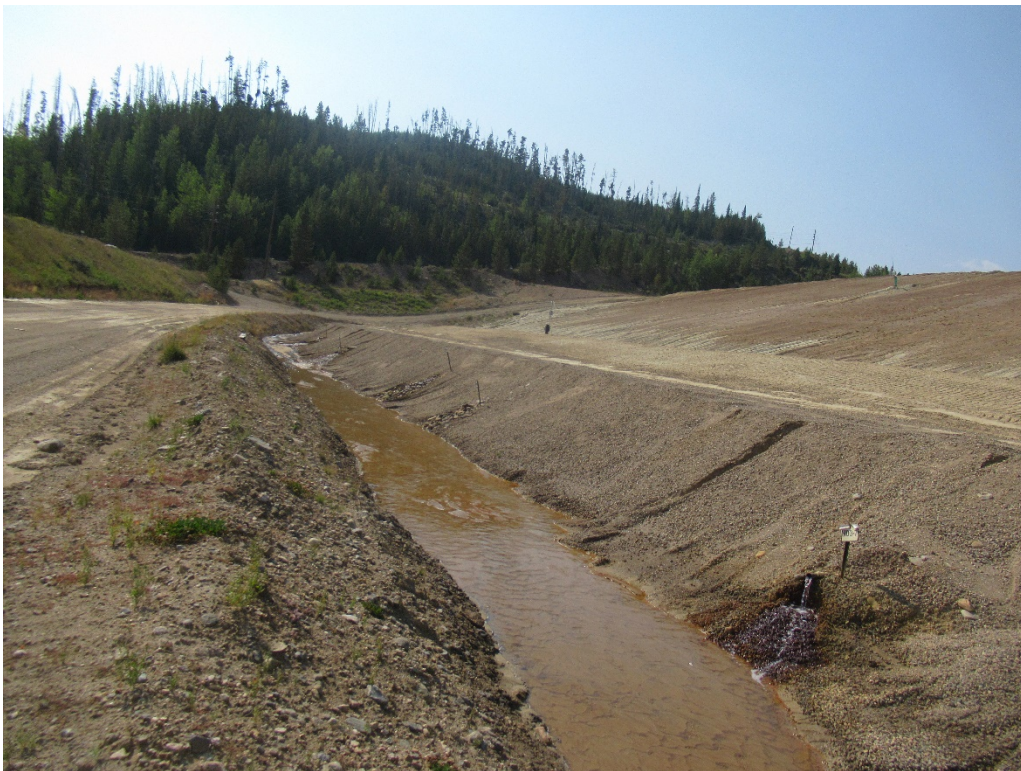
View of the seepage collection ditch below 3-Dam

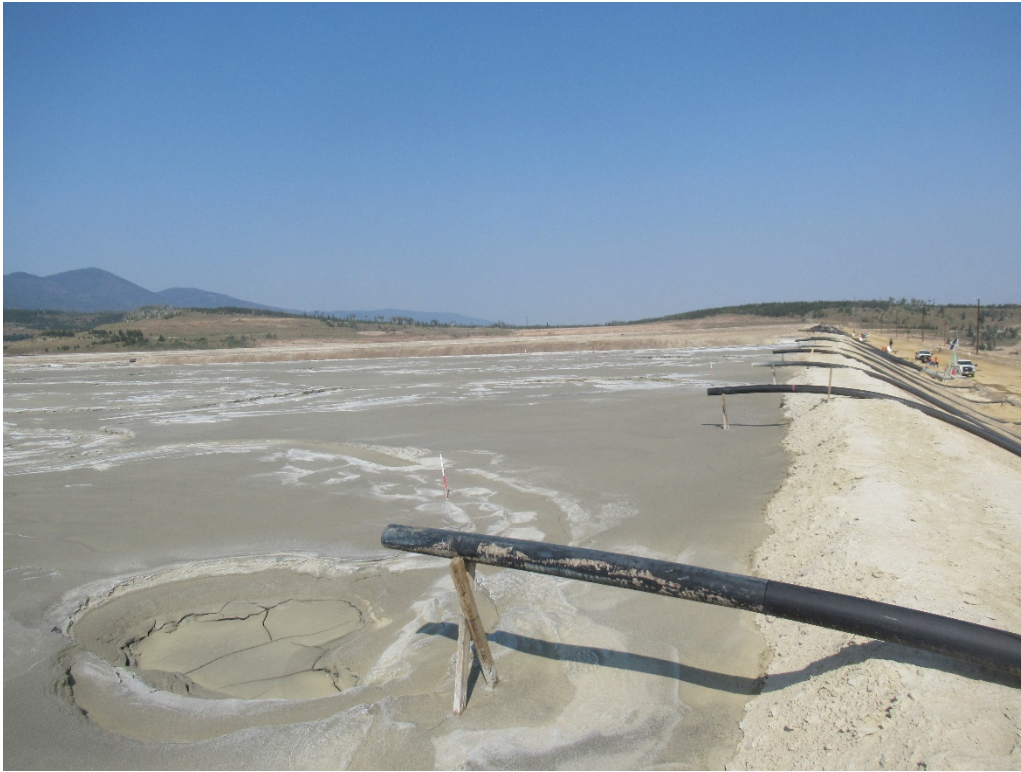
View of recent spigot deposition in cell 5 on 1-Dam

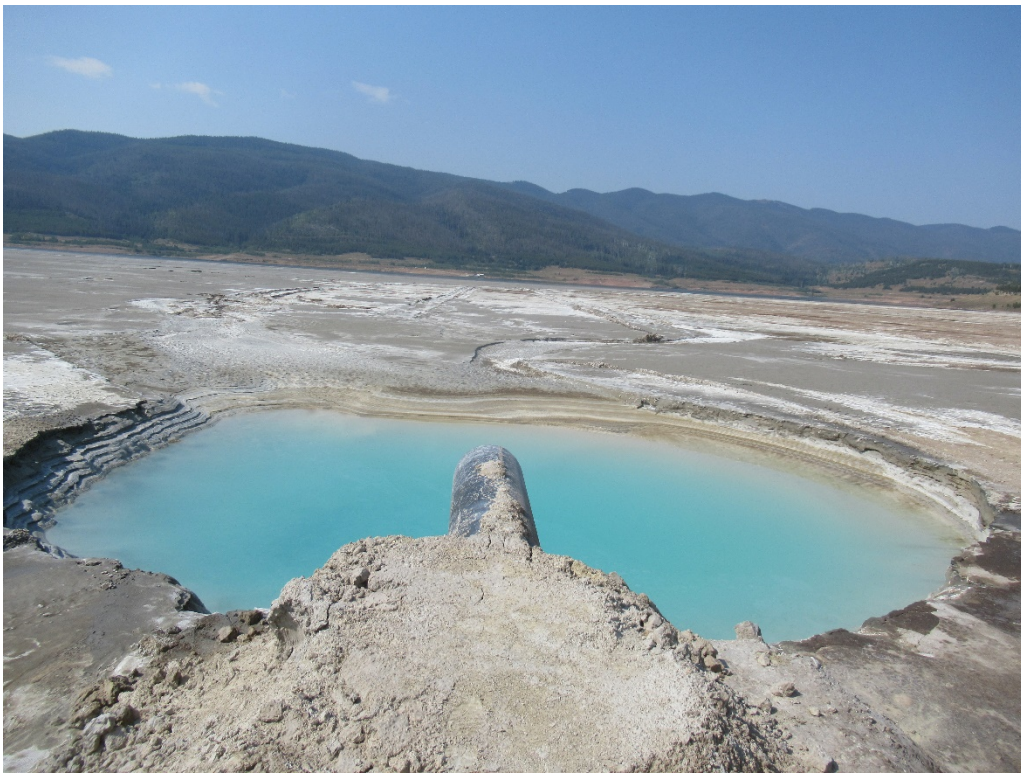
View of the plunge pool from the cell 5 lead off on 1-Dam

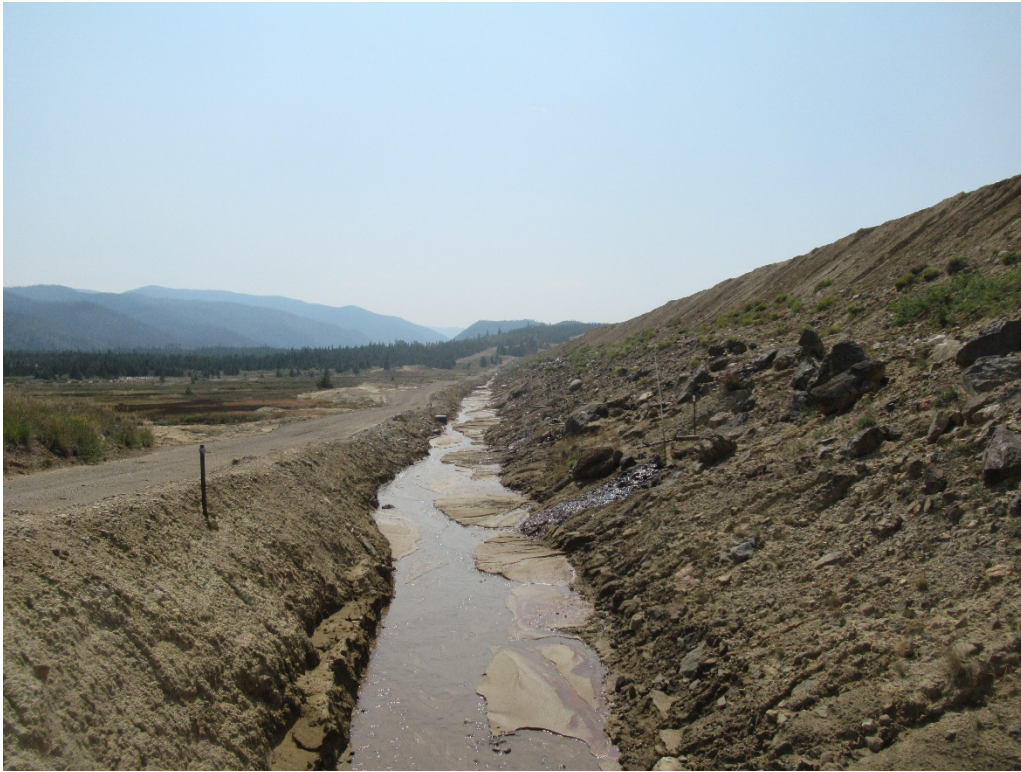
View of the seepage collection ditch and horizontal drains below 1-Dam

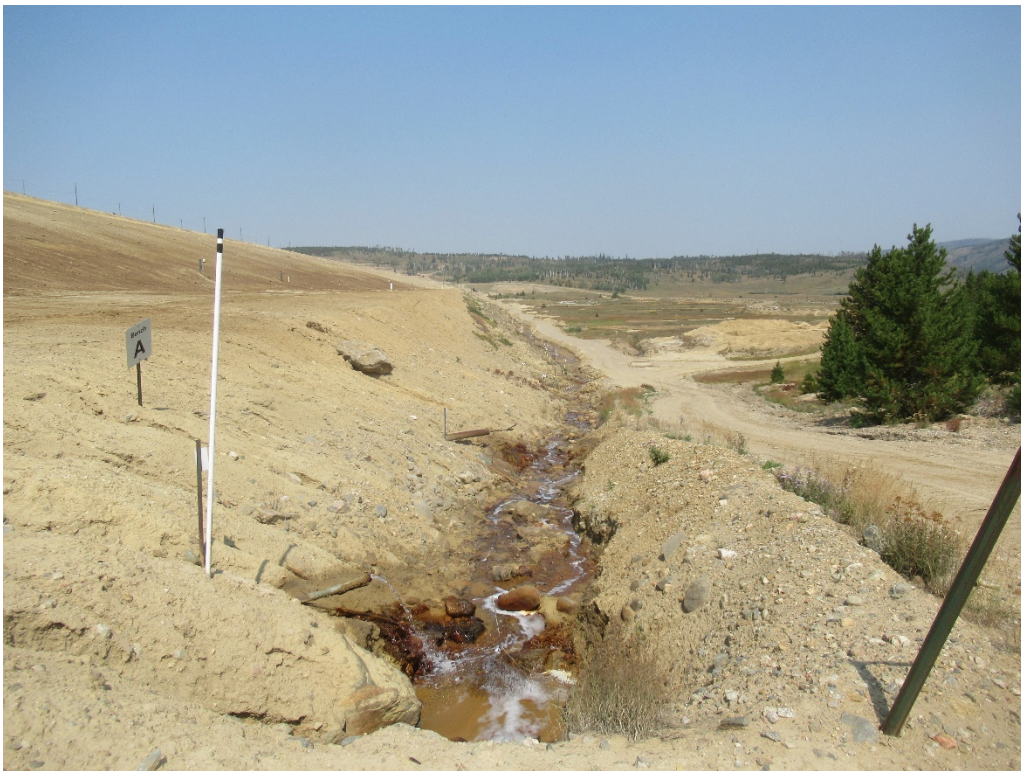
View of the seepage collection ditch and horizontal drains below 1-Dam
