**MINERALS PROGRAM INSPECTION REPORT**  
**PHONE: (303) 866-3567**

<b>MINE NAME:</b> Revenue Mine	<b>MINE/PROSPECTING ID#:</b> M-2012-032	<b>MINERAL:</b> Lead, silver and gold	<b>COUNTY:</b> Ouray
<b>INSPECTION TYPE:</b> Multi Person Inspection	<b>INSPECTOR(S):</b> Amy Yeldell	<b>INSP. DATE:</b> August 31, 2021	<b>INSP. TIME:</b> 10:00
<b>OPERATOR:</b> Ouray Silver Mines Inc.	<b>OPERATOR REPRESENTATIVE:</b>	<b>TYPE OF OPERATION:</b> 112d-1 - Designated Mining Operation	
<b>REASON FOR INSPECTION:</b> Normal I&E Program	<b>BOND CALCULATION TYPE:</b> None	<b>BOND AMOUNT:</b> \$476,269.41	
<b>DATE OF COMPLAINT:</b> NA	<b>POST INSP. CONTACTS:</b> None	<b>JOINT INSP. AGENCY:</b> DRMS	
<b>WEATHER:</b> Clear	<b>INSPECTOR'S SIGNATURE:</b>

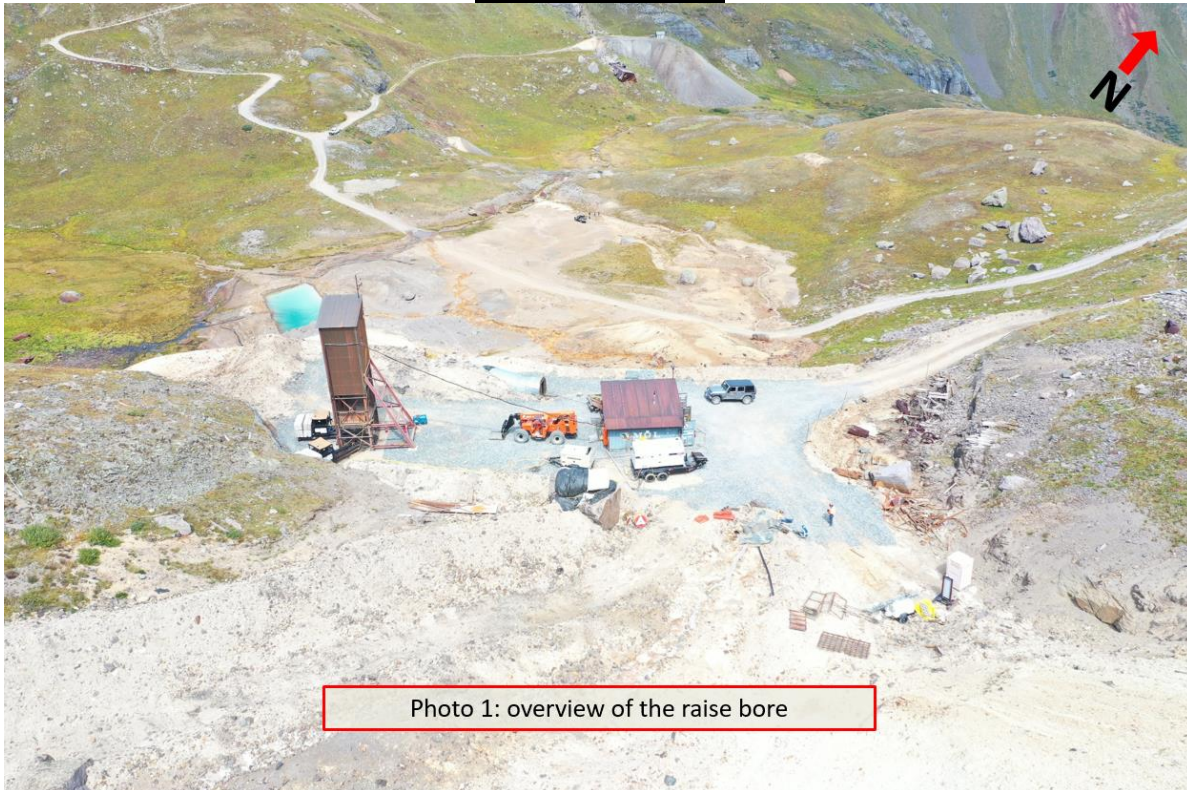
Contractors were on site working on rehabbing the raise bore. In the near future the lifting system will be modified to be internally driven and not dependent on the hoist house. The lifting system was described as having a larger capacity (more people). Open communication is encouraged as improvements continue to ensure that any necessary permitting changes are completed. While at the raise bore, the revised permit boundary to be submitted under AM-2 was extensively discussed. Staff provided input regarding the interaction between DRMS permitted areas and adjacent AML projects. Concerns regarding stormwater run-on and run-off were brainstormed. Lastly Division staff took drone footage of the raise bore and adjacent areas.

Photo 1: overview of the raise bore

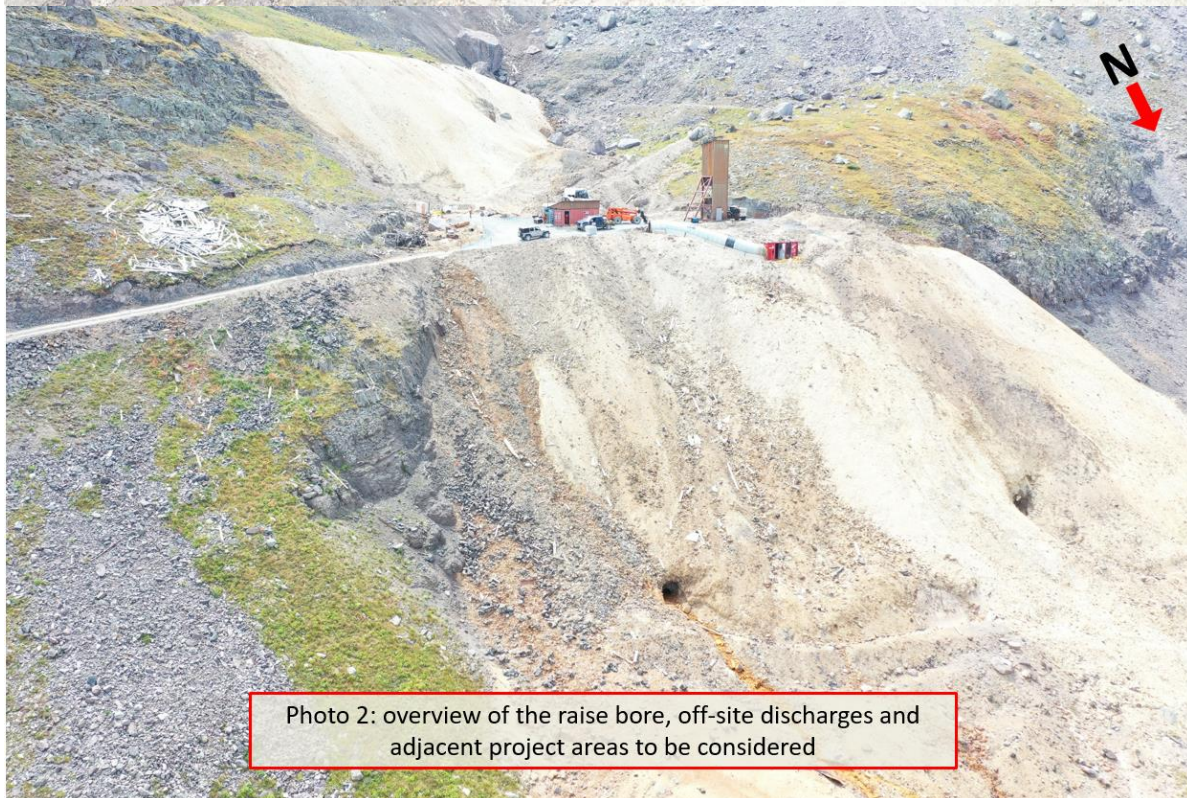
Photo 2: overview of the raise bore, off-site discharges and adjacent project areas to be considered

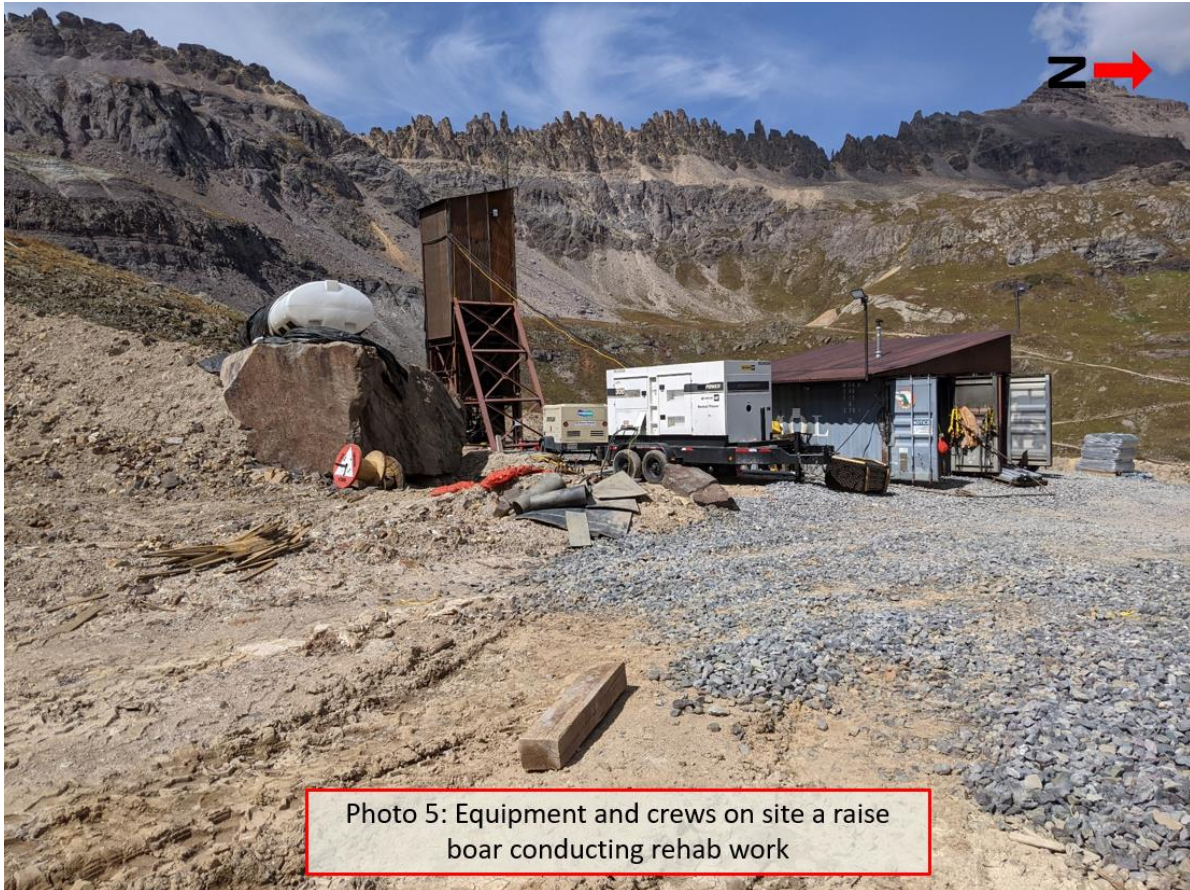
Photo 5: Equipment and crews on site a raise boar conducting rehab work

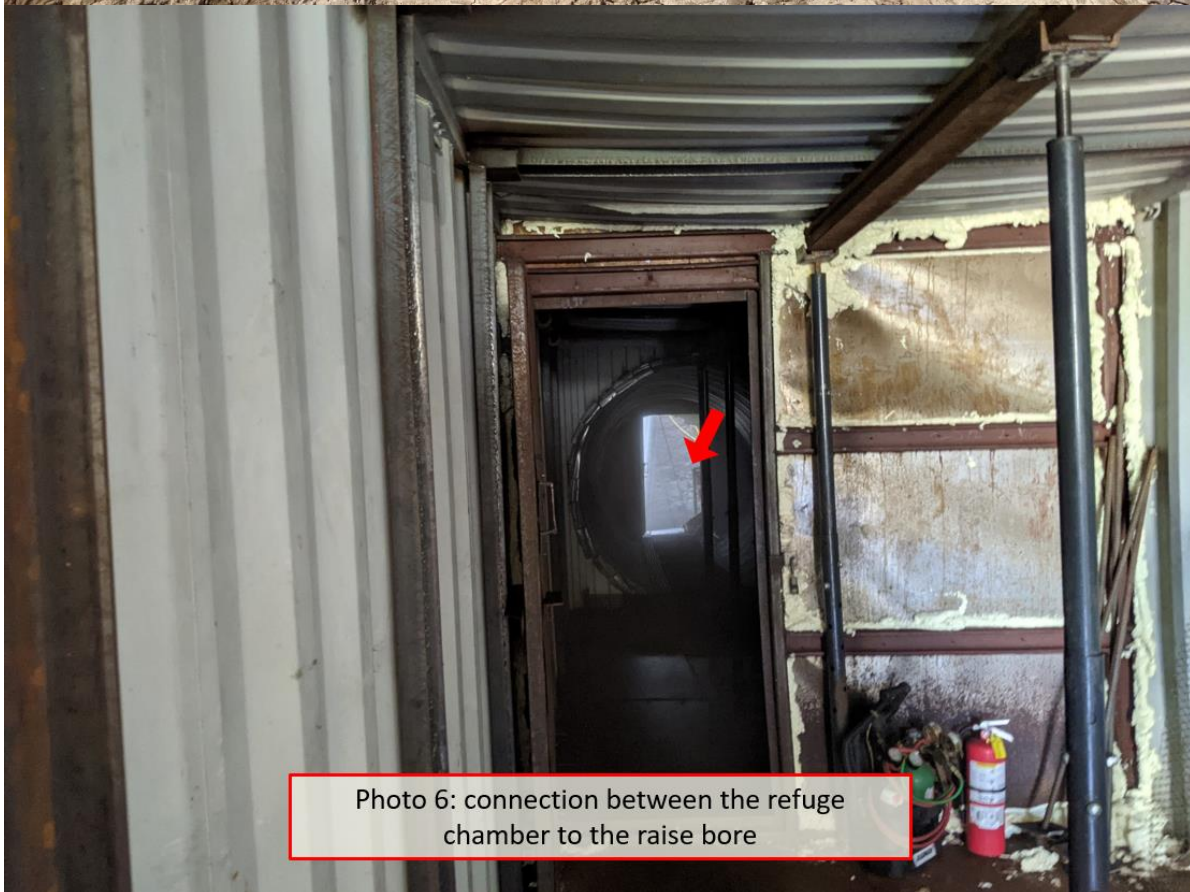
First the Division inspected the secondary escape/raise bore area. Since previous inspections significant progress has been made towards completion of the refuge chamber. The sea cans have been covered with earthen material. The inside of the sea cans were observed, the roof of the sea cans are slightly collapsed and are resting on the interior structural supports. If additional settling occurs more supports may be necessary. Staff was able to observe that the buried refuge chamber has been connected to the Monongahela raised bore.

Photo 6: connection between the refuge chamber to the raise bore

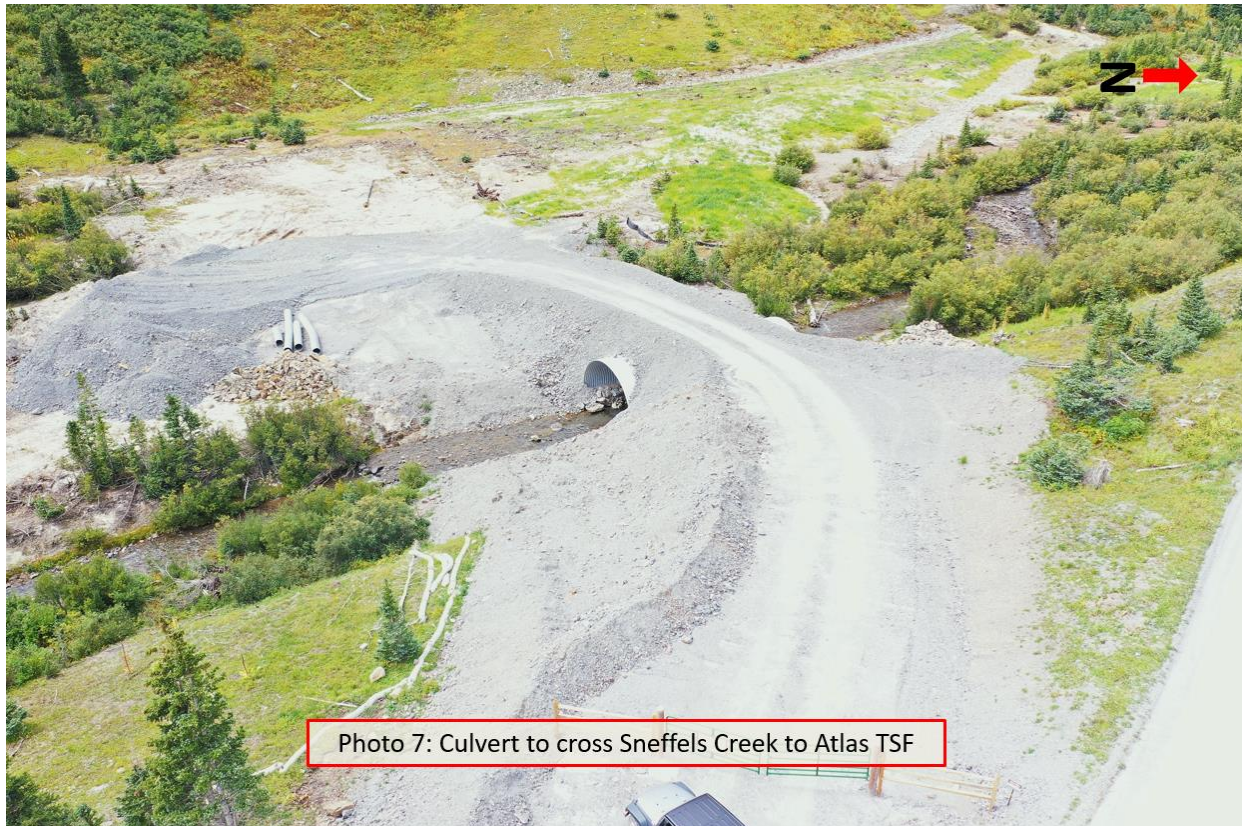
Next the Atlas tailing storage facility (TSF) was observed. The culvert to cross Sneffels creek has been installed. No other work to the Atlas TSF has been completed to date. Drone footage of this area was also obtained.

Photo 7: Culvert to cross Sneffels Creek to Atlas TSF

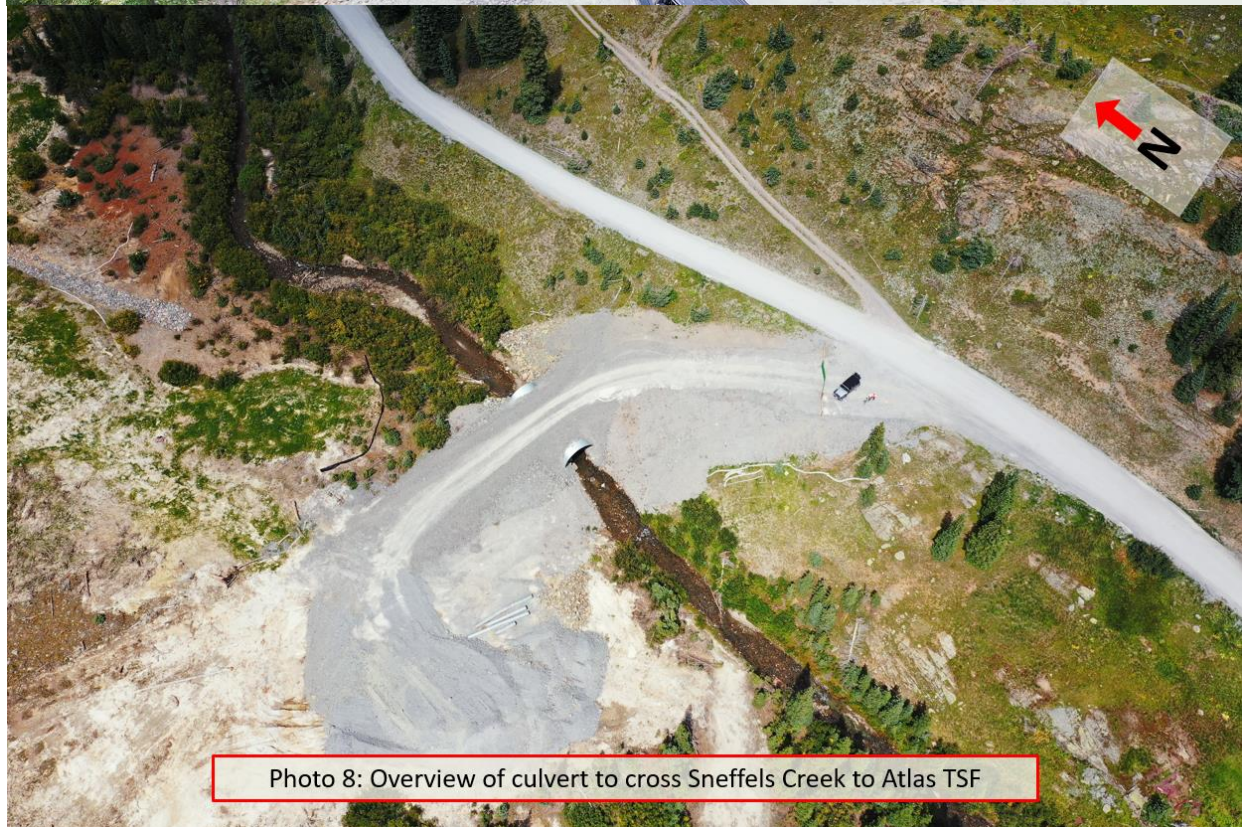
Photo 8: Overview of culvert to cross Sneffels Creek to Atlas TSF

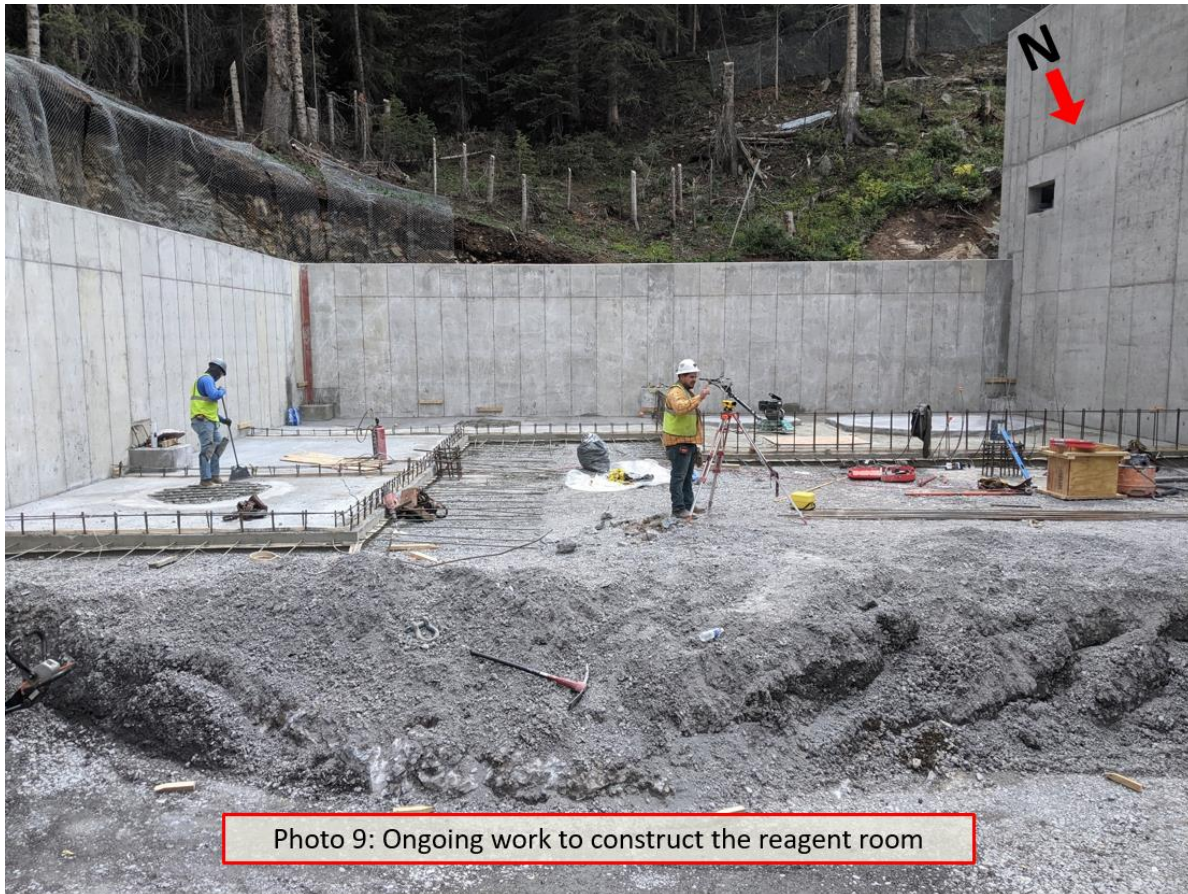
Construction on the new reagent room (TR-14) was well under way. Cement forms of the floor were being constructed. No EPF related observations were made as part of this inspection. Staff conducted a quick inspection of the mill that is under construction (TR-15). OSMI staff walked the Division through all of the equipment and piping installed to date. This was not a formal EPF inspection of the mill under TR-15, it was purely educational. Division staff was invited to partake in the commissioning process once mill construction is completed.

Photo 9: Ongoing work to construct the reagent room

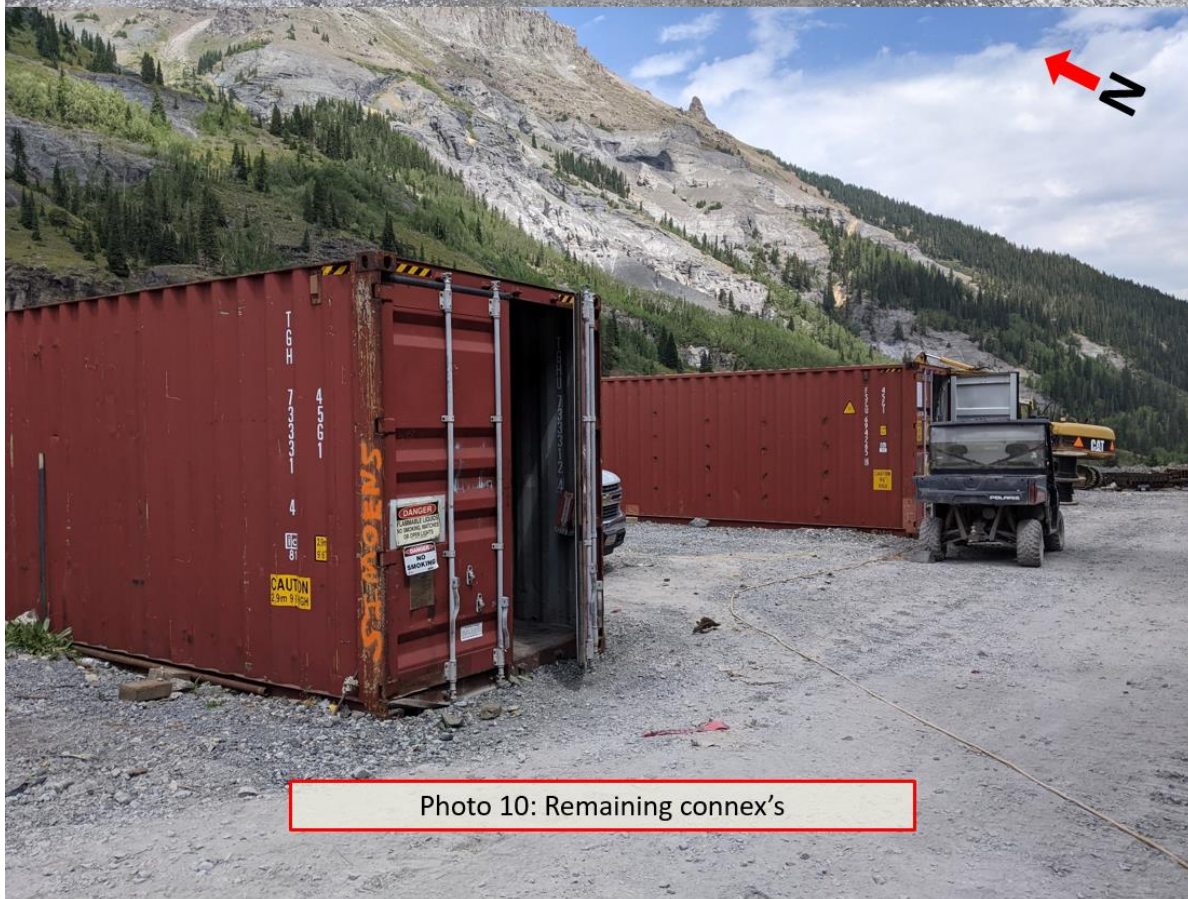
Photo 10: Remaining connex's

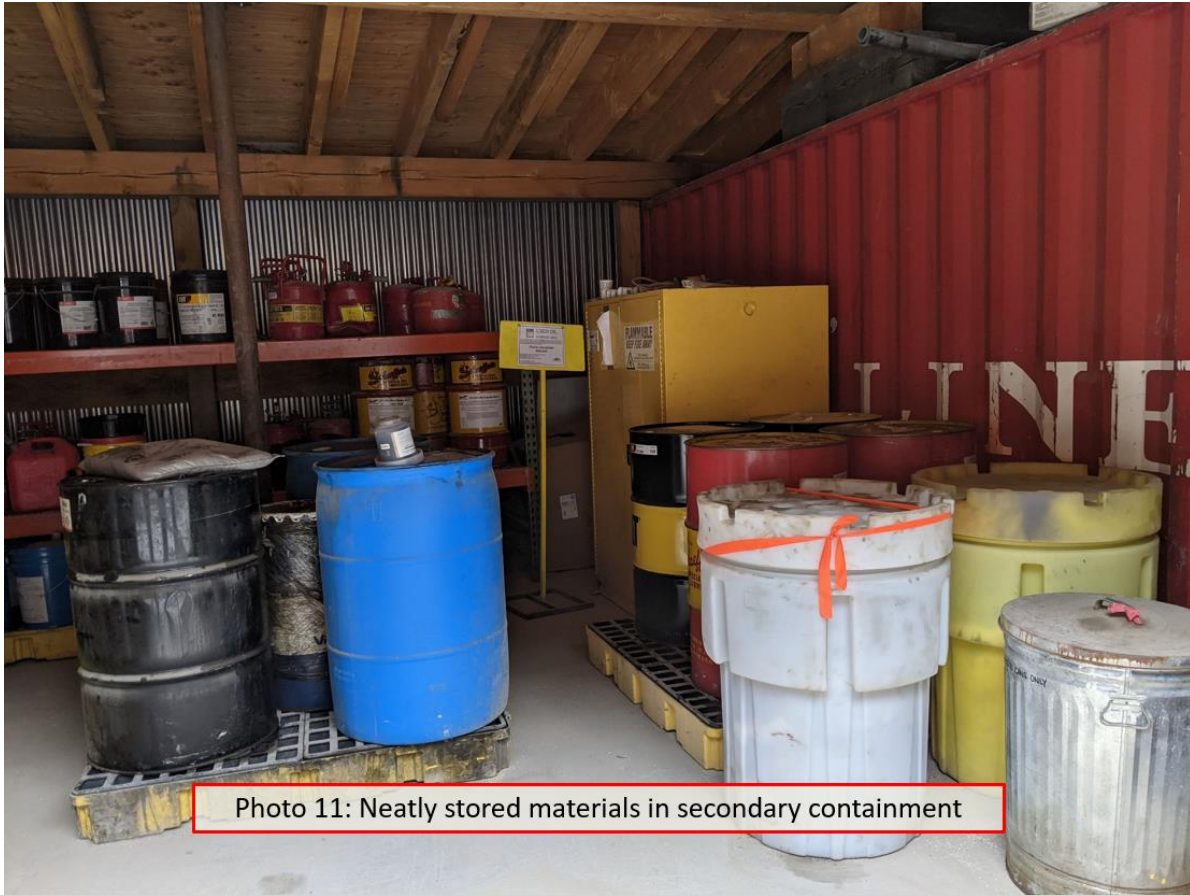
To finish off staff moved to main the Revenue mine site. As Revenue moves forward with commissioning of the mill a large amount of waste rock has been generated. There are several stockpiles located on the surface and storage room is limited. It was indicated that OSMI is crushing the majority of the waste rock generated at this time for Ouray County to use on roads. The expanded train shed appears to be nearly completed. The area proposed to be used for the equipment wash area (TR-16) was observed and briefly discussed. The Division was able to see the area for temporary office trailers proposed under TR-16. "Connex City" is in the process of being removed. During the inspection only 3 connexs remain and according to Mr. Jesse the remaining connexs were slated to be removed in the next 2 weeks. All items within the waste storage shed were well organized and contained within proper secondary containment.

Photo 11: Neatly stored materials in secondary containment

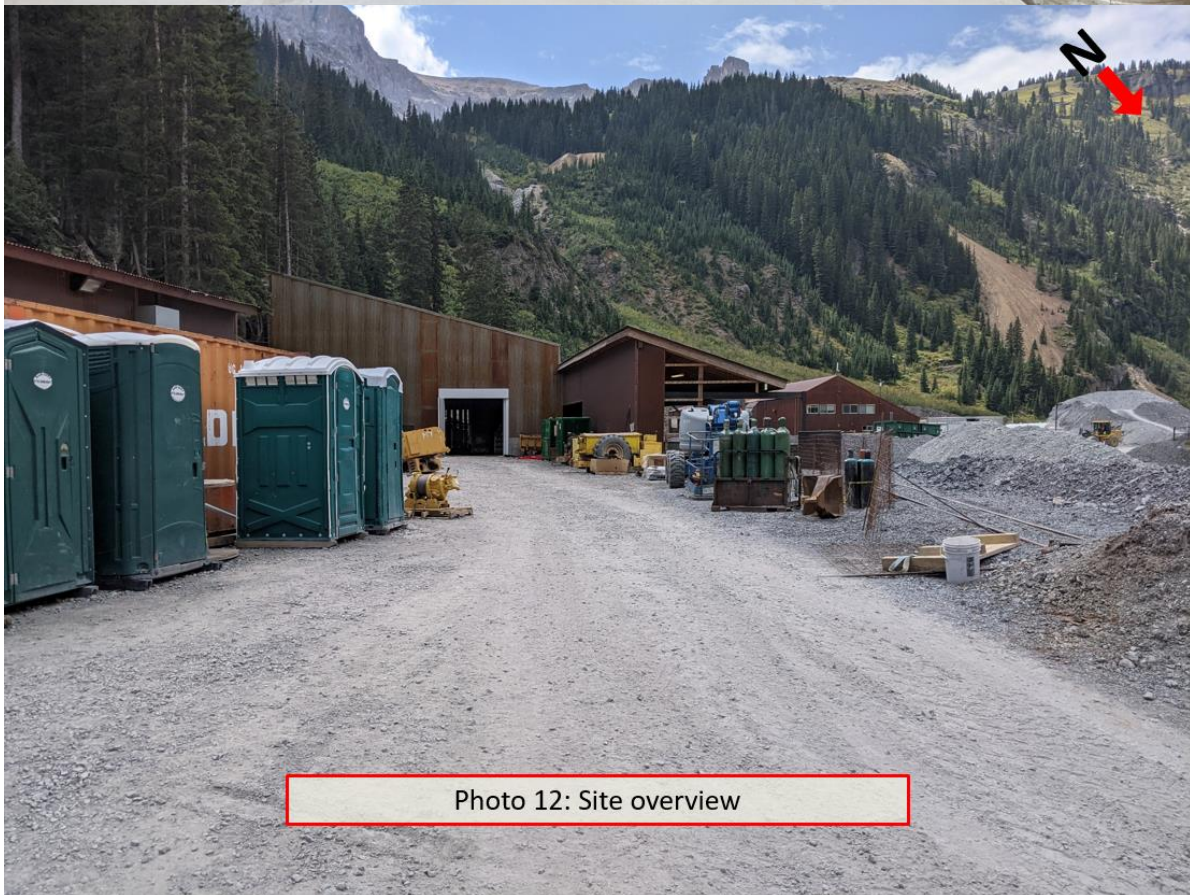
Photo 12: Site overview

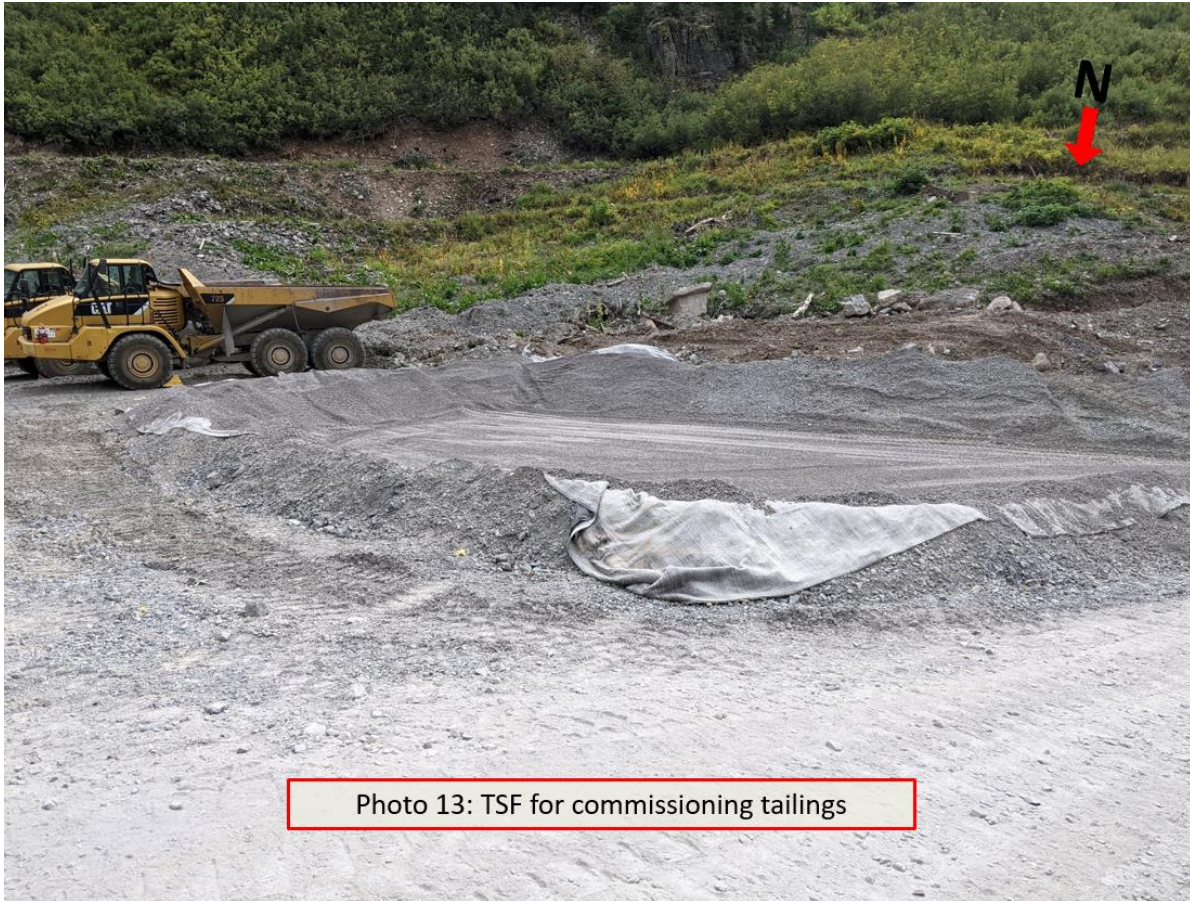
The Revenue TSF area was inspected. The area in which the tailings generated during the mill commissioning has been completed. The constructed facility appears to meet the specification of TR-15 and is ready to accept tailings as commissioning activities allow. The Revenue TSF as a greater whole will require additional work before it can start accepting tailings in large quantities. Much of the area is being utilized to store additional

Photo 13: TSF for commissioning tailings

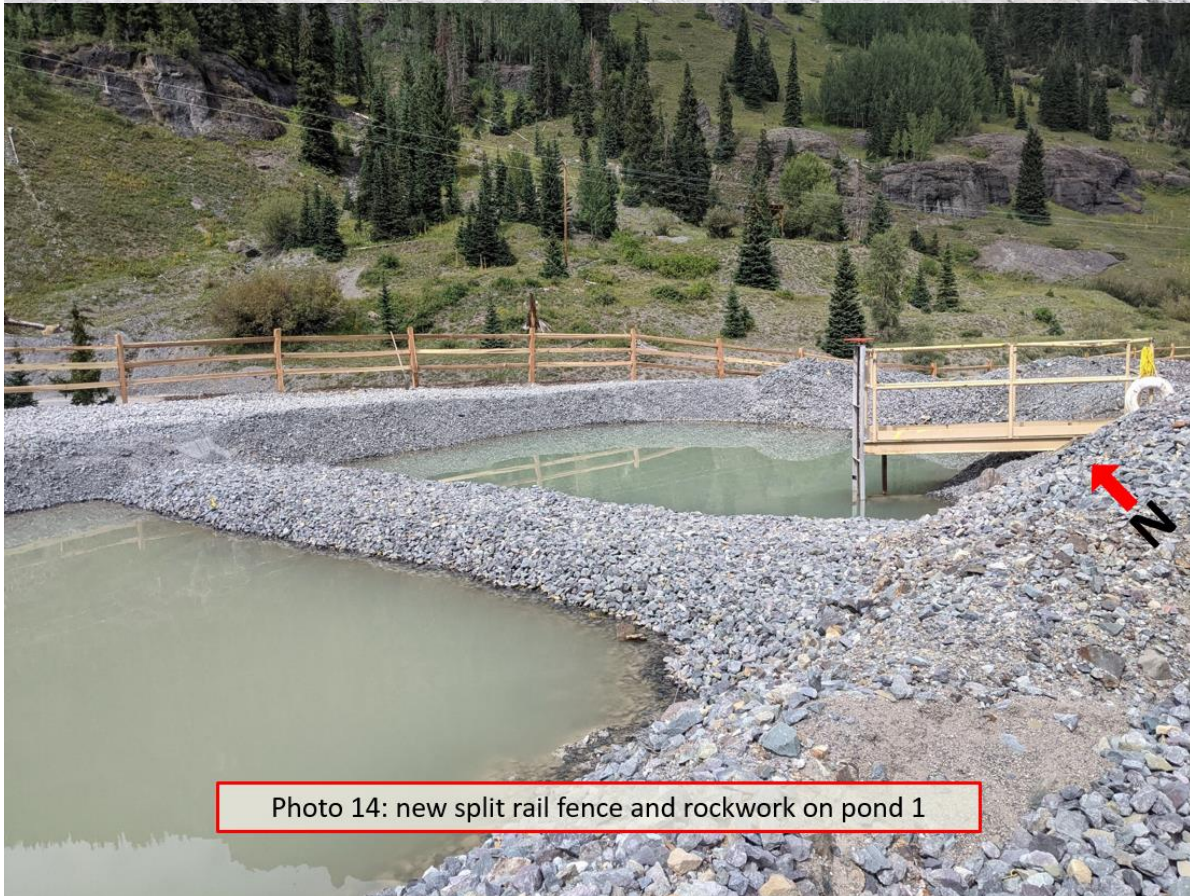
Adjacent to the water treatment ponds a split rail fence has been constructed. The areas around the ponds now have crushed waste rock and overall appear more visually appealing. The rock berm within pond one has been reworked. The fence similar to the security shed at the entrance to the site are in an effort to keep the public out of the active mine site. Some vegetation is beginning to establish on the rocked slopes around the ponds though spars.

Photo 14: new split rail fence and rockwork on pond 1
