MINERALS PROGRAM INSPECTION REPORT
PHONE: (303) 866-3567

| MINE NAME: Idarado Mining Co | MINE/PROSPECTING ID#: M-1977-403-HR | MINERAL: Lead, zinc, copper, c gold | COUNTY: San Miguel |
| INSPECTION TYPE: Monitoring | INSPECTOR(S): Lucas West | INSP. DATE: August 25, 2021 | INSP. TIME: 15:58 |

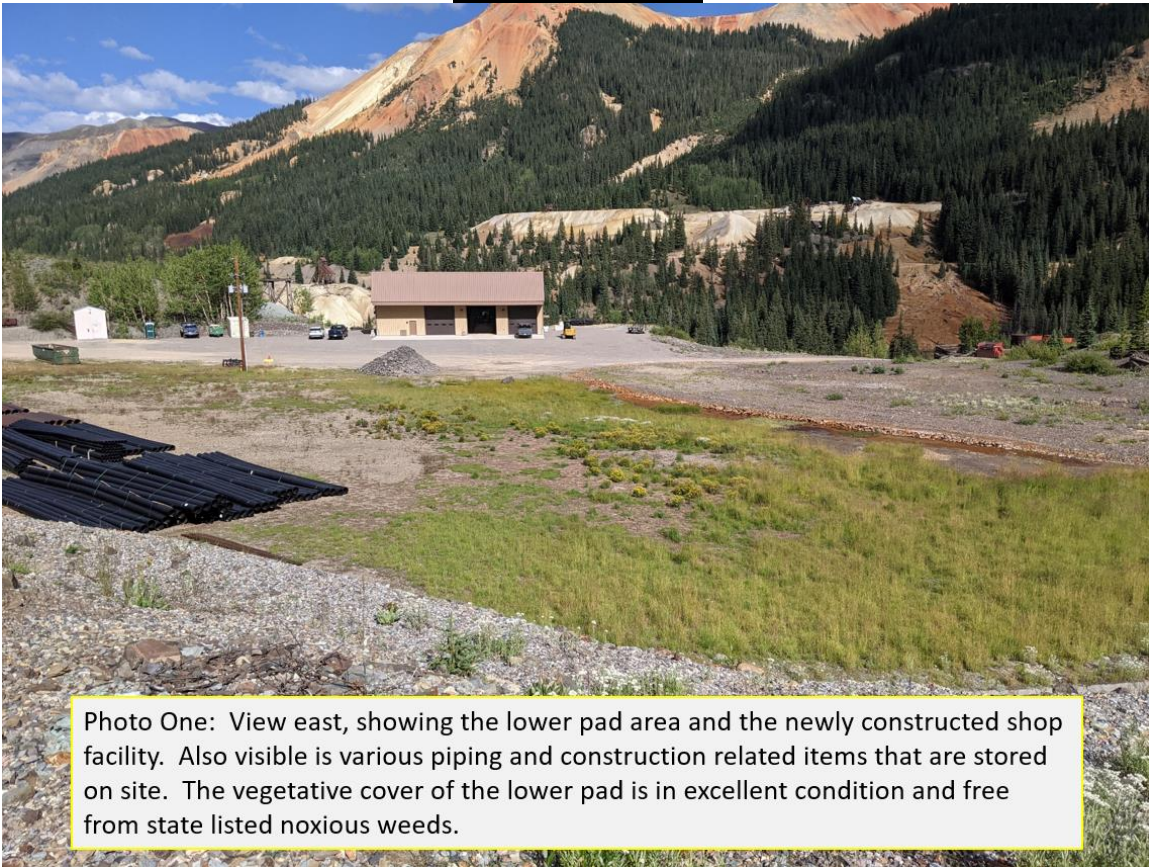
Photo One: View east, showing the lower pad area and the newly constructed shop facility. Also visible is various piping and construction related items that are stored on site. The vegetative cover of the lower pad is in excellent condition and free from state listed noxious weeds.

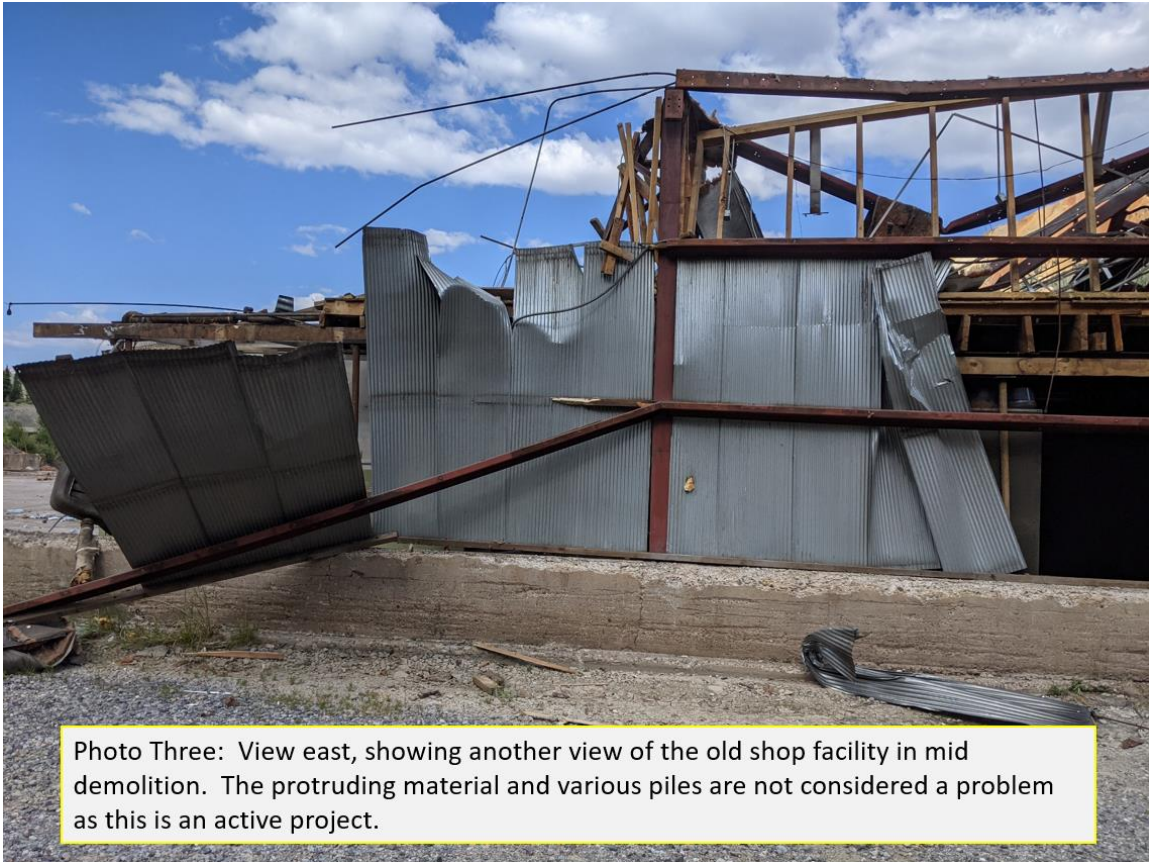
Photo Three: View east, showing another view of the old shop facility in mid demolition. The protruding material and various piles are not considered a problem as this is an active project.

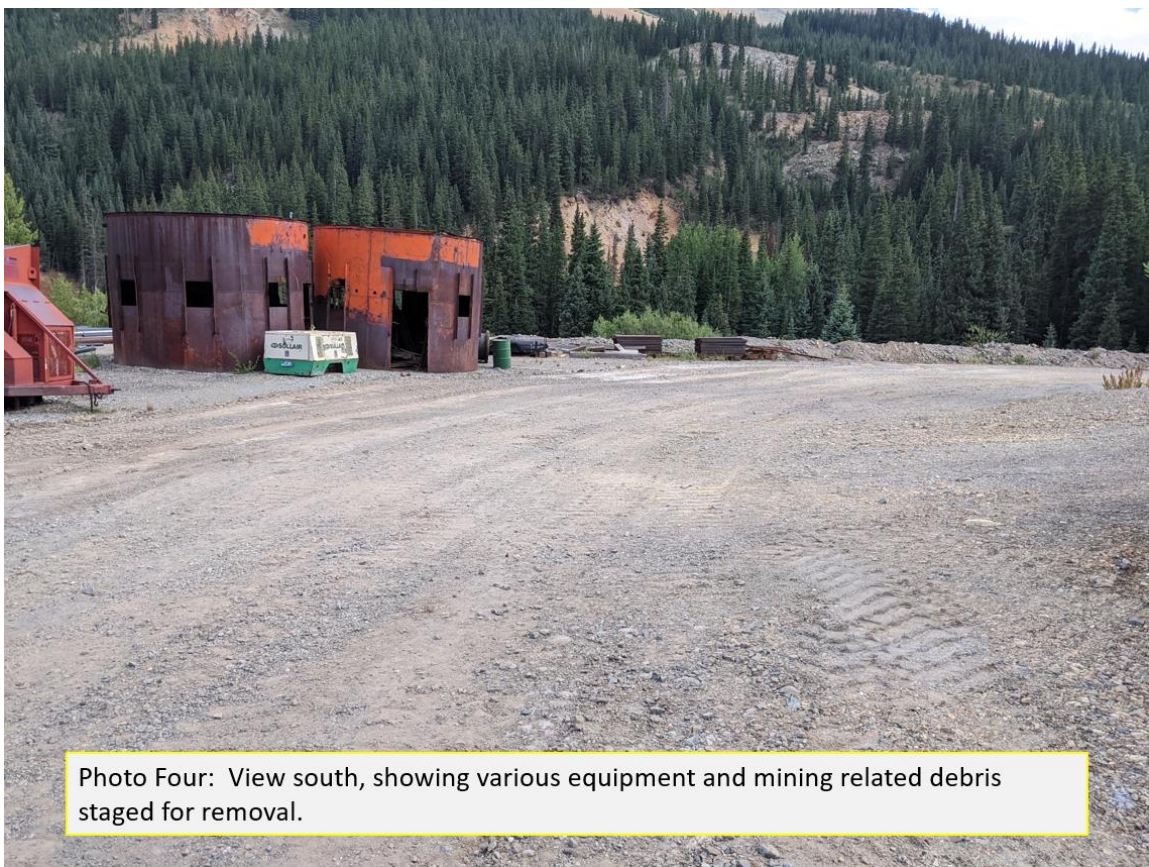
Other reclamation activities are ongoing, several historic tanks and other various mining related debris has been staged for removal. All items are stored in neat and orderly fashion and can be seen in Photo **Four**. Discussions with the Operator indicate that further reclamation of the historic mill foundation located on site is slated to take place over the next years. The foundation can be seen in Photo **Five**. The portal, shown in Photo **Six**, was also observed, and secured. No signs of vandalism or attempted unauthorized entry was noted.

Photo Four: View south, showing various equipment and mining related debris staged for removal.
