**MINERALS PROGRAM INSPECTION REPORT**  
**PHONE: (303) 866-3567**

<b>MINE NAME:</b> Coyote Ridge	<b>MINE/PROSPECTING ID#:</b> M-2000-052	<b>MINERAL:</b> Sand and gravel	<b>COUNTY:</b> Fremont
<b>INSPECTION TYPE:</b> Monitoring	<b>INSPECTOR(S):</b> Timothy Cazier, P.E.	<b>INSP. DATE:</b> August 19, 2021	<b>INSP. TIME:</b> 09:20
<b>OPERATOR:</b> Rocky Mountain Materials and Asphalt, Inc.	<b>OPERATOR REPRESENTATIVE:</b> Phillip Courtney	<b>TYPE OF OPERATION:</b> 112c - Construction Regular Operation	
<b>REASON FOR INSPECTION:</b> Normal I&E Program	<b>BOND CALCULATION TYPE:</b> Partial Bond	<b>BOND AMOUNT:</b> \$32,400.00	
<b>DATE OF COMPLAINT:</b> NA	<b>POST INSP. CONTACTS:</b> None	<b>JOINT INSP. AGENCY:</b> None	
<b>WEATHER:</b> Clear	<b>INSPECTOR'S SIGNATURE:</b>

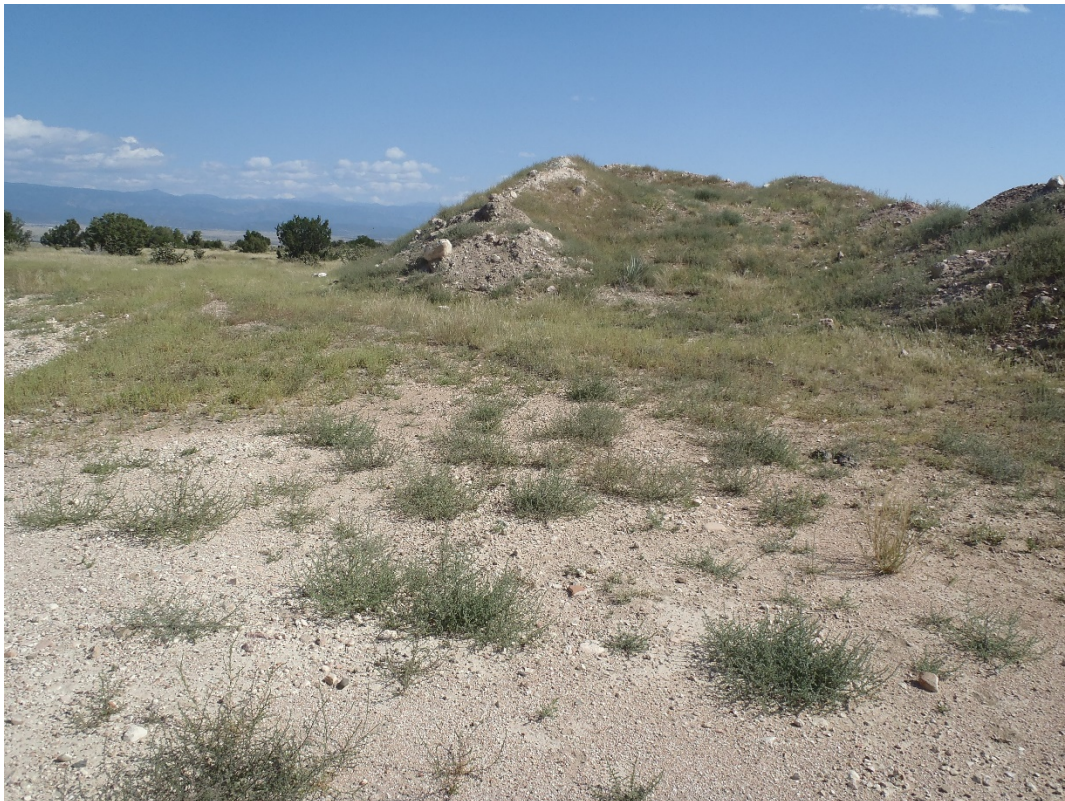
Excess Spoil and Dev. Waste: An overburden stockpile (see **Photo 1**) that could be used for backfill was observed adjacent to the most recently active pit on the east end of the site.

Photo 1. Overburden stockpile (adjacent to recent active pit, looking NNW).

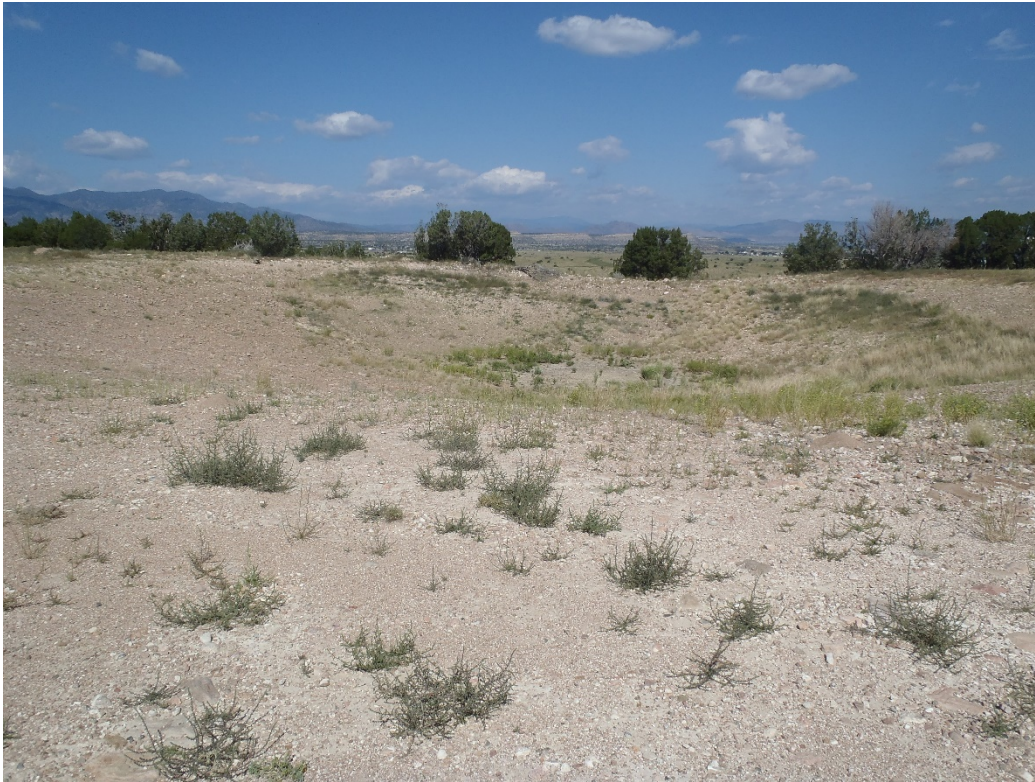
Backfilling and Grading: All highwalls have been graded to 3H:1V of flatter.

Gen. Compliance with Mine Plan: The operation appeared to be in compliance with the approved mine plan. The maximum allowed disturbed area is 45 acres. Google Earth was used to determine the historically disturbed area, which was measured to be approximately 9.5 acres. All highwalls have been flattened to at least 3H:1V (see **Photo 2**).

Photo 2. Most recent active pit (east end, looking NW; note flattened highwalls).

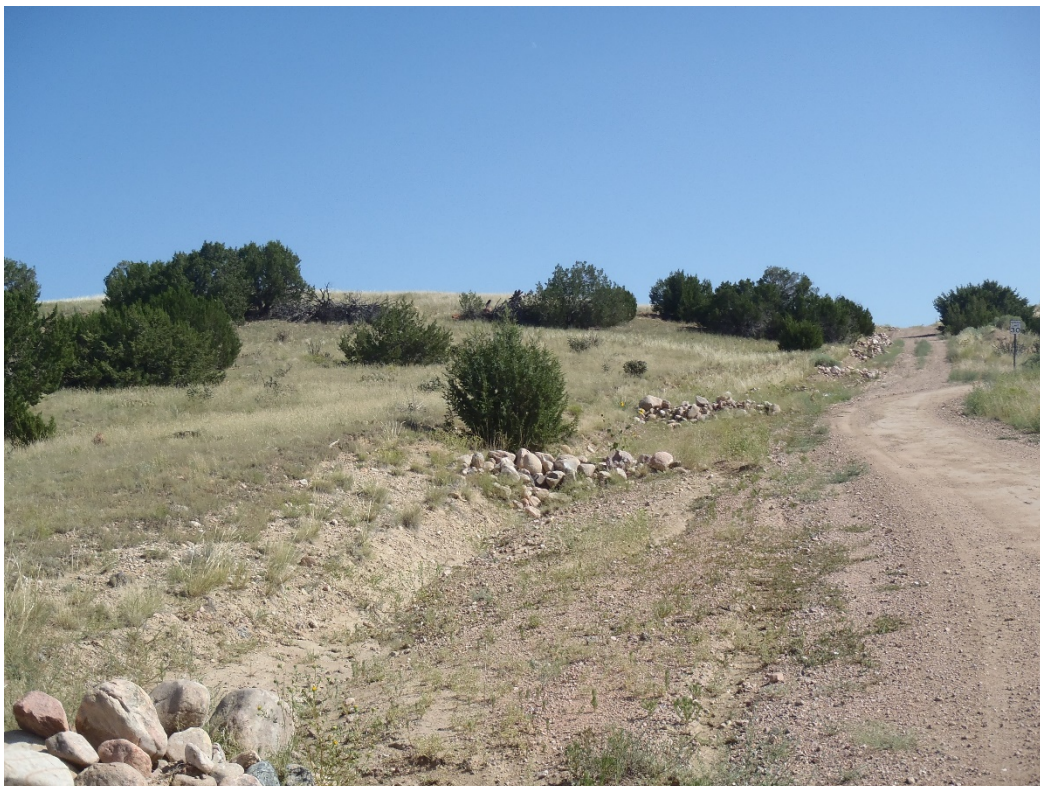
Roads: Haul and access roads were in good condition and did not appear to be a source of sediment that could be tracked offsite. Road side ditches were clean with rock check dams to control erosion (see **Photo 3**).

Photo 3. Access road and roadside ditch (note rock check dams).

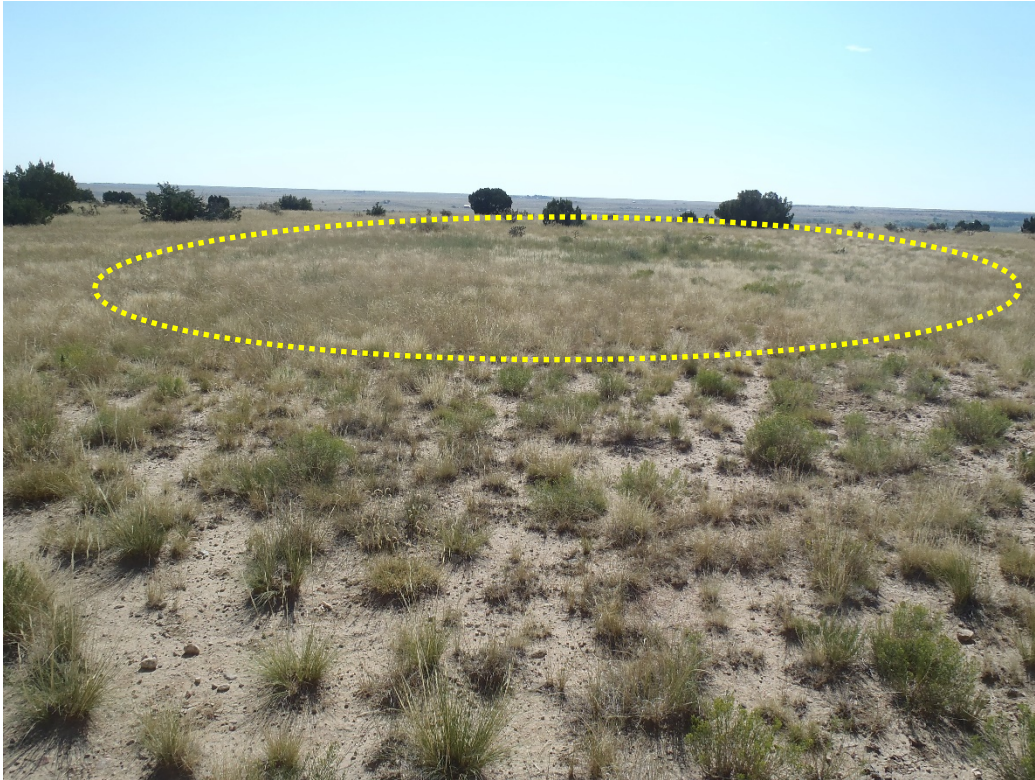
Reclamation Success: One acre has been completely reclaimed (see **Photo 4**) midway (Area B in Figure 1 of the 2016 inspection report) along the existing two-track access road. The majority of the 5.25-acre disturbance on the west end is reclaimed (see **Photo 5**). The most recent disturbance at the northeast end of the access road where the product stockpile (see **Photo 6**), and overburden (see **Photo 1**) and topsoil (see **Photo 7**) stockpiles were observed, needs additional grading and seeding. Boulder stockpiles were observed at the west end (see **Photo 8**) and the northeast end (see **Photo 9**). These are considered potential product, but would need crushing.

Revegetation: The west end disturbance (excepting the boulder stockpile seen in **Photo 8**) and the midway disturbance (**Photo 4**) are considered adequately revegetated. A single tamarisk (salt cedar) plant was observed near the west permit boundary on the north side of the access road. I recommended Mr. Courtney and other site personnel watch for more and treat them before they become a problem.

Photo 4. Reclaimed midway disturbed area (looking SE from access road).

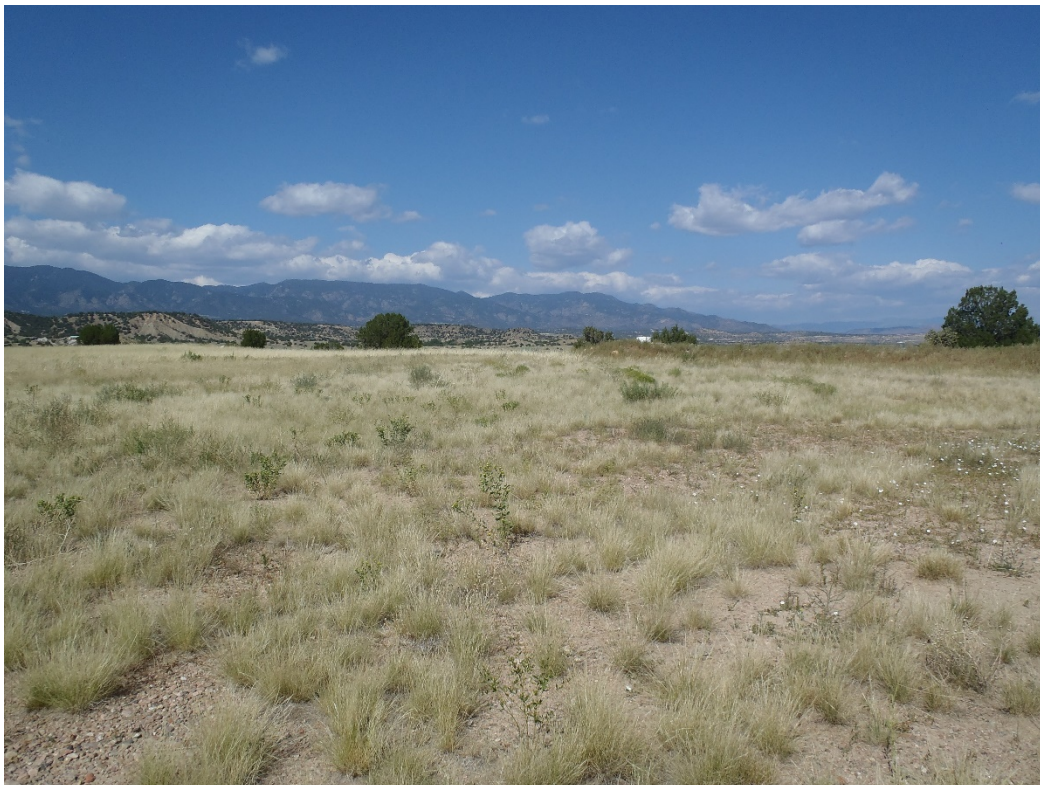
Photo 5. Well established vegetation (west end disturbance - west of boulders, looking west).

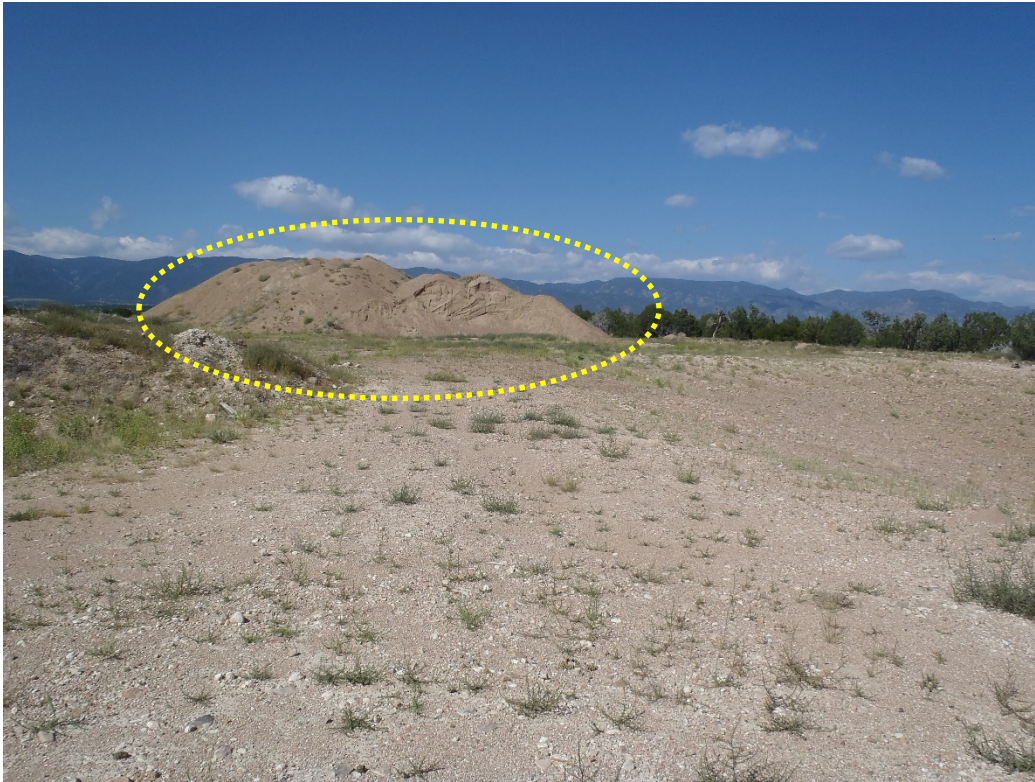
Photo 6. Product stockpile near most recent active pit (NE end, looking SW).

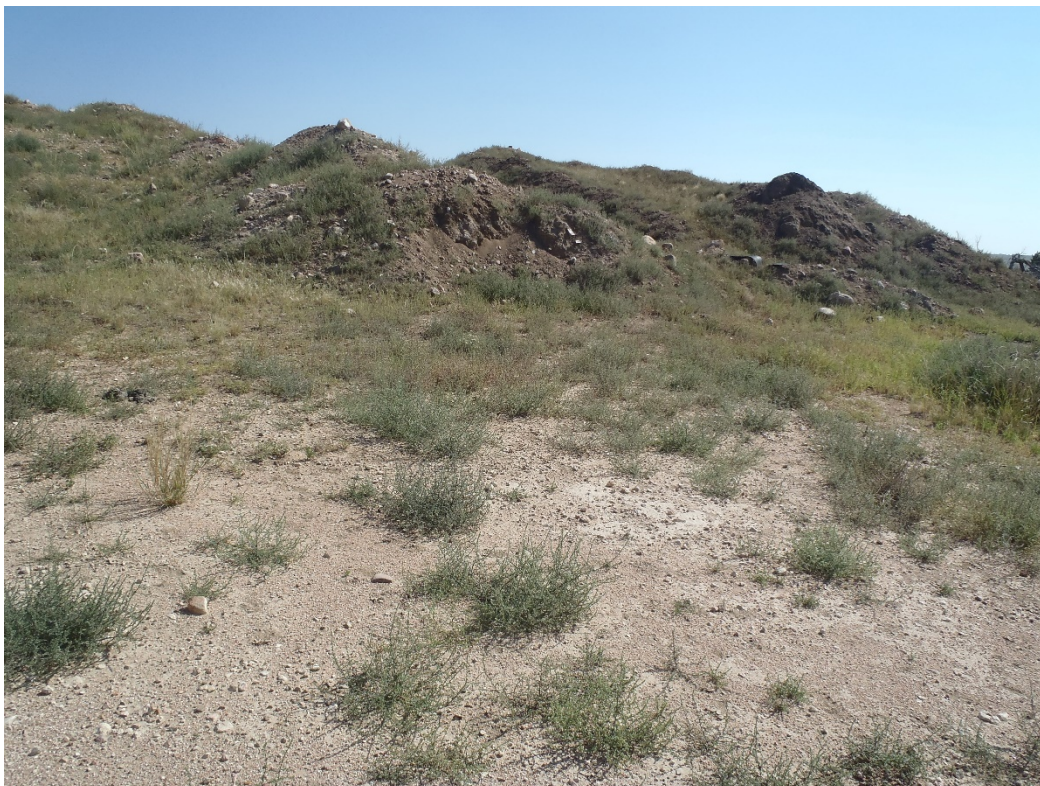
Topsoil: A topsoil stockpile was observed next to the overburden stockpile in the northeast corner of the site.

Photo 7. Topsoil stockpile (adjacent to NE disturbance overburden stockpile).

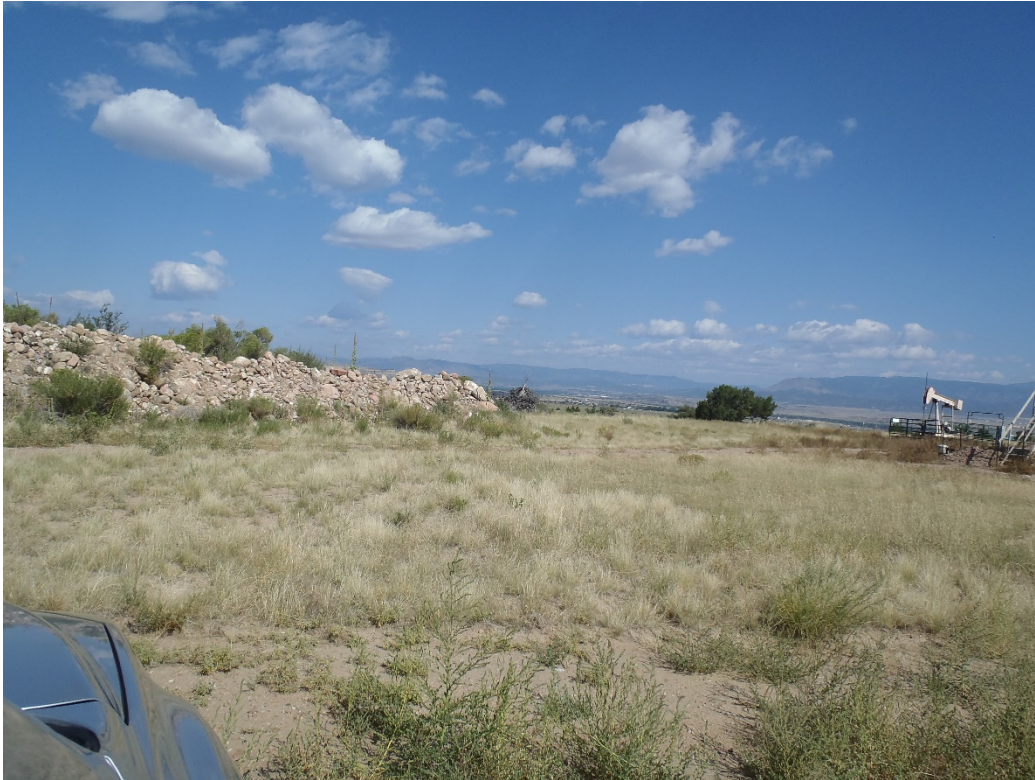
Photo 8. Boulder stockpile (east side of west end disturbance – looking north).

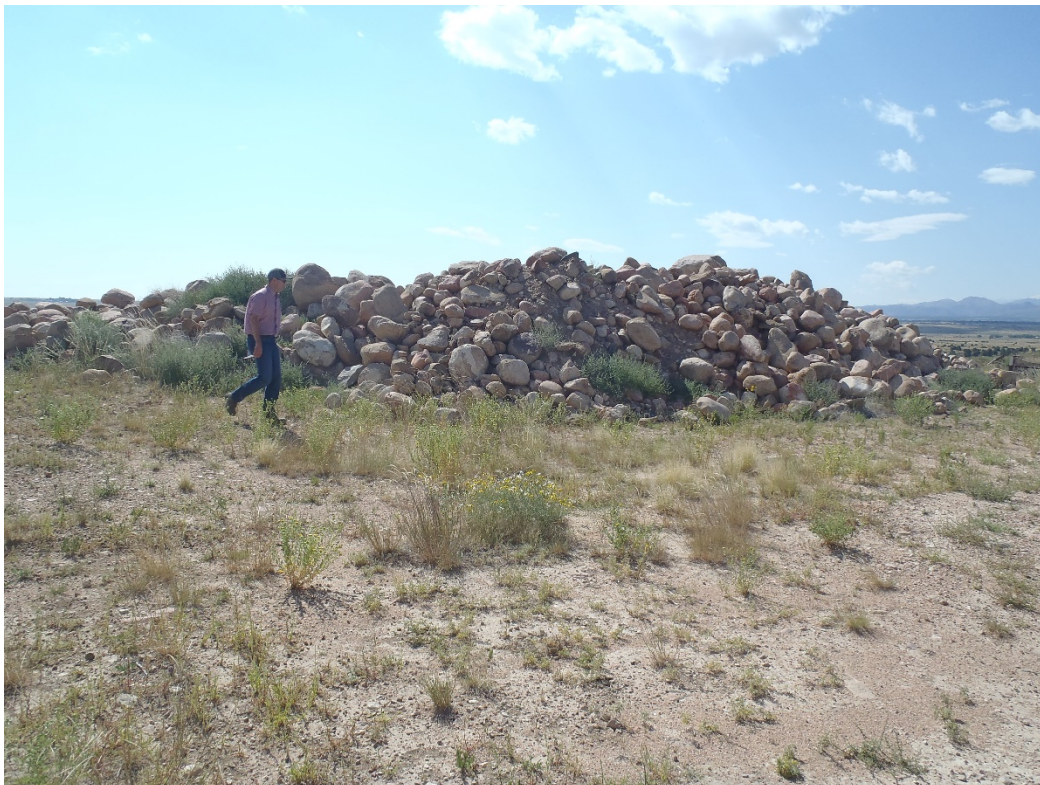
Photo 9. Boulder stockpile (SE of recent active pit – looking SE).

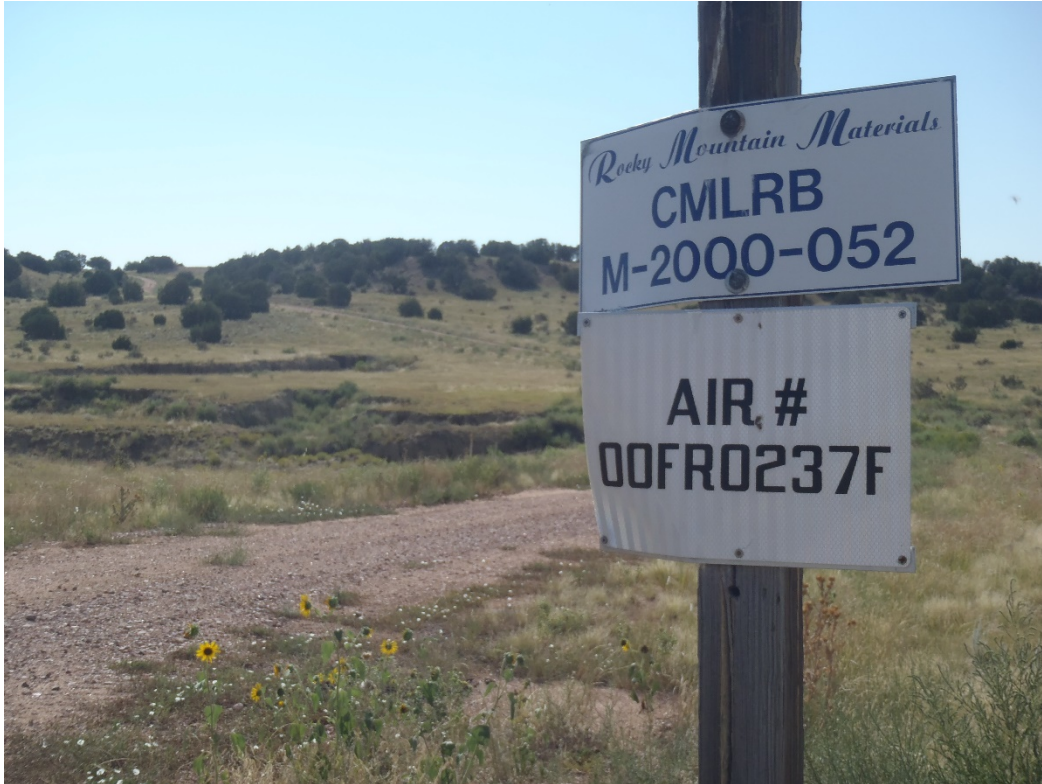
Signs and Markers: The permit sign was properly posted (see **Photo 10**). This is a ridge top operation and mining activity is restricted by topography.

Photo 10. Permit sign off entrance from Hwy 67.

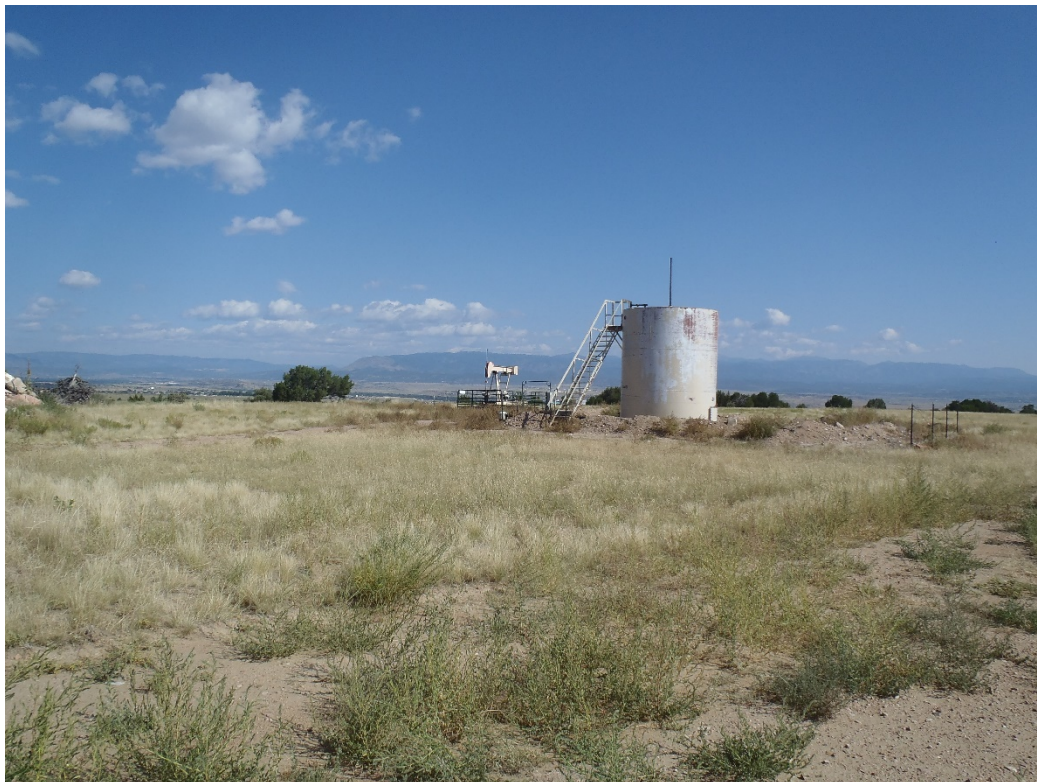
Structures: An oil derrick and storage tank have been in place since before the site was permitted (see **Photo 11**).

Photo 11. Oil derrick & storage tank (just east of west end disturbance, looking NE from access road).
