MINERALS PROGRAM INSPECTION REPORT
PHONE: (303) 866-3567

MINE NAME: Berthoud Pink Quarry	MINE/PROSPECTING ID#: M-1985-211	MINERAL: Sandstone (silica, st quartzite)	COUNTY: Larimer
INSPECTION TYPE: Monitoring	INSPECTOR(S): Brock Bowles	INSP. DATE: August 18, 2021	INSP. TIME: 11:00
OPERATOR: Arkins Park Stone Corporation	OPERATOR REPRESENTATIVE: David Sprague	TYPE OF OPERATION: 110c - Construction Limited Impact	
REASON FOR INSPECTION: Normal I&E Program	BOND CALCULATION TYPE:	BOND AMOUNT: \$20,000.00	
DATE OF COMPLAINT: NA	POST INSP. CONTACTS: None	JOINT INSP. AGENCY: None	
WEATHER: Clear	INSPECTOR'S SIGNATURE:

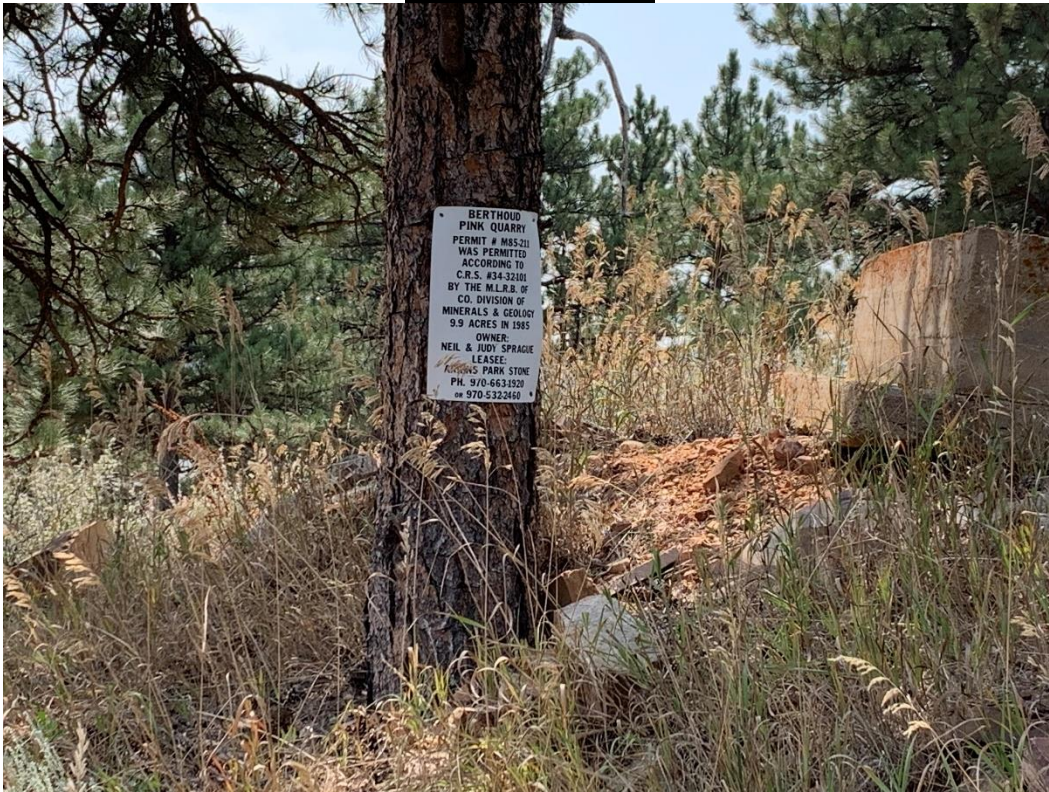
The mine identification sign was in place at the entrance gate (photo 1). The gate was lock upon arrival. The permit boundary was walked and the markers were in place (photo 2).

Photo 1 – Mine entrance sign

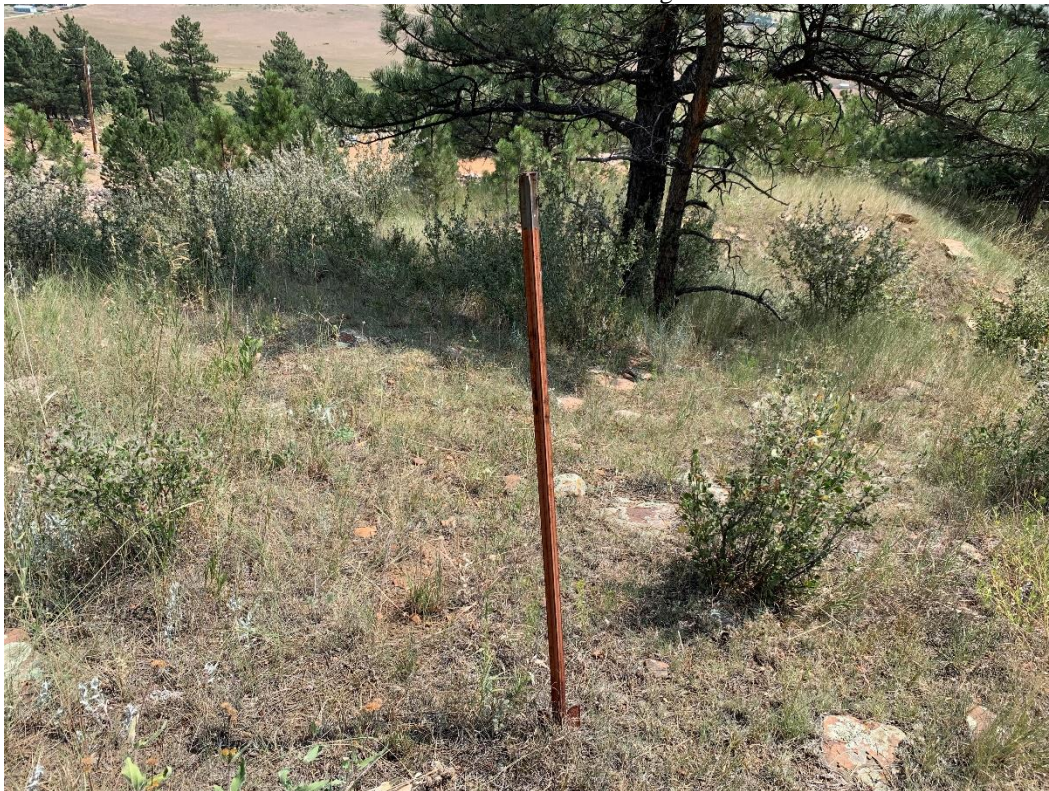
Photo 2 – Western boundary marker

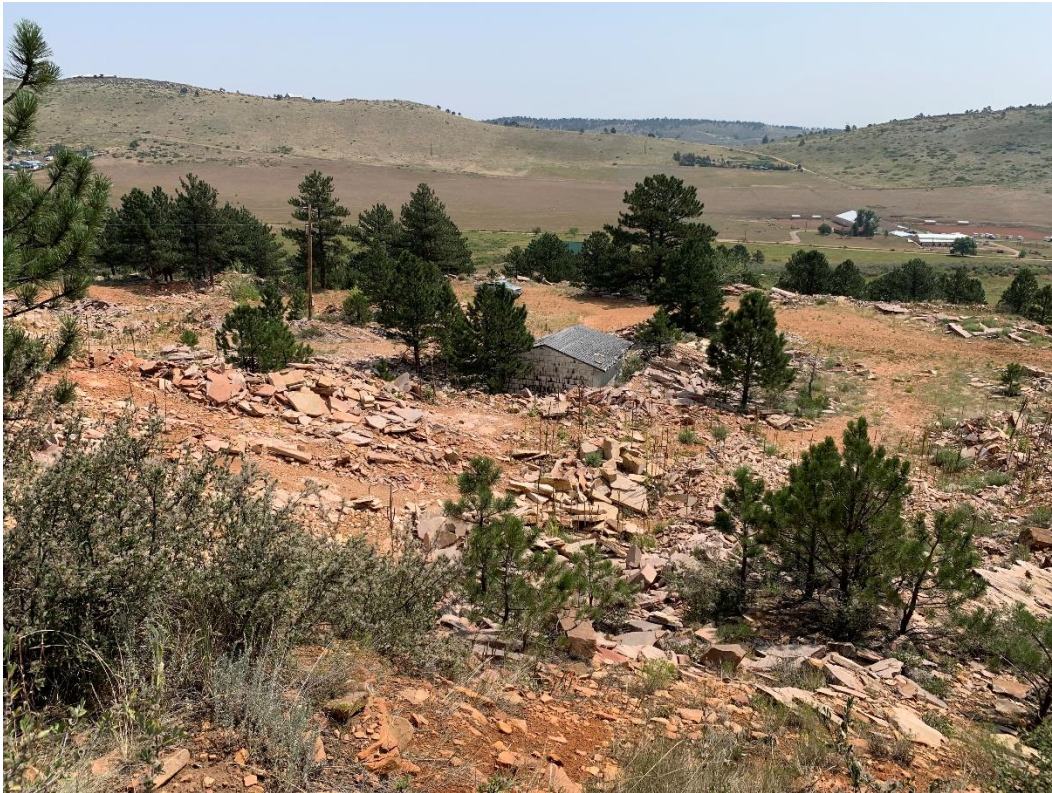
The north minesite has two shallow quarry areas. A large amount of rubble is scattered across the minesite (photo 3). Mr. Sprague said he leased the quarry last year and some sandstone was produce. No mining activity was happening at the time of this inspection. An old garage is located between the two quarries along with an old truck.

Photo 3 – North mining area

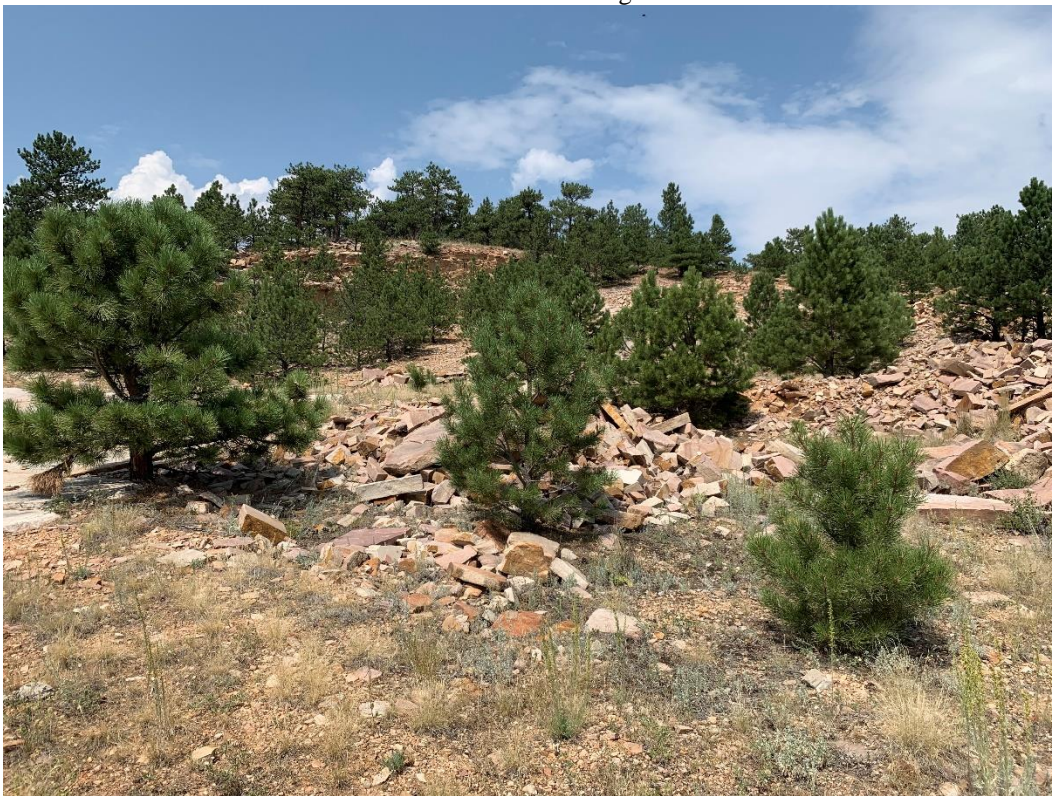
The south minesite is known as the Gold Stain site (photo 4). It has one quarry area and it has not produce in many years as evident by the size of the trees growing in the quarry. There are several rubble piles in this area also. No structures were noted in this area.

Photo 4 – Southern mining area (Gold Stain)
