MINERALS PROGRAM INSPECTION REPORT
PHONE: (303) 866-3567

MINE NAME: Berthoud Sunset	MINE/PROSPECTING ID#: M-1994-080	MINERAL: Sandstone (silica, st quartzite)	COUNTY: Larimer
INSPECTION TYPE: Monitoring	INSPECTOR(S): Brock Bowles	INSP. DATE: August 18, 2021	INSP. TIME: 13:00
OPERATOR: Arkins Park Stone Corporation	OPERATOR REPRESENTATIVE: David Sprague	TYPE OF OPERATION: 110c - Construction Limited Impact	
REASON FOR INSPECTION: Normal I&E Program	BOND CALCULATION TYPE:	BOND AMOUNT: \$38,122.32	
DATE OF COMPLAINT: NA	POST INSP. CONTACTS: None	JOINT INSP. AGENCY: None	
WEATHER: Clear	INSPECTOR'S SIGNATURE:

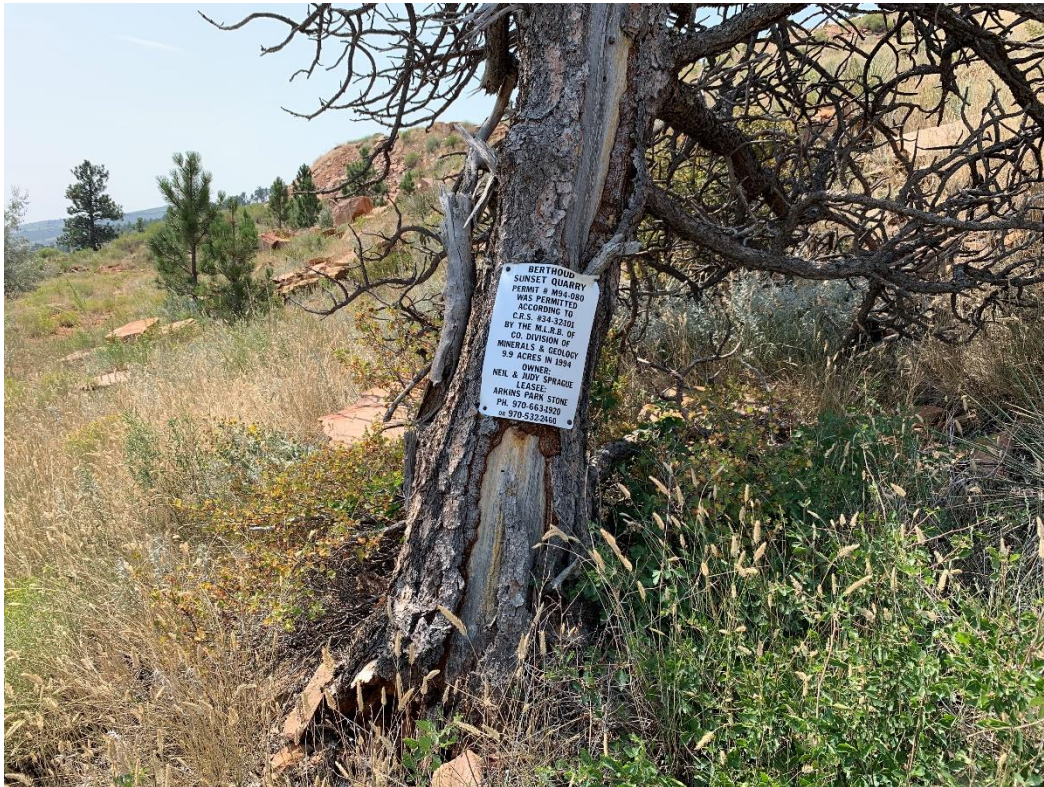
The permit entrance sign was in place (photo 1). The permit boundary markers were in place.

Photo 1 – Mine entrance sign

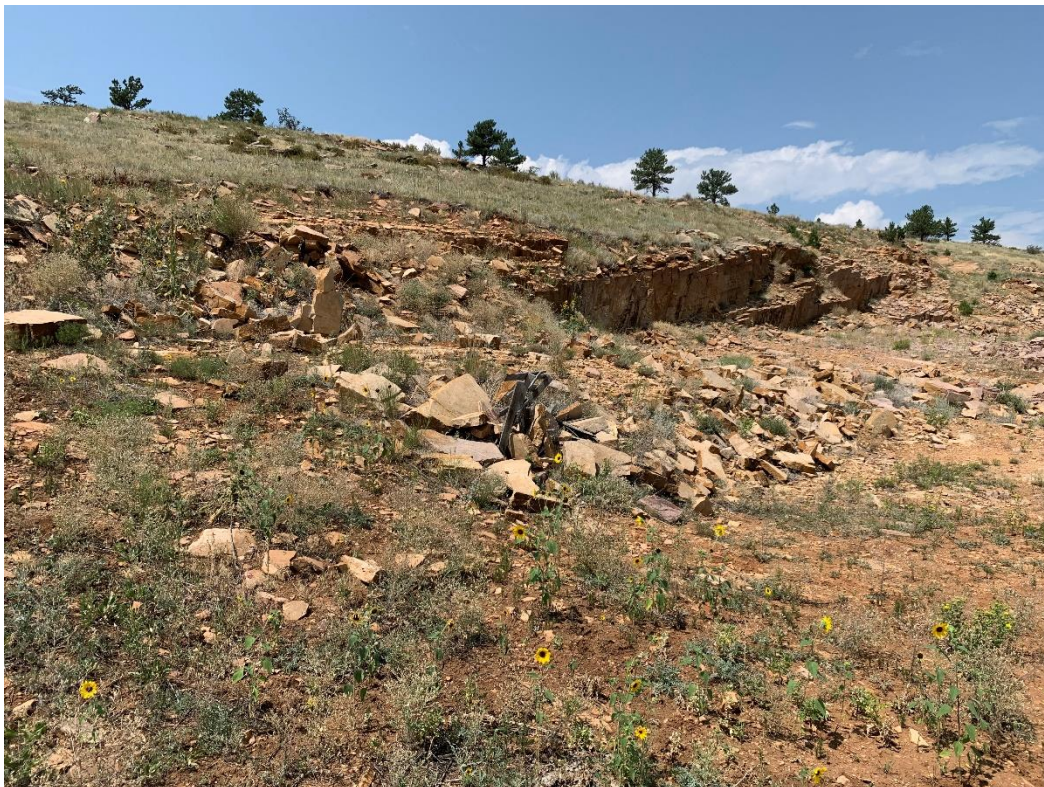
The highwall is about 15 feet high and 100 feet long on the upper bench (photo 2). There are some scattered stone piles around the site (photo 3).

Photo 2 – Highwall at upper bench

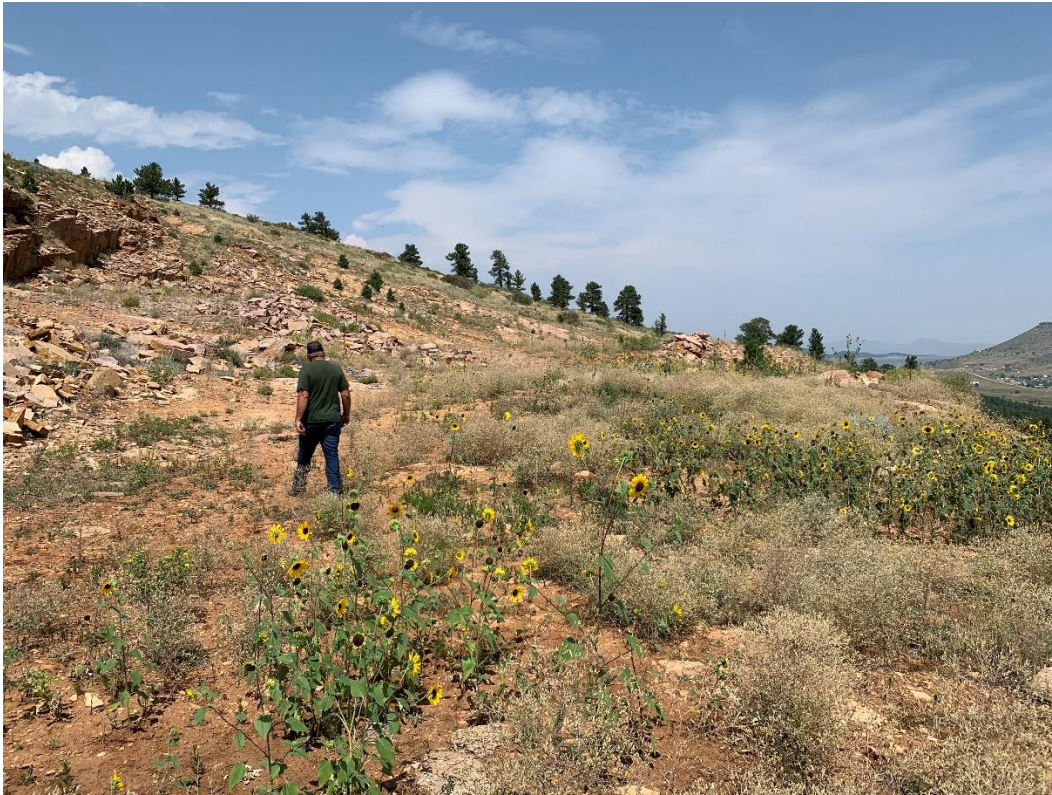
Photo 3 – Scattered stone on upper bench
