**MINERALS PROGRAM INSPECTION REPORT**  
**PHONE: (303) 866-3567**

<b>MINE NAME:</b> Revenue Mine	<b>MINE/PROSPECTING ID#:</b> M-2012-032	<b>MINERAL:</b> Lead, silver and gold	<b>COUNTY:</b> Ouray
<b>INSPECTION TYPE:</b> Monitoring	<b>INSPECTOR(S):</b> Lucas West	<b>INSP. DATE:</b> September 27, 2021	<b>INSP. TIME:</b> 10:00
<b>OPERATOR:</b> Ouray Silver Mines Inc.	<b>OPERATOR REPRESENTATIVE:</b> Todd Jesse	<b>TYPE OF OPERATION:</b> 112d-1 - Designated Mining Operation	
<b>REASON FOR INSPECTION:</b> Normal I&E Program		<b>BOND CALCULATION TYPE:</b> None	
<b>DATE OF COMPLAINT:</b> NA		<b>BOND AMOUNT:</b> \$517,219.00	
<b>WEATHER:</b> Clear		<b>JOINT INSP. AGENCY:</b> None	
<b>INSPECTOR'S SIGNATURE:</b>

This inspection was conducted as part of the incremental inspections for the installation of the Reagent Room Environmental Protection Facility associated with Technical Revision 14 (TR-14). The Revenue Mine is an active 112d (1) underground operation located approximately 5 miles southwest of Ouray, Colorado and is accessed from Ouray County Road 26 at nearly 10,600 Feet in Elevation. Public Access to the site is controlled by a locked gate at the entrance to the site. Todd Jesse r

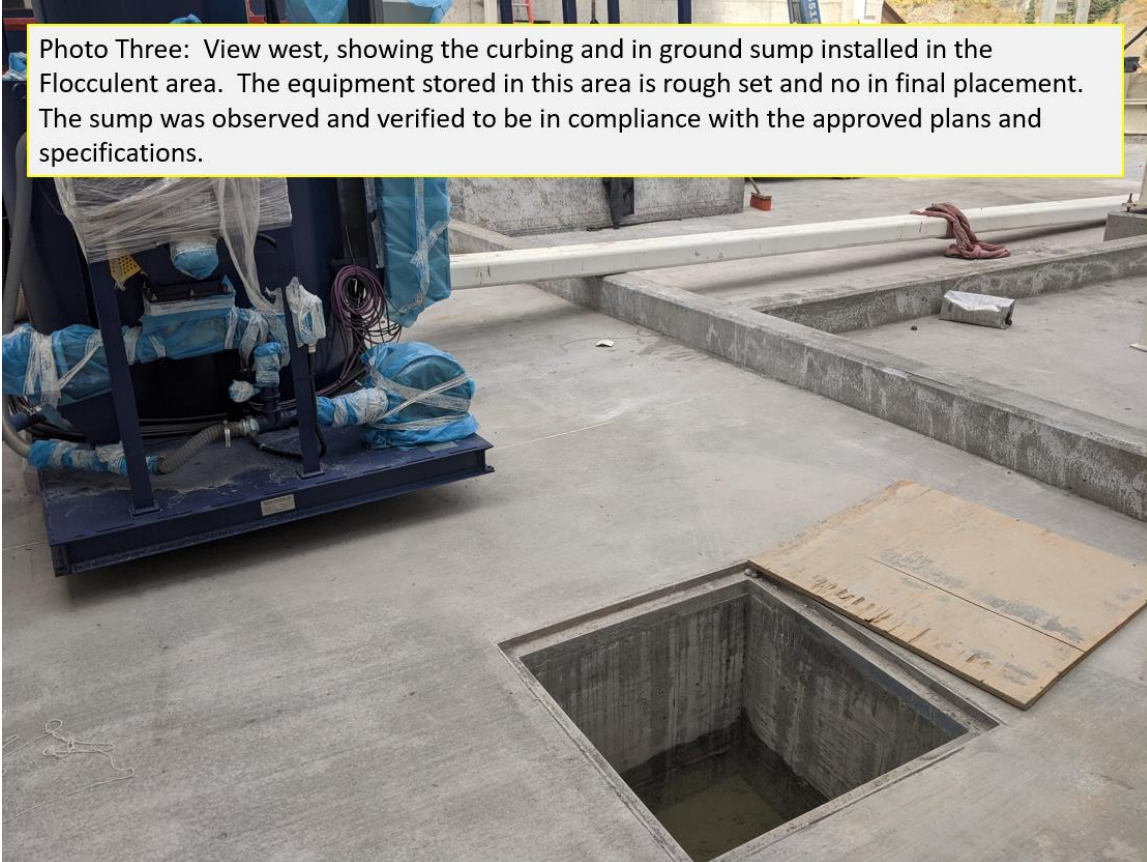
Located in the Southeast corner of the Reagent Room, is the Flocculent storage and mixing area. The curbing for secondary containment has been completed and is in excellent condition. Unlike the Frother, Xanthate and 3418A rooms, the Flocculent area contains an in ground sump that has been constructed in the concrete. The sump and curbing for the Flocculent area can be seen in Photo Three. The sump matches the specifications set forth in the revision. A small amount of collected storm water was present in the sump but is not considered a problem at this time. The concrete for the Flocculent area is also in excellent condition and showed no signs of chipping, cracking or compromise during the curing process. Adjacent to the Flocculent area, in the southwest corner of the reagent room is the lime storage and mixing area shown in Photo Four. The tank foundation has been completed and the tanks have been rough set on the foundation. The tanks needed to be rough set prior to the structural steel installation and will be inspected and finalized at a later date. The curbing is has been installed in accordance with the approved plans. The Lime area also contains an in ground sump located near the northeast corner of the lime area. The sump has been installed, and in accordance with the approved plans as seen in Photo Five.

Photo Three: View west, showing the curbing and in ground sump installed in the Flocculent area. The equipment stored in this area is rough set and no in final placement. The sump was observed and verified to be in compliance with the approved plans and specifications.

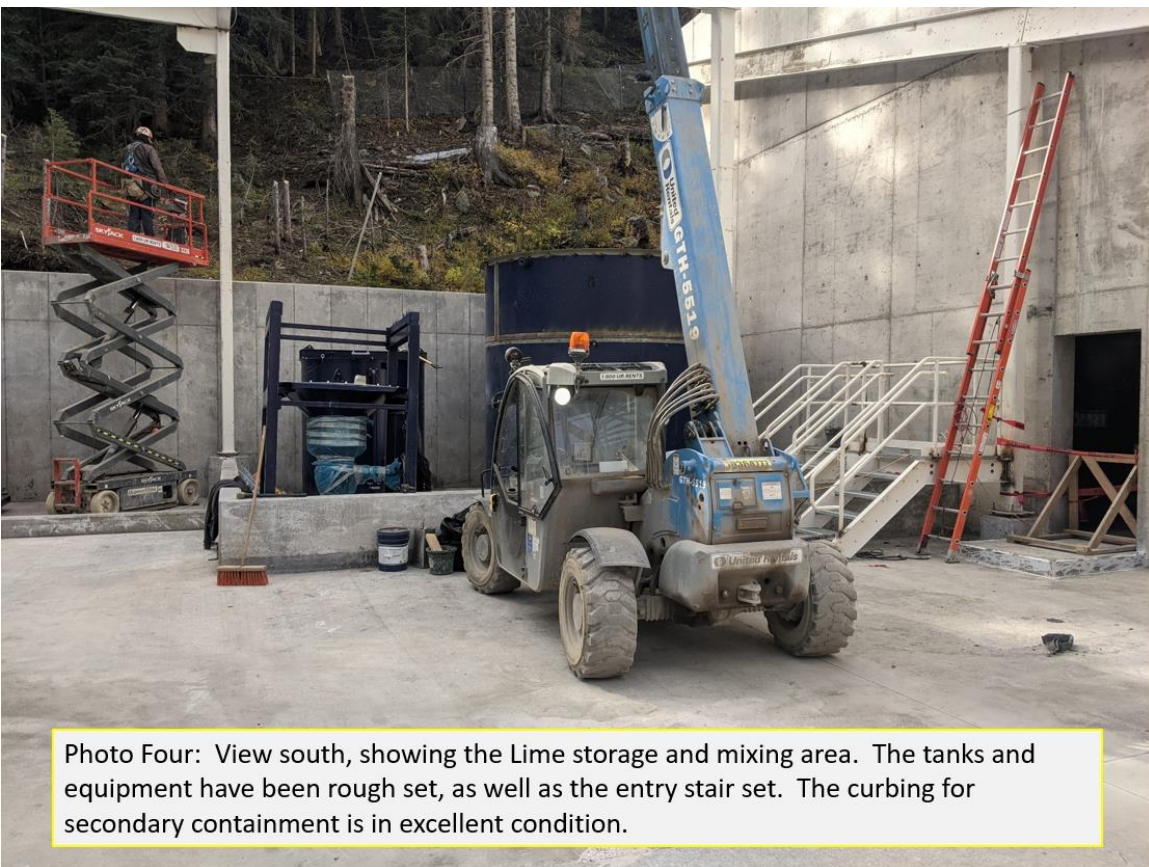
Photo Four: View south, showing the Lime storage and mixing area. The tanks and equipment have been rough set, as well as the entry stair set. The curbing for secondary containment is in excellent condition.

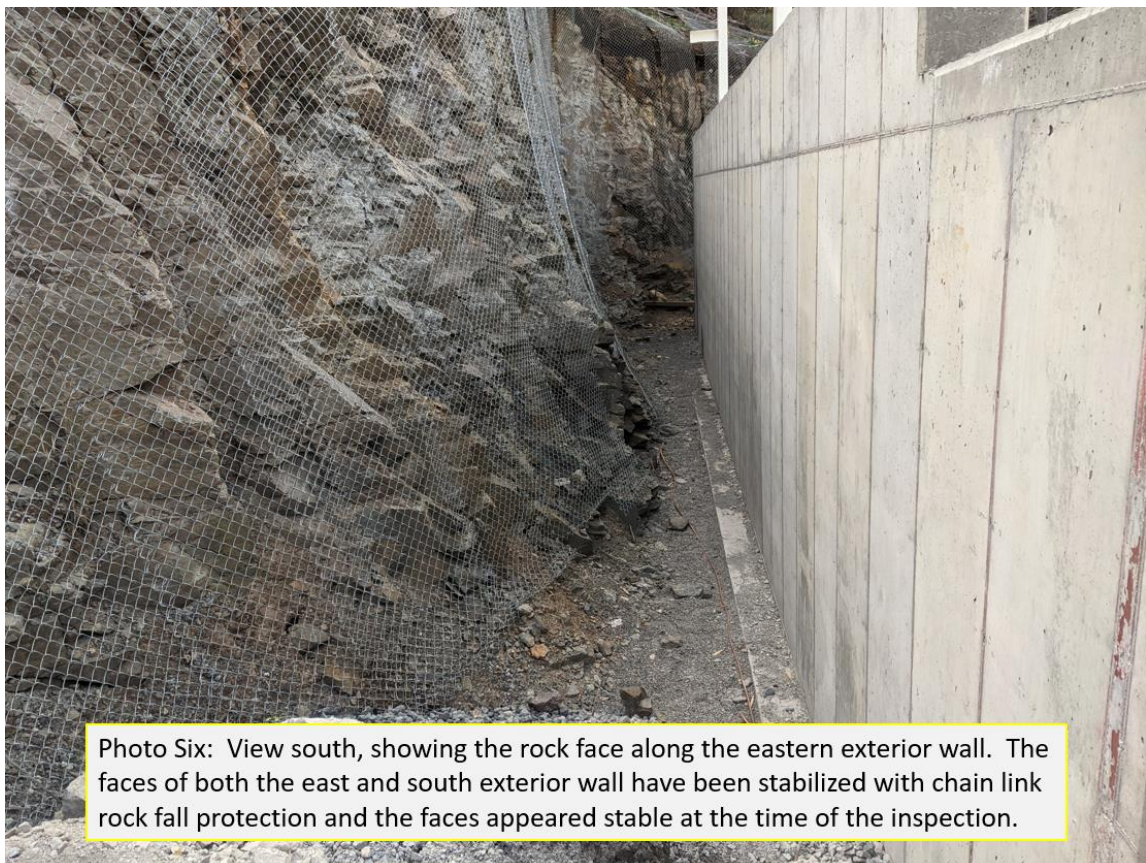
The hill cuts created on the south and east sides of the reagent room were also observed and in good condition. An example of the east face can be seen in Photo Six. The face of the area has been stabilized with chain link rock fall fencing to prevent any fugitive rocks from coming down on the exterior of the building. At the time of the inspection the faces were stable and in good condition and no evidence of rock fall was observed.
