MINERALS PROGRAM INSPECTION REPORT
PHONE: (303) 866-3567

| MINE NAME: Deep Creek Placer | MINE/PROSPECTING ID#: M-1986-102 | MINERAL: Limestone (general) | COUNTY: San Miguel |
| INSPECTION TYPE: Surety Release Inspection | INSPECTOR(S): Lucas West | INSP. DATE: September 27, 2021 | INSP. TIME: 12:45 |

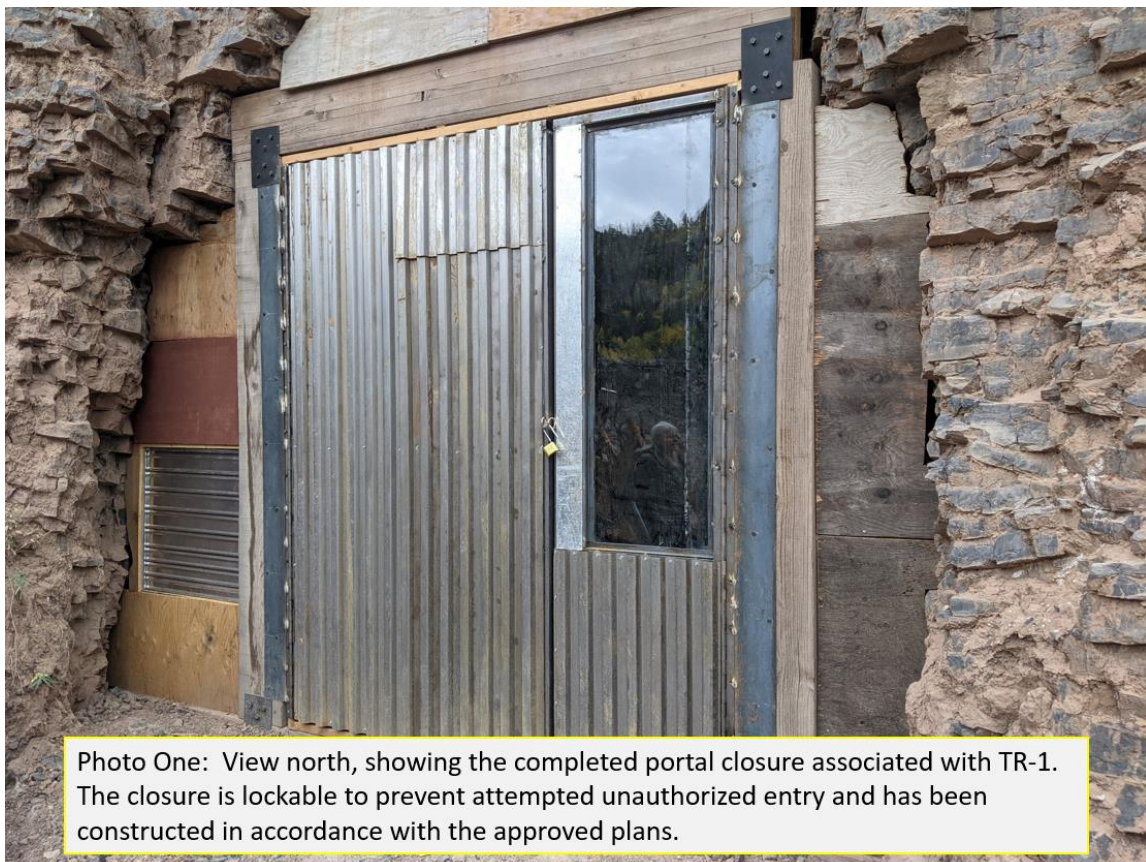
The proper Mine Identification sign was posted on the gate at the bottom of the access road that can be seen in Photo One. The access road leading up to the equipment apron and portal areas is in good condition. No signs of significant erosion were noted and all storm water control features associated with the access road appeared to be functioning as designed at the time of the inspection. The site was not active during the inspection, all mining activities were completed some years ago and the site has been working towards reclamation since 2015 when a Permit Amendment was conducted to clarify the reclamation plan. Details included in the Amended Reclamation Plan include that the underground workings and associated portals will be left for private use, and the equipment apron will be used for light fabrication and certain "permitted cultural events" post reclamation.

The main focus of this inspection is to observe the completed portal closure, associated with TR-01. During the Division's previous inspection the portal was observed to be open, with significant amounts of material that had sloughed off from the area above the portal. The portal seen in Photos One and Two has been rehabilitated and secured in accordance with the approved plans. Material was excavated away from the portal, so that a retaining wall (not visible), complete anchor bars, and the portal closure constructed. The material was backfilled to promote positive drainage away from the portal. The backfill and grading has been completed and was stable at the time of the inspection. The portal closure is a lockable door, with areas to allow light to enter the underground workings and a fan to provide ventilation. The portal closure is in excellent condition and securely safeguards the opening. Material from above the portal has been removed and was stable at the time of the inspection. This was the last remaining reclamation task to achieve final reclamation of the site.

Photo One: View north, showing the completed portal closure associated with TR-1. The closure is lockable to prevent attempted unauthorized entry and has been constructed in accordance with the approved plans.
