TRAPPER MINING INC.
CRAIG, COLORADO

HORSE GULCH FILL
QUARTERLY FILL CERTIFICATION

Horse Gulch Fill Quarterly Inspection Report

Fourth Quarter 2021

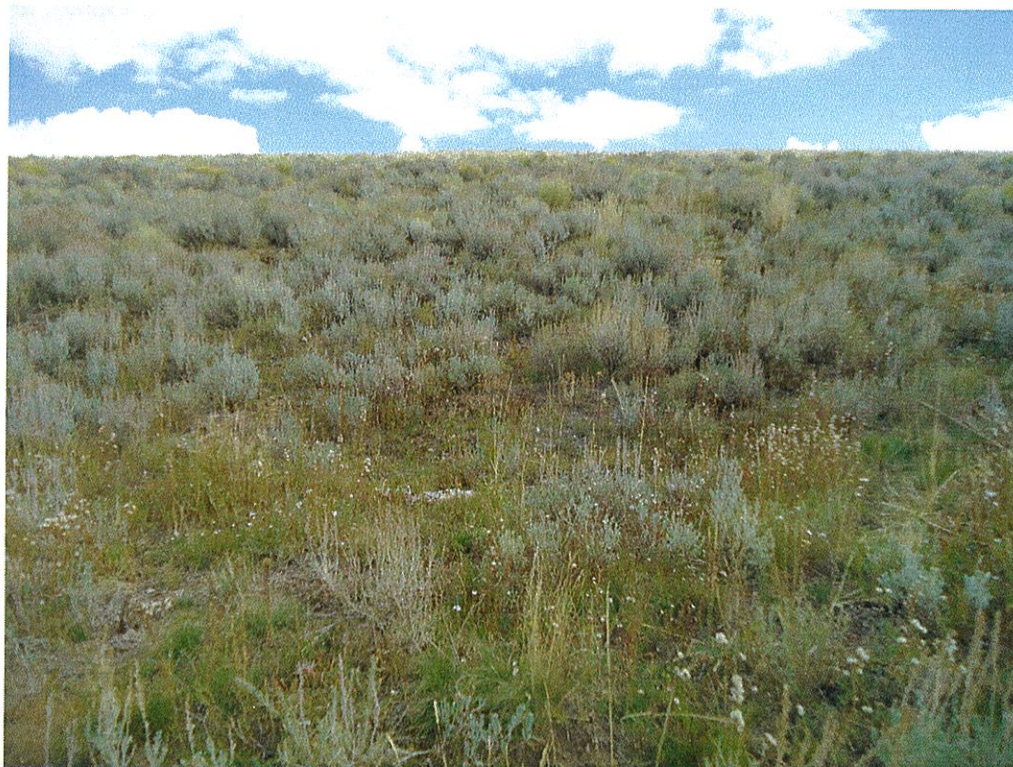
The two spots above the 7350' elevation on the south side of the dump that showed some differential settling in the second quarter of 2013 were inspected and there was no additional settling (Photographs 1 and 2).

Photograph 1: South Site above the 7350 Bench Elevation (10/7/2021)

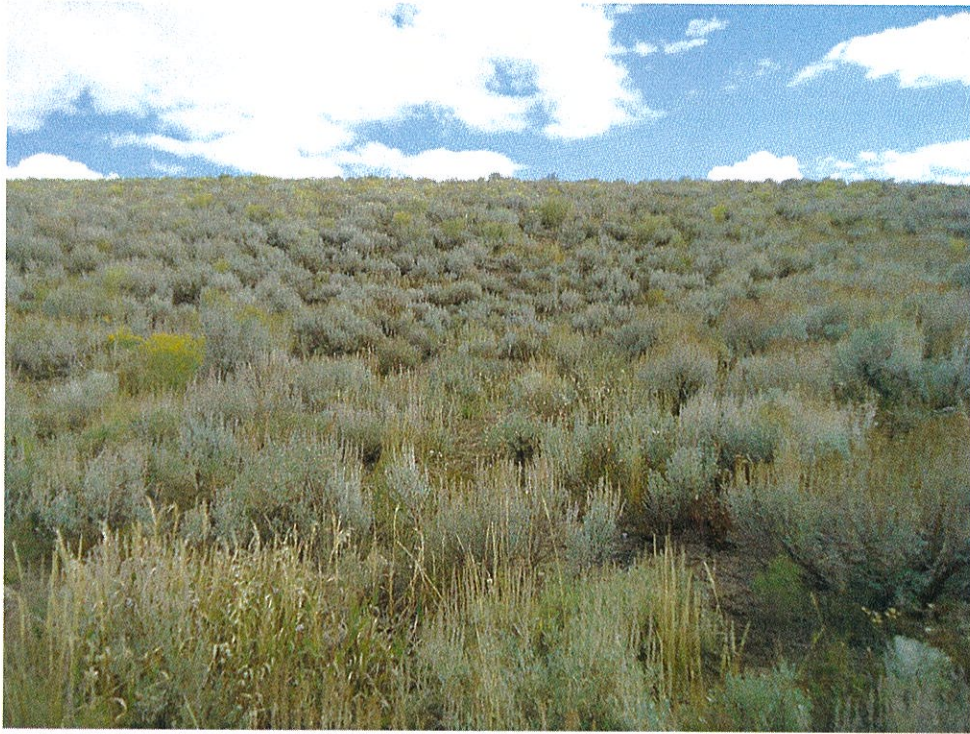
Photograph 2: North Site above the 7350 Bench Elevation (10/7/2021)

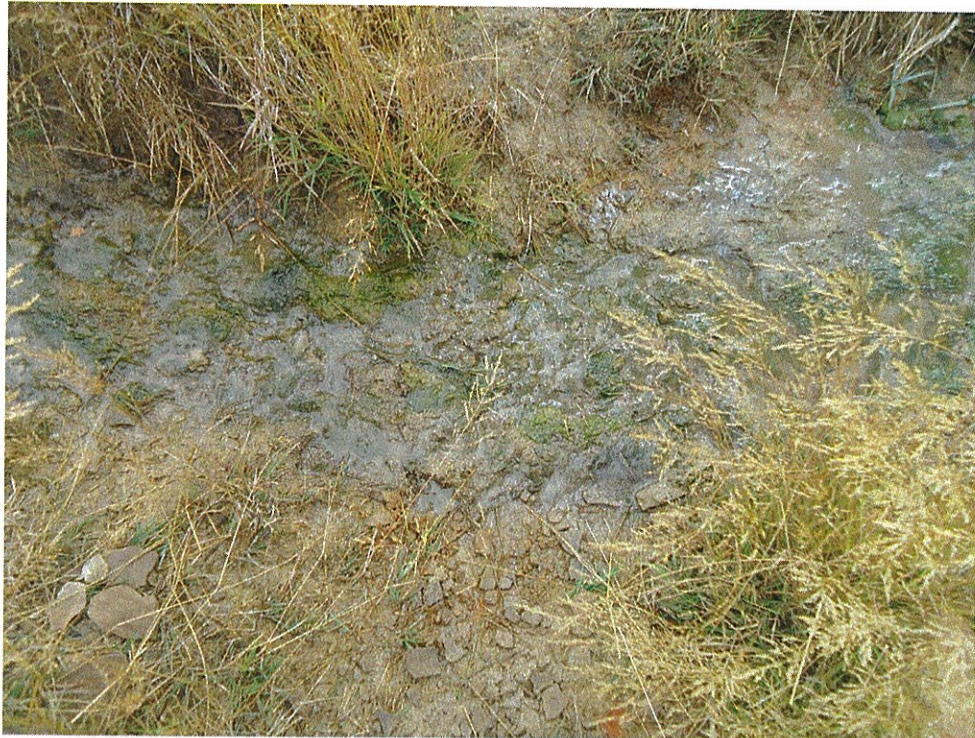
The underdrainage system was completed in the first quarter of 2010; additional work on this system is not anticipated. During the time of the inspection, there was approximately a tenth of a gallon per minute of water flow. (Photograph 3).

Photograph 3: Water from the Underdrainage System (10/7/2021)

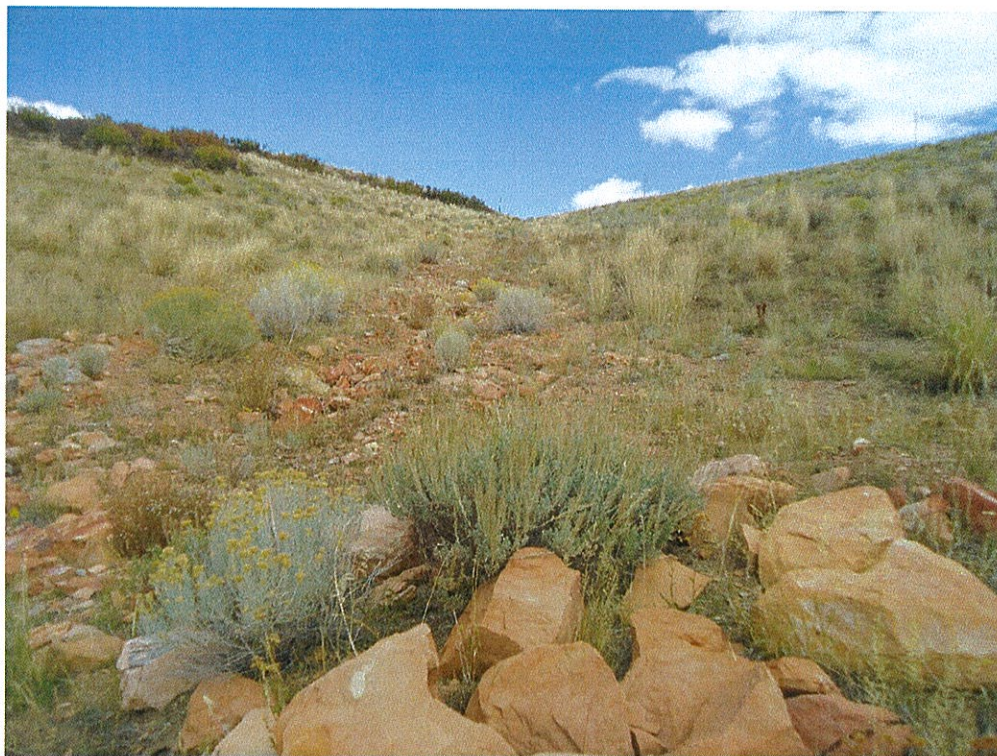
Both the north and south surface drains were inspected (Photographs 4 and 5). At the time of the inspection there was no water flow.

Photograph 4: North Surface Drain Looking East (10/7/2021)

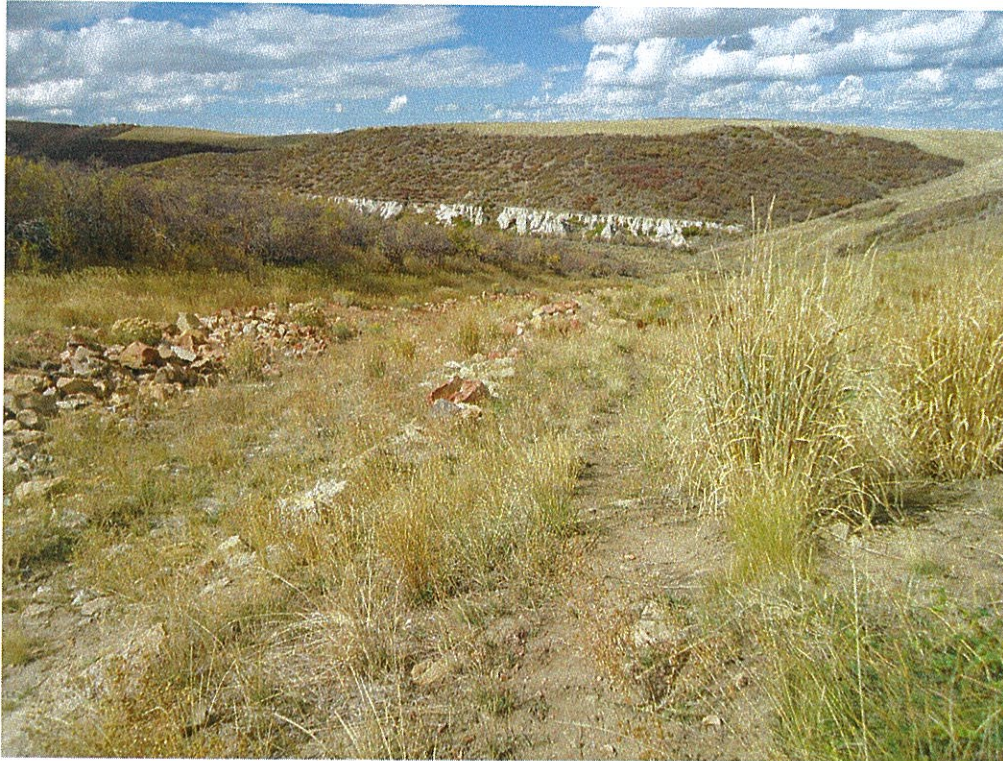
Photograph 5: South Surface Drain Looking North-west (10/7/2021)

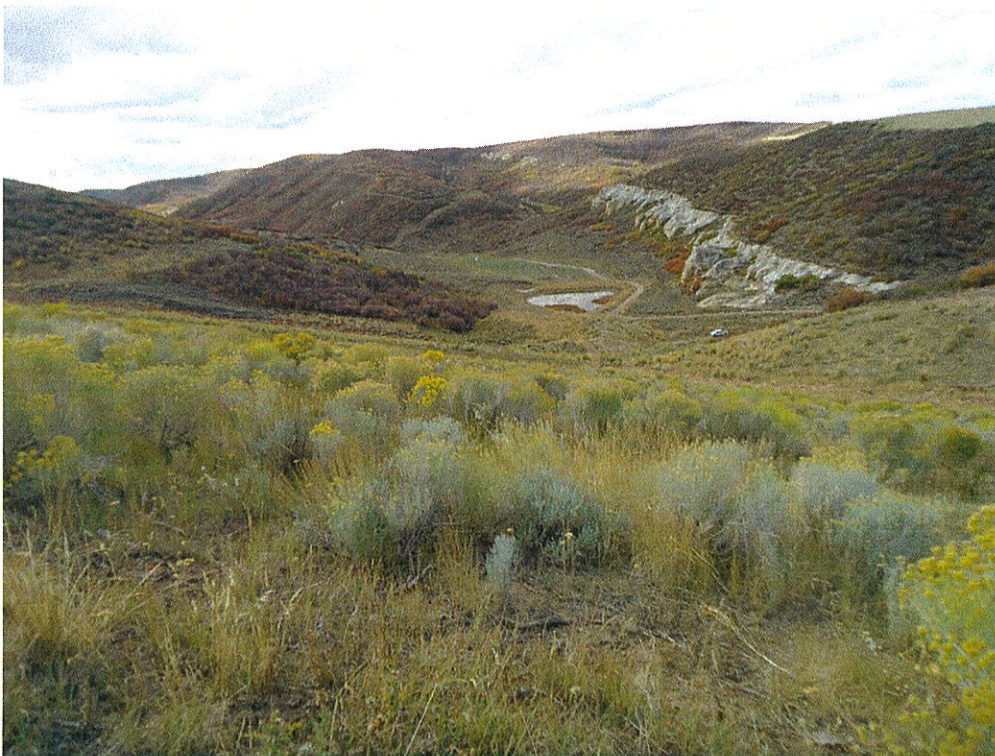
Photograph 6 depicts the west facing slope of the fill in the area where the slope of the fill is at 3H: 1V.

Photograph 6: West Side Fill 3H: 1V Face Looking West (10/7/2021)
