**MINERALS PROGRAM INSPECTION REPORT**  
**PHONE: (303) 866-3567**

<b>MINE NAME:</b> 120th Estates Partners	<b>MINE/PROSPECTING ID#:</b> M-2001-085	<b>MINERAL:</b> Sand and gravel	<b>COUNTY:</b> Adams
<b>INSPECTION TYPE:</b> Multi Person Inspection	<b>INSPECTOR(S):</b> Patrick Lennberg	<b>INSP. DATE:</b> October 5, 2021	<b>INSP. TIME:</b> 09:30
<b>OPERATOR:</b> 120 85 LLC	<b>OPERATOR REPRESENTATIVE:</b> Juan Padilla and Miles Buescher Adams County	<b>TYPE OF OPERATION:</b> 112c - Construction Regular Operation	
<b>REASON FOR INSPECTION:</b> Priority	<b>BOND CALCULATION TYPE:</b> None	<b>BOND AMOUNT:</b> \$368,590.00	
<b>DATE OF COMPLAINT:</b> NA	<b>POST INSP. CONTACTS:</b> None	<b>JOINT INSP. AGENCY:</b> None	
<b>WEATHER:</b> Clear	<b>INSPECTOR'S SIGNATURE:</b>

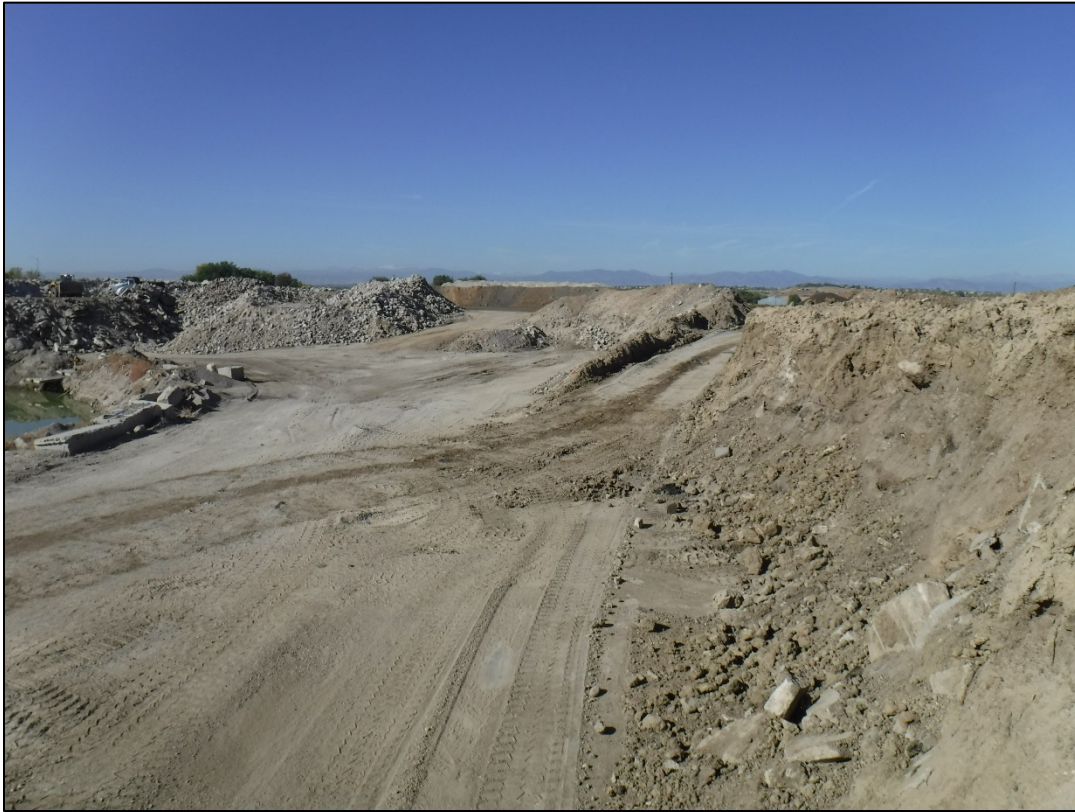
**Photo 1:** Looking southwest across the remaining open pit area

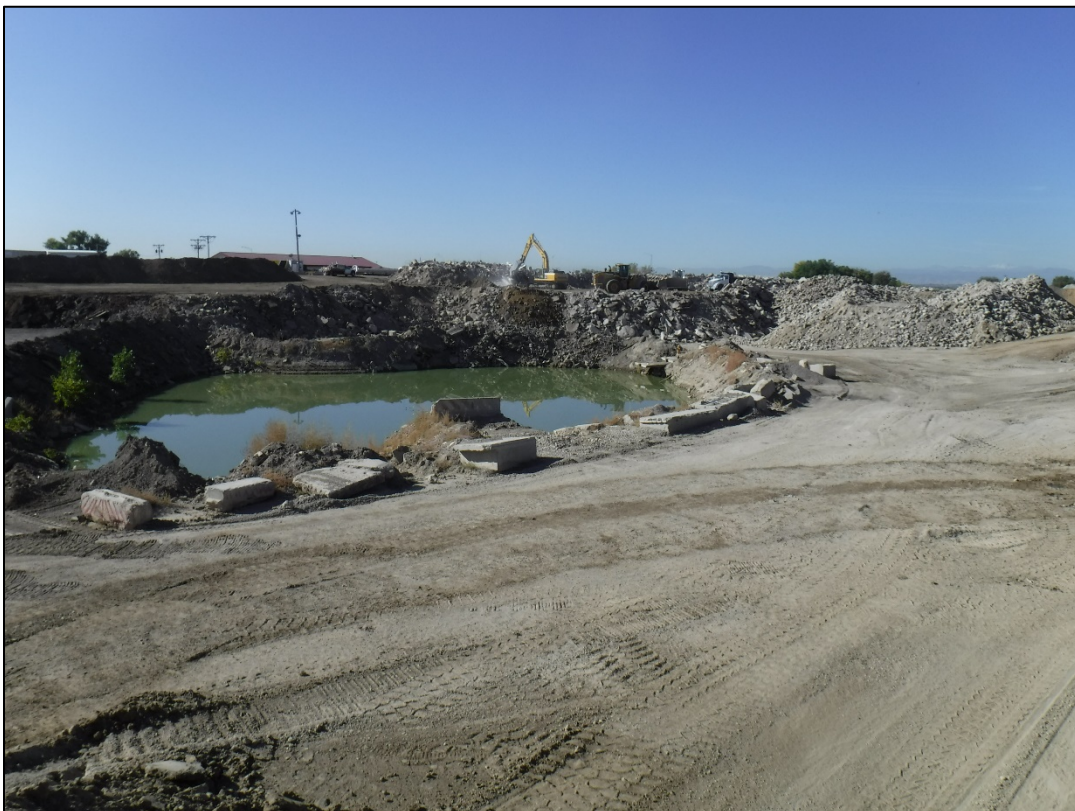
**Photo 2:** Looking south across the remaining open pit area including the exposed groundwater pond

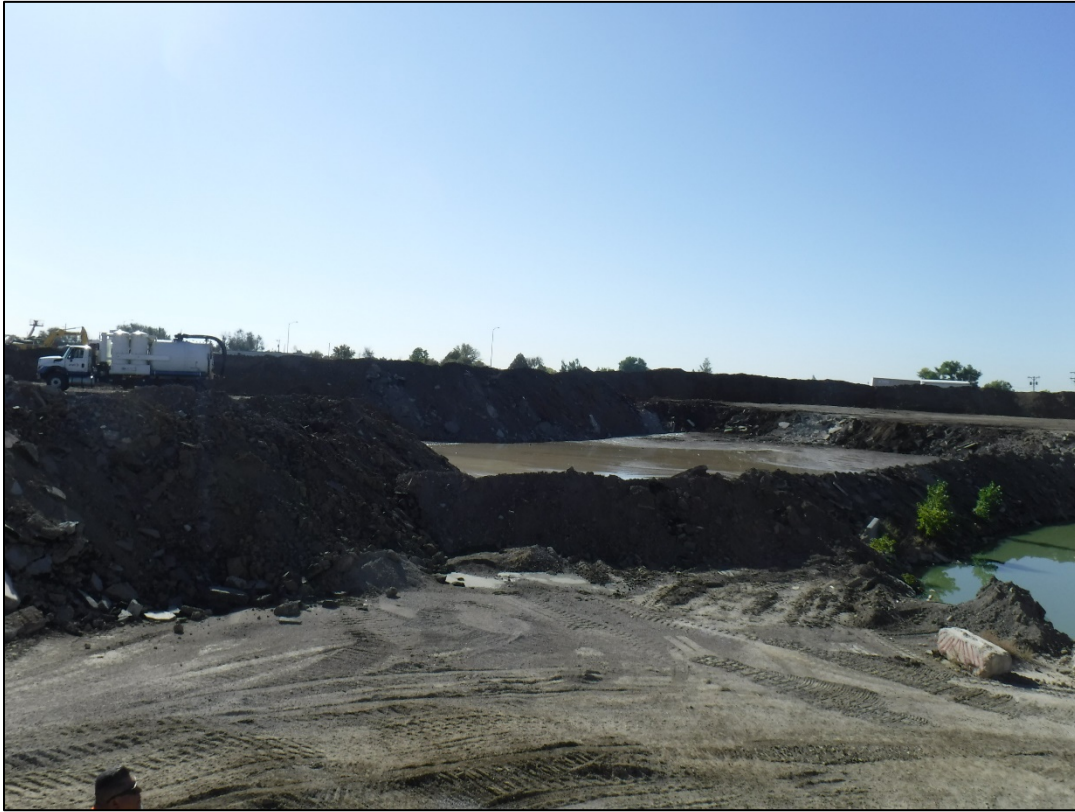
**Photo 3:** Looking southeast across the remaining open pit area including a pond that is used to allow solids to settle out

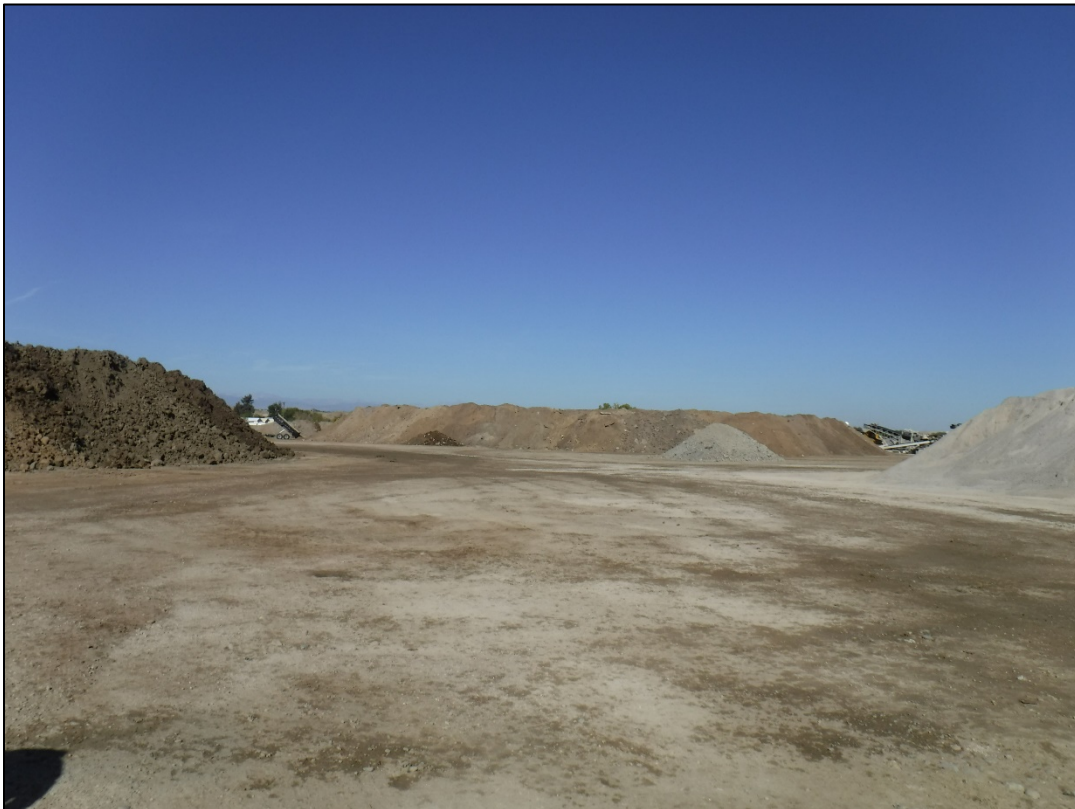
**Photo 4:** Typical stockpiles of material remaining onsite that can be used for reclamation

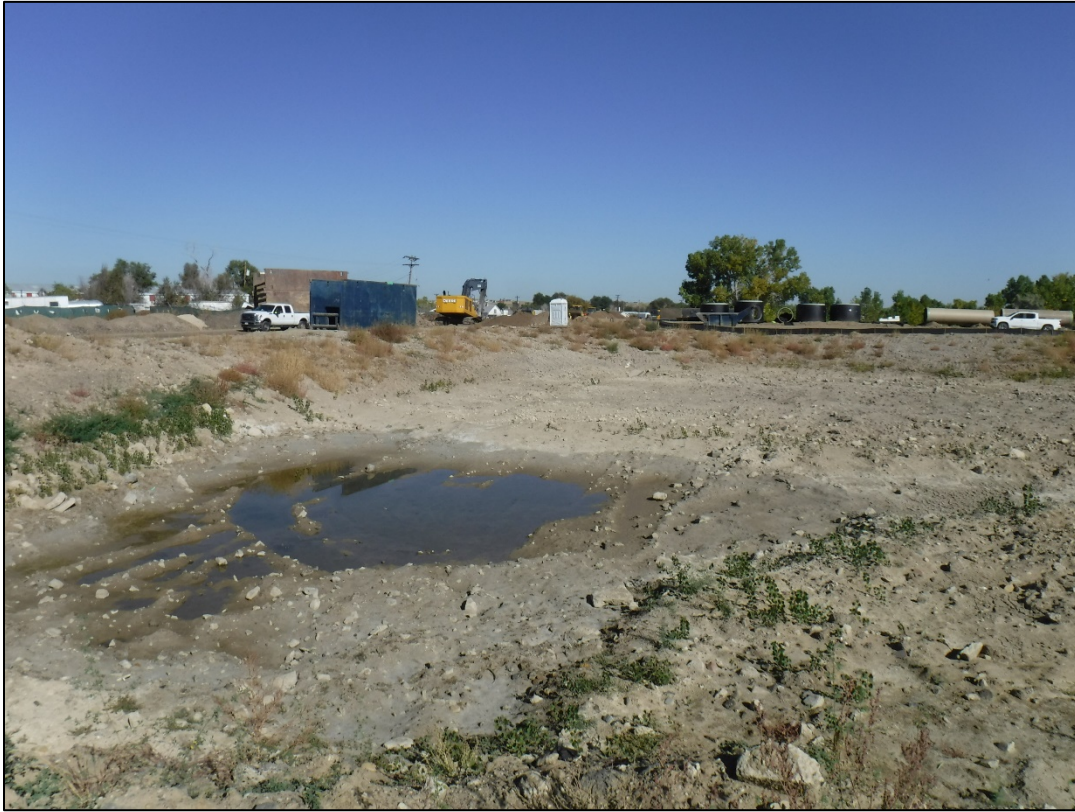
In the northwestern corner of the site, where the majority of the pipeline construction was located, there is an area that has not been backfilled yet. When asked about it Juan indicated he thought it was the location of the wetland seeding area. A review of Amendment 6 indicates the approved wetland seeding area is to be located in the southwestern corner of the site near the entrance. A copy of the approved reclamation plan map is attached to this report. If the operator wants to change the wetland seeding area a permit revision is required.

**Photo 5:** Depressed area where the operator plans on making the wetland seeding area, water pipeline construction background of photo

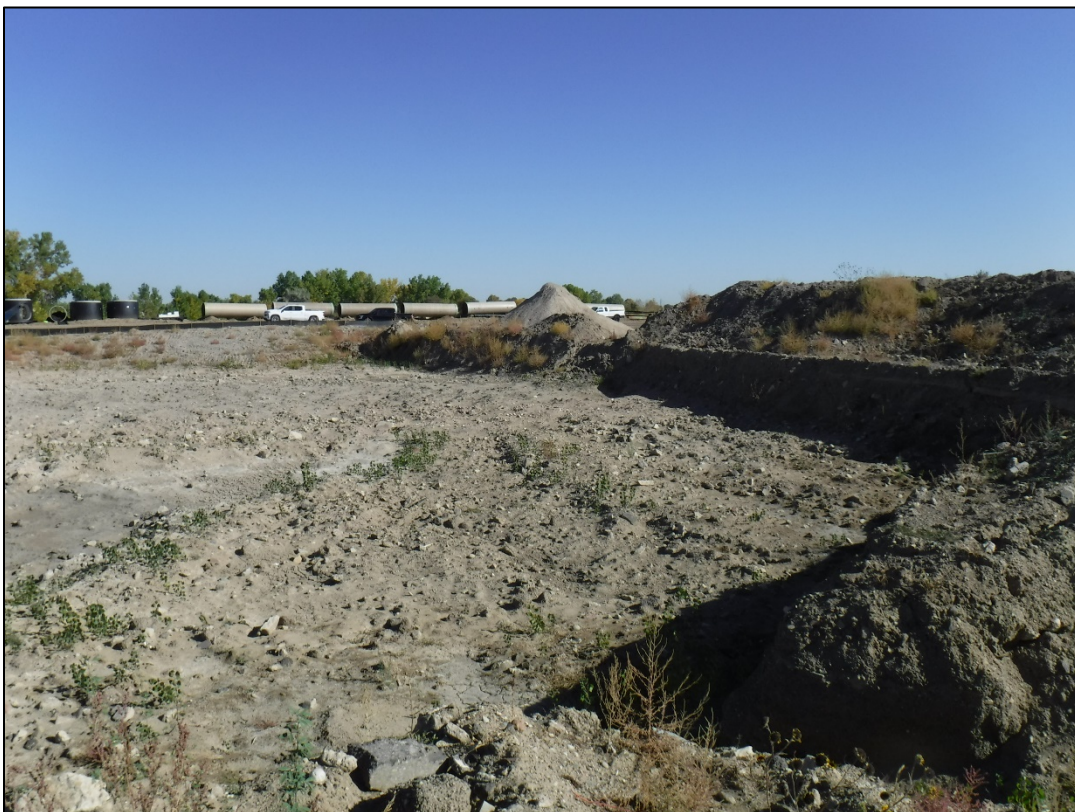
**Photo 6:** Eastern side of depressed area

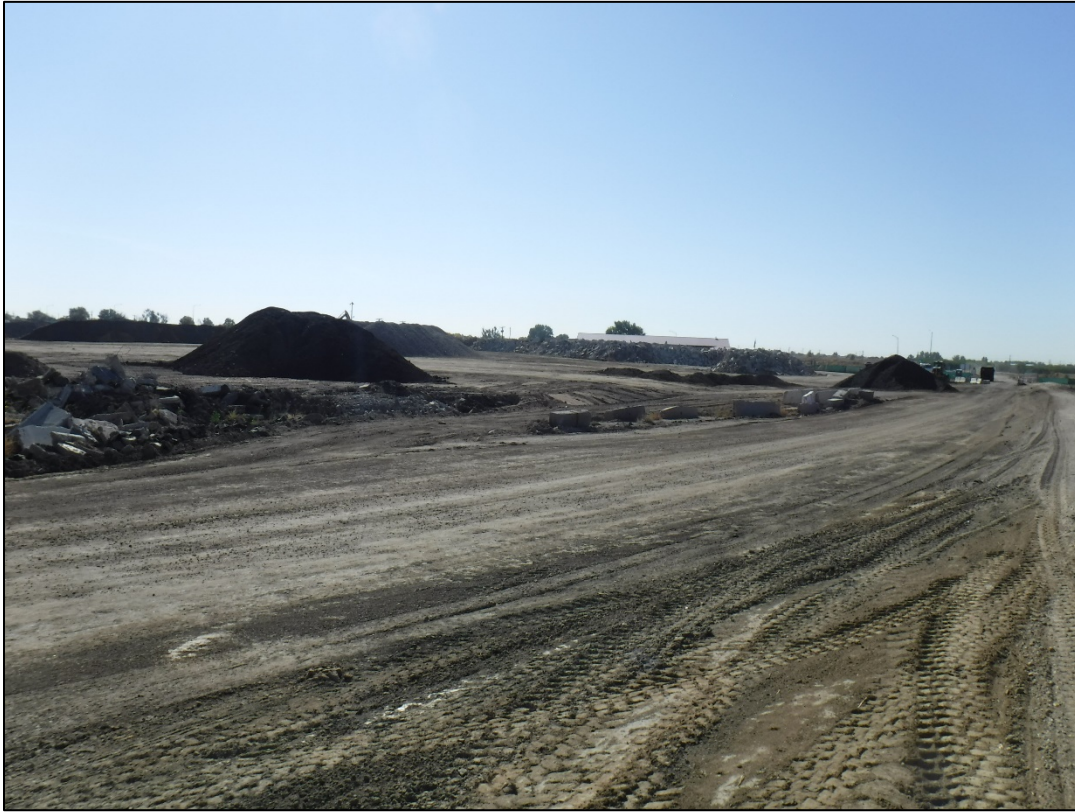
**Photo 7:** Graded area of the permit where during the last inspection had recently been backfilled

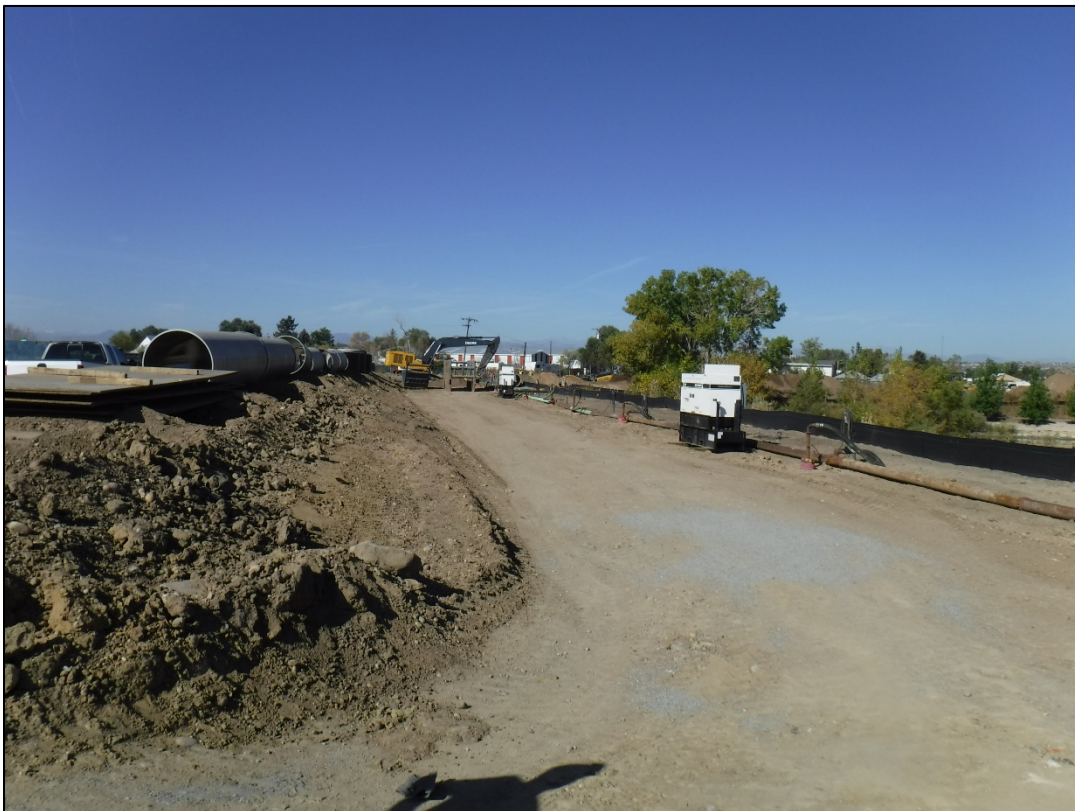
Along the northern boundary of the site there is a large pipeline project whose trucks are utilizing the mine entrance and exit. It is not clear what entity is performing the work but it is suspected to be a Denver Water project. As mentioned in the earlier inspection report, a permit revision will be needed to reflect the pipeline location as well as any adjustment needed to reflect the potential loss of land.

**Photo 8:** Pipeline construction in the northwestern portion of site
