MINERALS PROGRAM INSPECTION REPORT

MINE NAME: Cresson Project	MINE/PROSPECTING ID#: M-1980-244	MINERAL: Gold	COUNTY: Teller
INSPECTION TYPE: Monitoring	INSPECTOR(S): Elliott Russell	INSP. DATE: September 2, 2021	INSP. TIME: 10:00
OPERATOR: Cripple Creek & Victor Gold Mining Company	OPERATOR REPRESENTATIVE: Jeana Ratcliff	TYPE OF OPERATION: 112d-3 - Designated Mining Operation

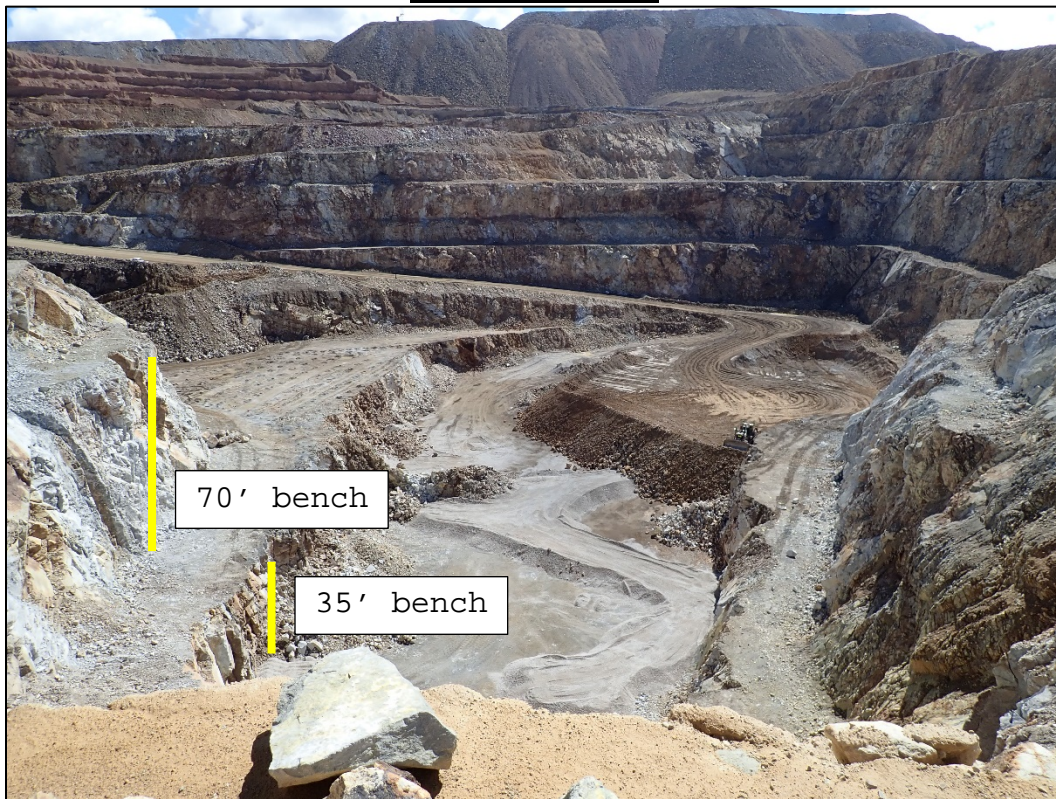
Prior to the inspection, the Operator notified the Division that backfilling operations in the Schist Island Pit would commence the week of August 30th. The first low compaction lift, at height of 20 feet, was being backfilled at the time of the inspection (see **Photo 1** and **Photo 2**). This lift was started in the southeast corner of the pit and was advancing to the north and west. The Operator stated the plan is to complete four lifts with heights of 20, 15, 20, and 20 feet. The second lift is planned for only 15 feet because the Operator needs complete remediation of historic workings on the first 35-foot highwall bench in the northern part of the pit. The Division observed several haul truck cycles during the inspection and all material dumped appeared to pass the approved specification of all material being smaller than 60 inches (see **Photo 3**). One truck contained a rock larger than 60 inches, but was flagged by a shift supervisor while the truck was descending into the Schist Island Pit (see **Photo 4**); this truck was rerouted to the ECOSA and the Operator stated the shift supervisor had a follow-up discussion with the equipment operator who loaded the oversized material into the haul truck. Based on the Division’s observations, CC&V was complying with the Amendment 13 Schist Island Backfill Specifications at the time of the inspection.

Photo 1. Schist Island backfill, first 20-foot lift; looking east.

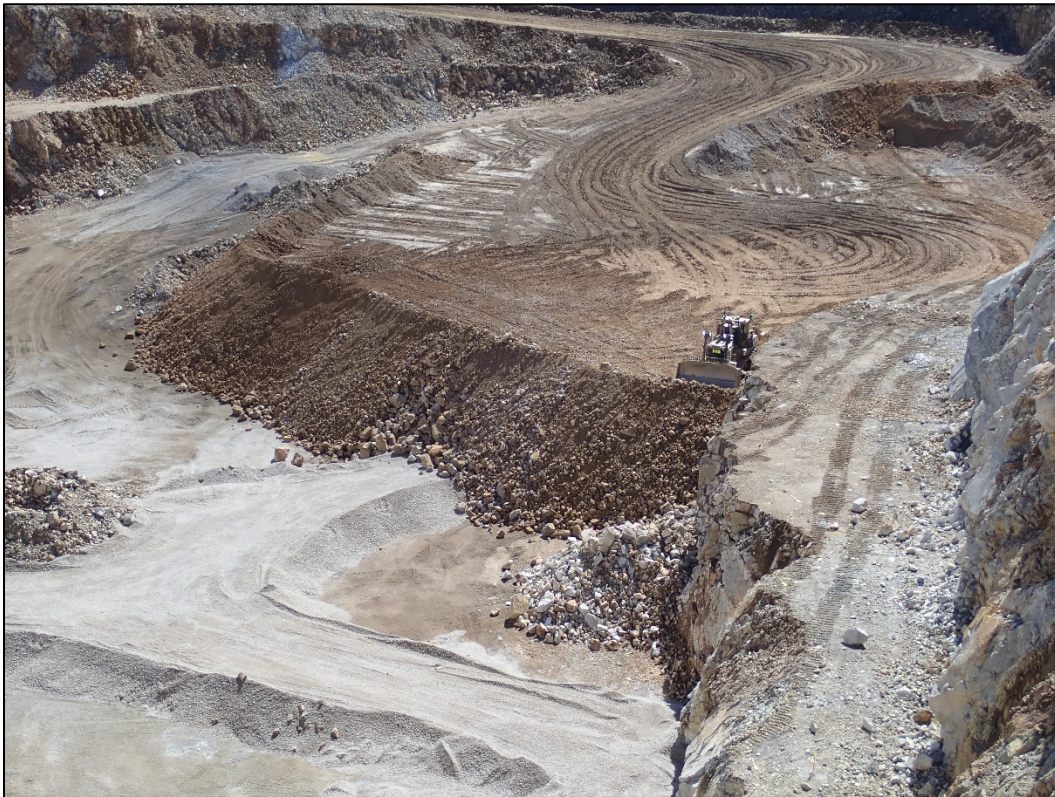
Photo 2. First lift of the Schist Island backfill, all material on dump face appears to be less than the 60-inch maximum specification; looking east.

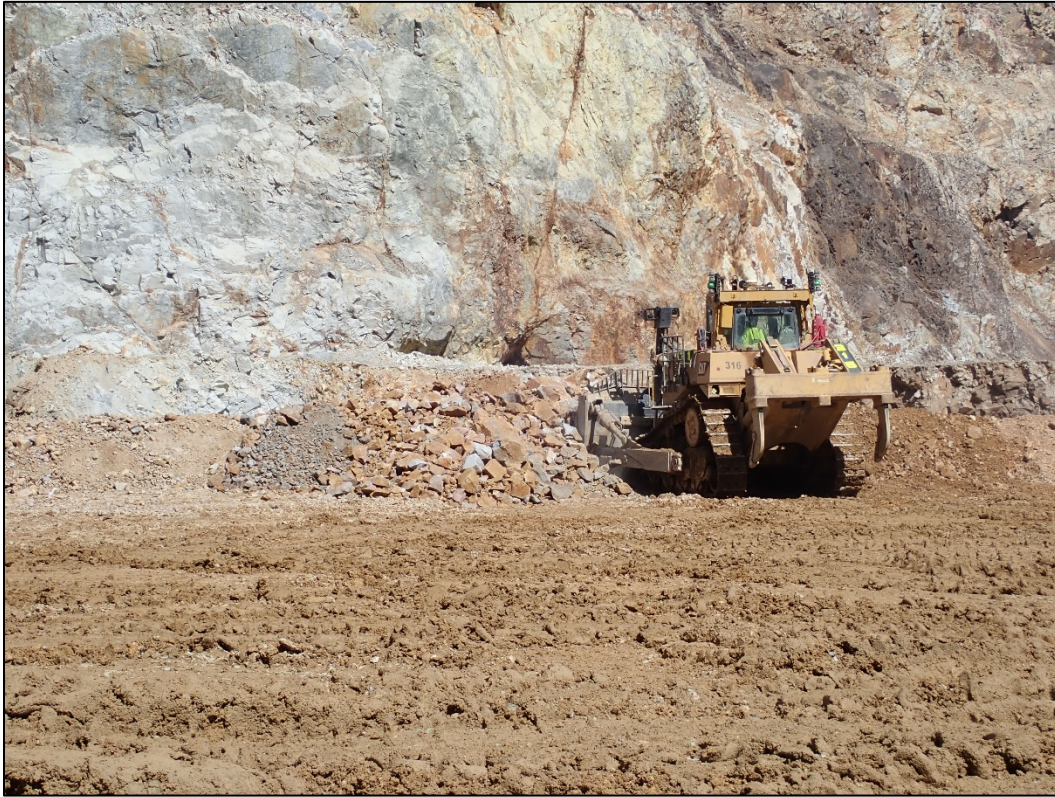
Photo 3. First lift backfilling activities, all material dumped from the previous haul truck appears to be less than less than the 60-inch maximum specification; looking north.

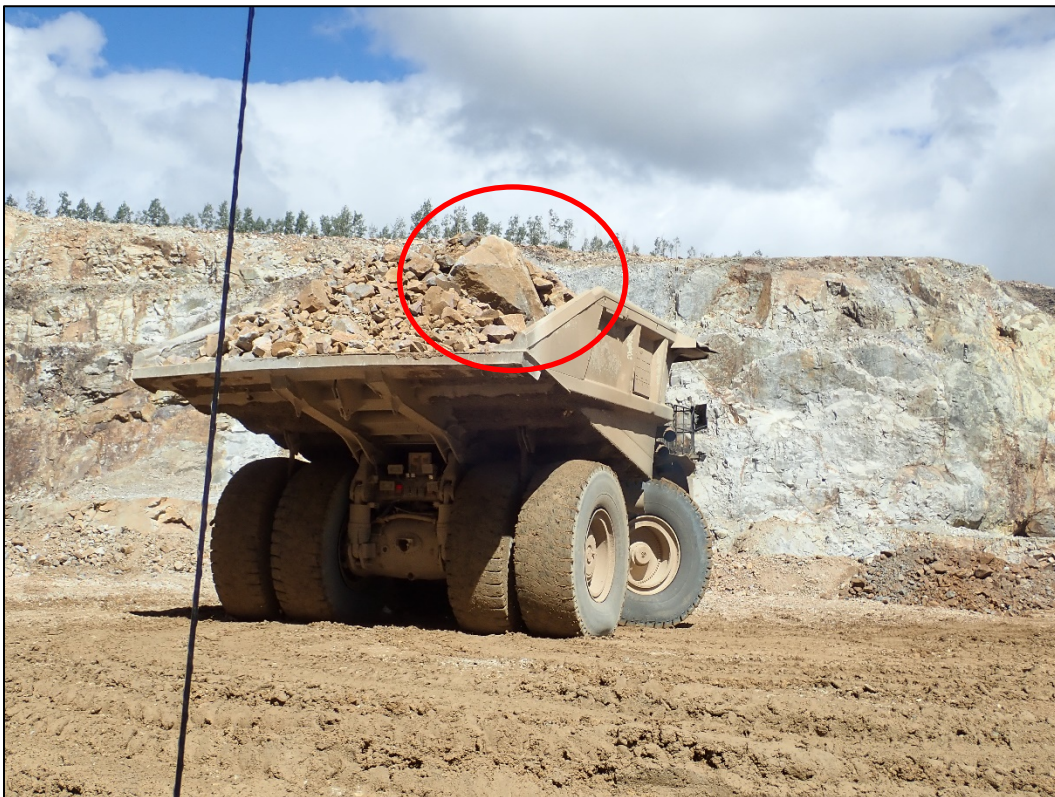
Photo 4. Oversized material leaving the Schist Island Pit; looking northeast.

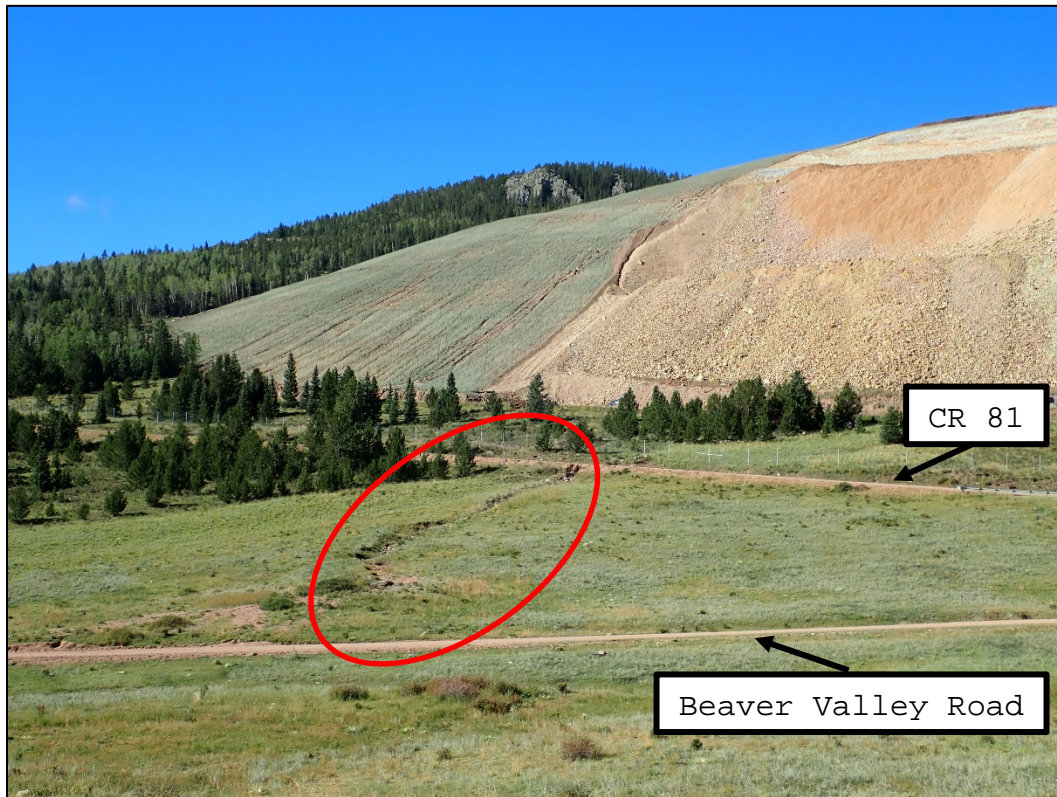
On August 17, 2021, the Division was copied on a CDPHE incident spill report regarding a caller who reported white foam on Beaver Creek on August 15th. The caller alleged the foam was from the Victor Mine and provided a location of 100 yards east of CR 81 and Beaver Valley Road. Following the incident report, the Division was involved in multiple discussions with CDPHE and Colorado Parks and Wildlife. It was believed the foam was directly associated with the August 15th storm event and that it was likely no longer visible. Additionally, it was discussed that the operation has no processing facilities nor chemical usage within the area of the report. CDPHE requested the Division, during the next monitoring inspection, inspect the area where the caller reported the source of the foam, a gulley at approximately 38°44'27.36"N 105° 7'15.81"W just down gradient of a culvert under CR 81 (see **Photo 5**). The Division inspected this gulley, the culvert, and the path of stormwater associated with CR 81 and the adjacent area above the culvert (see **Photo 6**). The eastern side of the CR 81 culvert contains significant erosion head-cutting and the culvert is suspended in the air with an approximate 12” drop (see **Photo 7**). The Division inspected the western bar ditch of CR 81 from above the culvert to the crest of the drainage divide, approximately 3,200 feet to the south. The Division observed no evidence of any recent sedimentation or erosional features entering into the bar ditch from the permit area which is located west of CR 81 (see **Photo 8**).

Photo 5. Gulley where foam was reported; looking south.

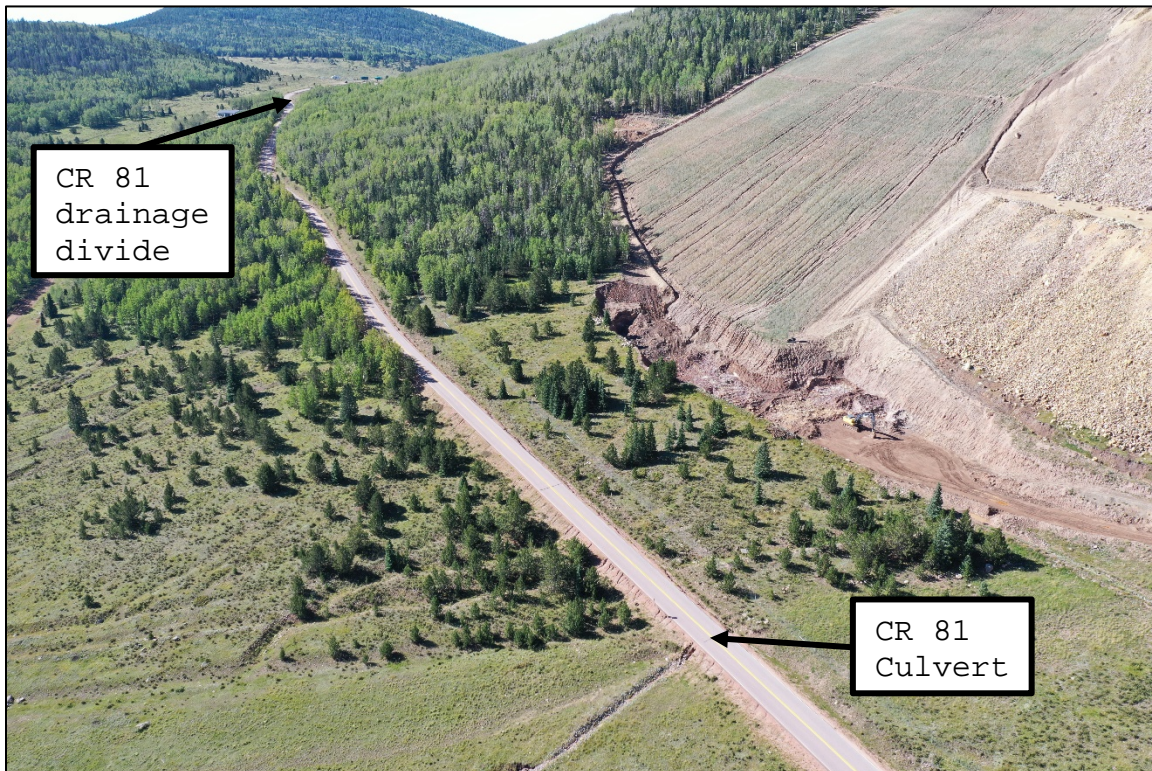
Photo 6. Aerial view of CR 81; looking south.

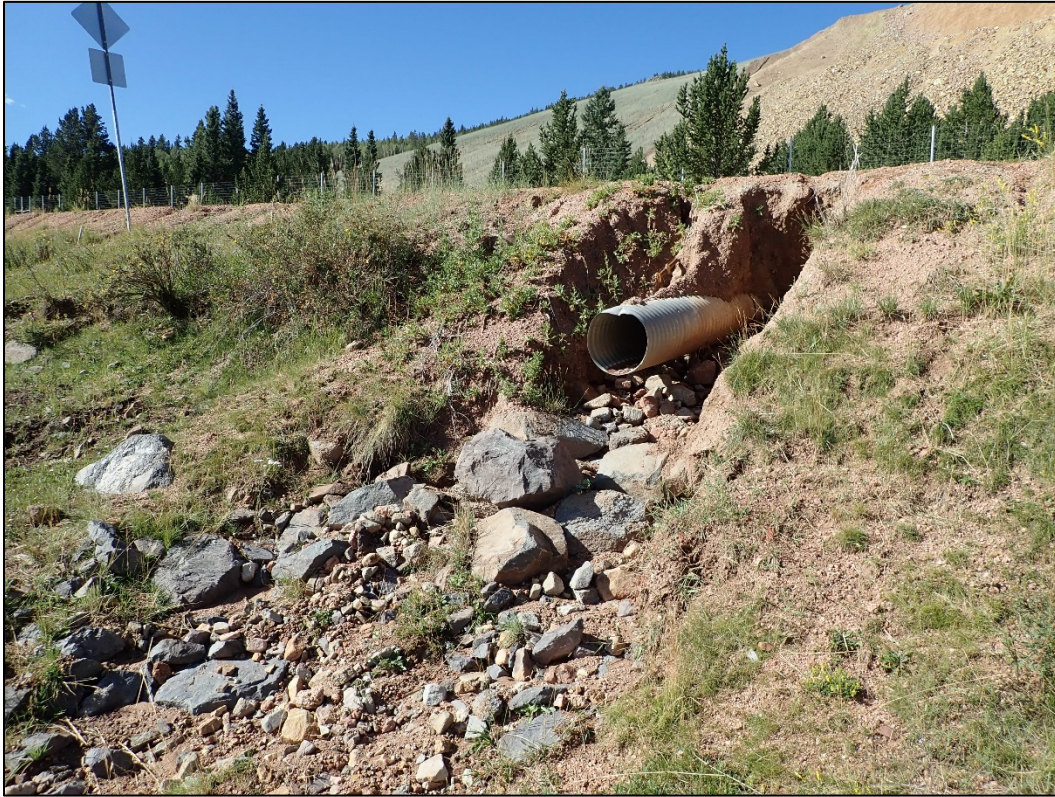
Based on the observations made during the inspection and the information presented in the spill report, it appears the foam is unrelated to the Cresson Project operation; through discussions with CDPHE after the inspection, the source of this foam may have been from decaying plant matter that had accumulated in and near the bar ditch of CR 81. This material breaks down into organic compounds of fatty acids and oils which act like surfactants; when air and turbulence is introduced to the water containing these compounds, such as the height

drop on the east side of the CR 81 culvert, foam could be created. In the future, if the Division is on-site conducting an inspection during a rain event, this area will be further inspected.

Photo 7. Eastern side of the CR 81 culvert; looking south.

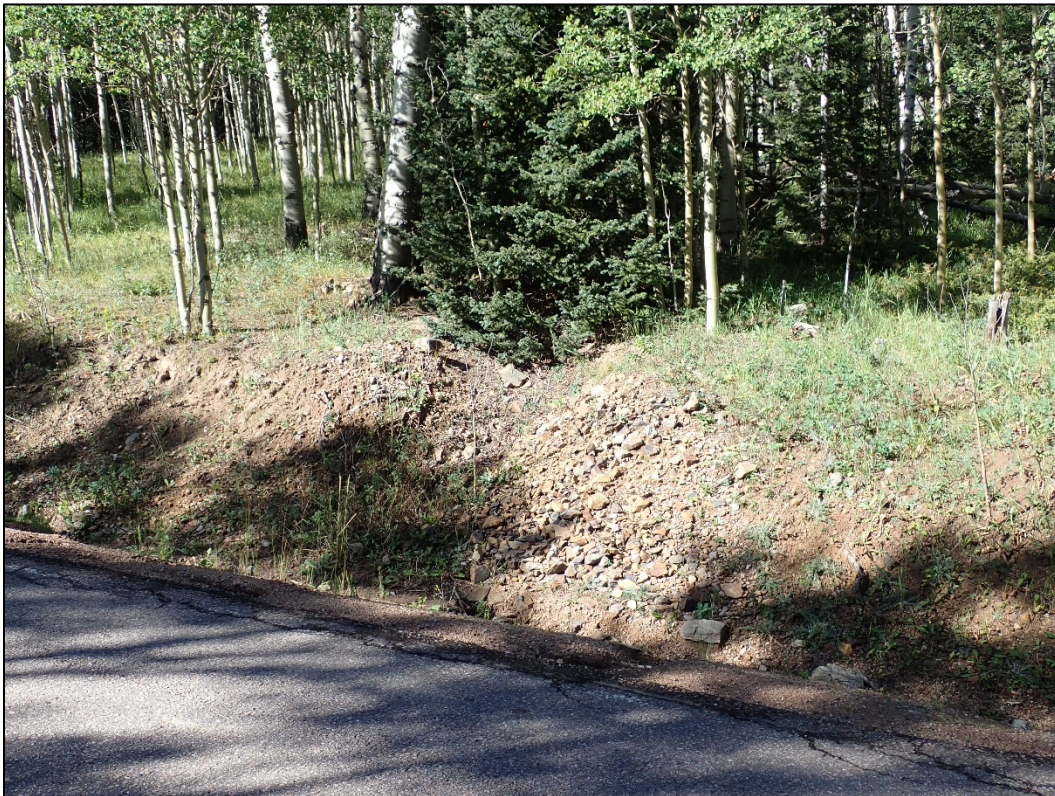
Photo 8. One of two old but stabilized drainages which flow into the western bar ditch; looking southwest.

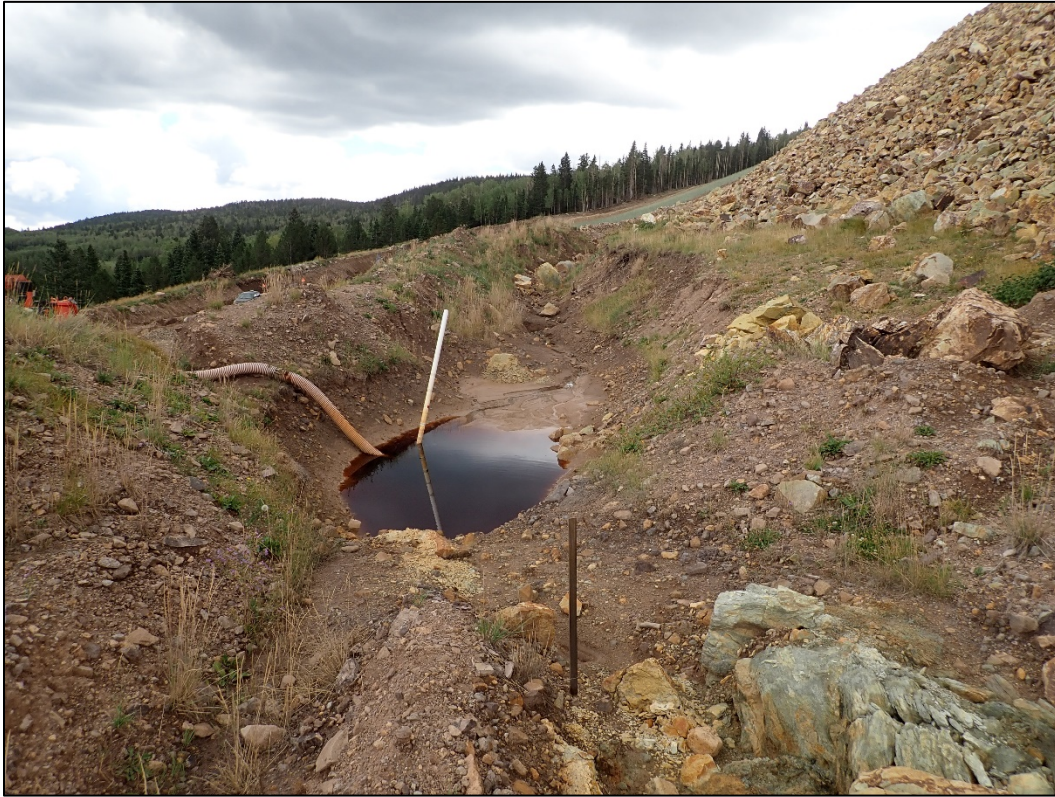
Photo 9. Original seep collection area; looking southeast.

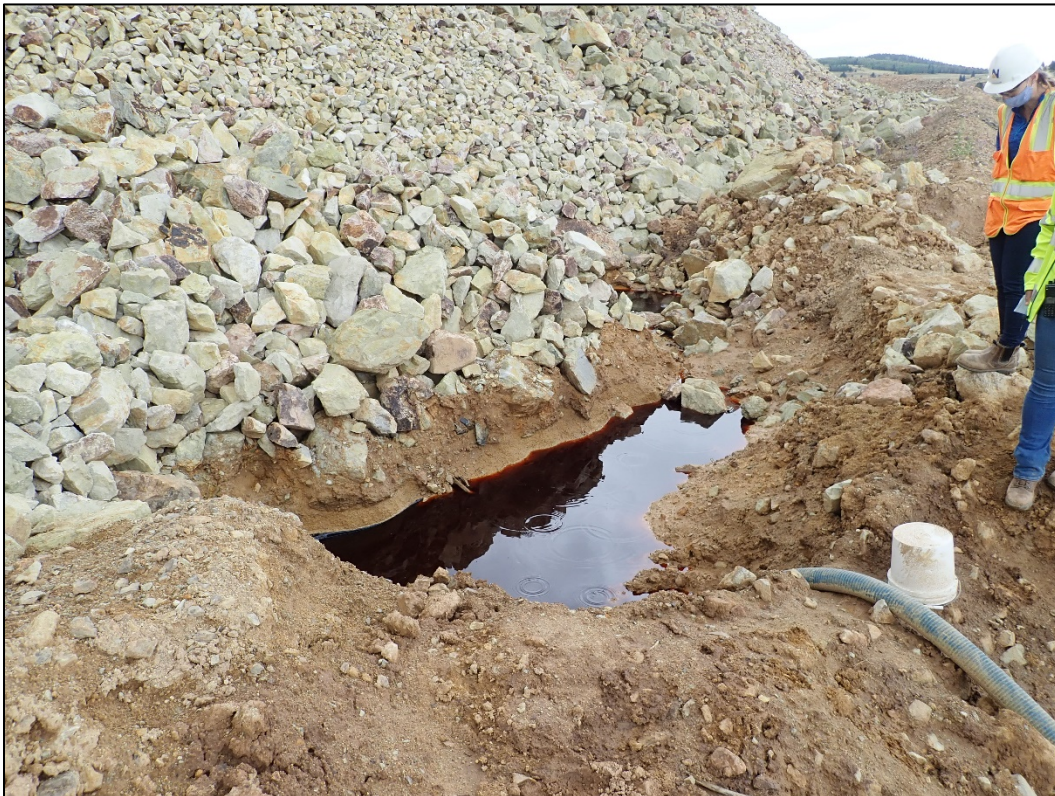
COMPLIANCE PROBLEM #1: A seep has expressed at the toe of the East Cresson Overburden Storage Area. This is a problem at this time in accordance with the approved Mine Plan, Rule 3.1.5, and C.R.S. 34-32-116(7)(c).

Photo 10. First sump of the new seep, located inside of the toe berm; looking northwest.

CORRECTIVE ACTIONS: The Operator shall submit a report regarding the new seep by the corrective action date. Within this report the Operator needs to include: 1) Background information on the design of the ECOSA and an overview of the seeps; 2) An update on the status of the original seep and any information regarding a reduction of flow rates as a result of the concurrent reclamation; 3) A description of the new seep and a discussion about the possible cause(s); 4) A water quality sample result of the seep; and 5) A formal plan on how the new seep will be monitored and managed.

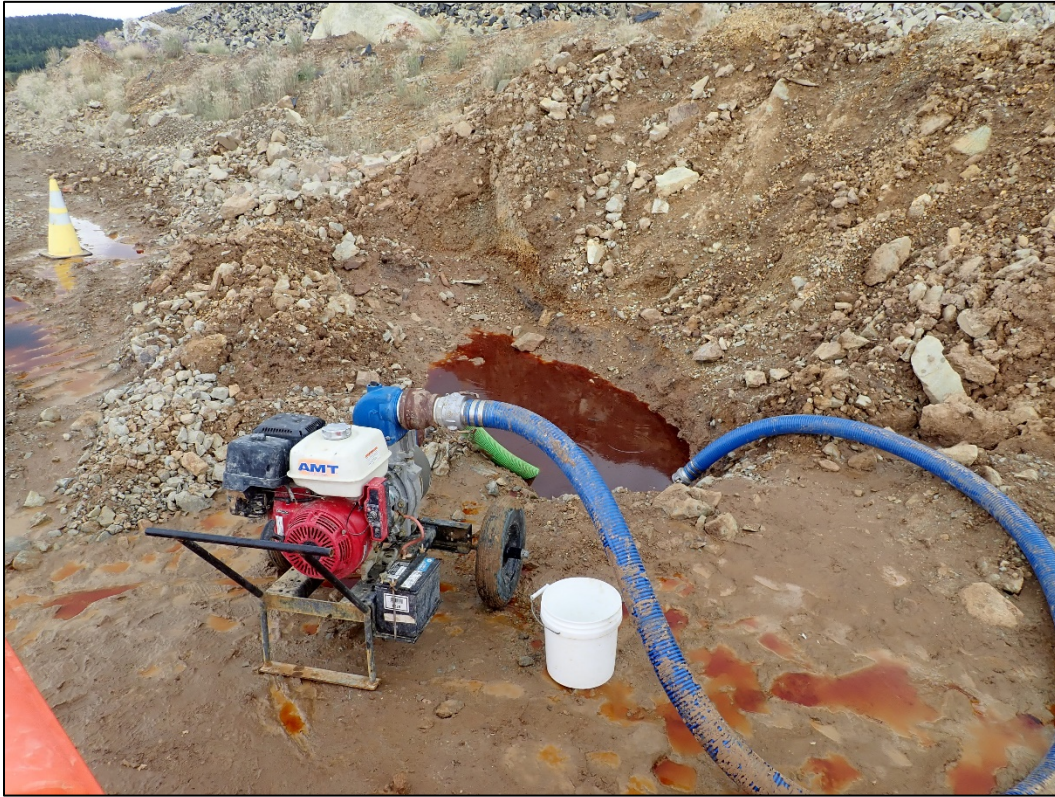
Photo 11. Second sump of the new seep, excavated into access road area outside of the toe berm; looking southeast.

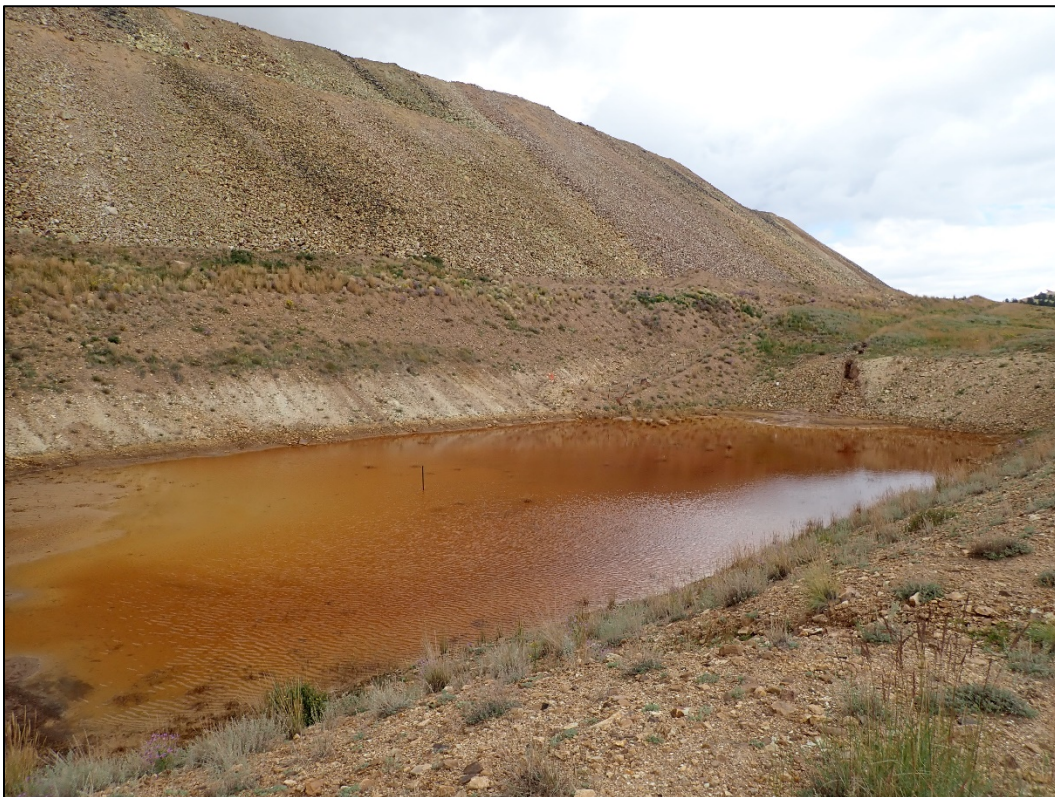
Photo 12. EMP-20 pond with discolored water; looking west.

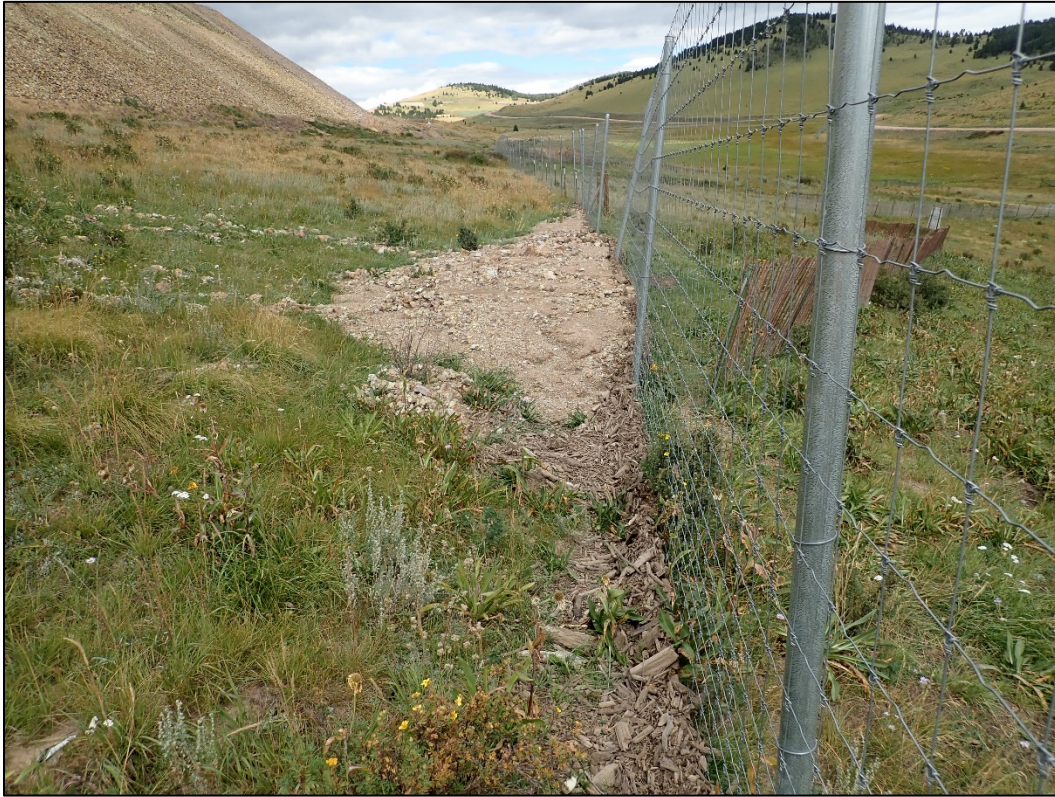
COMPLIANCE PROBLEM #3: A stormwater ditch failed and caused sediment to accumulate on undisturbed lands within the permit boundary. Additionally, an inactive drill pad, located west of the ECOSA near EMP-20, does not have adequate stormwater and sediment controls in place. This is a problem at this time for failure to protect the affected land from erosion pursuant to Rule 3.1.6 and C.R.S. 34-32-116(7)(i).

While inspecting the area between the original seep and EMP-20, the Division observed a large sediment deposit located against the wildlife fence, just downgradient of an inactive drill pad (see **Photo 13** and **Photo 14**). The Operator stated that this damage occurred during a storm event on July 16th where a section of the ECOSA's perimeter stormwater ditch failed and caused stormwater and sediment to flow across the drill pad and deposited against the fence. This failure appears to have been at the location of where the access road to the drill pad crossed the ditch. The inactive drill pad had berms along the northern and eastern sides, but no berm was along the southern side where the stormwater and sediment had traveled off the pad (see **Photo 15** and **Photo 16**). Furthermore, the edge of the drill pad disturbance did not have any sediment control features (silt fencing, straw wattles, catch ditches/berms, etc.). Following the storm event, the Operator repaired the ditch and increased the height of the outside ditch bank in several areas (see **Photo 17**), however the sediment that had been deposited on the undisturbed lands against the wildlife fence had not been cleaned up. Additionally, no further stormwater controls were installed around the inactive drill pad to control sediment from precipitation falling within the footprint of the drill pad. This has been cited as Compliance Problem #3 requiring the Operator to remove the deposited sediment and reclaim the disturbance between the drill pad and the wildlife fence. The Operator will also need to install stormwater controls for the drill pad. The Operator also discussed the possibility of reclaiming the inactive drill pad; this is an option, however, stormwater controls will still need to be constructed/installed along the edge of the reclaimed footprint until adequate vegetation is established. Lastly, the Operator will need to demonstrate the ECOSA perimeter ditch is appropriately sized and constructed to safely convey the modeled 100yr/24hr storm event to EMP-20. The Operator mentioned they had recently constructed the final reclamation 500yr channel along the reclaimed portions of the ECOSA above the area where clay was currently being mined and that the plan is to continue this channel once the clay area is backfilled and graded. As this area is just above the ditch which failed in the recent storm event, the Operator may want to submit the designs to construct the 500yr channel all the way to EMP-20 as a part of the corrective action, however, the minimum requirement at this time is for the 100yr/24hr event.

Photo 13. Sediment deposited against wildlife fence; looking northwest.

CORRECTIVE ACTIONS: The Operator shall provide photo documentation to the Division verifying the deposited sediment has been appropriately cleaned up and sediment control measures have been installed/constructed around the drill pad by the corrective action date. Additionally, the Operator shall demonstrate the repaired ECOSA perimeter ditch is appropriately sized and constructed to safely convey the modeled 100yr/24hr storm event to EMP-20 by the corrective action date

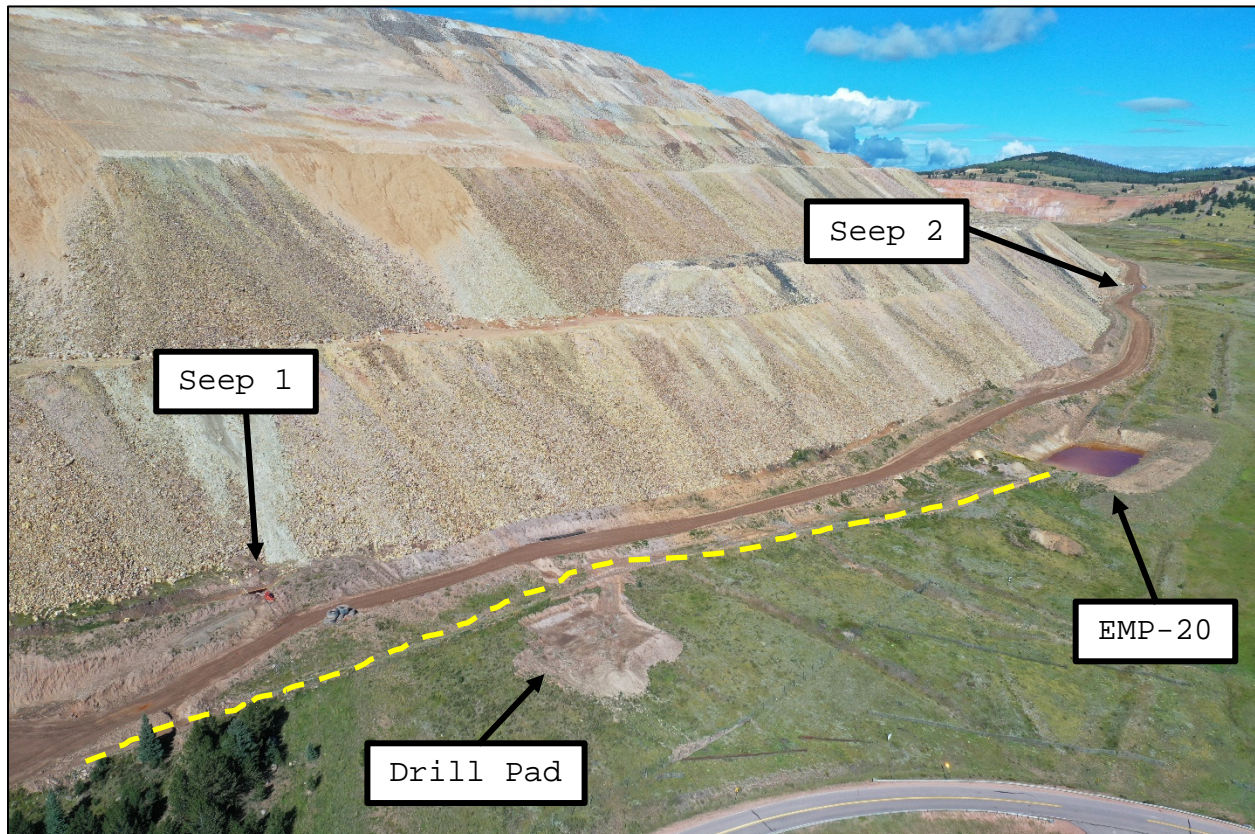
Photo 14. Aerial overview of the ECOSA, perimeter ditch identified by dash line; looking west.

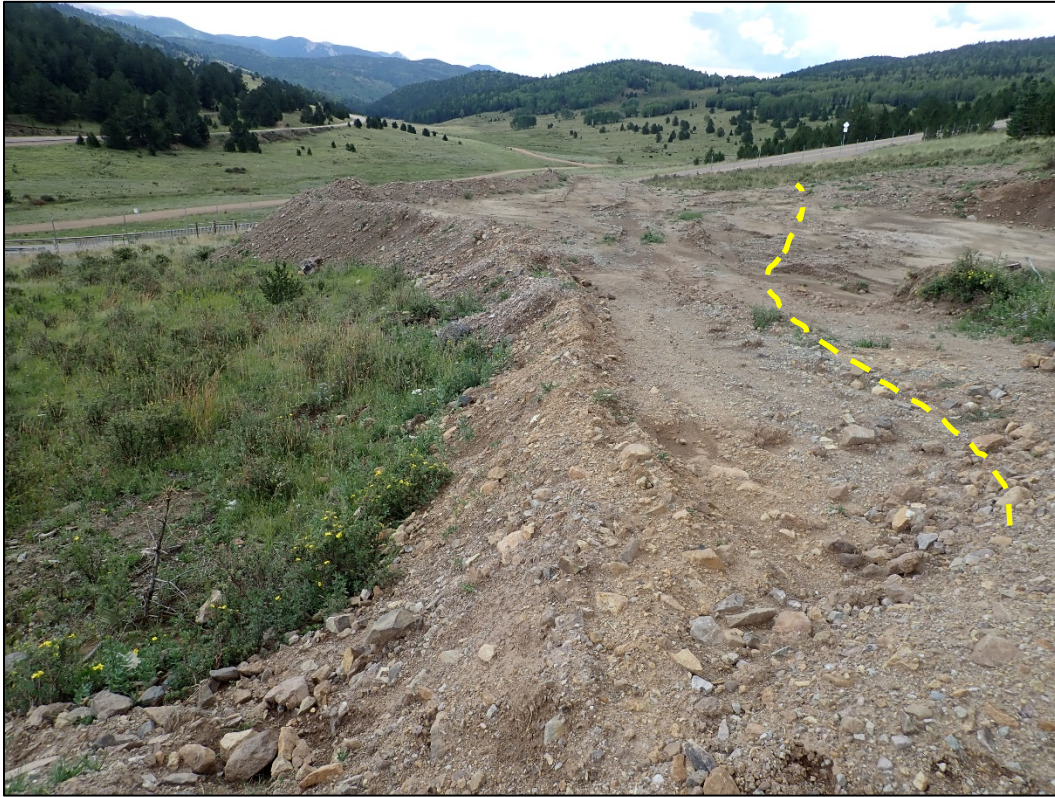
Photo 15. Drill pad, path of stormwater identified by dashed line; looking east.

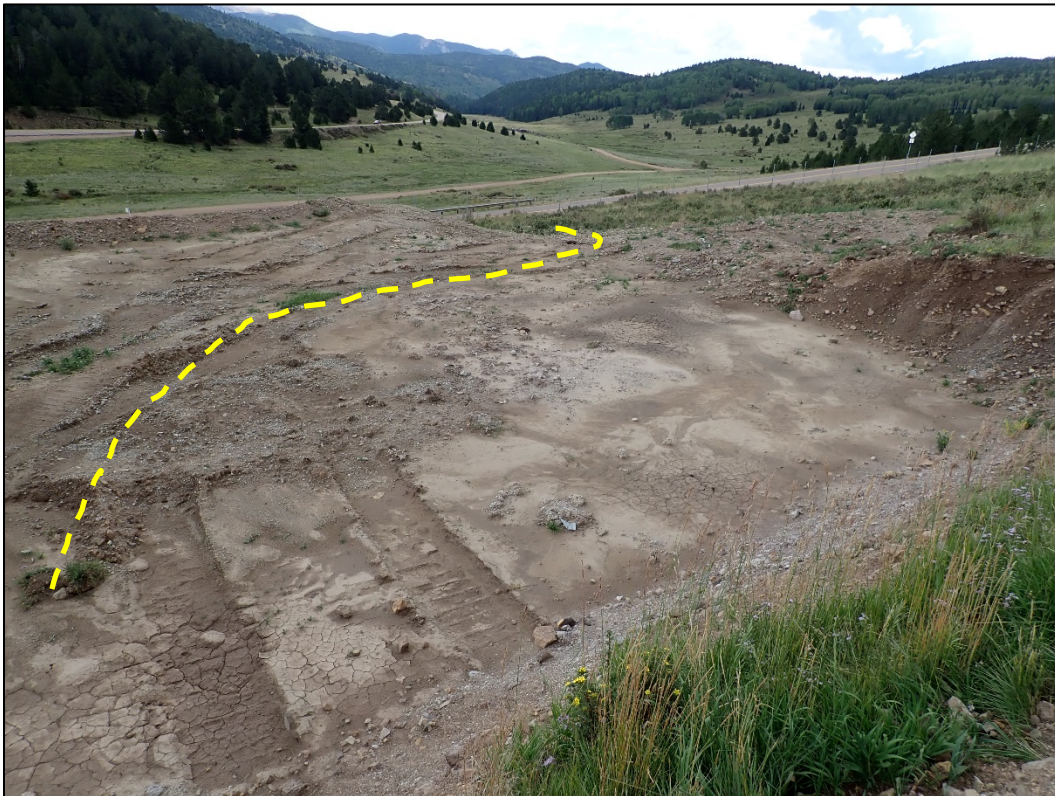
Photo 16. Drill pad, path of stormwater identified by dashed line; looking east.

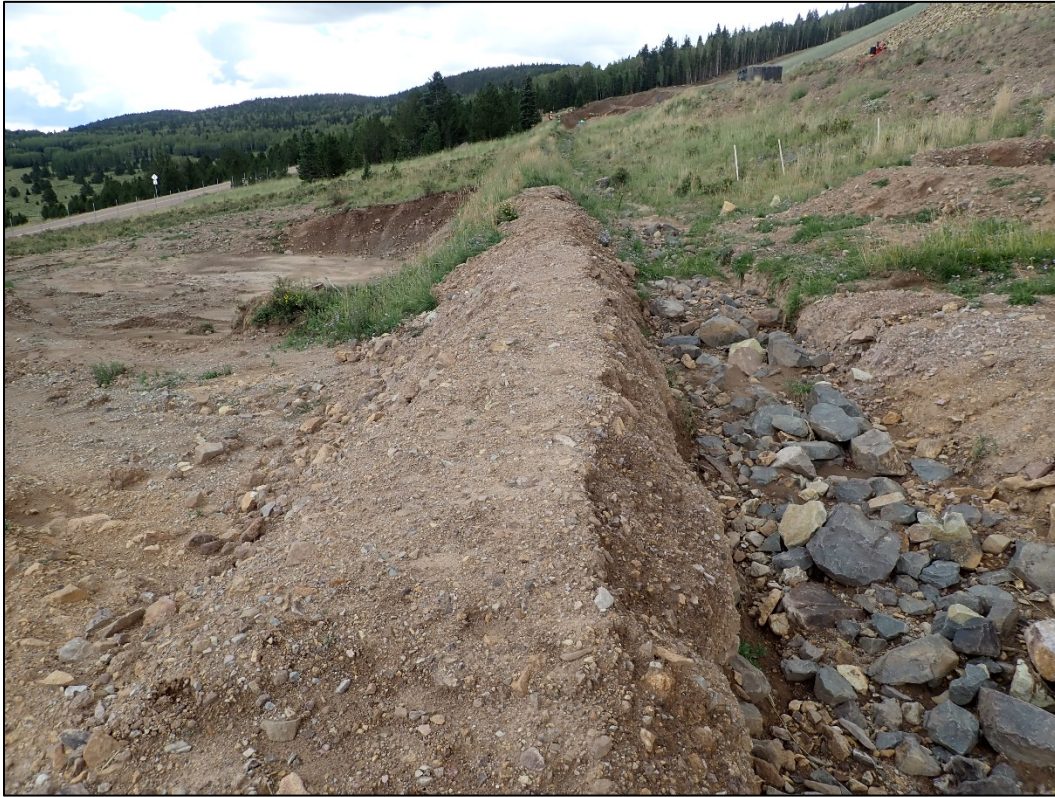
Photo 17. Repaired ECOSA perimeter ditch; looking southeast.
