## New Elk Mine, C-1981-012, October 13, 2021 Inspection Report

**COLORADO**  
Division of Reclamation,  
Mining and Safety  
Department of Natural Resources

<b>Permit Number:</b> C-1981-012 <b>Mine Name:</b> New Elk Mine <b>Operator:</b> New Elk Coal Company, LLC <b>Operator Address:</b> Mr. Larry Cook 12250 Highway 12 Weston, CO 81091	<b>County:</b> Las Animas <b>Operation Type:</b> Underground <b>Permit Status:</b> Active <b>Ownership:</b> Private
	<b>Operator Representative Present:</b>  Vince Massarotti
<b>Operator Representative Signature:</b> (Field Issuance Only)

<b>Inspection Start Date:</b> October 13, 2021 <b>Inspection Start Time:</b> 08:00 <b>Inspection End Date:</b> October 13, 2021 <b>Inspection End Time:</b> 13:00		<b>Inspection Type:</b> Coal Partial Inspection <b>Inspection Reason:</b> Normal I&E Program <b>Weather:</b> Clear	
<b>Joint Inspection Agency:</b>  None		<b>Joint Inspection Contacts:</b>	
<b>Post Inspection Agency:</b>  None		<b>Post Inspection Contacts:</b>	
<b>Inspector(s):</b>  Jared Ebert	<b>Inspector's Signature:</b>

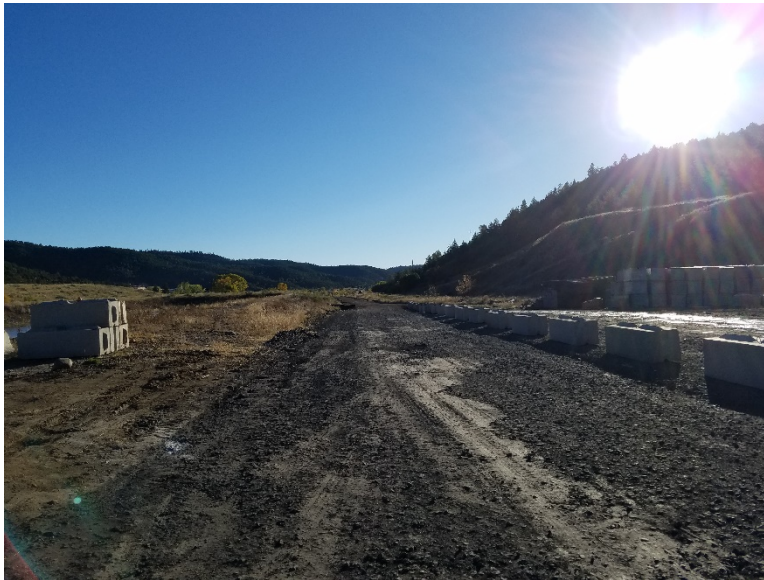
*Figure 1. From the south end of Pond 007a looking east at access road.*

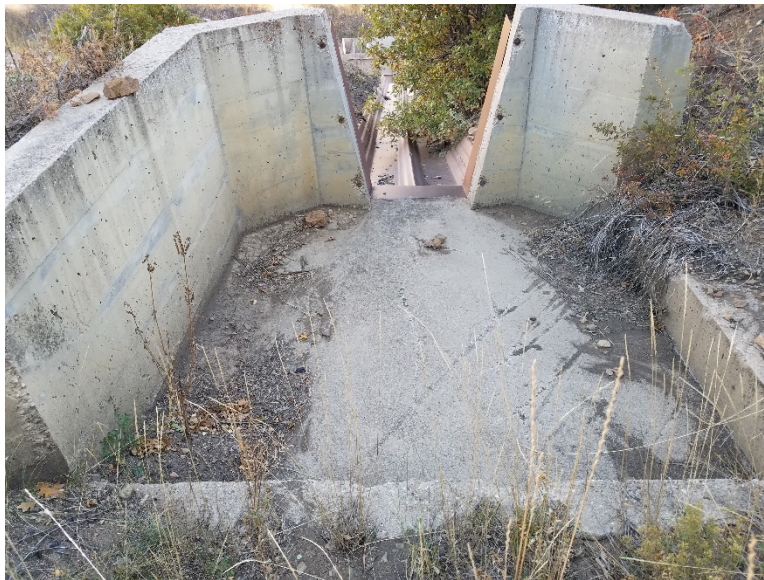
*Figure 2. Upper drop down structure and flume from the end of ditch D26.*

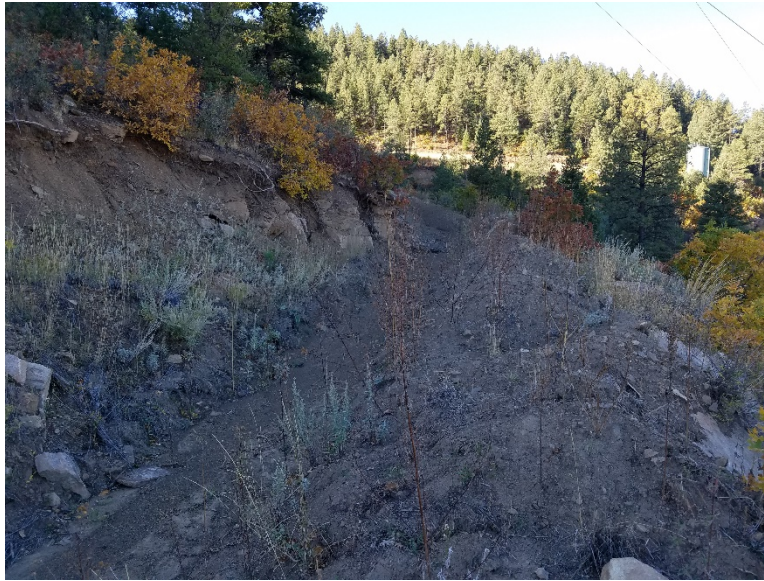
Clean water diversion ditch D26 was observed. The majority of the ditch is vegetated, a small section is lined with concrete. Overall, the ditch is clear and functional. **Several trees were observed that have fallen over the ditch and will need to be cleared away.** The upper reaches of the ditch were cleaned in January/February of 2021 according to Mr. Massaroitti.

*Figure 3. Ditch D26 looking west.*

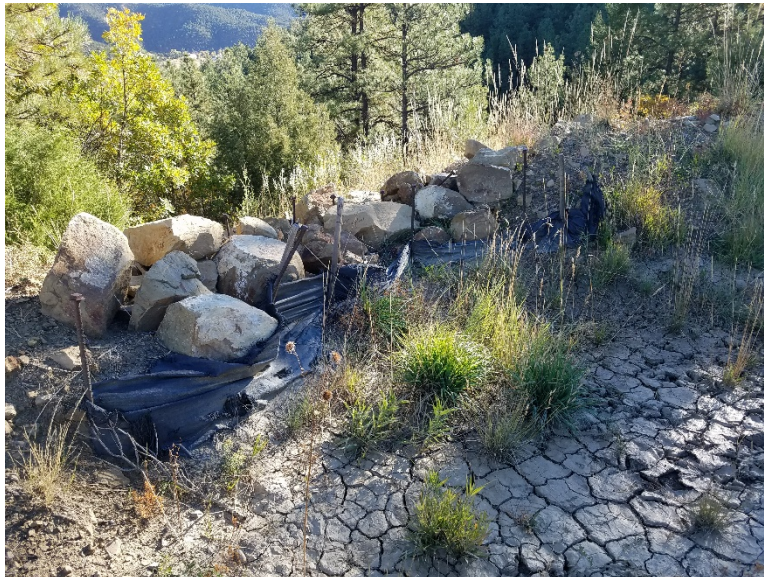
The upper water tank S.A.E. area was observed. A berm is in place surrounding the pad area where the tanks are located. The berm, small sump, and checkdam lined with rock and silt fence appear to be functional at preventing off-site sedimentation at this SAE.

*Figure 4. Drainage control structure on the pad where the water tank S.A.E. is located.*

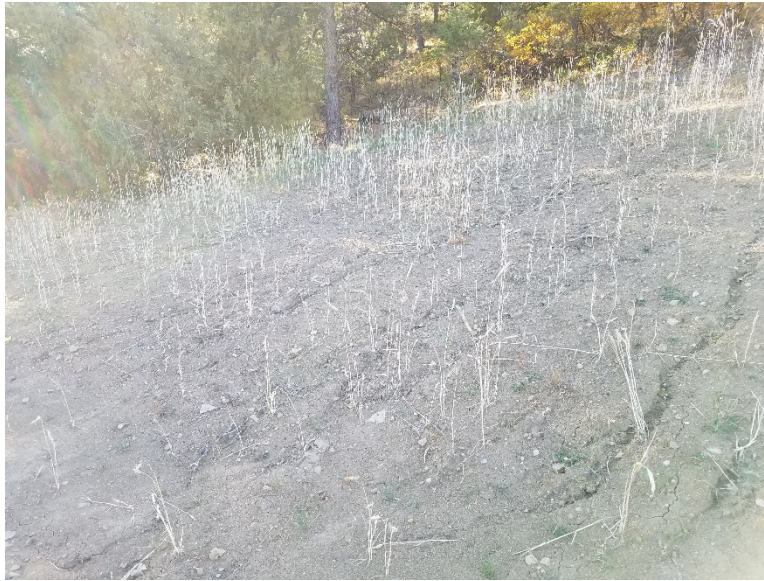
Core hole pads NE-02-20 and NE-01-20 were observed. Drilling is complete and the pads have been reclaimed. The pads have been graded to blend into the surrounding topography and they have been seeded. Vegetation has begun to establish on the pad area. Two wooden borehole markers were found on the ground on the drill pad area. **These markers will need to be replaced in the location of the drill hole in accordance with Rule 4.07.3(2).**

*Figure 5. Core hole pad NE-02-20.*

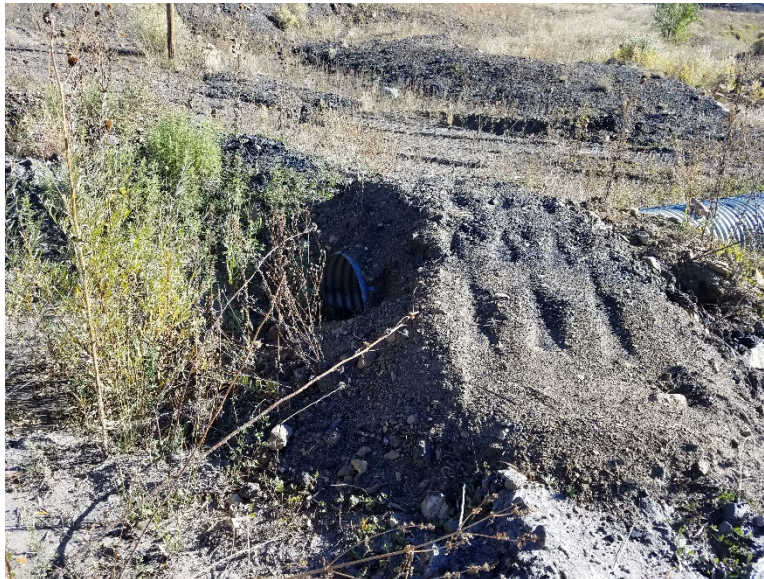
NECC cleaned sediment from the sump and re-established the berm upstream of culvert C13 on the southeast corner of the DWDA #2.

*Figure 6. Repair work at culvert C13.*

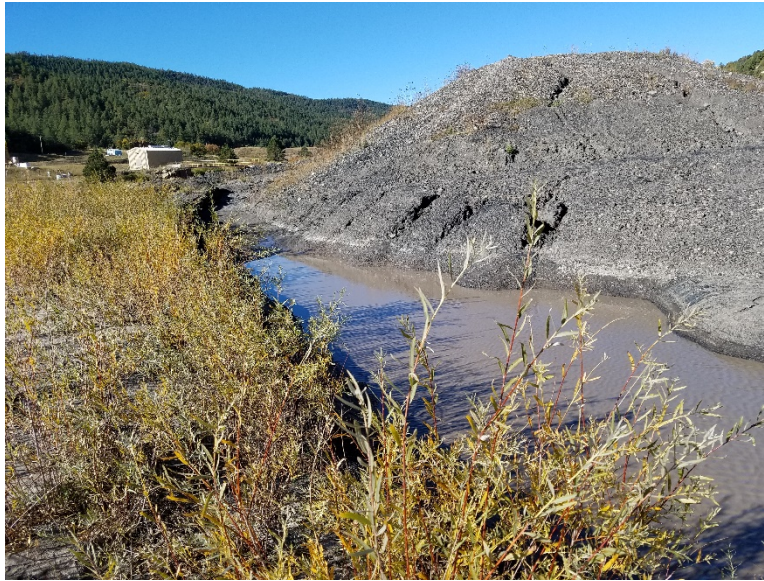
*Figure 7. Sump upstream of Culvert C13 deepened.*

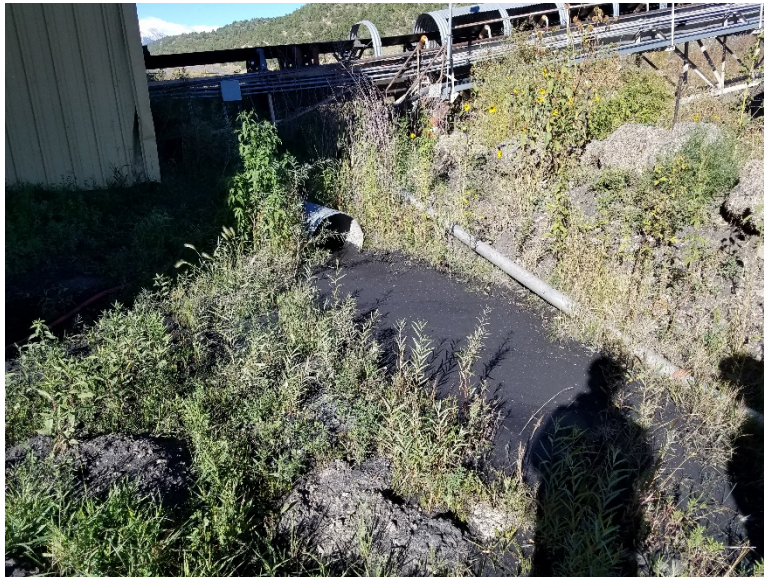
northern slope of ditch D32 as the slopes are a little steep in areas and small rills were observed on the ditch side slopes. **Culvert C64 is about ¼ full of sediment and needs to be cleaned out on the outlet end.**

*Figure 8. Culvert C64 outlet that needs to be cleaned out.*
