## Lorencito Canyon Mine, C-1996-084, October 13, 2021 Inspection Report

<b>Permit Number:</b> C-1996-084 <b>Mine Name:</b> Lorencito Canyon Mine <b>Operator:</b> New Elk Coal Company, LLC <b>Operator Address:</b> Mr. Larry Cook 12250 Highway 12 Weston, CO 81091	<b>County:</b> Las Animas <b>Operation Type:</b> Surface <b>Permit Status:</b> Permanent Cessation <b>Ownership:</b> Private
	<b>Operator Representative Present:</b>  Vince Massarotti
<b>Operator Representative Signature: (Field Issuance Only)</b>

<b>Inspection Start Date:</b> October 13, 2021 <b>Inspection Start Time:</b> 11:00 <b>Inspection End Date:</b> October 13, 2021 <b>Inspection End Time:</b> 12:30		<b>Inspection Type:</b> Coal Partial Inspection <b>Inspection Reason:</b> Normal I&E Program <b>Weather:</b> Clear	
<b>Joint Inspection Agency:</b>  None		<b>Joint Inspection Contacts:</b>  	
<b>Post Inspection Agency:</b>  None		<b>Post Inspection Contacts:</b>  	
<b>Inspector(s):</b>  Jared Ebert	<b>Inspector's Signature:</b>

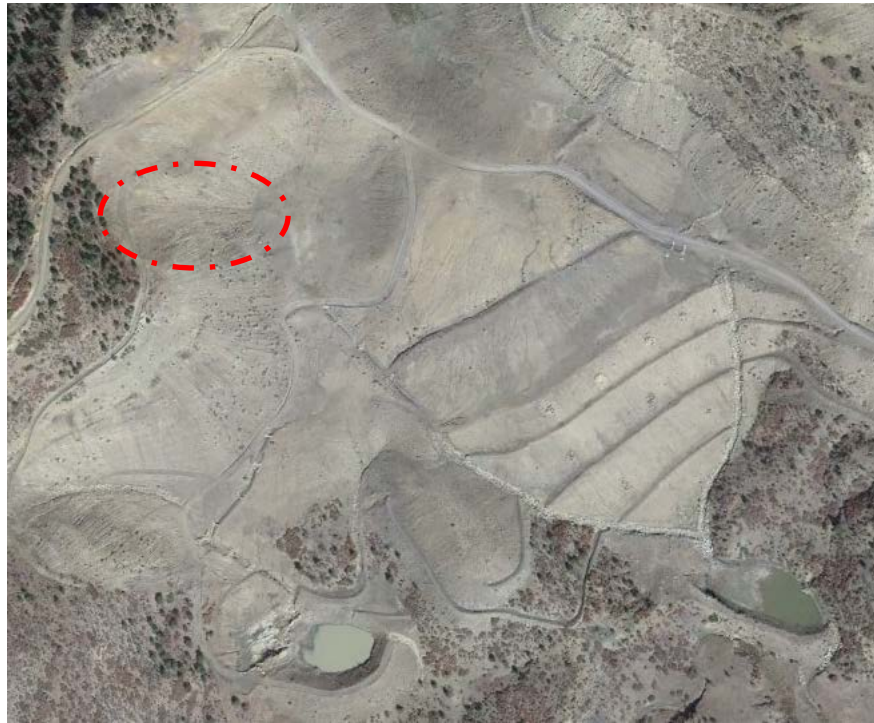
The area northwest of Fill 7, reclaimed in 2006 and 2007 (according to the 2020 annual reclamation report map) was observed. NECC has repaired rills and gullies formed in the area overtime using brush placement in rills and gullies, regrading/repair efforts, and the installation of straw waddles. Two notable gullies where repair efforts have been conducted in the past appeared to have held up during this year's precipitation events; however, **several small gullies broke through some of the erosion control structures and should be monitored and repaired.** In the southwest portion of this area, several larger rills were observed (see Figure #1 for the location). It does not appear any erosion control or repair has occurred in this area recently. Mr. Massarotti indicated NECC will likely place brush in these erosional features. **NECC will need to monitor and repair these areas.**

*Figure 1. Location of several large rills observed. (Google Earth photo dated 10/18/2016)*

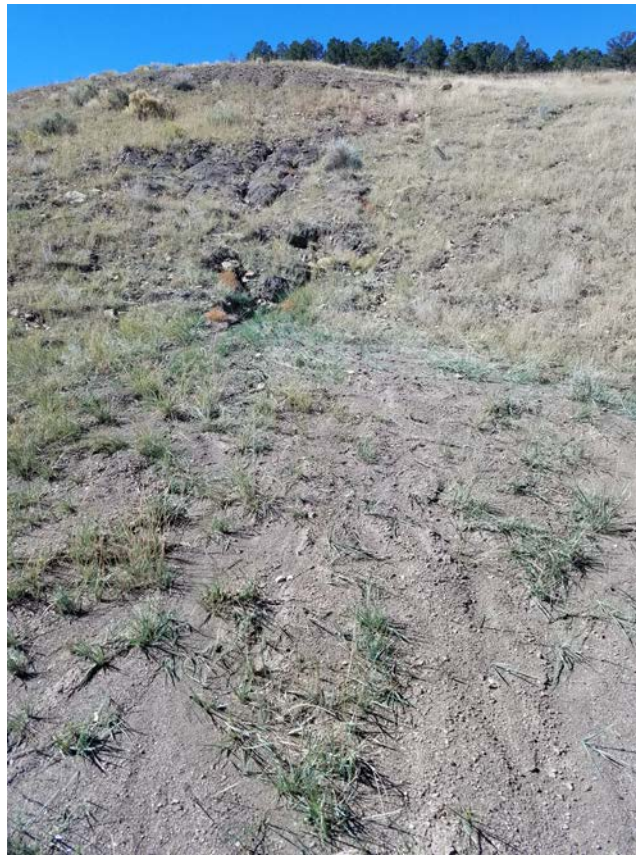
*Figure 2. Larger rills in 2006/2007 reclaimed area that will need to be monitored and repaired.*

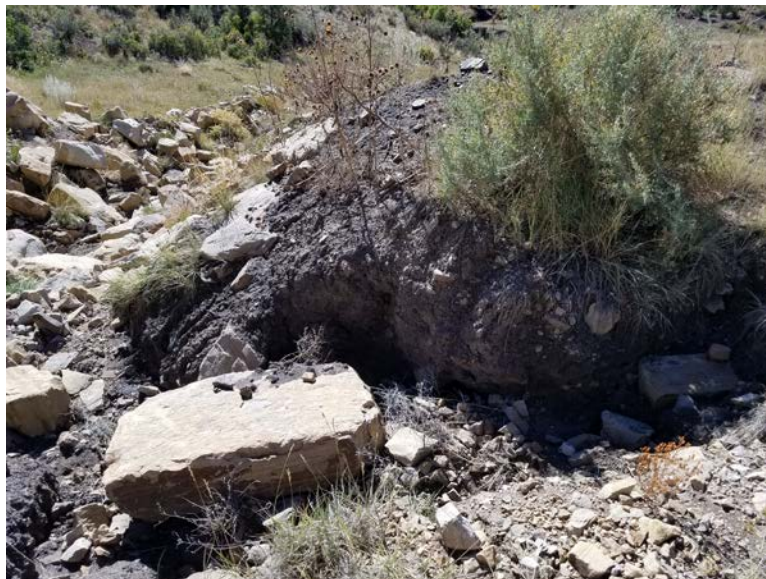
Ditches D94 and D92 are side channels west and east of Fill 9 respectively. Overall, these channels are stable and functional. **Some minor rock placement and maintenance of side erosion will need to be conducted in these channels.** For example the top of D92 is undercutting in places and needs repair. According to Mr. Massarotti, these items will be addressed in the repair effort planned later this year.

*Figure 3. Erosional feature on D92.*

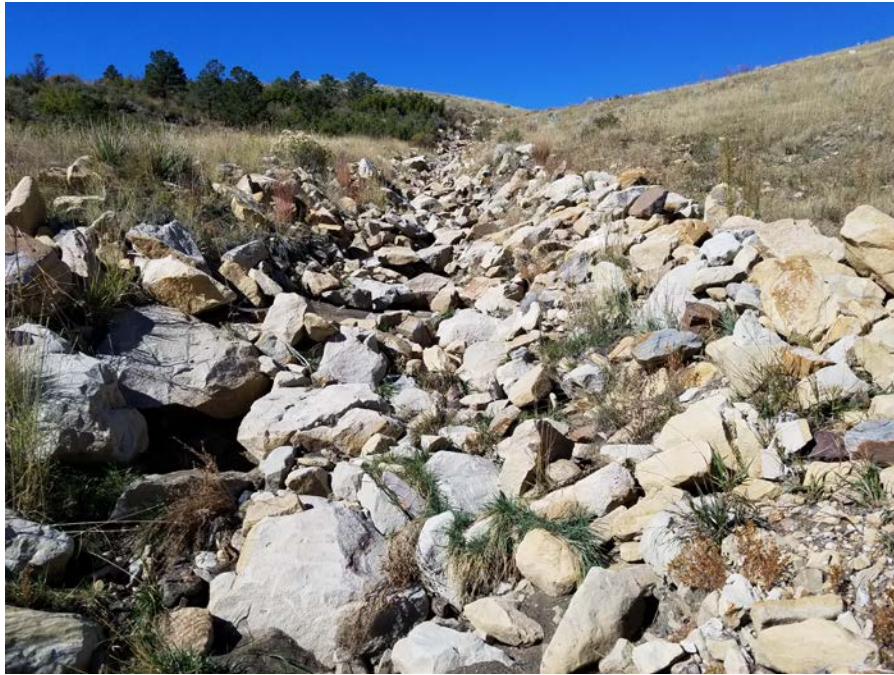
*Figure 4. Ditch D94.*

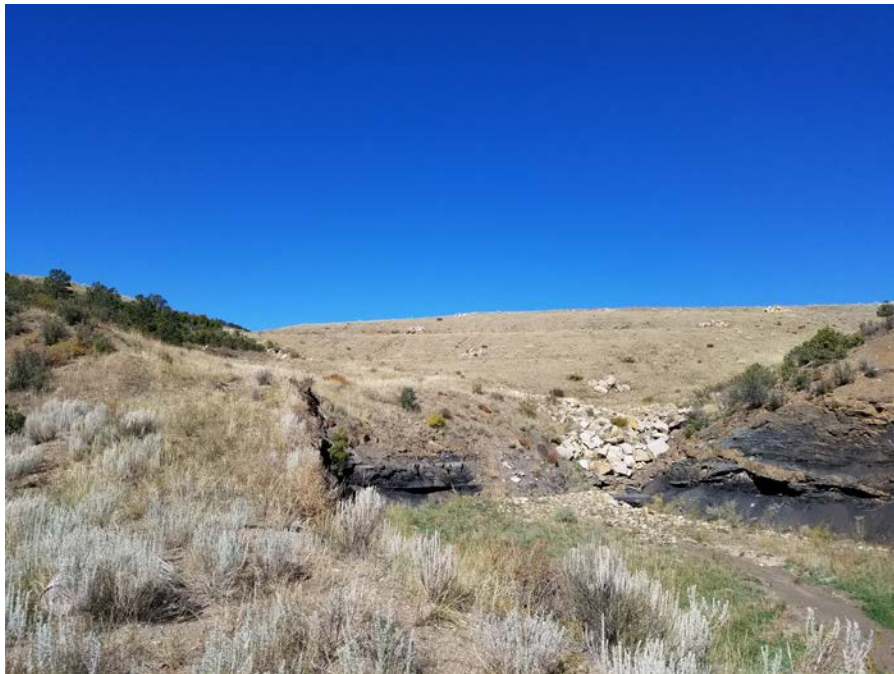
Fill numbers 7 and 9 were observed. The area during this growing season experienced significant precipitation events. Dense vegetation has established on the face of the fills including native grass species and woody plants. Some weedy vegetation was observed but it appears to have been treated with herbicide. Minor rills have been repaired overtime and vegetation has begun to establish in many of the rills observed. The side channels and bench drains are functional with minor maintenance items noted in the Hydrologic Balance section of this report below.

*Figure 5. Fill 7 from the Pond 007 area.*

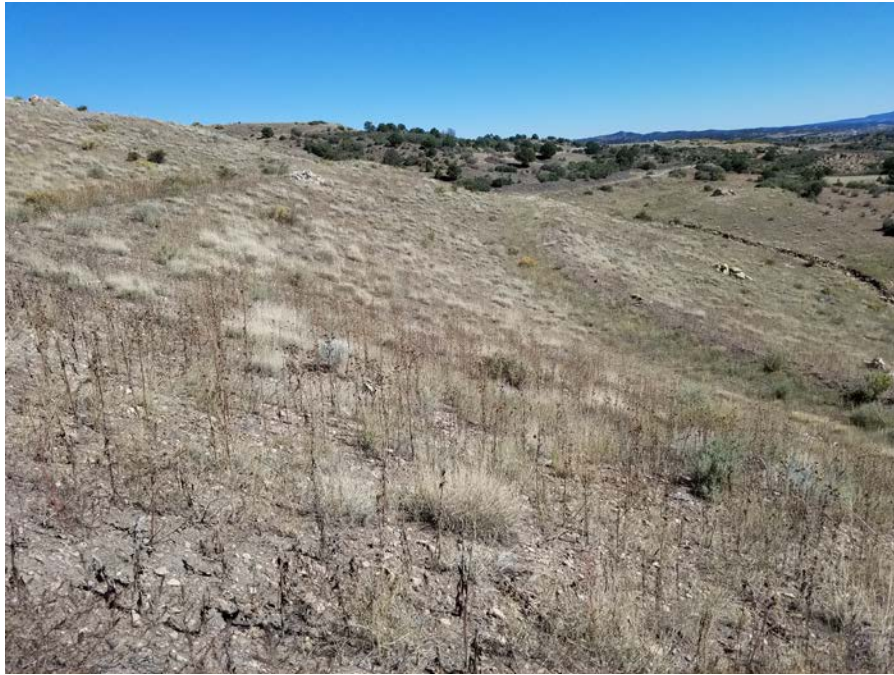
*Figure 6. Fill 9 from the west side looking east.*

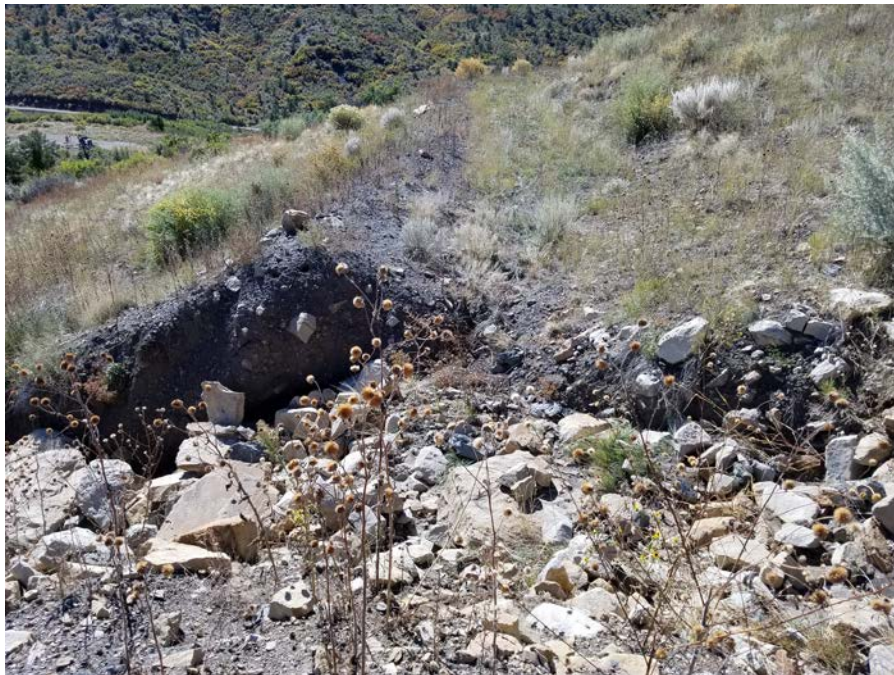
*Figure 7. Larger side cut where D75 meets D94.*

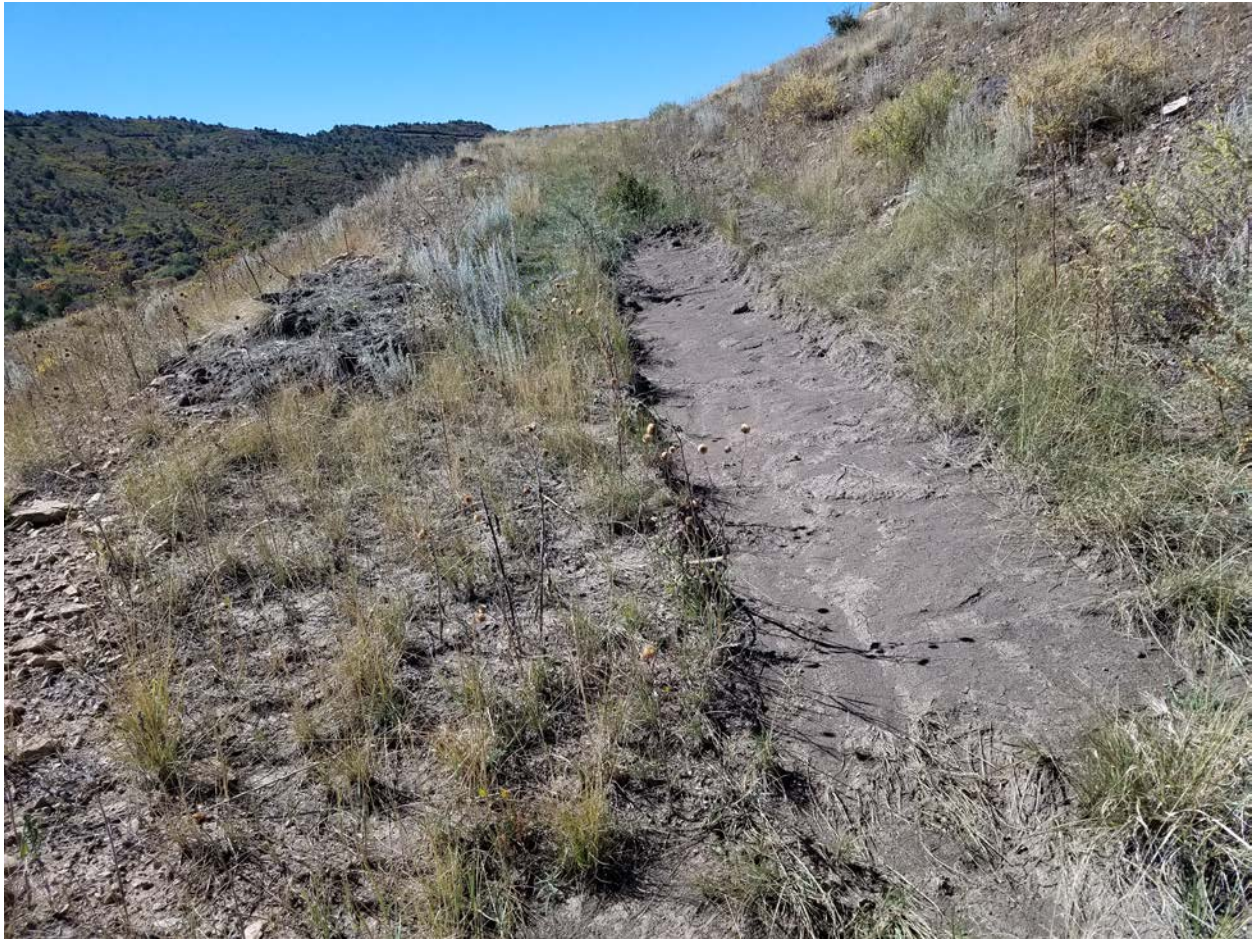
*Figure 8. Repair work conducted on Fill 9 terrace and drainage ditch. Out slope repaired and positive drainage re-established to D92.*
