**Daniels Sand Pit 2, Permit No. M-1973-007-SG: Monthly Monitoring Report**

October 10, 2021  
Project No.: 19125

Regarding: Daniels Sand Pit 2, Permit No. M-1973-007-SG  
Slope Stability Monthly Monitoring Report

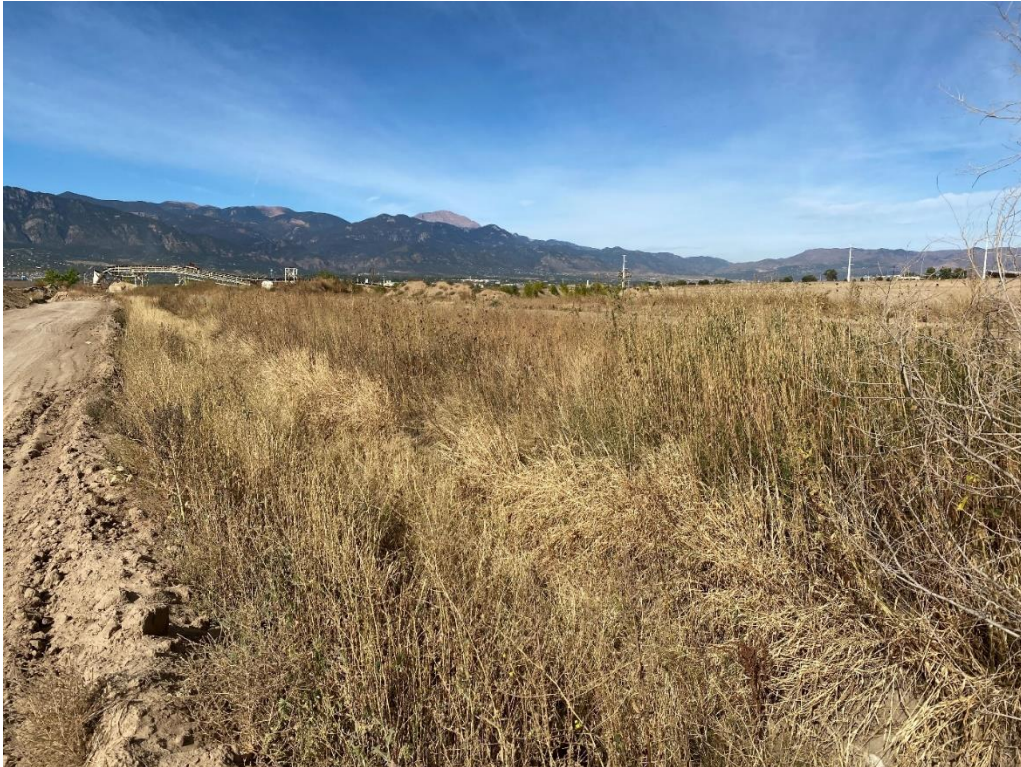
- Weather: 61-79°, partially cloudy, wind 5-10 mph
- Visual observation of the Fountain Mutual Ditch:
  - No tension cracks
  - No toe erosion
  - No moisture changes, ditch is dry
  - No sloughed slope surfaces

Photo 1. Fountain Mutual Ditch looking west

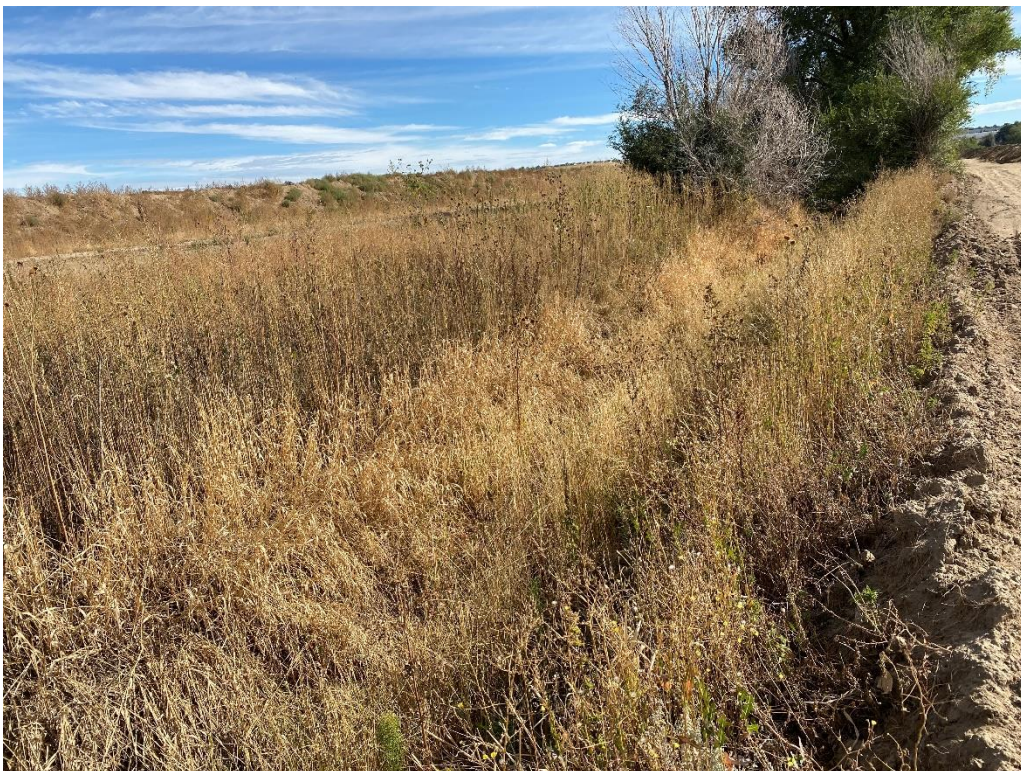
Photo 2. Fountain Mutual Ditch looking east

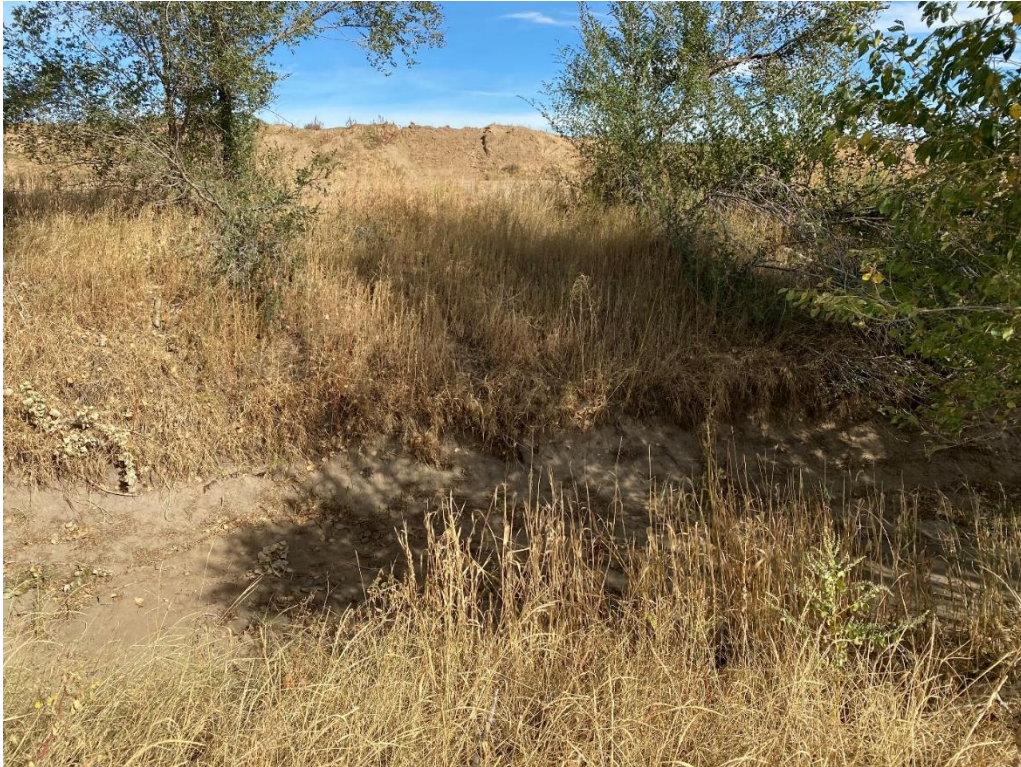
Photo 3. Fountain Mutual Ditch looking north

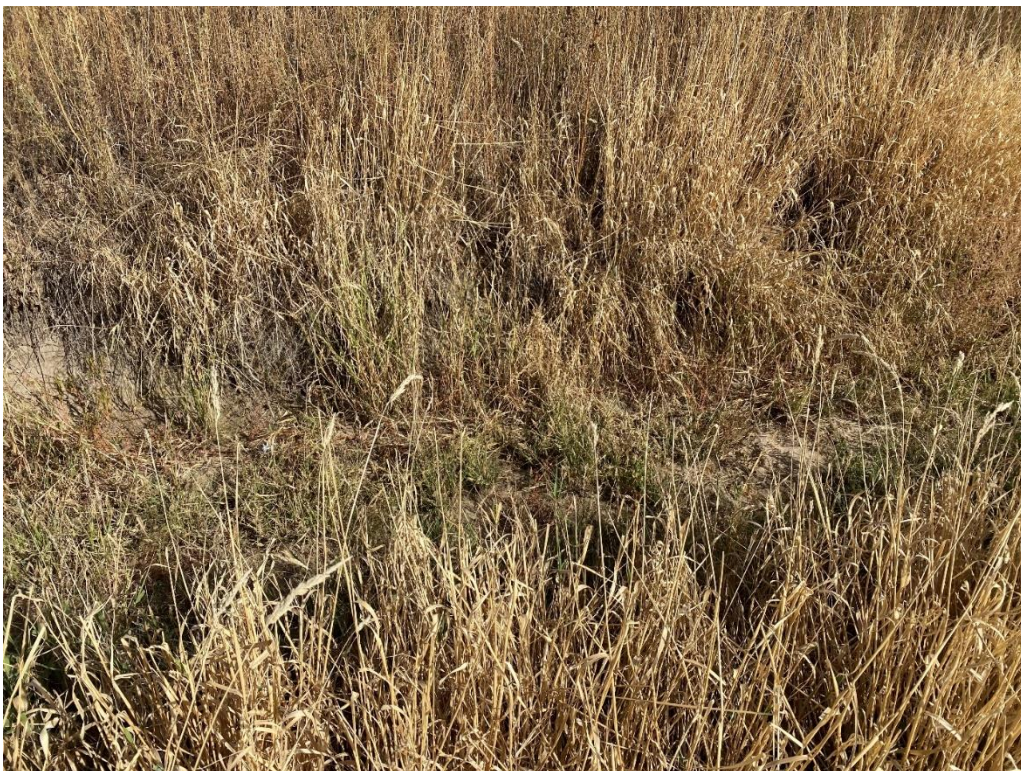
Photo 4. Fountain Mutual Ditch invert

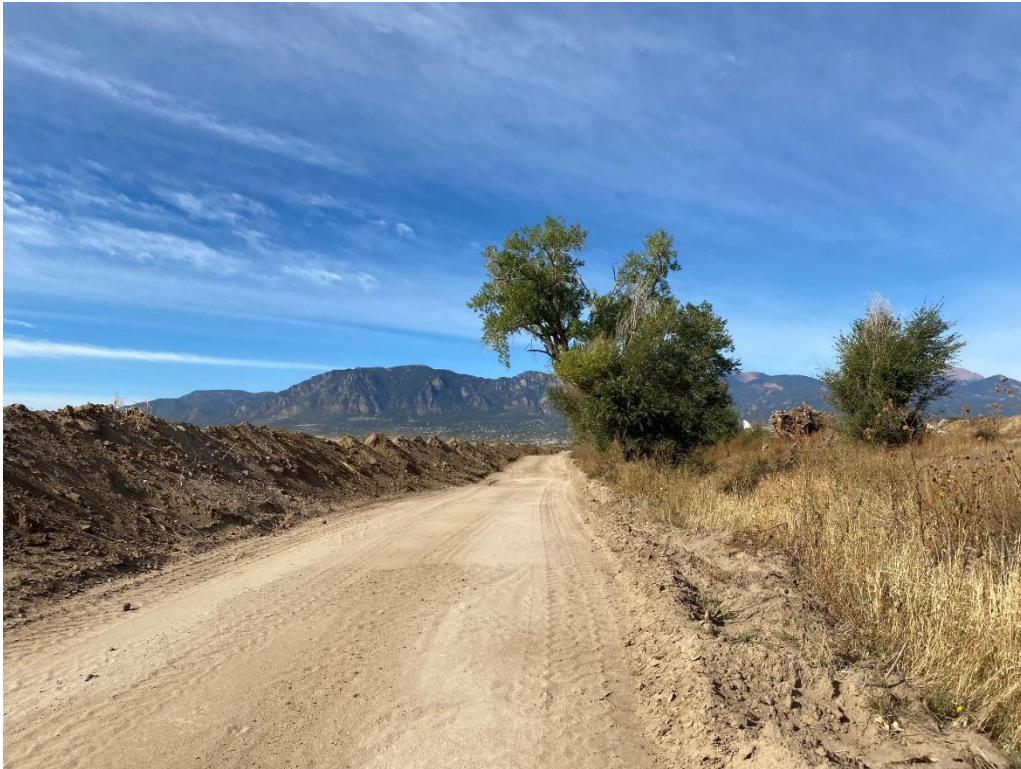
- Construction sequence discussion
  - At this time, the buttress slope varies from 3H:1V to 4H:1V
  - Preparation for final lift
    - Stockpiled sand located at crest of embankment for the whole length
    - Will be completed within the next few weeks
    - Working on obtaining materials for seeding

Photo 5. Stockpiled sand for final lift, access road and ditch (looking west)

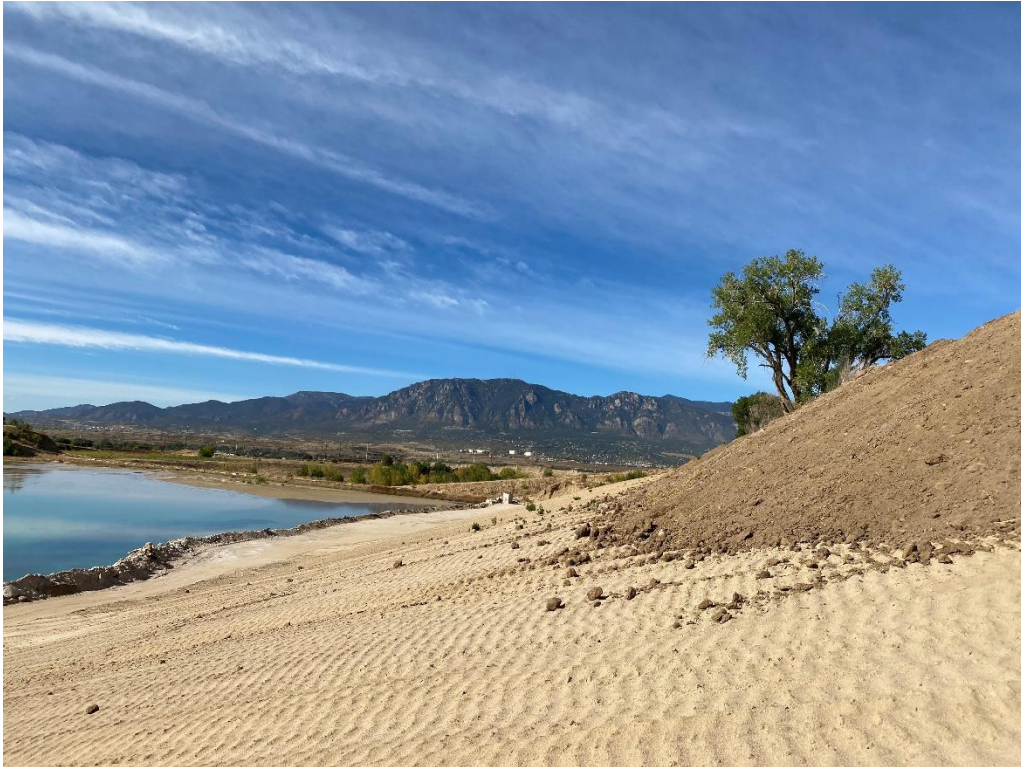
Photo 6. Stockpiled sand for final lift
