MINERALS PROGRAM INSPECTION REPORT
PHONE: (303) 866-3567

| MINE NAME: Loloff Mine | MINE/PROSPECTING ID#: M-1985-112 | MINERAL: Sand and gravel | COUNTY: Weld |
| INSPECTION TYPE: Surety Release Inspection | INSPECTOR(S): Peter Hays | INSP. DATE: October 6, 2021 | INSP. TIME: 10:00 |

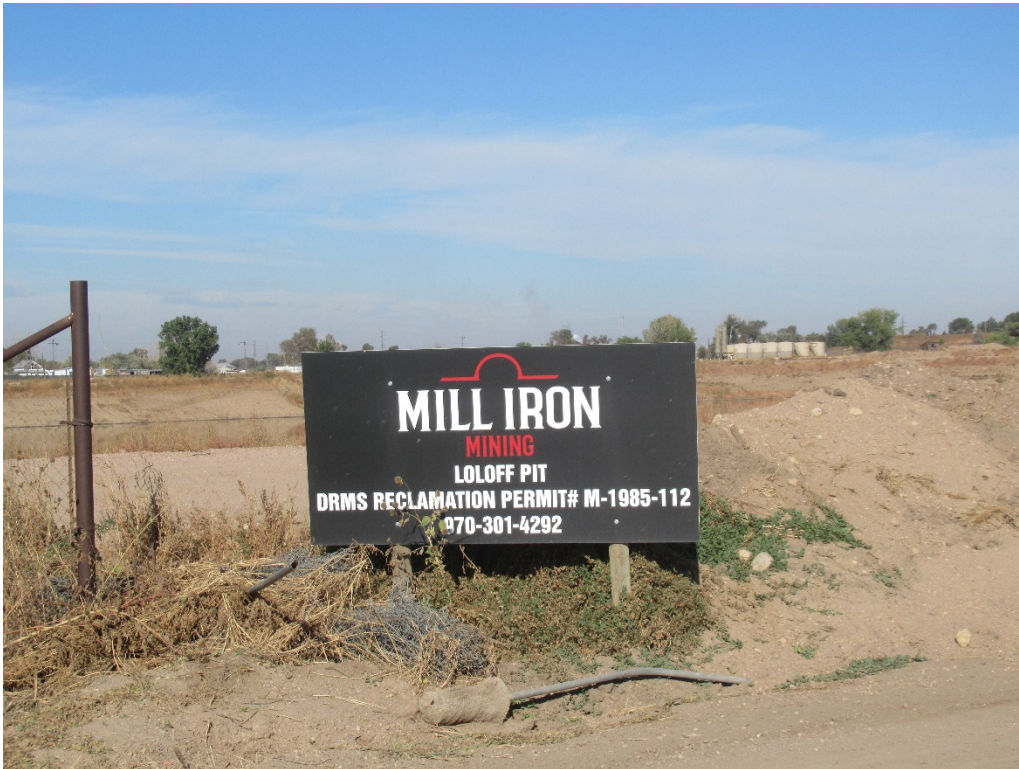
View of the Loloff Mine mine sign

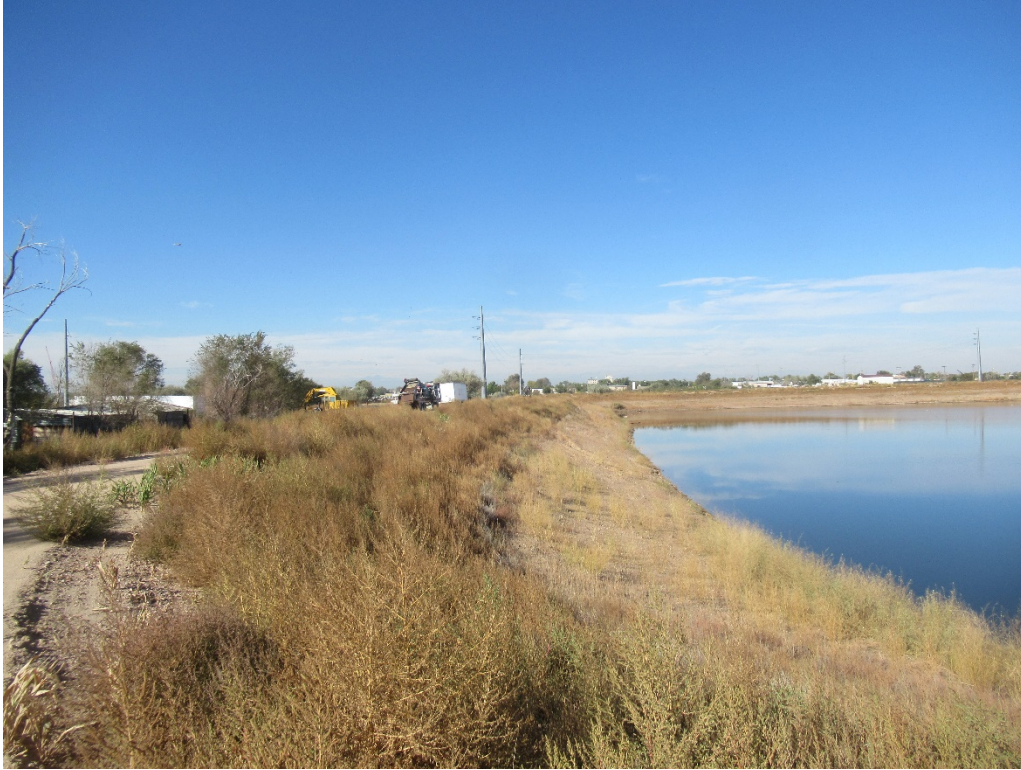
The approved Reclamation Plan seed mixture for the site contains the following species of native grasses; prairie sandreed, sand bluestem, sideoats grama, western wheatgrass, switchgrass and yellow indiagrass. The shoreline vegetation consisted of kochia with patches of sorghum, which the Operator planted as a cover crop. No evidence of the required reclamation grasses was observed during the inspection. The Division recommends the Operator controls the kochia and reseeds the shoreline with the approved seed mixture.

View of the south shoreline from the southeast corner of the reservoir looking west

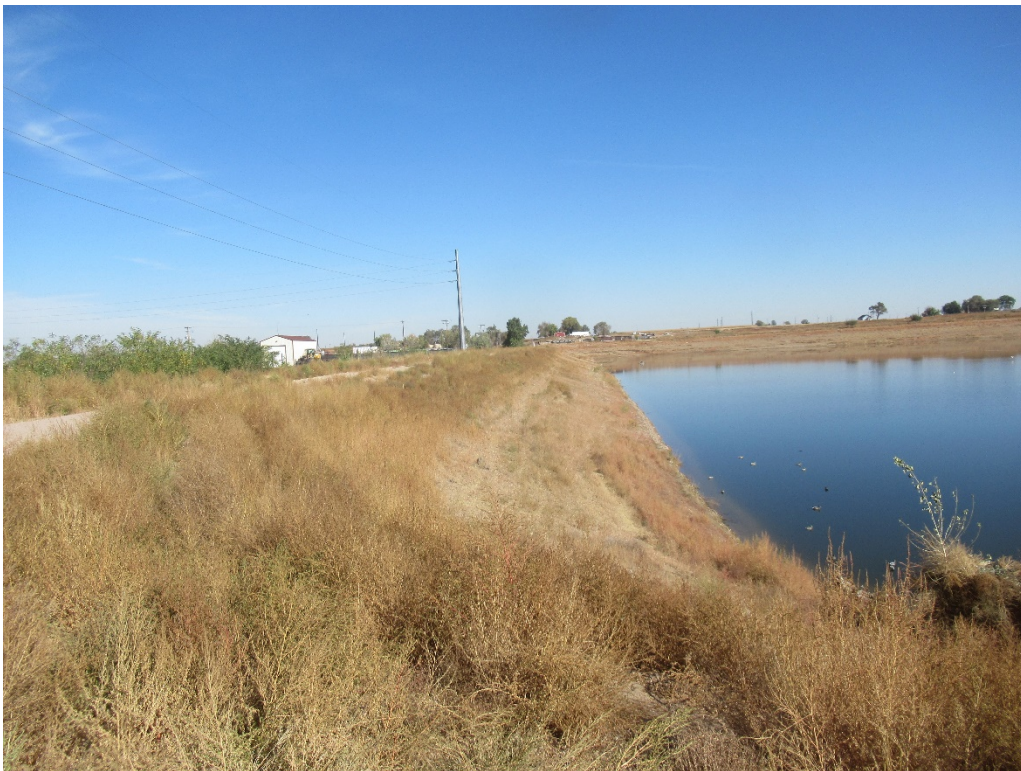
View of the west shoreline from the southwest corner of the reservoir looking north

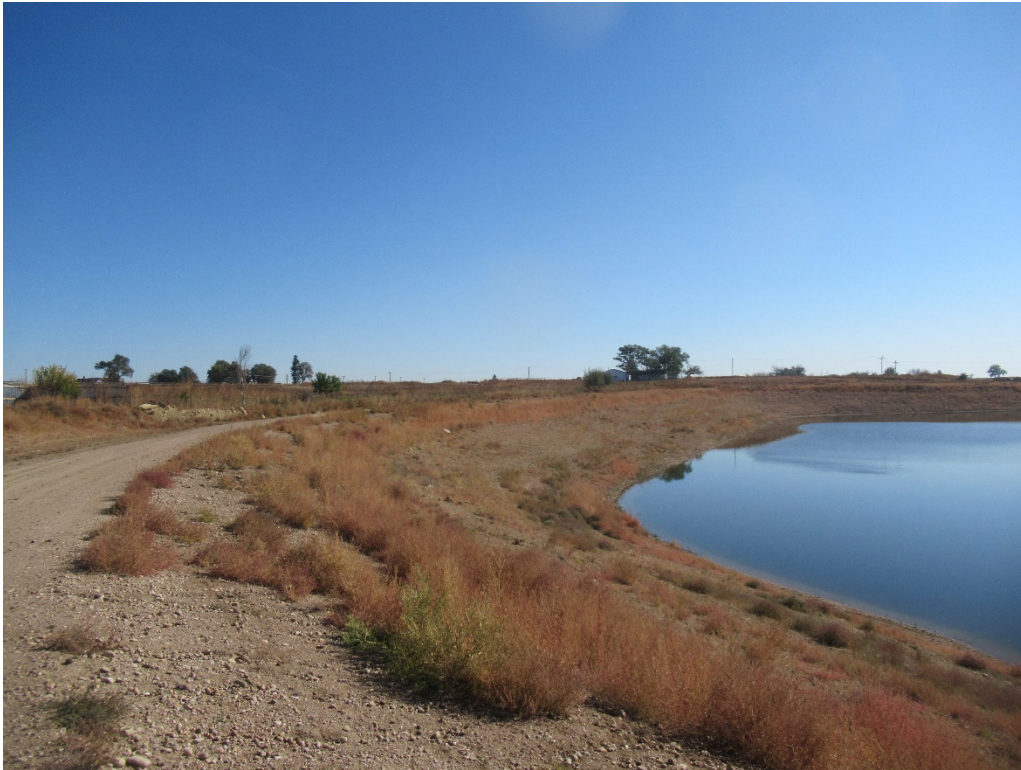
View of the north shoreline from the northwest corner of the reservoir looking east

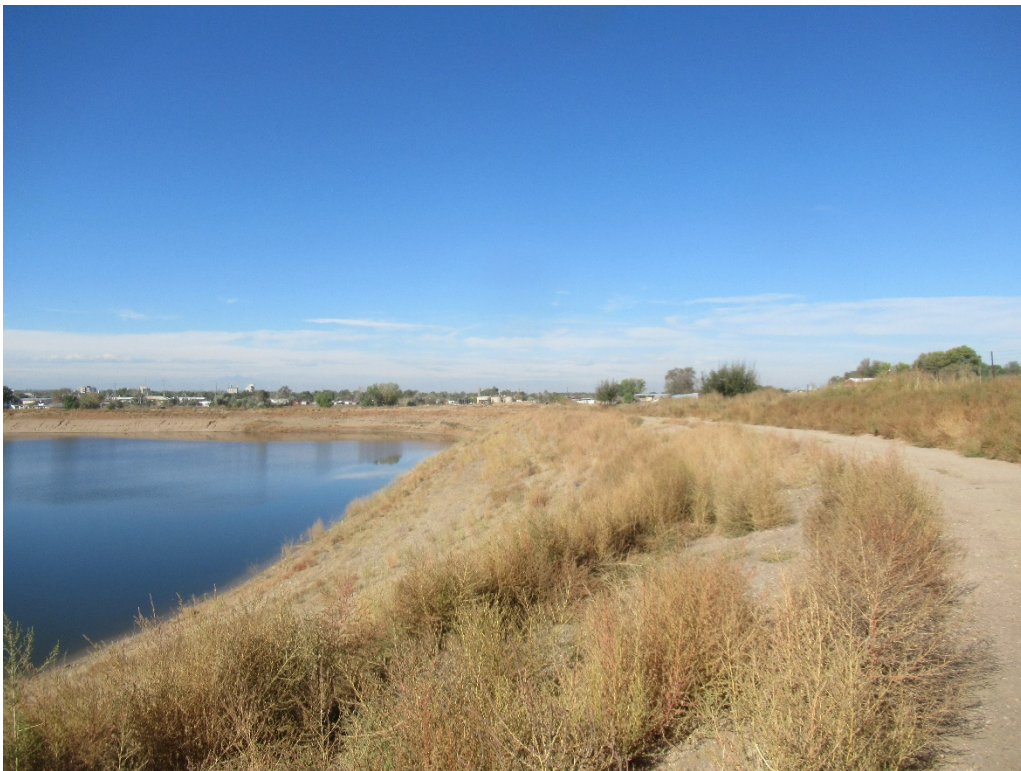
View of the north shoreline from the northeast corner of the reservoir looking west

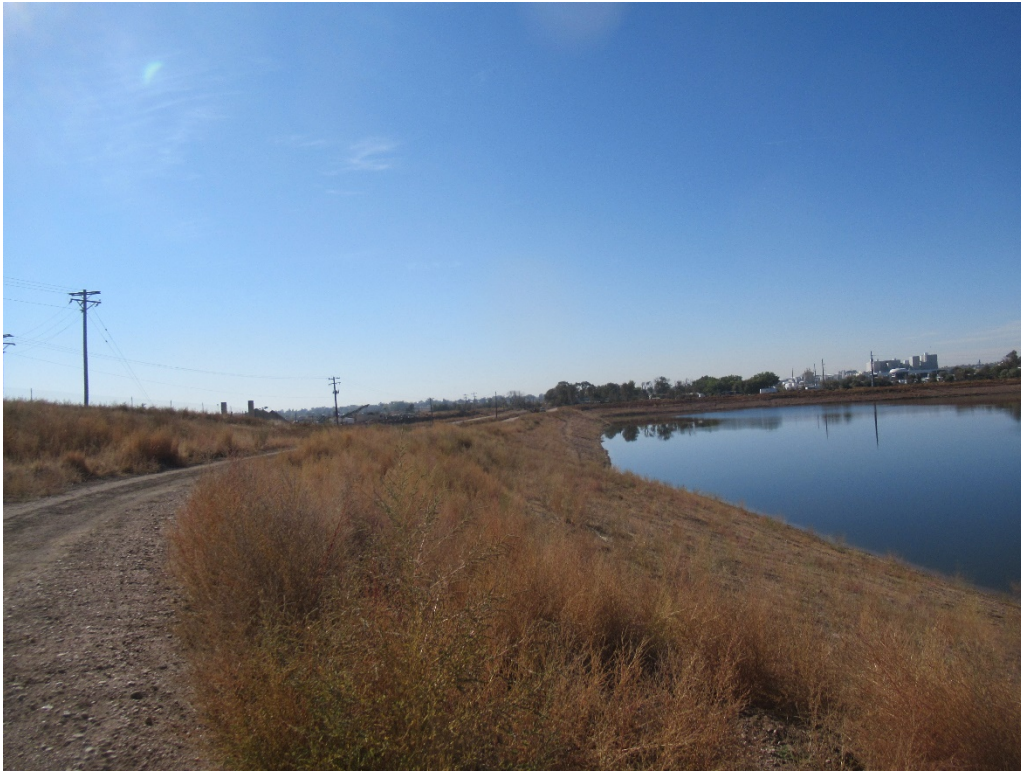
View of the east shoreline from the northeast corner of the reservoir looking south
