MINERALS PROGRAM INSPECTION REPORT
PHONE: (303) 866-3567

MINE NAME: Valco T Pit	MINE/PROSPECTING ID#: M-2004-043	MINERAL: Sand and gravel	COUNTY: Las Animas
INSPECTION TYPE: Monitoring	INSPECTOR(S): Jared Ebert	INSP. DATE: October 12, 2021	INSP. TIME: 14:30
OPERATOR: Larry and Christine Tortorice	OPERATOR REPRESENTATIVE: Larry and Christine Tortorice	TYPE OF OPERATION: 112c - Construction Regular Operation	
REASON FOR INSPECTION: Normal I&E Program	BOND CALCULATION TYPE: Partial Bond	BOND AMOUNT: \$48,000.00	
DATE OF COMPLAINT: NA	POST INSP. CONTACTS: None	JOINT INSP. AGENCY: None	
WEATHER: Raining	INSPECTOR'S SIGNATURE:

Valco T Pit, M-2004-043, October 12, 2021 Inspection

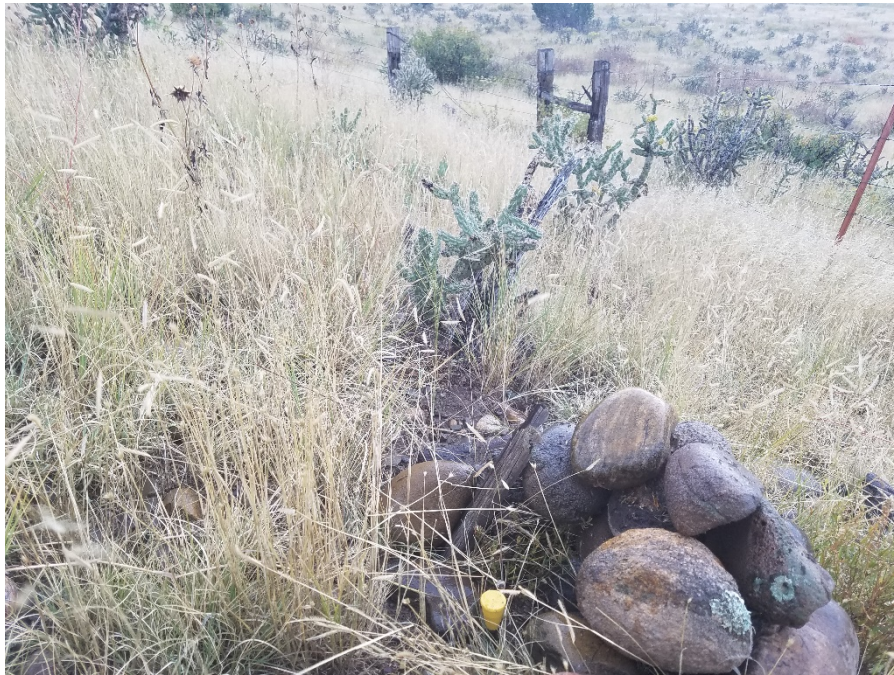
Mr. Tortorice showed me where each of the boundary markers were located at the site. A map with the Division's findings is enclosed. All of the boundary markers were marked with a survey pin and a T-post except for the southwest corner marker that Mr. Tortorice showed me. The southwest corner marker was marked with a T-Post only (See Map, Point #4). Using ArcOnline, the Division geo-referenced the approved permit boundary map. All of the markers appear to be correctly placed with the exception of the southwest corner marker. The southwest corner marker appears to be placed farther east than the approved location. I navigated to where the southwest corner marker should be located and I found a survey pin that is likely the location of the approved southwest corner (See Map, Point #5). I placed a pile of rocks adjacent to this survey marker. After the inspection I spoke to Mrs. Tortorice and informed them of the correct location of the southwest corner marker. She affirmed that they would place the southwest marker in the correct location. On October 18, 2021, the Operator provided documentation to me that they placed a new t-post in the correct location of the southwest corner marker.

Figure 1. The southwest survey marker.
