COLORADO
Division of Reclamation,
Mining and Safety
Department of Natural Resources

Permit Number: C-1981-041 Mine Name: Roadside Portals Operator: Snowcap Coal Company, Inc. Operator Address: MS Tonya Hammond P.O. Box 1430 Palisade, CO 81526	County: Mesa Operation Type: Underground Permit Status: Active Ownership: Private
	Operator Representative Present: Tonya Hammond
Operator Representative Signature: (Field Issuance Only)

Inspection Start Date: October 18, 2021 Inspection Start Time: 10:10 Inspection End Date: October 18, 2021 Inspection End Time: 10:46		Inspection Type: Coal Partial Inspection Inspection Reason: Normal I&E Program Weather: Clear	
Joint Inspection Agency: None		Joint Inspection Contacts: None	
Post Inspection Agency: None		Post Inspection Contacts: None	
Inspector(s): Clayton Wein	Inspector's Signature: <i>Clayton Wein</i>		Signature Date: 10/19/2021

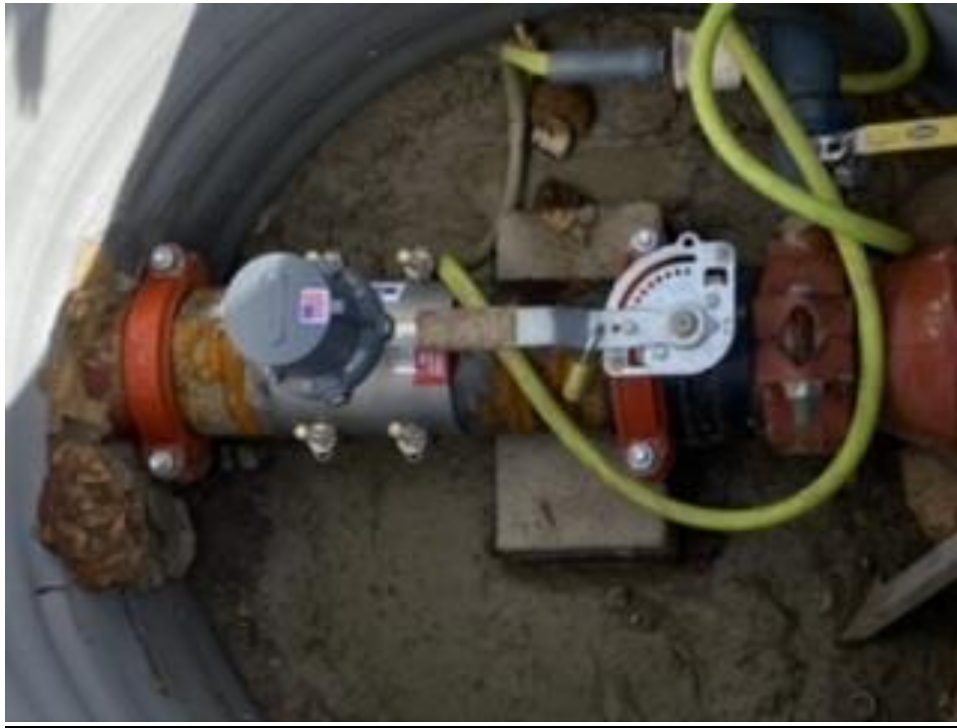
During the inspection the discharge monitoring location 016 was visited. A McMag2000 meter has been installed on the discharge pipe (Photo 1). The meter is currently fluctuating on its active readings. The operator's engineer is currently working with the meter manufacturer to resolve this issue. The current thought is that the pipe above and below the meter location is an 8 inch diameter. The location of the meter is a section of 6 inch diameter pipe. The change in pipe diameter may be causing turbidity resulting in the fluctuating readings. The operator will continue to pinpoint the cause of this issue and plans to replace any pipe or equipment as needed to ensure the location functions as designed. The totalizer reading was 112 gpm. This value is in within past readings which average 130 gpm.

Photo 1: The McGraw2000 meter at the 016 discharge location.

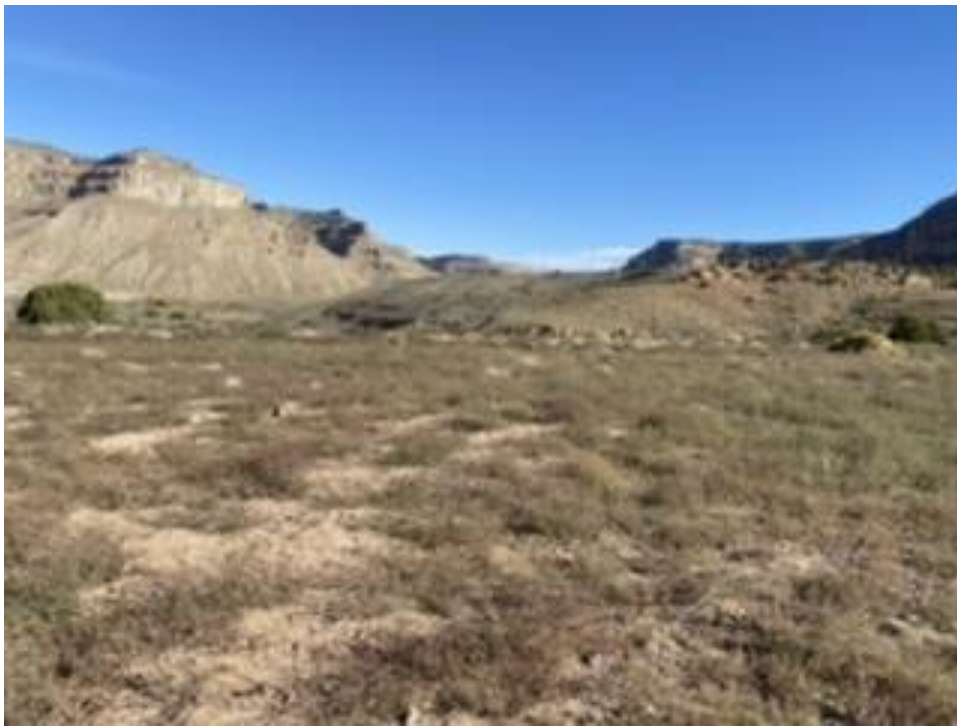
The remaining disturbed area within the Roadside Mine permit is the 0.4 acres associated with the TR-69 reclamation work. The site was marked by a mine ID sign and several t-posts delineating the disturbed boundary. The straw waddles were in good condition and no off site impacts were observed. The reclaimed site was stable with vegetative cover (Photos 2 and 3). There were no indications of surface settling. No erosional features were identified.

Photo 2: The northwestern portion of the TR-69 reclamation work.

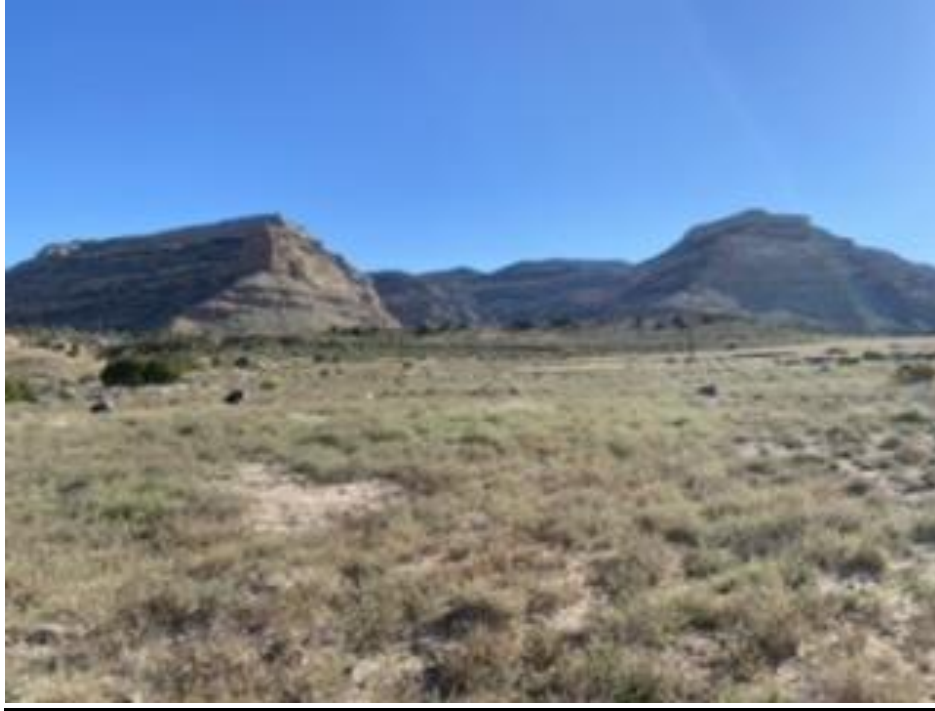
Photo 3: The northeastern portion of the TR-69 reclamation work.
