MINERALS PROGRAM INSPECTION REPORT
PHONE: (303) 866-3567

MINE NAME: Owl Canyon Quarry	MINE/PROSPECTING ID#: M-1977-302	MINERAL: Limestone (general)	COUNTY: Larimer
INSPECTION TYPE: Monitoring	INSPECTOR(S): Brock Bowles	INSP. DATE: September 29, 2021	INSP. TIME: 09:00
OPERATOR: Pete Lien & Sons, Inc.	OPERATOR REPRESENTATIVE: Dana Mellage	TYPE OF OPERATION: 112c - Construction Regular Operation	
REASON FOR INSPECTION: Normal I&E Program	BOND CALCULATION TYPE:	BOND AMOUNT: \$677,100.00	
DATE OF COMPLAINT: NA	POST INSP. CONTACTS: None	JOINT INSP. AGENCY: None	
WEATHER: Cloudy	INSPECTOR'S SIGNATURE:

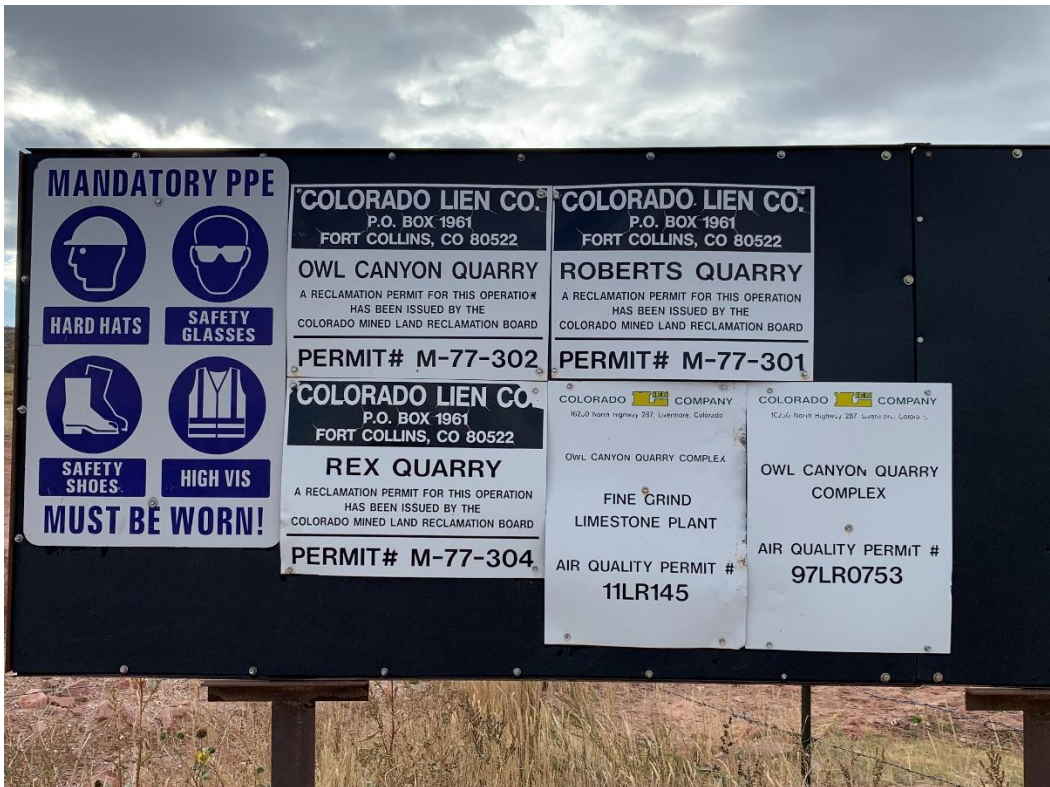
The mine entrance sign was in place facing Hwy 287 (photo 1).

Photo 1 – Mine entrance sign facing Hwy 287

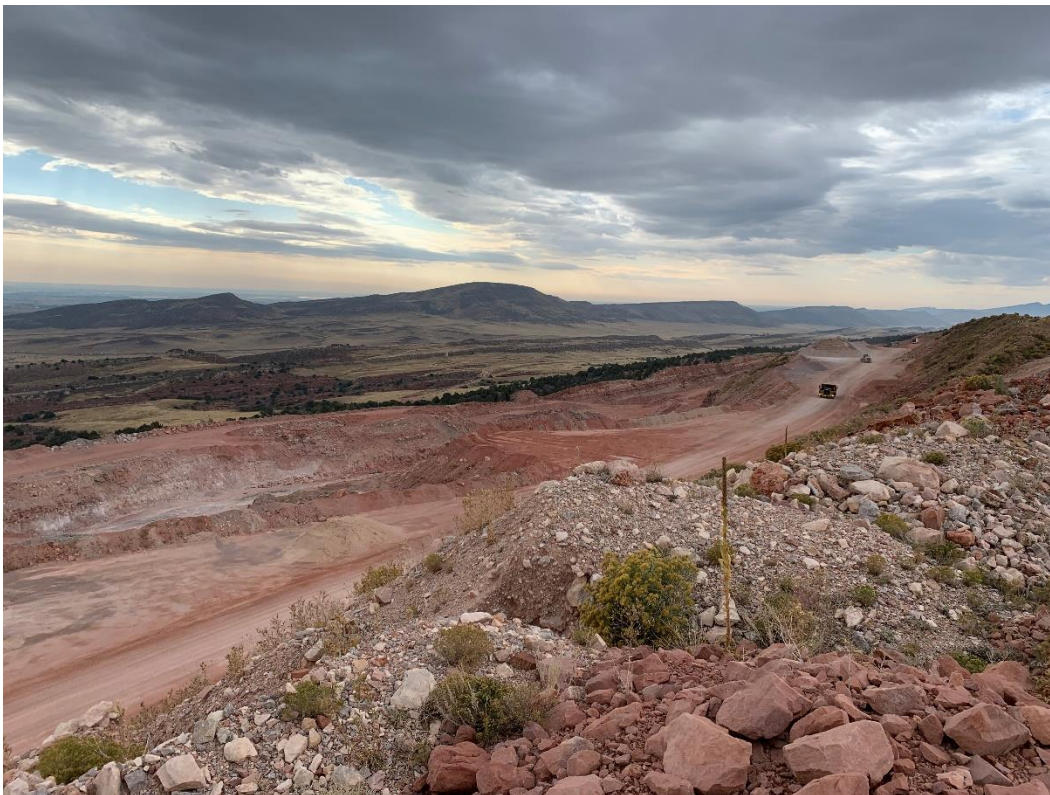
The active mining area was in the northern section of the permit area (photo 2). Mining progressed from west to east, downhill. A highwall on the eastern, downhill side of the mining area containing all runoff generated from the mining area. No standing water was seen any of the pit areas.

Photo 2 – Main mining area in northern section of permit area, facing southeast

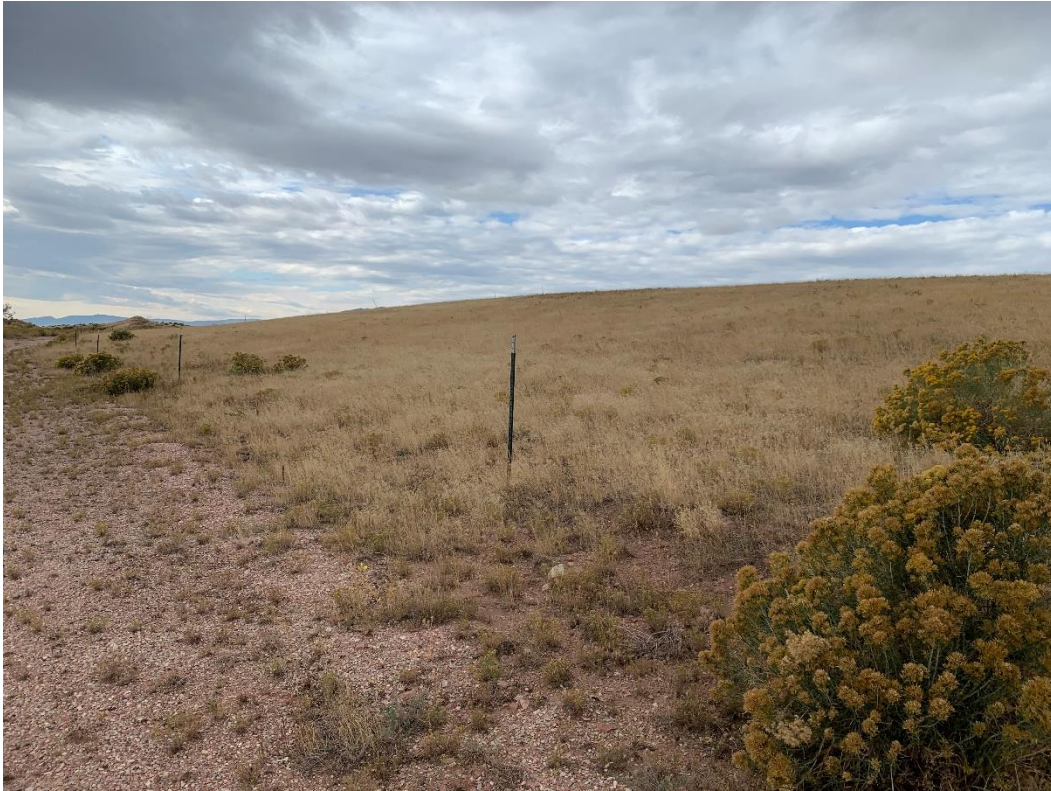
The overburden and topsoil piles were located west and above the mining area. The southern and western portions of the disturbed area have been reclaimed. The western reclaimed areas were marked with t-posts and the overburden piles were to the east of the t-posts (photo 3).

Photo 3 – Reclamation to the right of the t-posts, facing south

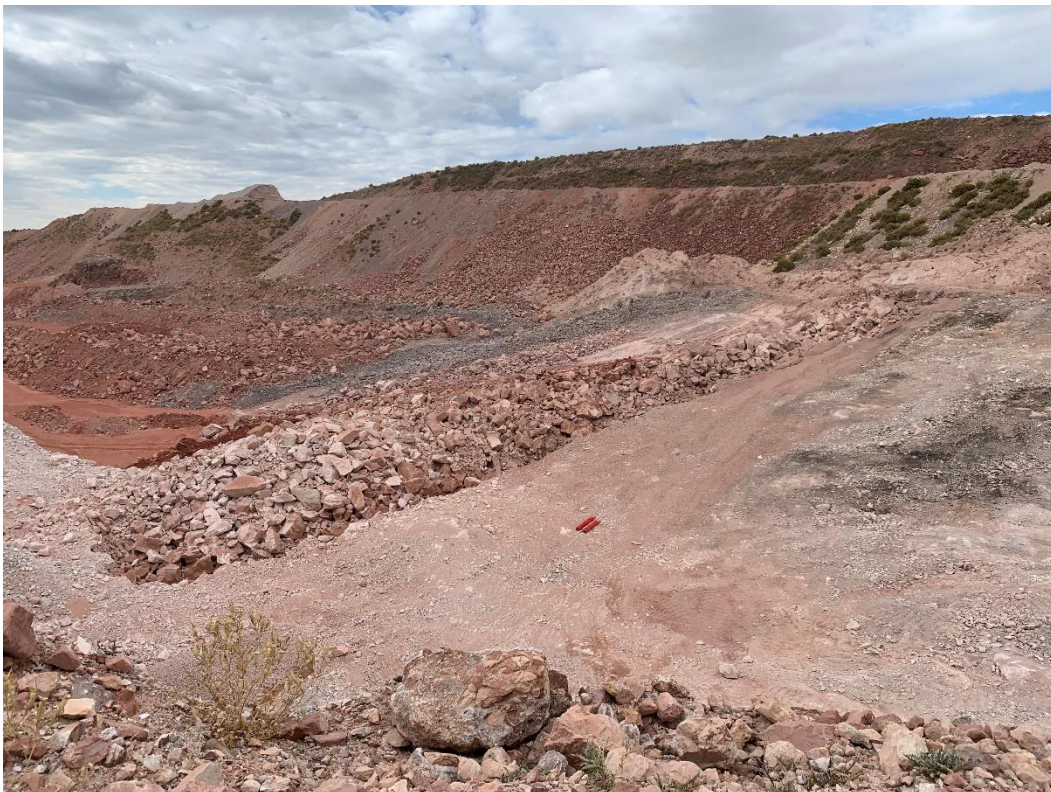
The last blast that took place was a couple of days prior to the inspection (photo 4). The blast logs were available for inspection in the main office.

Photo 4 – Rubblized material from last blast
