MINERALS PROGRAM INSPECTION REPORT
PHONE: (303) 866-3567

MINE NAME: Rex Quarry - Sec 36	MINE/PROSPECTING ID#: M-1977-304	MINERAL: Limestone (general)	COUNTY: Larimer
INSPECTION TYPE: Monitoring	INSPECTOR(S): Brock Bowles	INSP. DATE: September 29, 2021	INSP. TIME: 09:00
OPERATOR: Pete Lien & Sons, Inc.	OPERATOR REPRESENTATIVE: Dana Mellage	TYPE OF OPERATION: 112c - Construction Regular Operation	
REASON FOR INSPECTION: Normal I&E Program	BOND CALCULATION TYPE: Complete Bond	BOND AMOUNT: \$654,500.00	
DATE OF COMPLAINT: NA	POST INSP. CONTACTS: None	JOINT INSP. AGENCY: None	
WEATHER: Cloudy	INSPECTOR'S SIGNATURE:

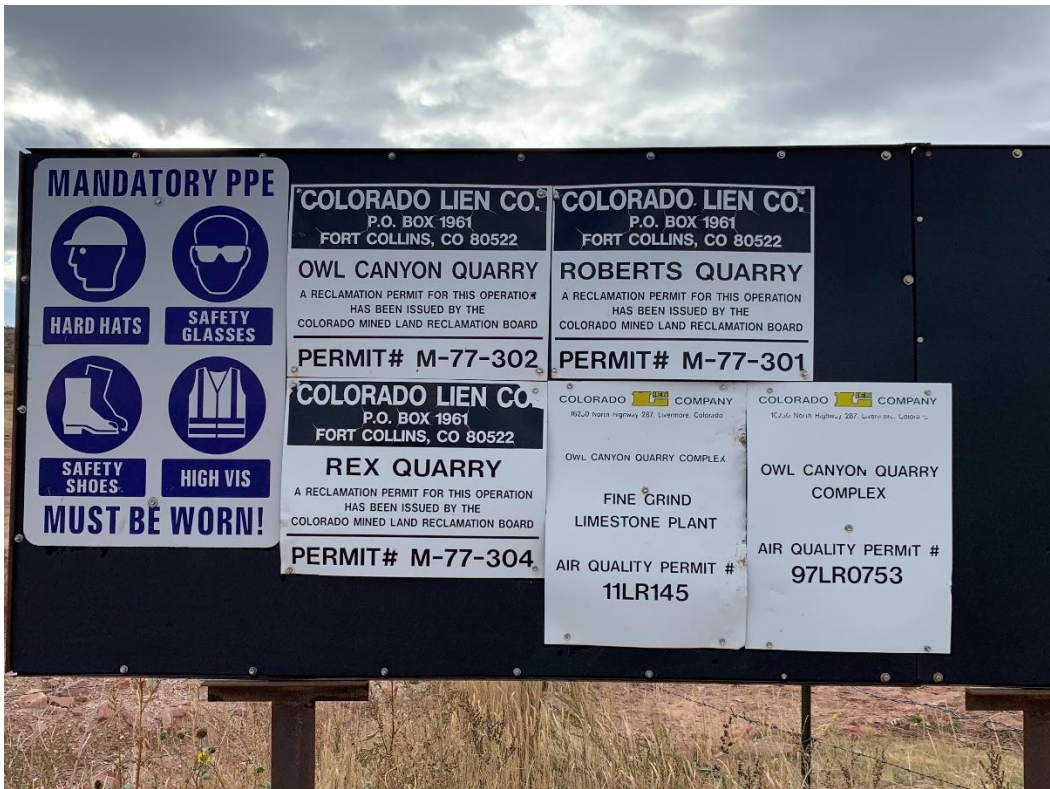
The mine entrance sign was in place facing Hwy 287 (photo 1).

Photo 1 – Mine entrance sign facing Hwy 287

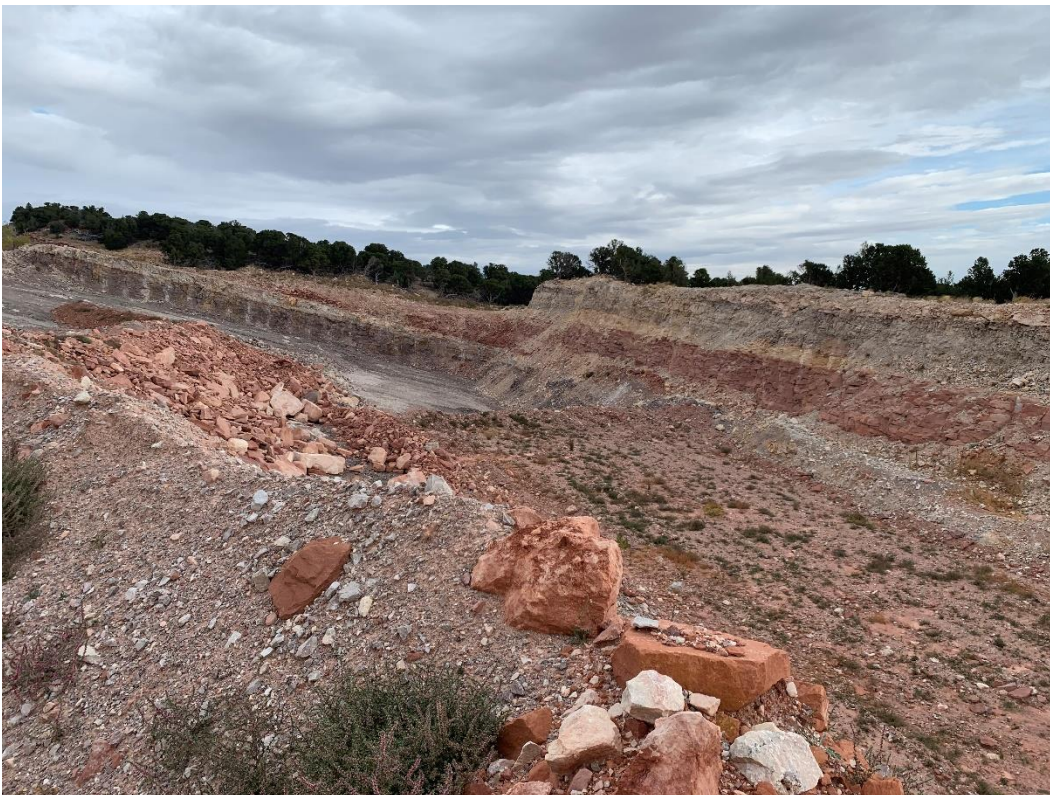
Most of the mining operations have shifted south the Owl Canyon permit area. No current mining activity was taking place in the Rex Quarry area. The highwall is along the eastern permit boundary (photo 2) and backfilling has begun on the southern section of the highwall (photo 3). No additional mining is anticipated to the north.

Photo 2 – Highwall, facing north, backfill in foreground

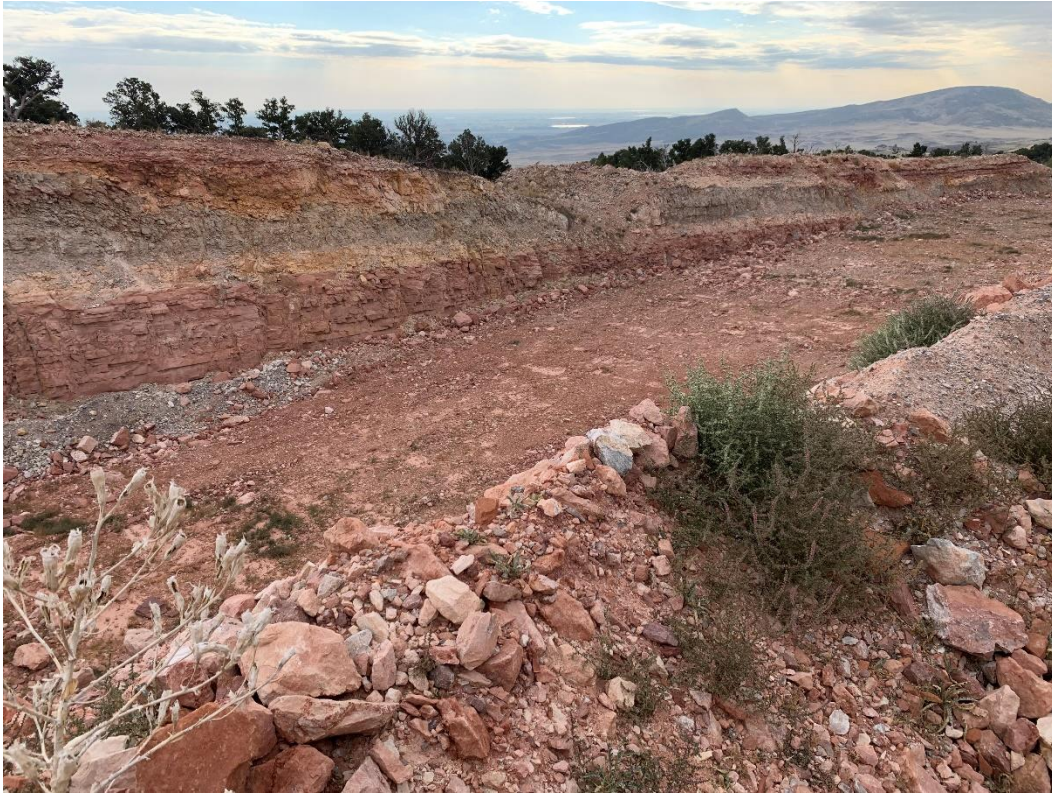
Photo 3 – Highwall, facing south, backfilling has begun

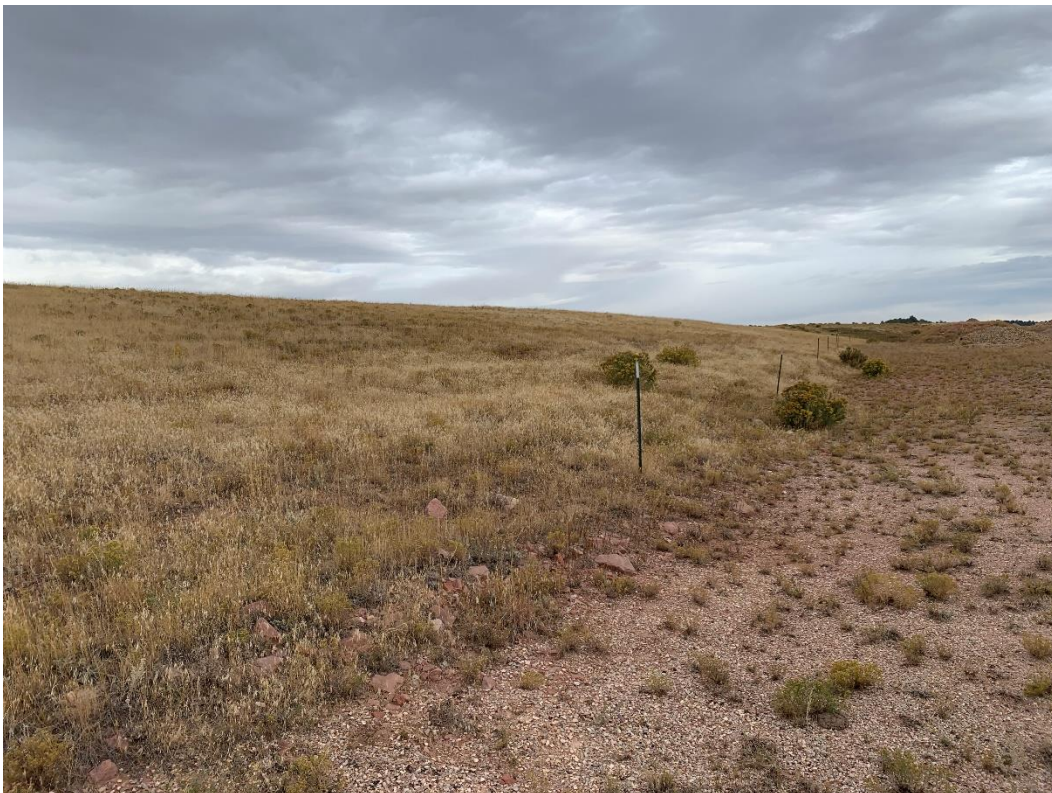
The western sections of the mined area have been reclaimed (photo 4). These areas have been backfilled, topsoiled and seeded. They were well vegetated with grasses and shrubs. No erosion features were seen.

Photo 4 – Reclaimed western section, facing north
