MINERALS PROGRAM INSPECTION REPORT
PHONE: (303) 866-3567

MINE NAME: Velarde Pit	MINE/PROSPECTING ID#: M-2002-118	MINERAL: Sand and gravel	COUNTY: Huerfano
INSPECTION TYPE: Surety-Related Inspection	INSPECTOR(S): Patrick Lennberg	INSP. DATE: October 12, 2021	INSP. TIME: 08:30
OPERATOR: APC Southern Construction Co., LLC	OPERATOR REPRESENTATIVE: None	TYPE OF OPERATION: 112c - Construction Regular Operation	
REASON FOR INSPECTION: Surety Related	BOND CALCULATION TYPE: Complete Bond	BOND AMOUNT: \$121,600.00	
DATE OF COMPLAINT: NA	POST INSP. CONTACTS: None	JOINT INSP. AGENCY: None	
WEATHER: Clear	INSPECTOR'S SIGNATURE:

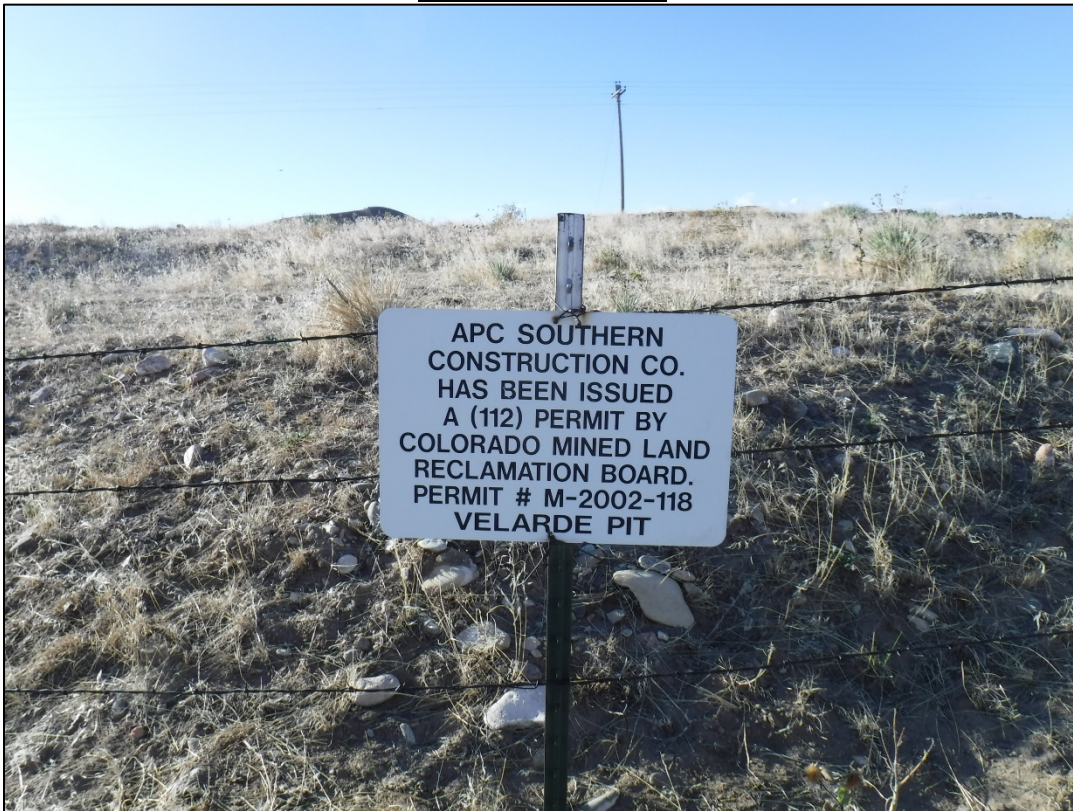
The Velarde Pit is located approximately 12.5 miles north of Walsenburg, Colorado. The site is 112c permitted for 300 total acres with 30 acres maximum allowed disturbance divided into three phases. It has an approved affected area of 149 acres at one time. The approved post-mining land use is rangeland. A mine sign was observed as required by Rule 3.1.12.

Photo 1: Mine sign at entrance

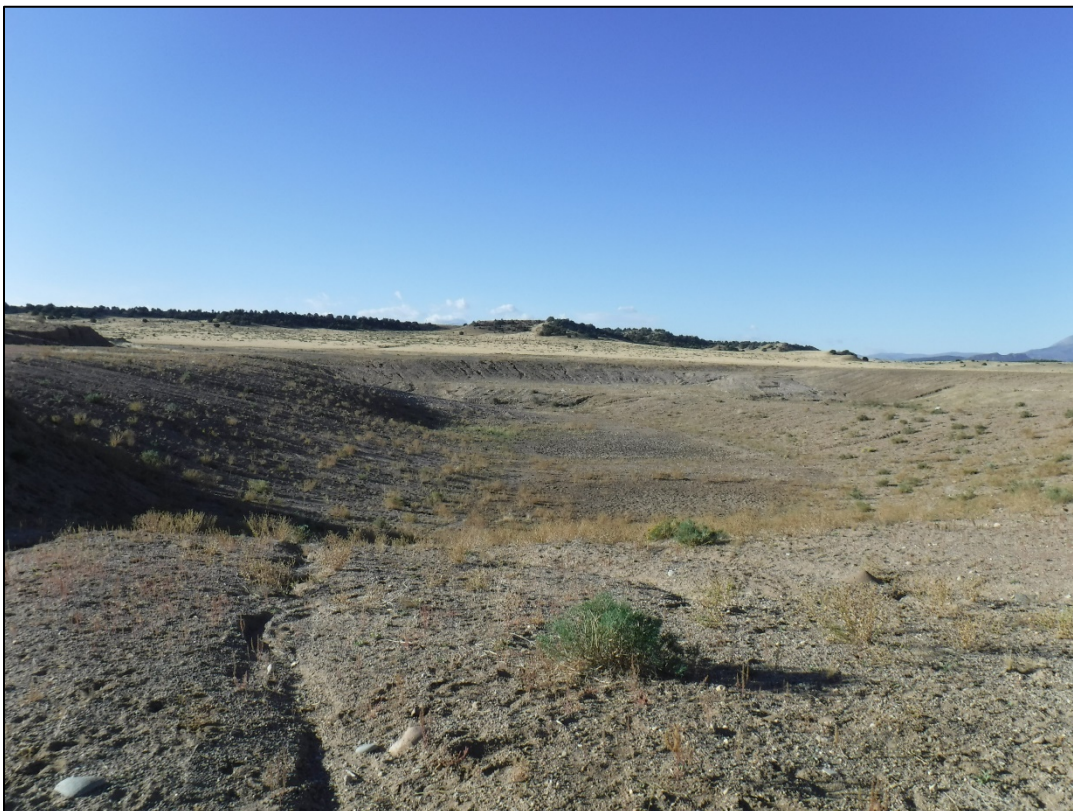
Photo 2: Looking south across pit area

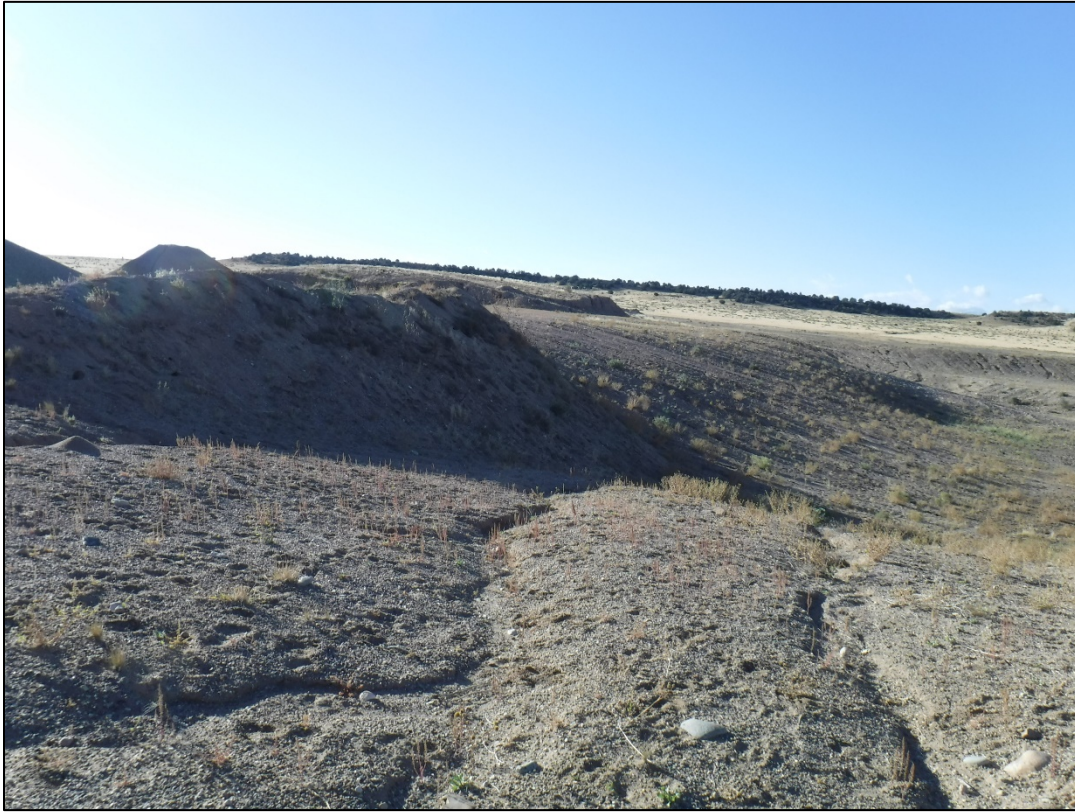
Photo 3: Looking south along eastern wall of pit area

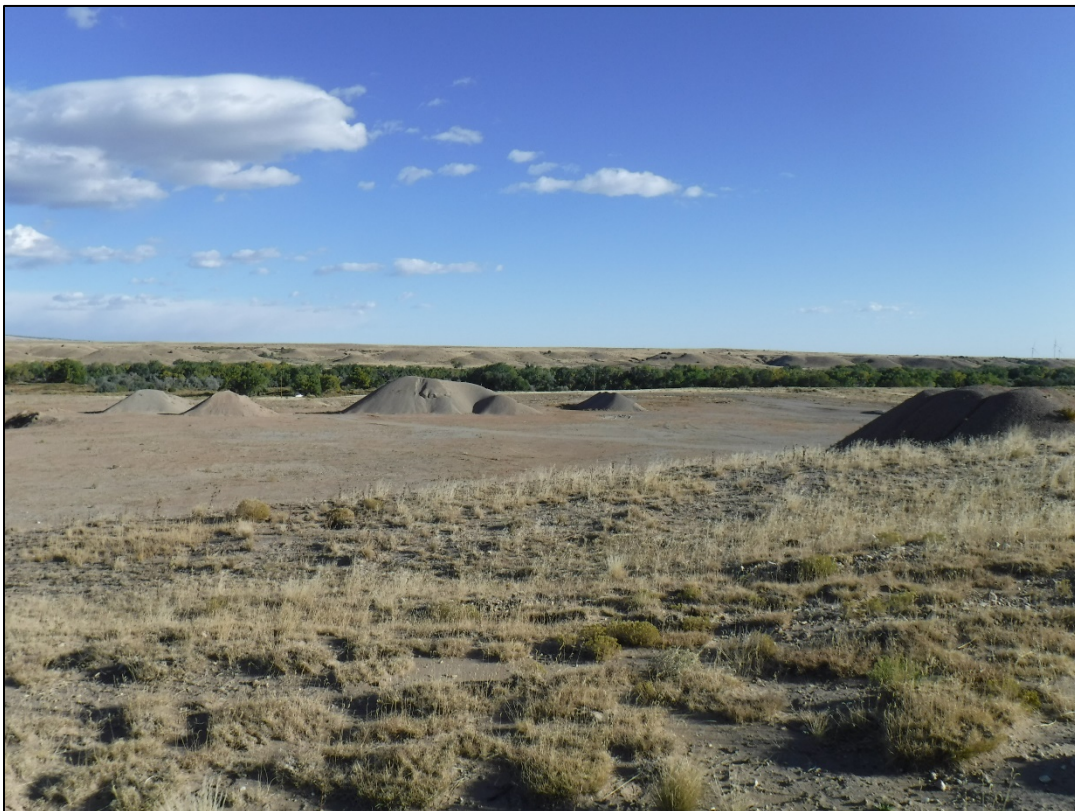
All current mining activity is contained within Phase 1 of the site and is progressing from the east to west. No processing facilities were observed but there were a few processed material stockpiles and recycled asphalt stockpiles located in the northeastern quadrant of Phase 1. Topsoil stockpile appears stable with some vegetation growing. The pit area was measured to be 8.9 acres and has near vertical highwalls along with other portions of the pit graded between 2H:1V to 3H:1V. Some rilling of the side slopes was observed but everything is contained within the pit. As mining proceeds from east to west the mined out areas are backfilled and graded. At this time it does not appear that any topsoil has been placed on the reclaimed areas. No groundwater was observed during the inspection.

Photo 4: Various product stockpiles, looking north from the top of the topsoil stockpile

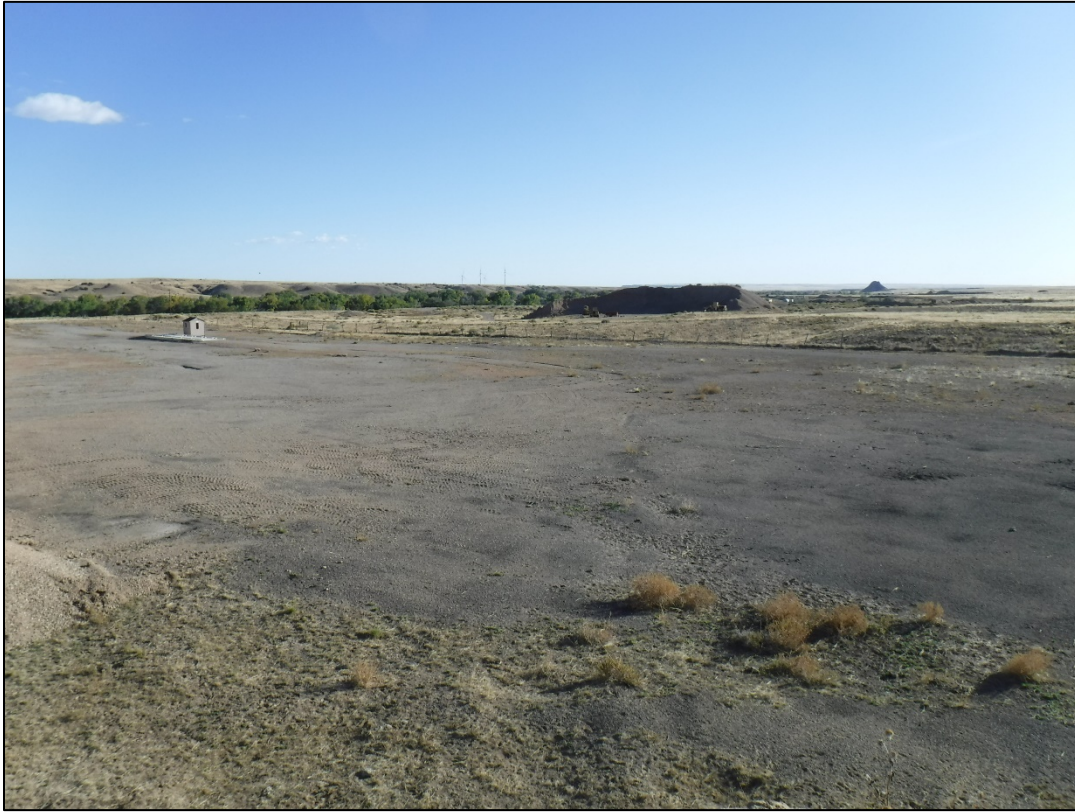
A portable scale house facility was located along the eastern portion of site. The affected area appears to be near the 30 acres maximum allowed.

Photo 5: Scale house and area along the eastern portion of the 30 acre affected area

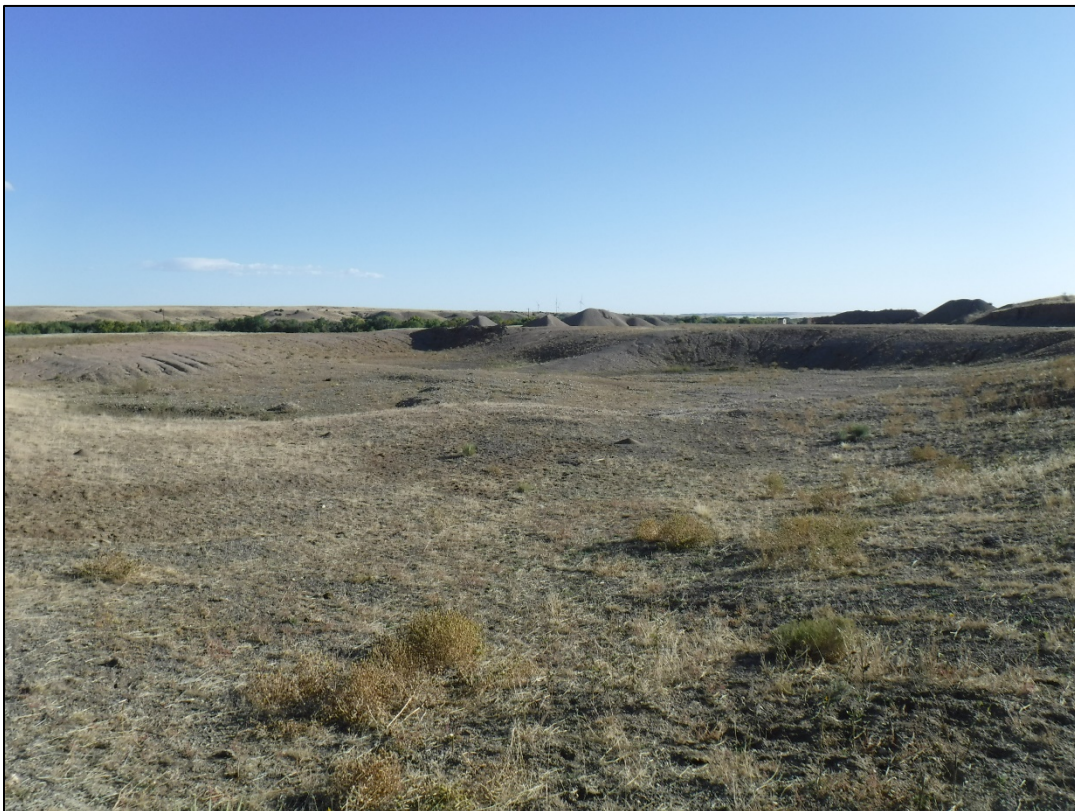
Photo 6: Looking northeast across the pit area

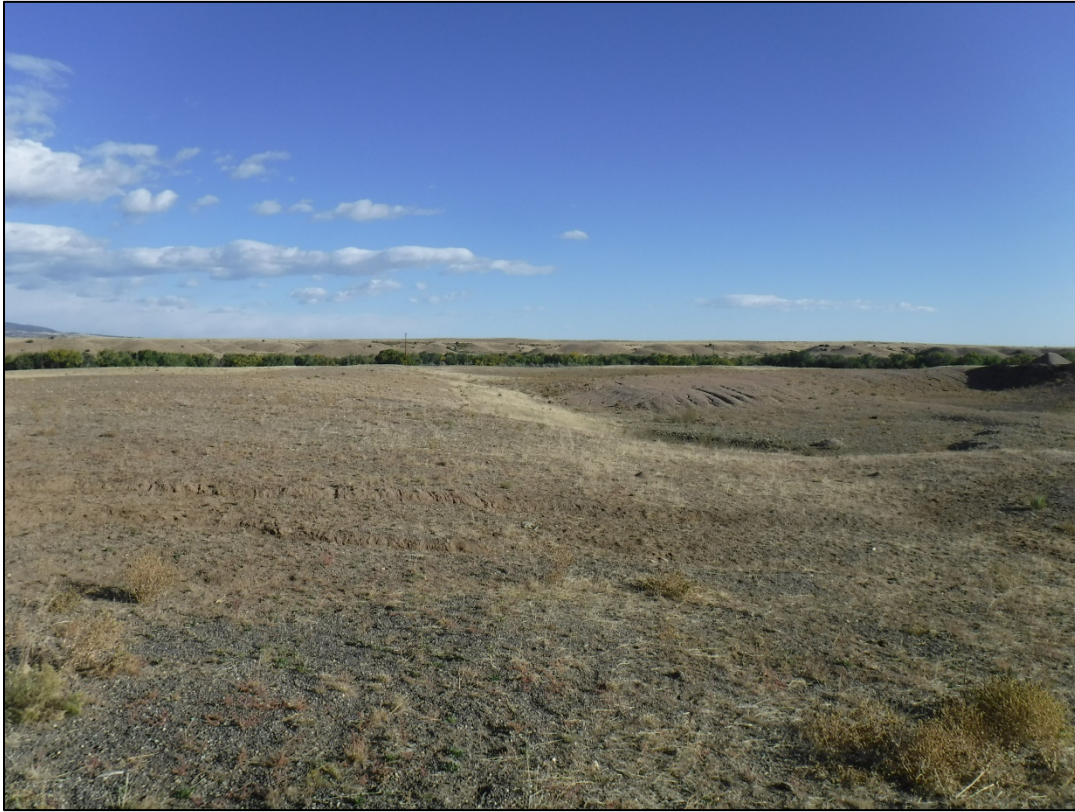
Photo 7: Looking north along the western pit area boundary

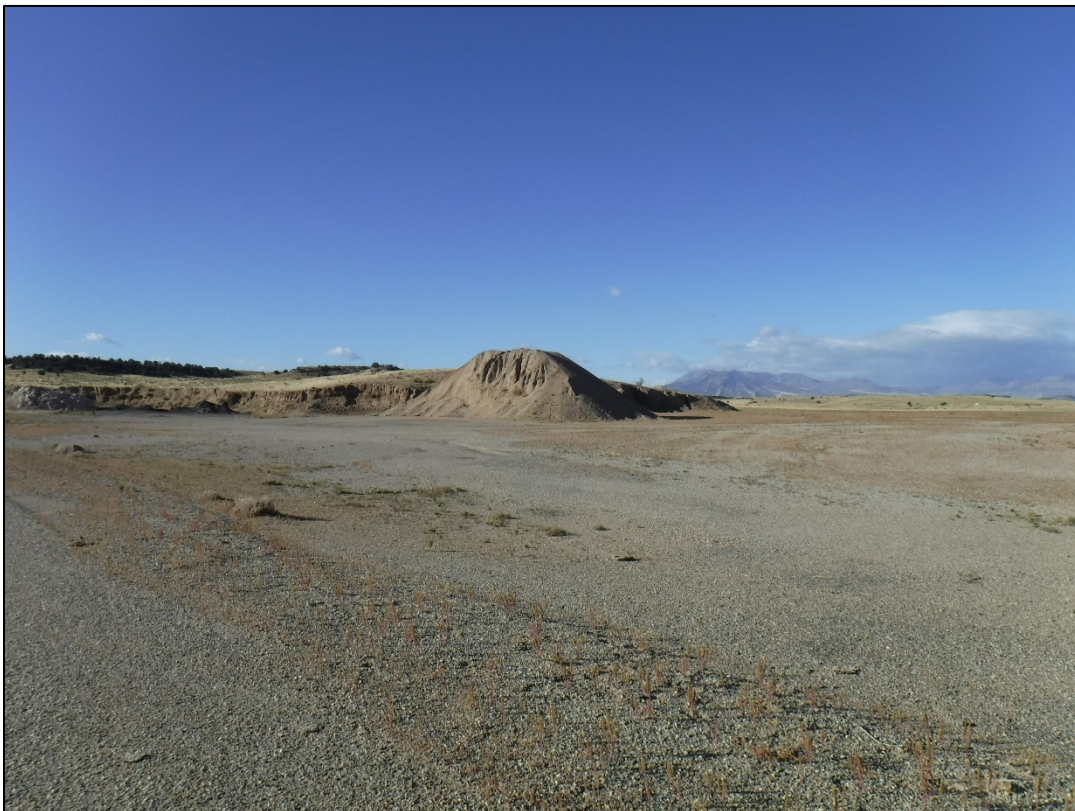
Photo 8: Topsoil stockpile
