MINERALS PROGRAM INSPECTION REPORT
PHONE: (303) 866-3567

MINE NAME: Franciscotti Pit #2	MINE/PROSPECTING ID#: M-2018-058	MINERAL: Sand and gravel	COUNTY: Huerfano
INSPECTION TYPE: Surety-Related Inspection	INSPECTOR(S): Patrick Lennberg	INSP. DATE: October 12, 2021	INSP. TIME: 09:30
OPERATOR: APC Southern Construction Co., LLC	OPERATOR REPRESENTATIVE: None	TYPE OF OPERATION: 112c - Construction Regular Operation	
REASON FOR INSPECTION: Surety Related	BOND CALCULATION TYPE: Complete Bond	BOND AMOUNT: \$343,600.00	
DATE OF COMPLAINT: NA	POST INSP. CONTACTS: None	JOINT INSP. AGENCY: None	
WEATHER: Clear	INSPECTOR'S SIGNATURE:

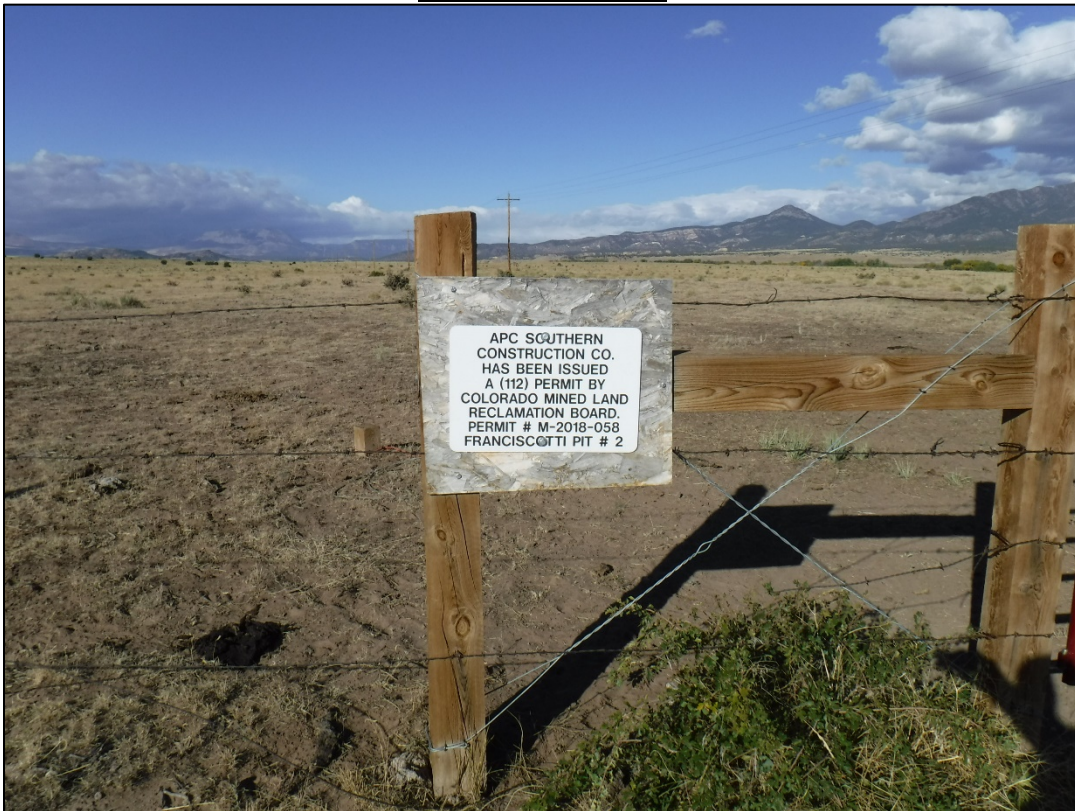
The entrance to the 112c 329.9 acre mine is from the eastside of the permit boundary via County Road 613 approximately 2 miles from the intersection of County Road 611 and State Highway 69 which is 7.5 miles northwest from Farista just north of Walsenburg, CO. A mine sign has been posted at the mine entrance pursuant to Rule 3.1.12.

Photo 1: Mine sign at mine entrance location

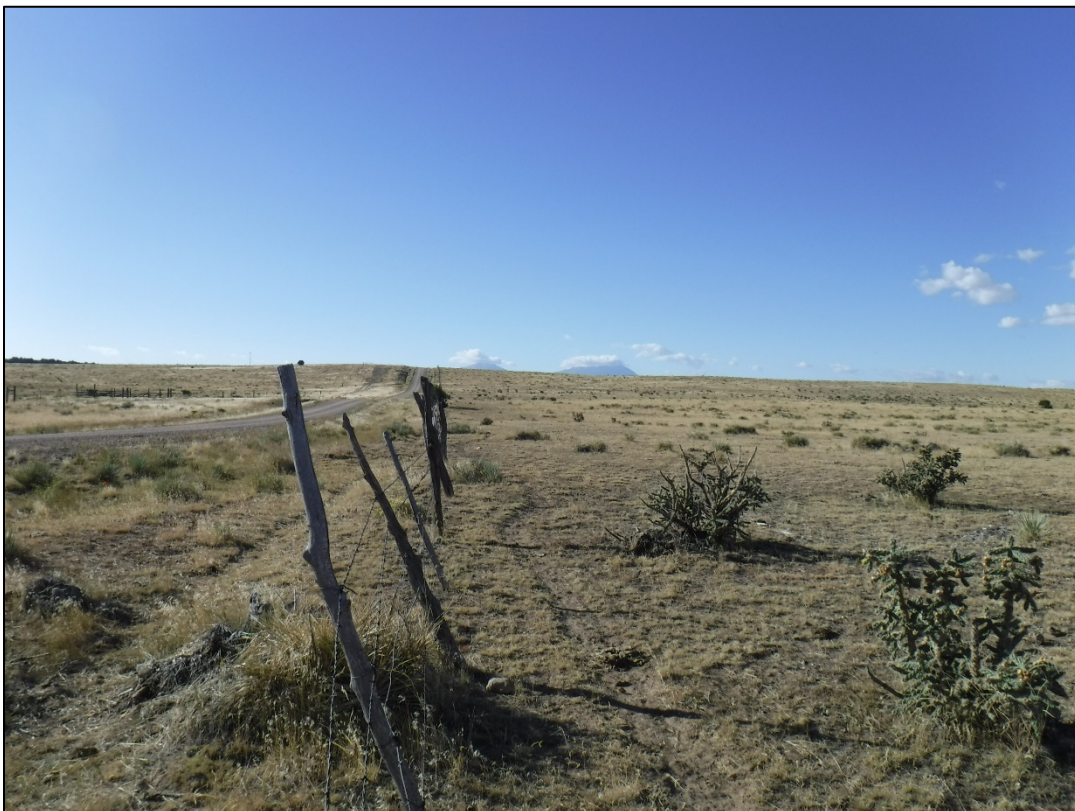
The mine has not begun operation yet. Some of permit boundary markers were visible from the road and the area is surrounded by a barbed wire fence.

Photo 2: Looking south along the eastern boundary of the permit

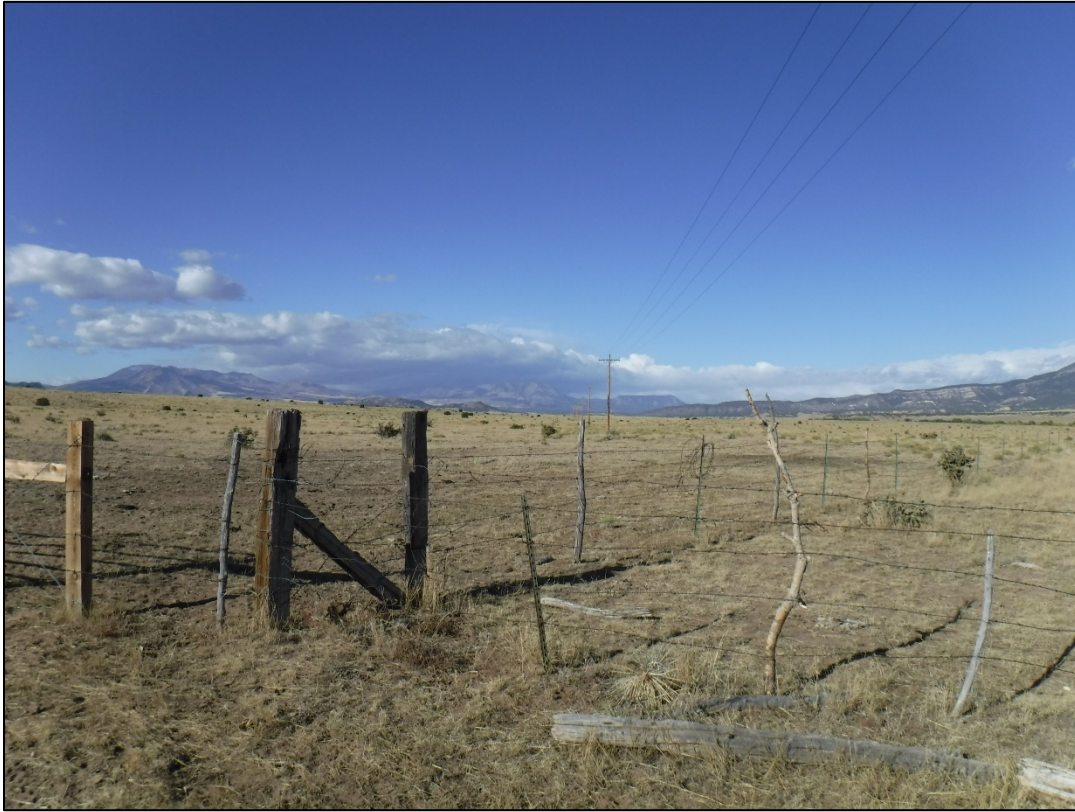
Photo 3: Looking west across the permit in line with the power poles

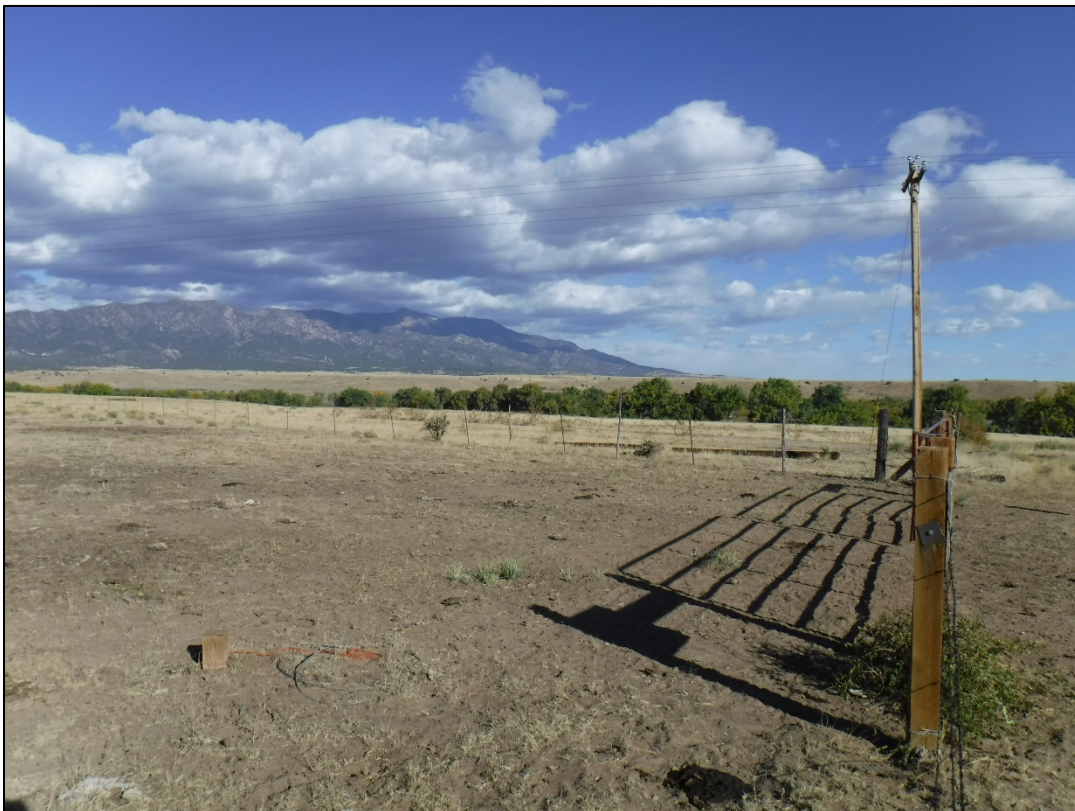
Photo 2: Looking north along the eastern boundary of the permit
