Ouray Silver Mines, Inc.  
1900 Main St. Unit 1  
PO Box 564  
Ouray, CO 81427

**Subject: Documentation of Corrective Action for Loss of Containment  
DRMS Permit No. M-2012-032  
Revenue Mine, Ouray County, Colorado**

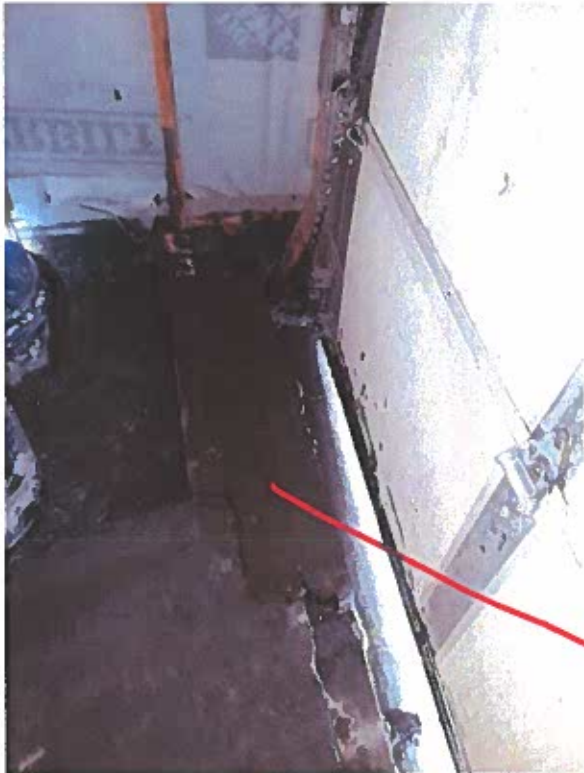
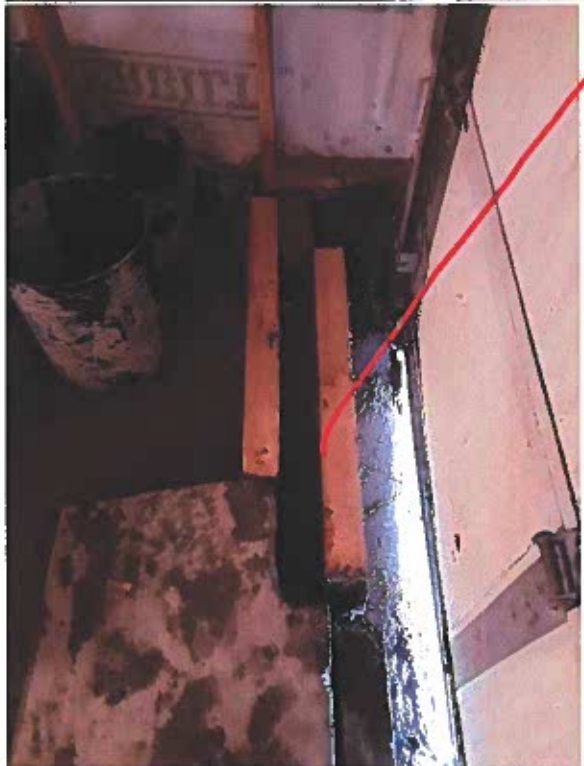
Photos of concrete curb repairs made on October 19, 2021. Curb is now fully repaired.

- Repair broken concrete curb. A temporary repair to the concrete curb was made on October 13, 2021, which involved placing sandbags in the broken area to complete containment. A permanent concrete curb was poured on October 19, 2021 to permanently repair the broken curb (see attached photos showing repaired curb).
