MINERALS PROGRAM INSPECTION REPORT

MINE NAME: Ranch Land Rock Pit #1	MINE/PROSPECTING ID#: M-2002-096	MINERAL: Sandstone (silica, stone, quartzite), limestone (general) and sand and gravel	COUNTY: Fremont
INSPECTION TYPE: Monitoring	INSPECTOR(S): Timothy Cazier, P.E.	INSP. DATE: August 19, 2021	INSP. TIME: 11:15
OPERATOR: Holcim (US) Inc.	OPERATOR REPRESENTATIVE: Tom Newman	TYPE OF OPERATION: 112c - Construction Regular Operation	
REASON FOR INSPECTION: Normal I&E Program	BOND CALCULATION TYPE: Partial Bond	BOND AMOUNT: \$43,500.00	
DATE OF COMPLAINT: NA	POST INSP. CONTACTS: None	JOINT INSP. AGENCY: None	
WEATHER: Clear	INSPECTOR'S SIGNATURE:

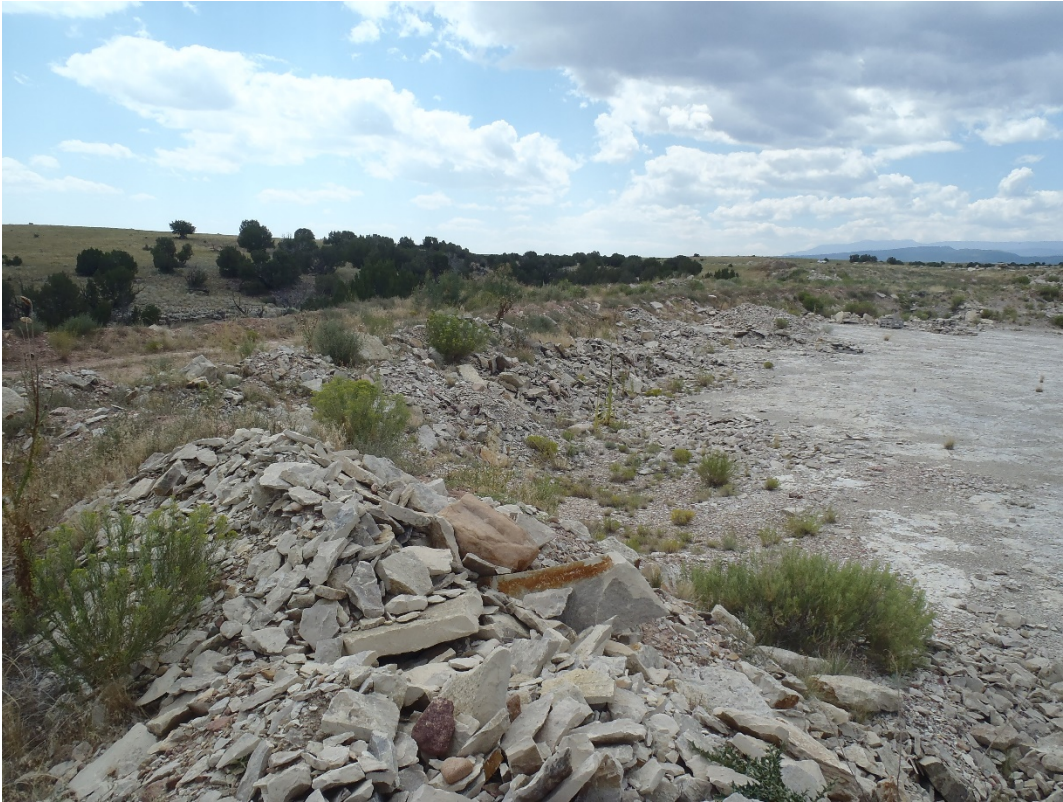
Backfilling and Grading: Sufficient backfill material (overburden) appeared to be available (see **Photo 1**).

Topsoil: Based on the Application's soil survey, the area mined to date is part of the Penrose series having an A horizon of zero to four inches. As such, there is no real difference between topsoil and overburden. All are stockpiled on the perimeter of the pit (see **Photo 1**).

Photo 1. Overburden/topsoil stockpile on east side of pit (looking SSE).

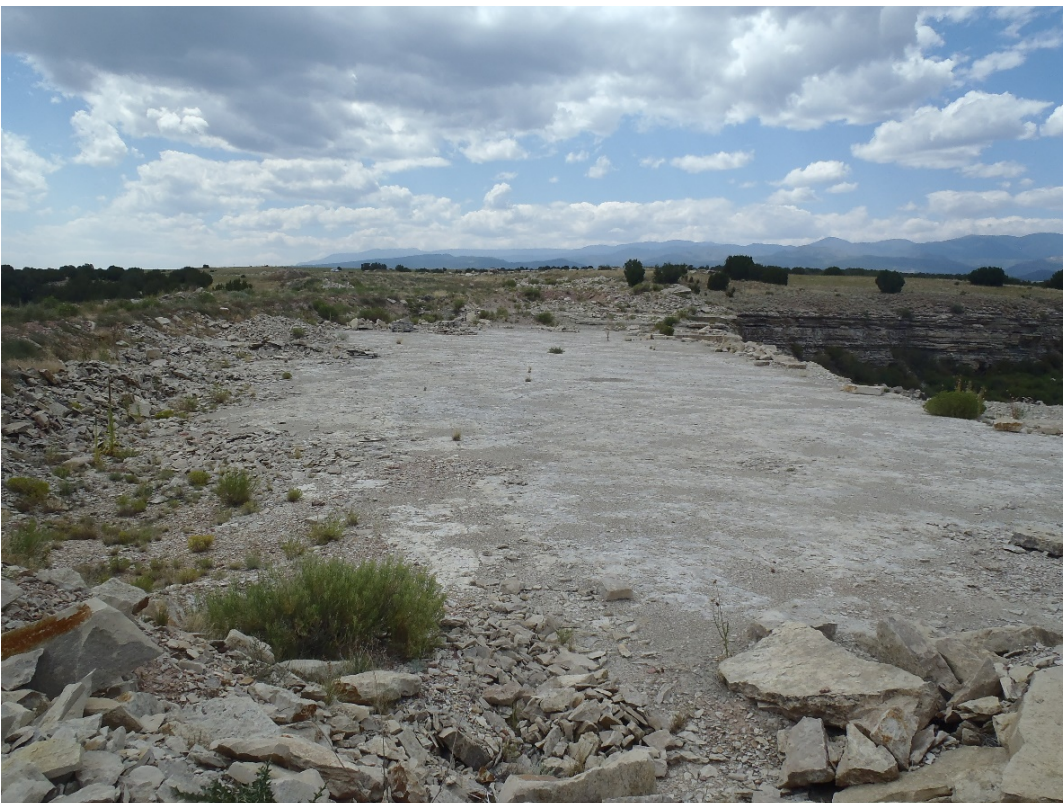
Photo 2. Active pit area (looking south).

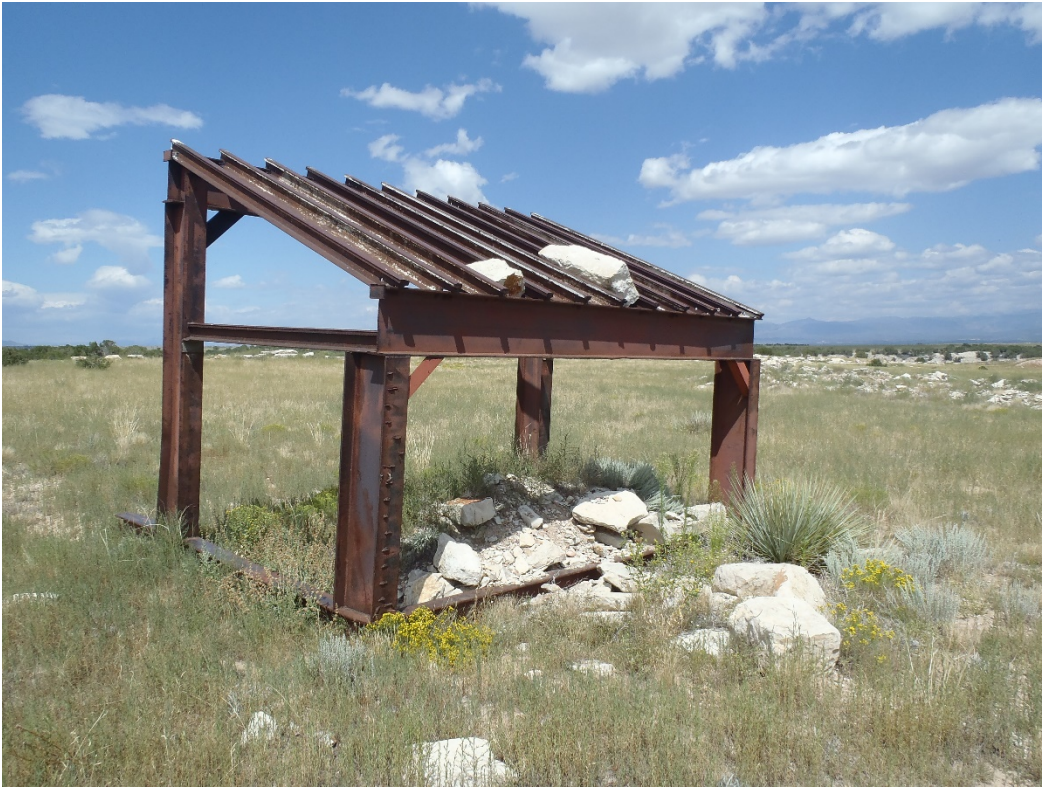
Support Facilities On-site: Only a large grizzly screen was observed (see **Photo 3**).

Photo 3. Large grizzly screen (staging area, looking NW).

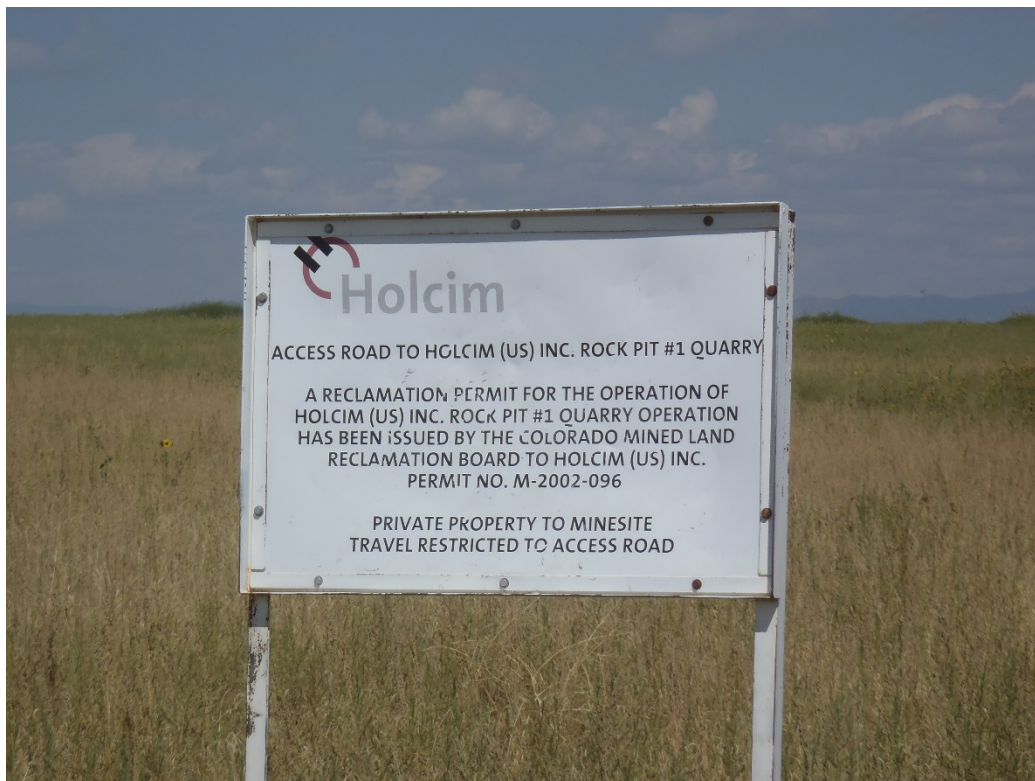
Signs and Markers: A permit sign was properly posted at both the south (see **Photo 4**) and north entrances (see **Photo 5**). The area mined to date is in Phase 1 which is bounded by ravines on the west, north and east sides (well within the Phase 1 boundary. To the south of Phase 1 is the permitted staging area where no mining is proposed.

Photo 4. Permit sign (south entrance off Hwy 96, looking north).

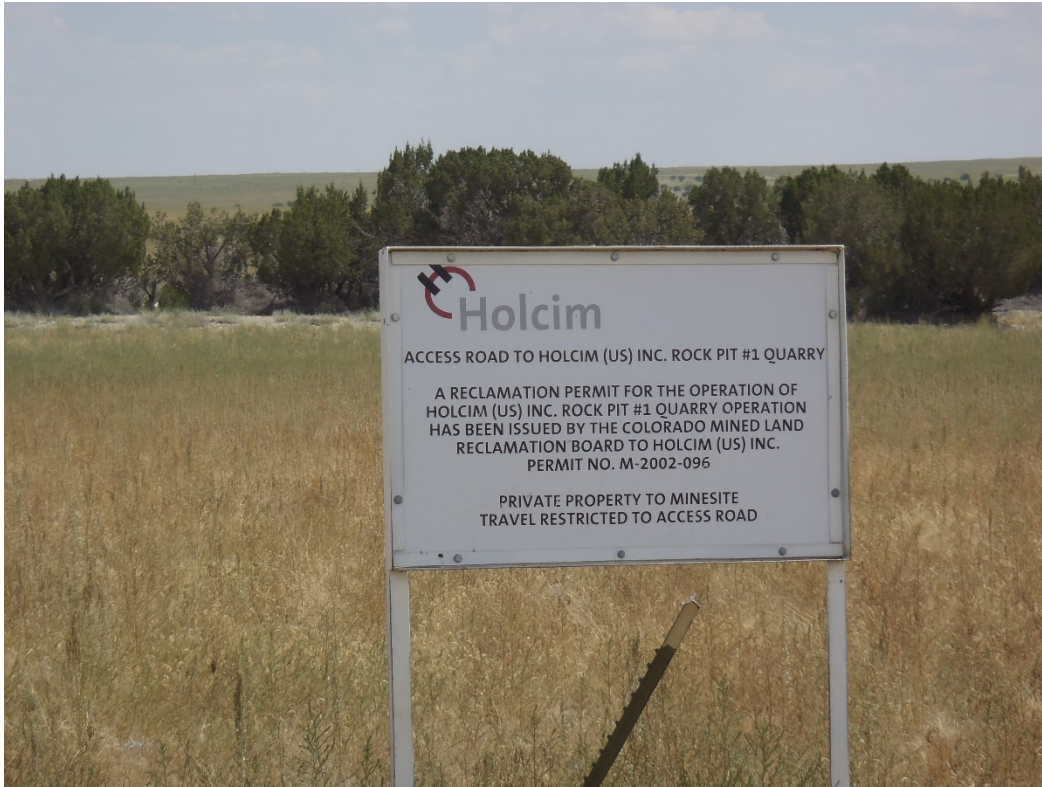
Photo 5. Permit sign (north entrance off ranch road, looking SE).
