**MINERALS PROGRAM INSPECTION REPORT**  
**PHONE: (303) 866-3567**

<b>MINE NAME:</b> Golden Wonder Mine	<b>MINE/PROSPECTING ID#:</b> M-1978-091-UG	<b>MINERAL:</b> Gold	<b>COUNTY:</b> Hinsdale
<b>INSPECTION TYPE:</b> Monitoring	<b>INSPECTOR(S):</b> Lucas West	<b>INSP. DATE:</b> October 11, 2021	<b>INSP. TIME:</b> 10:15
<b>OPERATOR:</b> LKA International Inc.	<b>OPERATOR REPRESENTATIVE:</b> Kye Abraham	<b>TYPE OF OPERATION:</b> 110d - Designated Limited Impact

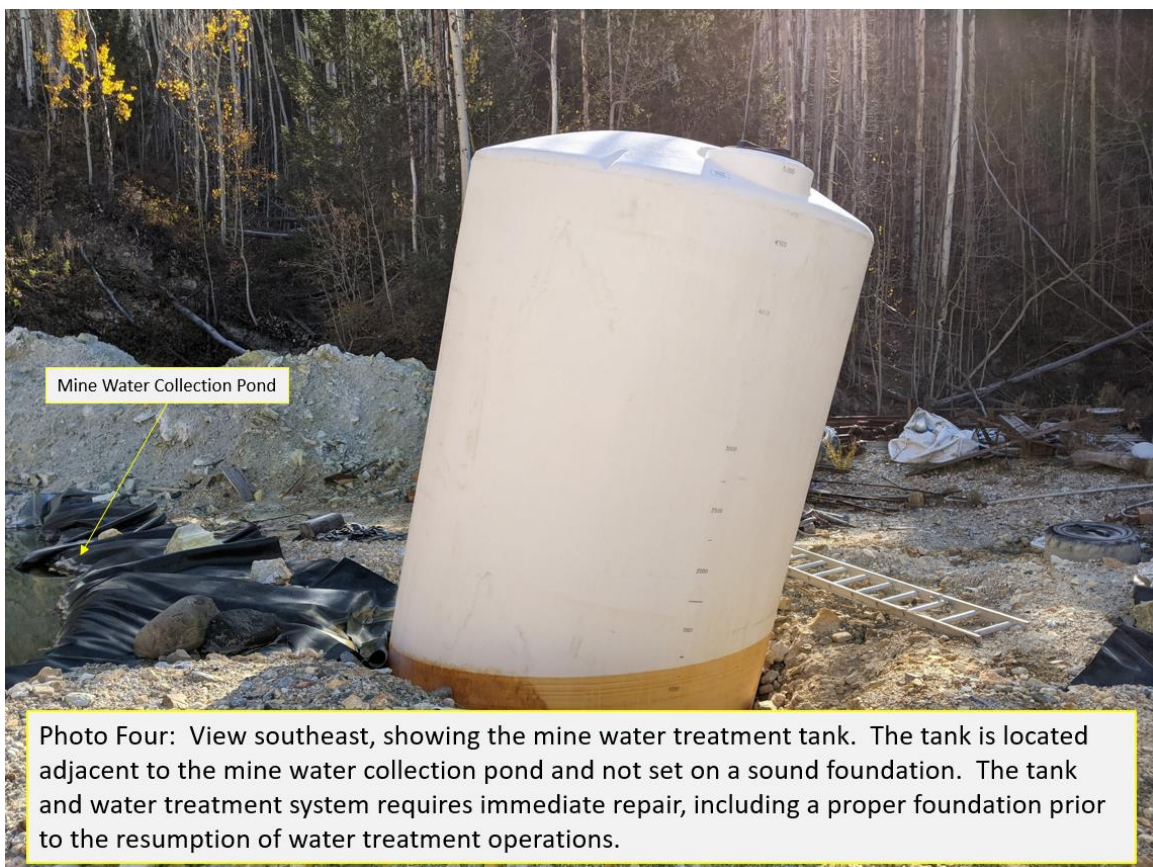
Located adjacent to the mine water collection pond, is the mine water treatment tank shown in Photo Four. The mine water treatment system was addressed in Technical Revisions 3 and 4. The tank was empty at the time of the inspection, and shows evidence of improper placement. The tank does not sit on a competent foundation, and has settled during use, resulting in a significant lean that will need to be corrected prior to use. Visual evidence of impaired water quality was also observed on the tank in the form of red staining around the base of the tank. Mine water treatment is achieved by the addition of chemicals to achieve water quality standards, and discharge via PVC pipe to the collection sump located down gradient in Deadman Gulch. The sump was observed, and can be seen in Photo Five. The sump acts as a collection and mixing pond for mine discharge water, as well as waters from Deadman Gulch that have been routed around the disturbed area. The sump contained no water, and has become silted in. As part of the Corrective Actions required

under this report, the Operator shall immediately mobilize any and all personnel and equipment necessary to clean out the sump and restore it to a proper functioning condition prior to use.

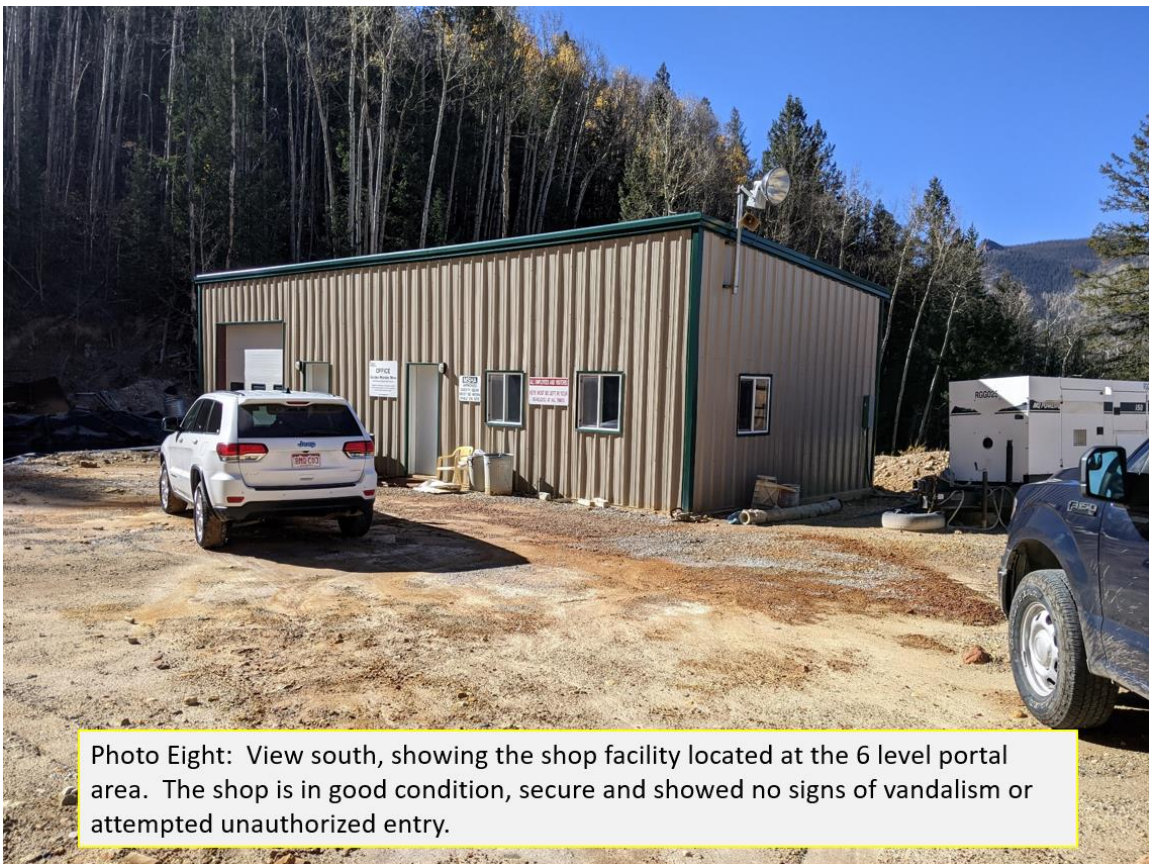
Other surface facilities associated with the 6 level portal area include a shop facility, shown in Photo Eight, which is in good condition and was secure. The shop facility shows no signs of damage, vandalism or attempted unauthorized entry. Adjacent to the shop lies a diesel powered generator, storage container and crusher equipment used for sizing ore material prior to exportation. The crusher equipment can be seen in Photo Nine, and is in marginal condition. Located at the shoulder of the portal pad, lies the waste rock dump. The waste rock dump appeared stable at the time of inspection but did show signs of monitored erosion along its face. These erosional features should be monitored by the Operator in the future. Conversations with the Operator indicate that the waste rock dump has not been used in years, and will not be used in the future. The materials storage area is located just to the north of the portal and consists of a concrete pad with pre-cast blocks used as walls and a low grade ore stockpile. The materials can be seen in Photo Ten. The low grade ore stockpile is covered to prevent exposure to precipitation, and the concrete pad contains remnants of iron ore slag that was imported to the site for previous iterations of a passive water treatment system.

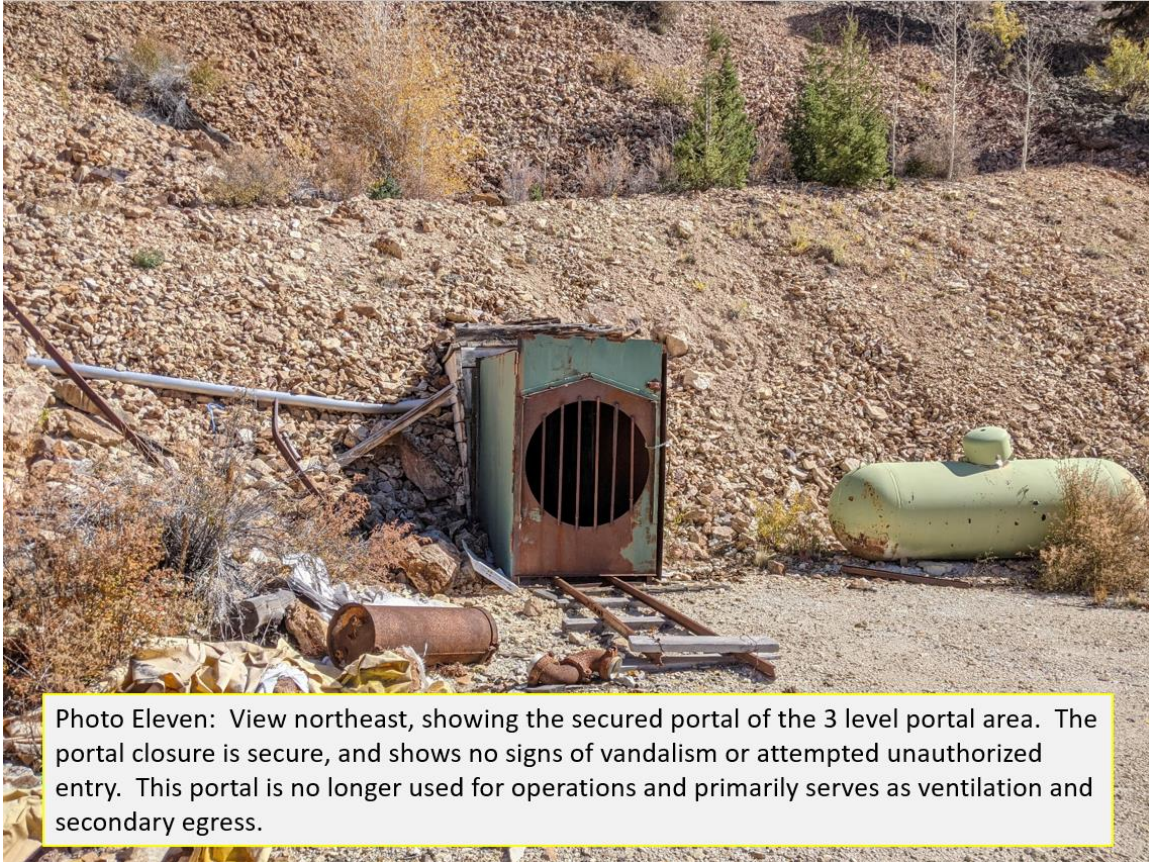
The secondary portion of the permit area is the 3 level portal area. This area consists of a secured portal, portal pad, waste rock dump and equipment storage areas. The three level portal, shown in Photo Eleven, was observed to be secured and showed no signs of vandalism or attempted unauthorized entry. Unlike the 6 level portal, the 3 level portal does not have an associated discharge. The portal pad and waste rock dump appeared stable at the time of the inspection and no signs of settling, slumping or erosion was noted. Various mining related equipment is stored at the 3 level portal area and is scattered and disorganized. As is the case with the 6 level area, a general site cleanup and organization should be conducted during the summer of 2022.

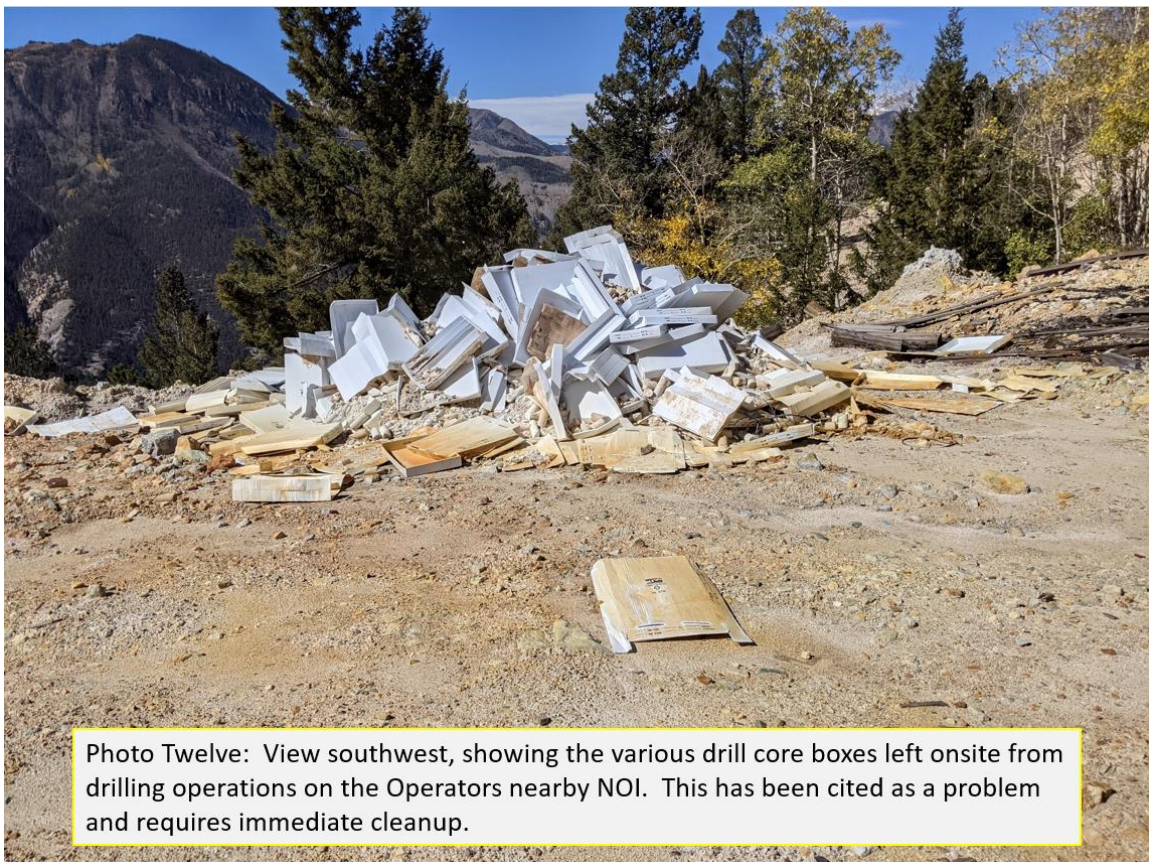
**PROBLEM/POSSIBLE VIOLATION:** Problem: Trash and refuse was noticed on the site. This is a problem at this time for failure to dispose of refuse in a manner that controls unsightliness or deleterious effects of such refuse pursuant to C.R.S. 34-32.5-116(4)(e). A large amount of drill core boxes were observed around the 3 level portal area. The boxes have been left unsecured, and dispersed across the site and the surrounding area.

The 3 level portal area has been used as a staging area for drilling operations associated with the Operator's currently held NOI, file no P-2018-010. As a result of using the area for staging, a significant pile of cardboard drill core boxes were left unsecured on site. The main pile, seen in Photo Twelve has been exposed to the elements and dispersed across the site and surrounding areas by wind. Photos Thirteen and Fourteen show the scattered boxes that were observed. This is being cited as a problem for failure to dispose of refuse in a manner that controls unsightliness or deleterious effects of such refuse pursuant to C.R.S. 34-32.5-116(4)(e). The Operator shall conduct cleanup and removal of all associated trash and debris, specifically the cardboard drill core boxes at the 3 level. Cleanup efforts should be conducted within 60 days of the date of this report, and the Operator shall provide photo documentation that all items have been removed from the site. Photo documentation should be received by the Division no later than **Monday December 13, 2021**.

**CORRECTIVE ACTIONS:** The operator shall submit a written notice to the Division with photo documentation, that the trash has been removed from the site by the corrective action date.
