COLORADO
Division of Reclamation,
Mining and Safety
Department of Natural Resources

Permit Number: C-1981-012 Mine Name: New Elk Mine Operator: New Elk Coal Company, LLC Operator Address: Mr. Larry Cook 12250 Highway 12 Weston, CO 81091	County: Las Animas Operation Type: Underground Permit Status: Active Ownership: Private
	Operator Representative Present: Vince Massarotti
Operator Representative Signature: (Field Issuance Only)

Inspection Start Date: October 13, 2021 Inspection Start Time: 08:00 Inspection End Date: October 13, 2021 Inspection End Time: 13:00		Inspection Type: Coal Partial Inspection Inspection Reason: Normal I&E Program Weather: Clear	
Joint Inspection Agency: None		Joint Inspection Contacts: NA	
Post Inspection Agency: None		Post Inspection Contacts: NA	
Inspector(s): Jared Ebert	Inspector's Signature:

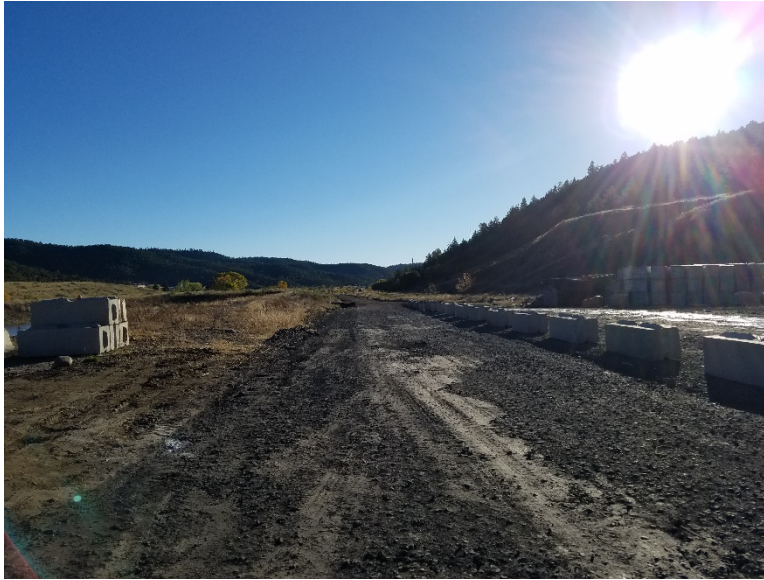
NECC is upgrading and reconstructing the light use road located south of Pond 007a that runs west to east adjacent to the Purgatory river. NECC is reconstructing the light use road in anticipation of truck hauling processed coal. NECC is currently not approved to reconstruct the light use road as a haul road and no revision to the New Elk Mine permit addressing the reconstruction has been received by the Division.

This activity constitutes a violation of Rule 2.05.3(3)(c) for failure to provide a description of each road to be constructed, used, or maintained within the proposed permit area. In addition, due to the anticipated haul road use of the reconstructed road, this activity constitutes a violation for failure to comply with the performance and design requirements for haul roads in accordance with Rule 4.03.1. No additional construction and no coal hauling on the road pertaining to this violation may occur until the violation has been abated.

Figure 1. From the south end of Pond 007a looking east at the light use road.

Abatement Step #	Description
1	No additional construction and no coal hauling on the road pertaining to this violation may occur until the technical revision required by Abatement Step #2 has been approved and issued. Due: Immediately
2	Submit and receive approval of a technical revision to revise the road design for the light use road to comply with Rule 2.05.3(3)(c) and Rule 4.03.1 for the new haul road. The technical revision must be submitted on or before the abatement due date noted below. Due: November 22, 2021

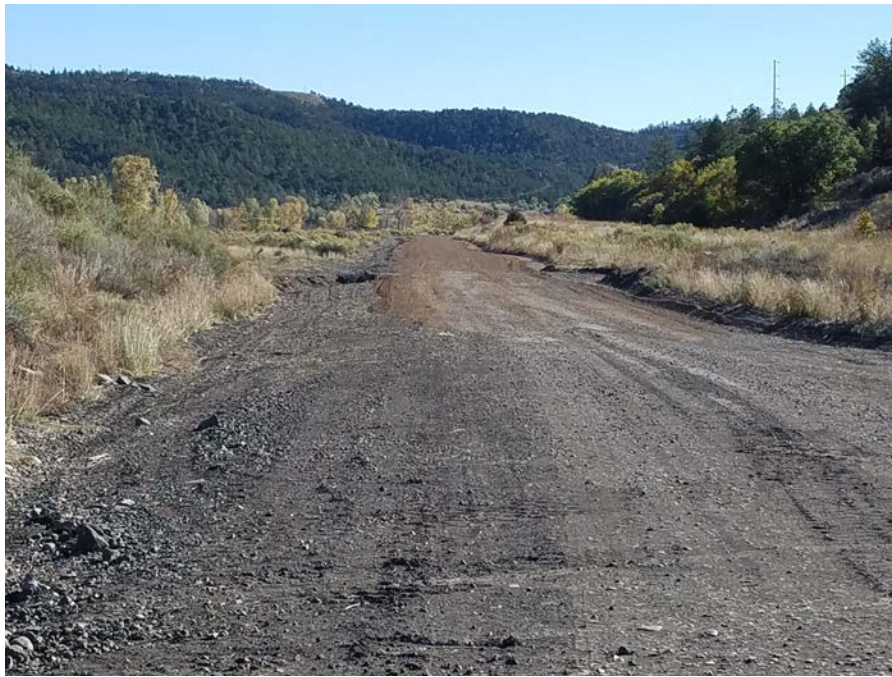
Figure 2. Light use road south of Pond 007a, newly placed road base.

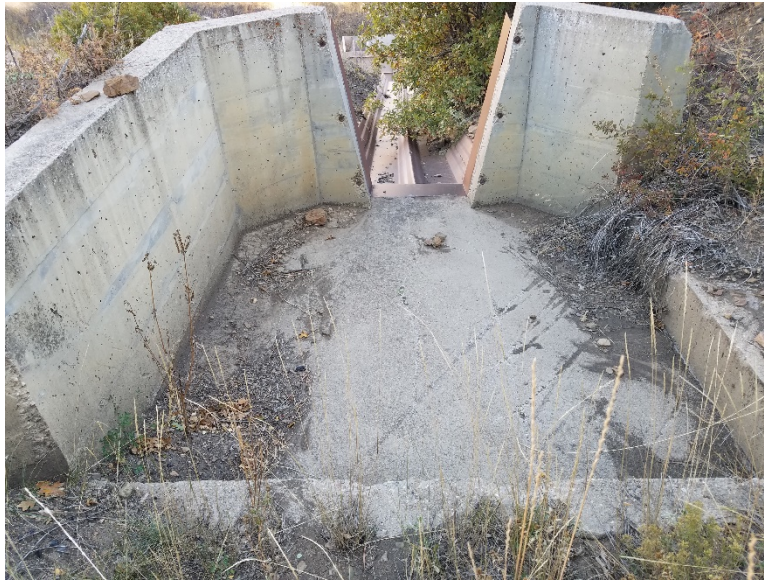
Figure 3. Upper drop down structure and flume from the end of ditch D26.

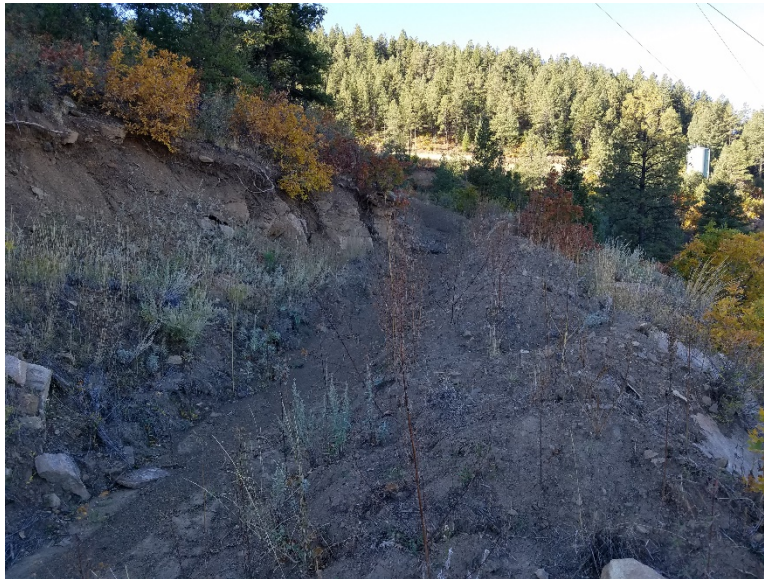
Clean water diversion ditch D26 was observed. The majority of the ditch is vegetated, a small section is lined with concrete. Overall, the ditch is clear and functional. **Several trees were observed that have fallen over the ditch and will need to be cleared away.** The upper reaches of the ditch were cleaned in January/February of 2021 according to Mr. Massarotti.

Figure 4. Ditch D26 looking west.

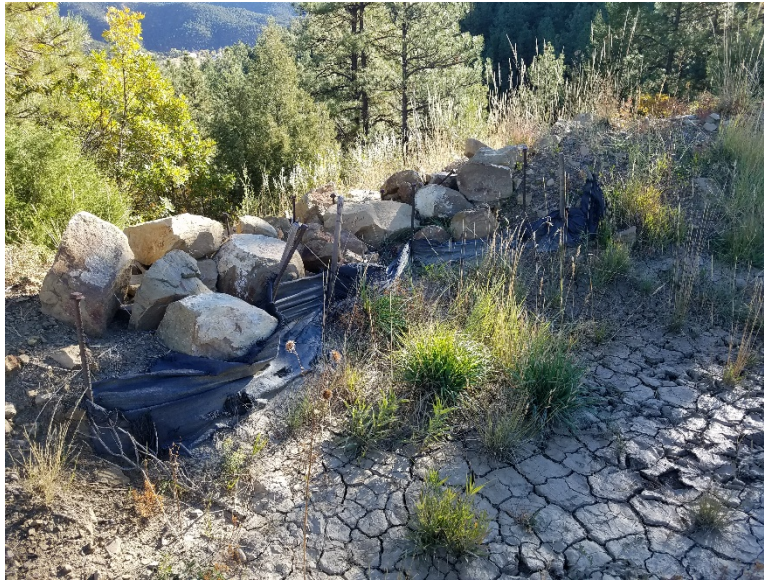
The upper water tank S.A.E. area was observed. A berm is in place surrounding the pad area where the tanks are located. The berm, small sump, and checkdam lined with rock and silt fence appear to be functional at preventing off-site sedimentation at this S.A.E.

Figure 5. Drainage control structure on the pad where the water tank S.A.E. is located.

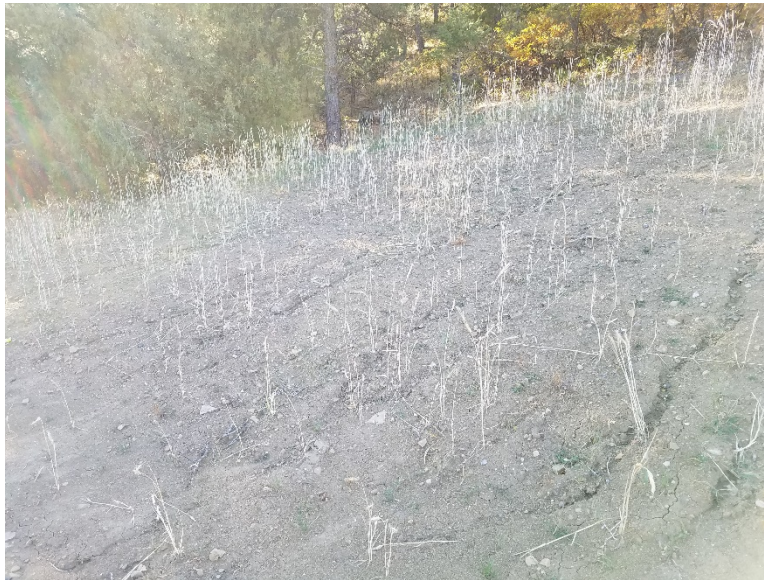
Core hole pads NE-02-20 and NE-01-20 were observed. Drilling is complete and the pads have been reclaimed. The pads have been graded to blend into the surrounding topography and they have been seeded. Vegetation has begun to establish on the pad area. Two wooden borehole markers were found on the ground on the drill pad area. **These markers will need to be replaced in the location of the drill hole in accordance with Rule 4.07.3(2).**

Figure 6. Core hole pad NE-02-20.

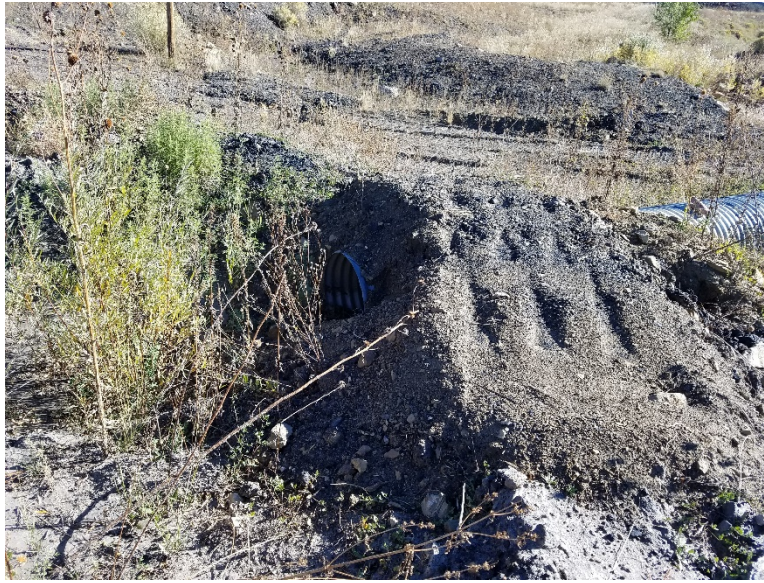
NECC cleaned sediment from the sump and re-established the berm upstream of culvert C13 on the southeast corner of the DWDA #2.

Figure 7. Repair work at culvert C13.

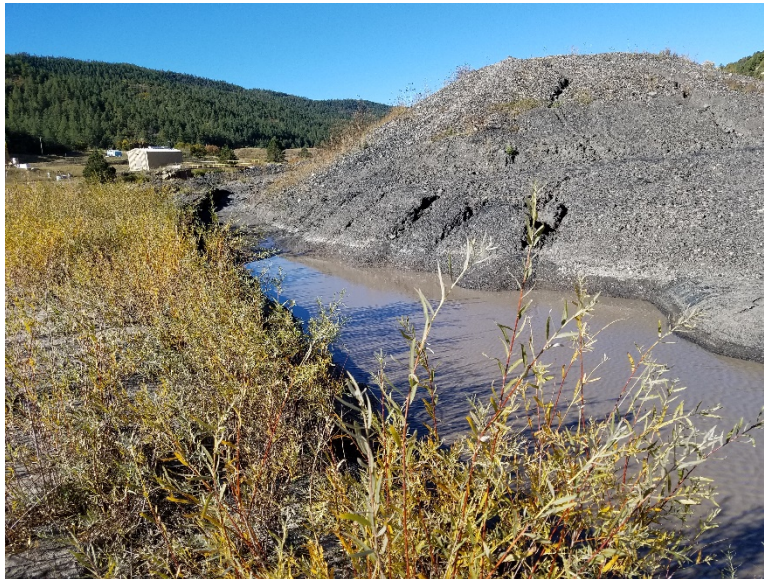
Figure 8. Sump upstream of Culvert C13 deepened.

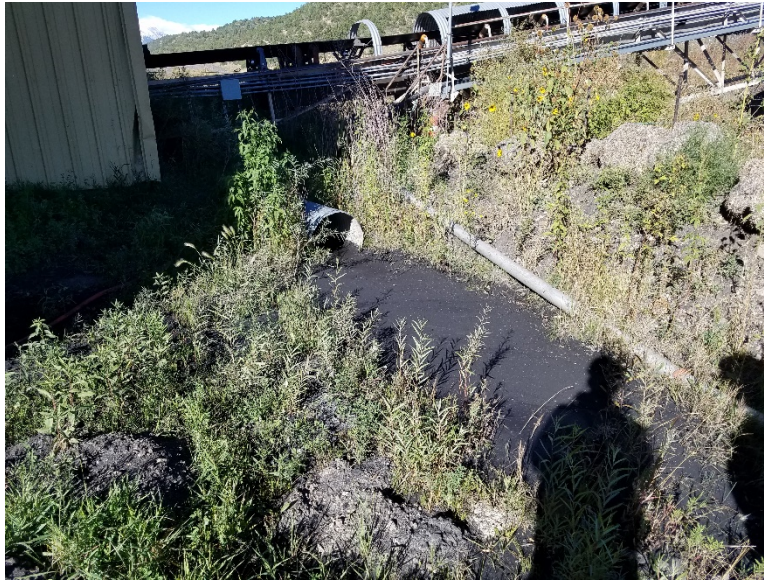
northern slope of ditch D32 as the slopes are a little steep in areas and small rills were observed on the ditch side slopes. **Culvert C64 is about ¼ full of sediment and needs to be cleaned out on the outlet end.**

Figure 9. Culvert C64 outlet that needs to be cleaned out.
