## Bowie 1 inspection report

<b>Permit Number:</b> C-1981-038 <b>Mine Name:</b> Bowie No. 1 Mine <b>Operator:</b> Bowie Resources, LLC <b>Operator Address:</b> Mr. Basil R Bear P.O. Box 1488 Paonia, CO 81428	<b>County:</b> Delta <b>Operation Type:</b> Underground <b>Permit Status:</b> Active <b>Ownership:</b> Private
	<b>Operator Representative Present:</b>  Basil Bear
<b>Operator Representative Signature: (Field Issuance Only)</b>

<b>Inspection Start Date:</b> October 21, 2021 <b>Inspection Start Time:</b> 07:15 <b>Inspection End Date:</b> October 21, 2021 <b>Inspection End Time:</b> 10:00		<b>Inspection Type:</b> Coal Partial Inspection <b>Inspection Reason:</b> Normal I&E Program <b>Weather:</b> Clear	
<b>Joint Inspection Agency:</b>  None		<b>Joint Inspection Contacts:</b>  	
<b>Post Inspection Agency:</b>  None		<b>Post Inspection Contacts:</b>  	
<b>Inspector(s):</b>  Robert Zuber, P.E.	<b>Inspector's Signature:</b>  <i>Robert D. Zuber</i>		<b>Signature Date:</b>  10/22/2021

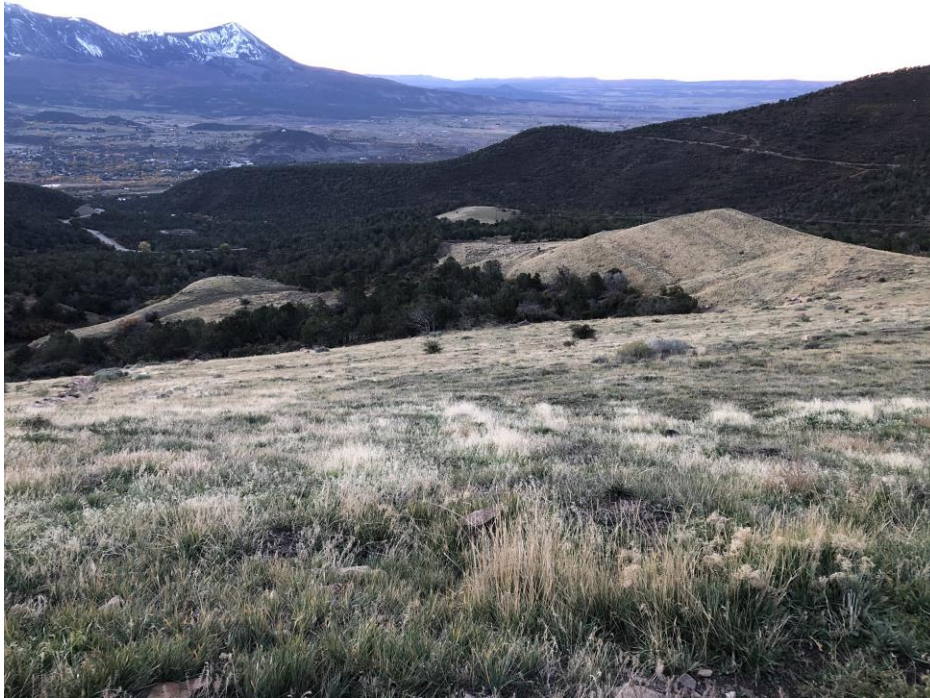
**Lower portion of East Mine**

No erosion or other problems were seen within the primary areas of the East Mine, including the Old Waste Pile and RDA. The drainage below the East Mine where the reclaimed ponds (1 – 4) are located was in good shape, as seen from the hill above (Old Waste Pile).

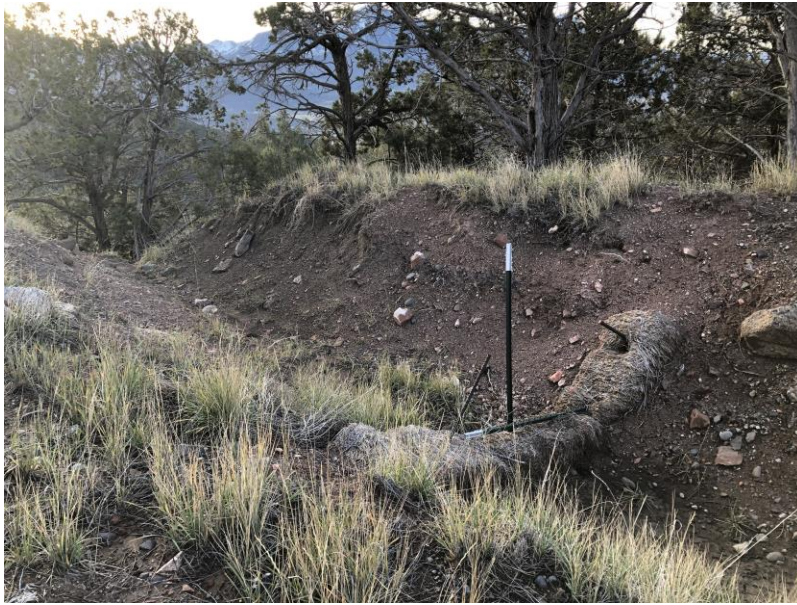
One area that requires maintenance is a small area east of the reclaimed pond below the RDA. The existing bails have deteriorated to the point where they do not function well. These should be replaced and others should be added to this area to address the small amount of erosion on the hill below.

**Deteriorating bales below RDA at East Mine**

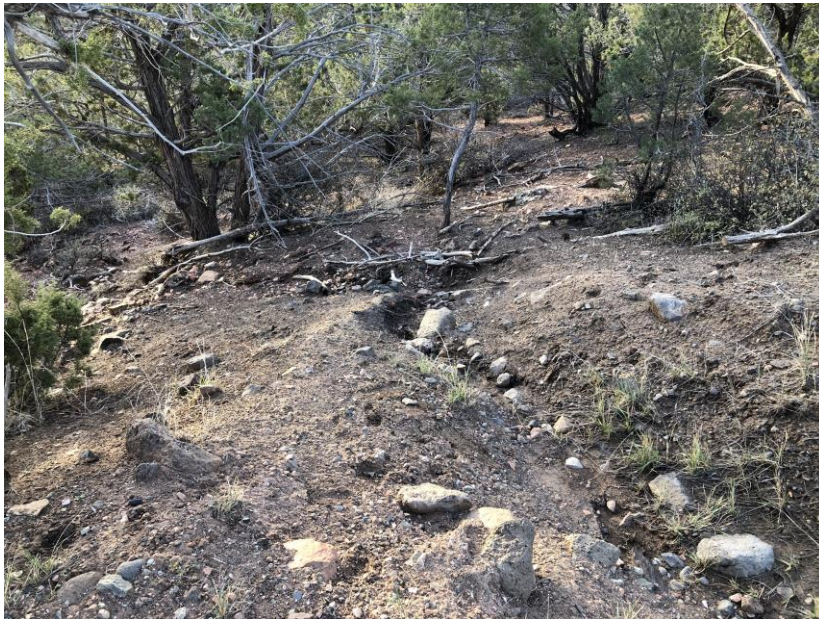
**Minor erosion in undisturbed area below RDA**

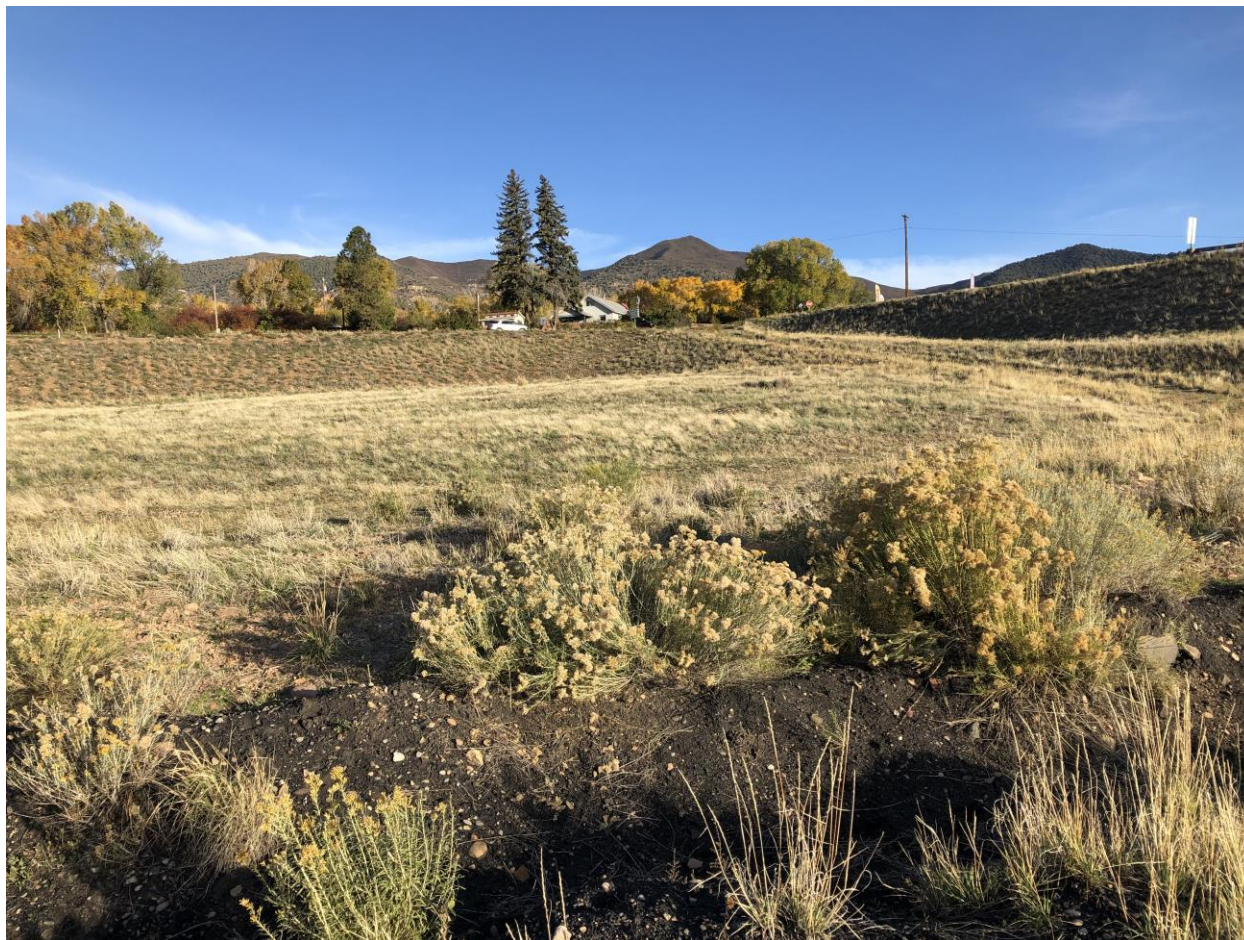
**Coal Storage area by Black Bridge Road**

No problems were seen with the Coal Storage Area by Black Bridge Road. The vegetation cover is good, with mostly grass species.
