## MINERALS PROGRAM INSPECTION REPORT

<b>MINE NAME:</b> 8-Mile Clay Mine	<b>MINE/PROSPECTING ID#:</b> M-1977-320	<b>MINERAL:</b> Clay (general)	<b>COUNTY:</b> Fremont
<b>INSPECTION TYPE:</b> Monitoring	<b>INSPECTOR(S):</b> Timothy Cazier, P.E.	<b>INSP. DATE:</b> June 15, 2021	<b>INSP. TIME:</b> 12:30
<b>OPERATOR:</b> Summit Brick & Tile Co.	<b>OPERATOR REPRESENTATIVE:</b> Julie Welte	<b>TYPE OF OPERATION:</b> 112c - Construction Regular Operation	
<b>REASON FOR INSPECTION:</b> Normal I&E Program	<b>BOND CALCULATION TYPE:</b> Partial Bond	<b>BOND AMOUNT:</b> \$49,166.00	
<b>DATE OF COMPLAINT:</b> NA	<b>POST INSP. CONTACTS:</b> None	<b>JOINT INSP. AGENCY:</b> None	
<b>WEATHER:</b> Cloudy	<b>INSPECTOR'S SIGNATURE:</b>

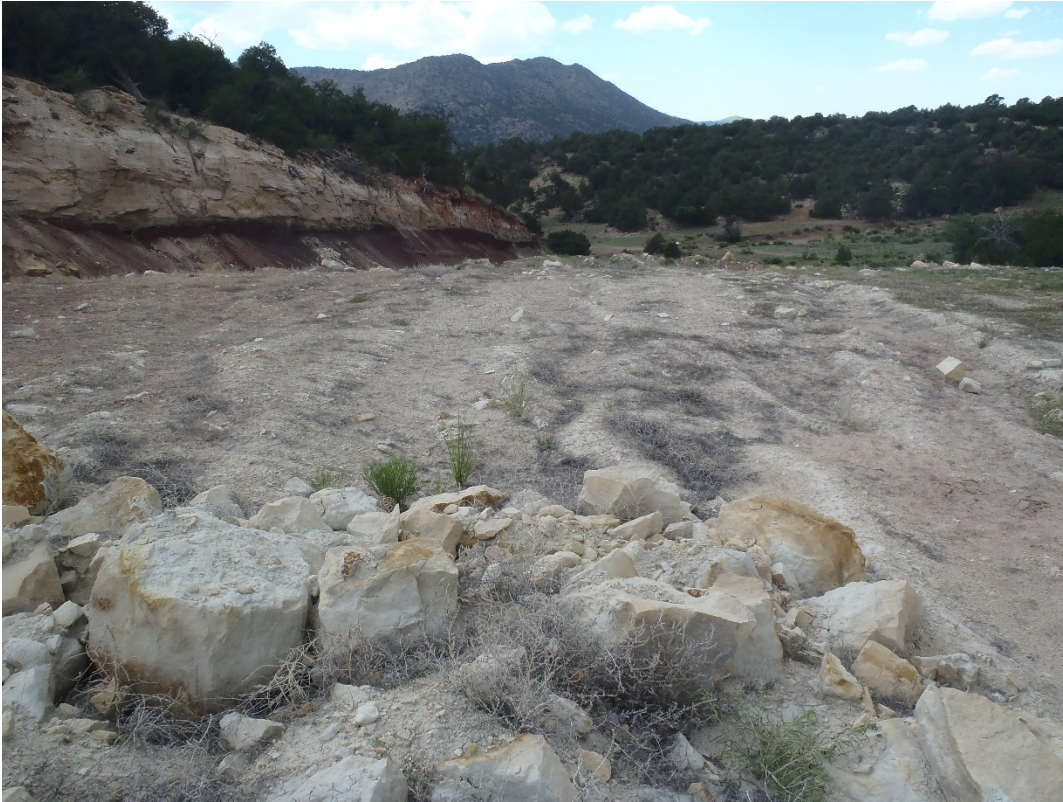
Excess Spoil and Dev. Waste: Ms. Welte explained overburden was used to backfill the area on the north end of the permit area (see **Photo 1**).

Reclamation Success: The Operator has placed additional backfill in the northern end of the pit since the previous inspection (see **Photo 1**).

Photo 1. Overburden backfill on north end of pit (looking NW).

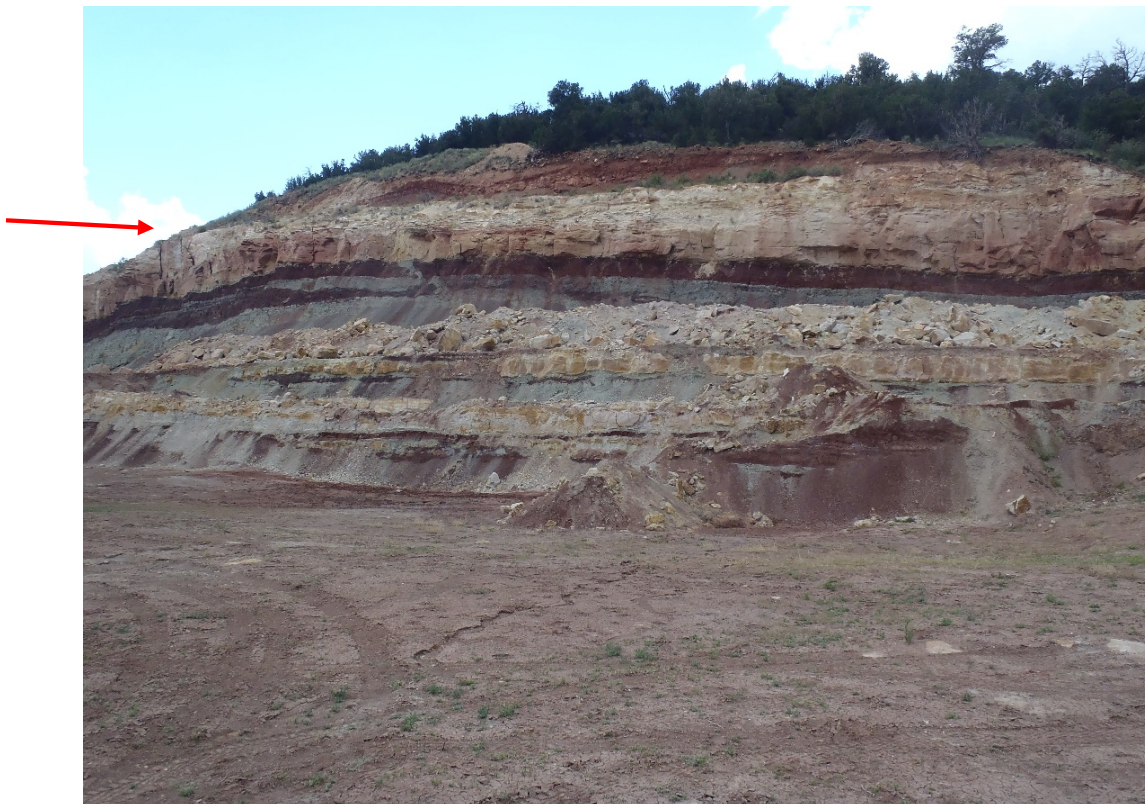
Explosives: The mine has filed a blasting plan with DRMS (July 2002). Ms. Welte stated blasting has not been performed recently, but will be required to mine through the thicker sandstone top layer above the clay (see **Photo 2**). There are three structures (based on Google Earth observations) within a quarter mile of the active pit: one to the northeast and two to the southwest on the other side of the ridge being mined (see **Figure 1**).

Photo 2. Working highwall (looking SW, note limestone layers that will require future blasting).

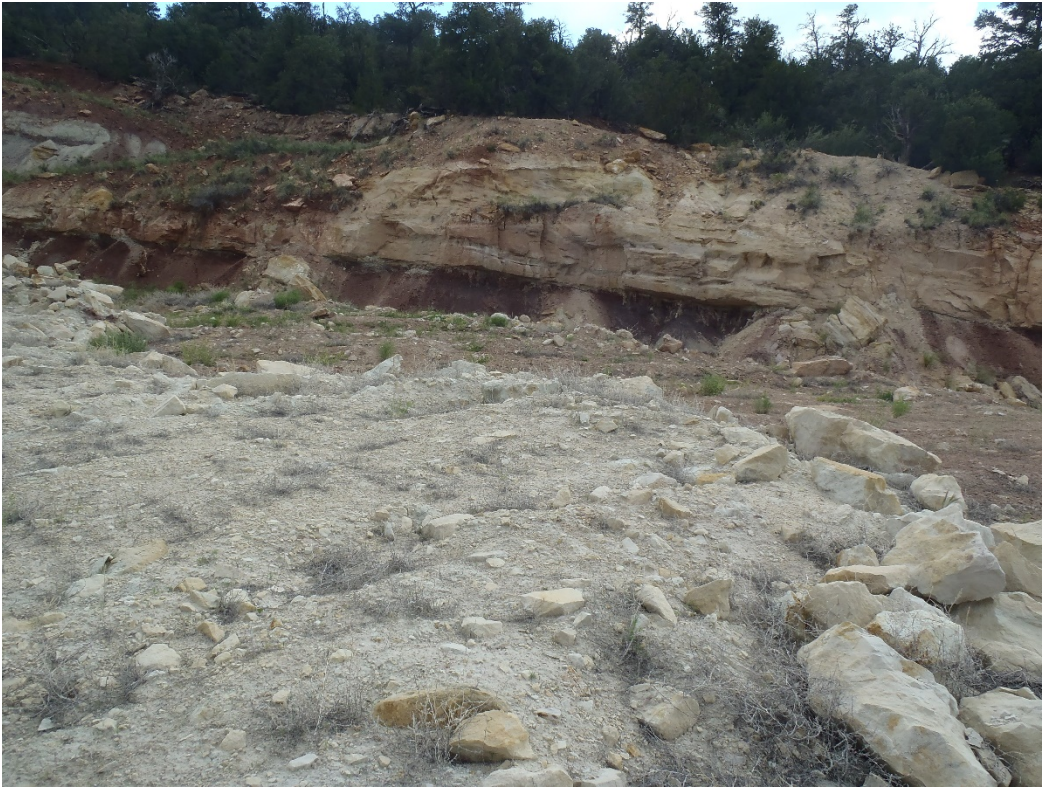
Photo 3. Shorter highwall in NW corner (looking south, backfill in foreground).

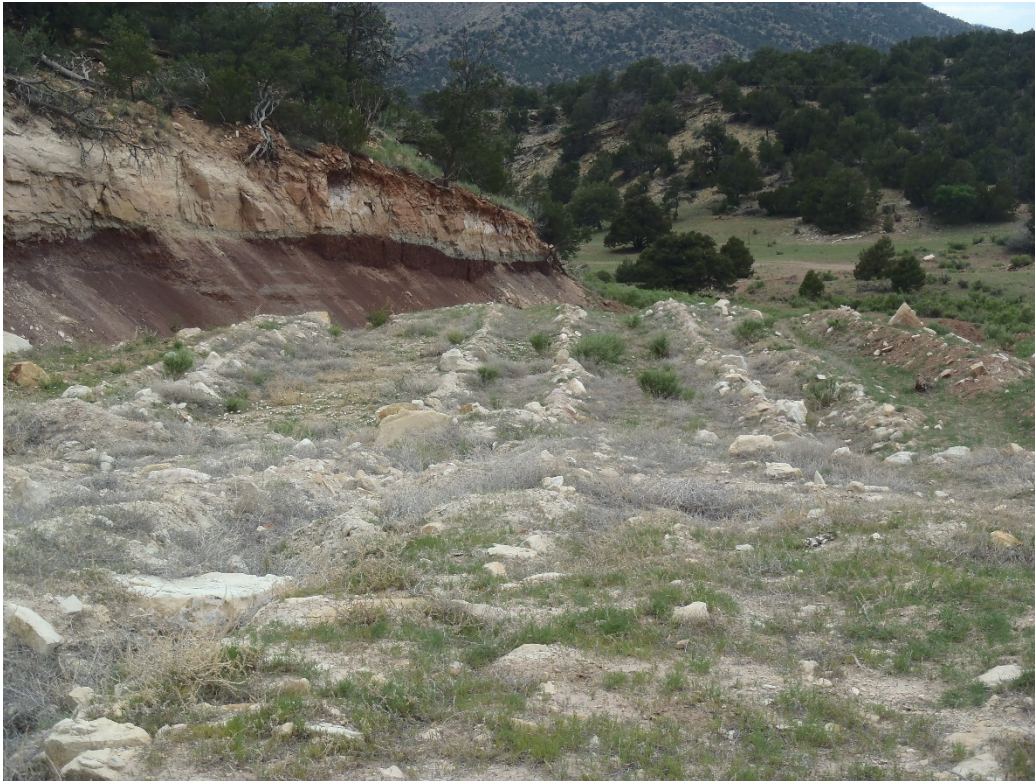
Revegetation: Ms. Welte indicated they had seeded the northwest corner (see **Photo 4**). No noxious weeds were observed.

Photo 4. Seeded area in NW corner of pit (looking west).

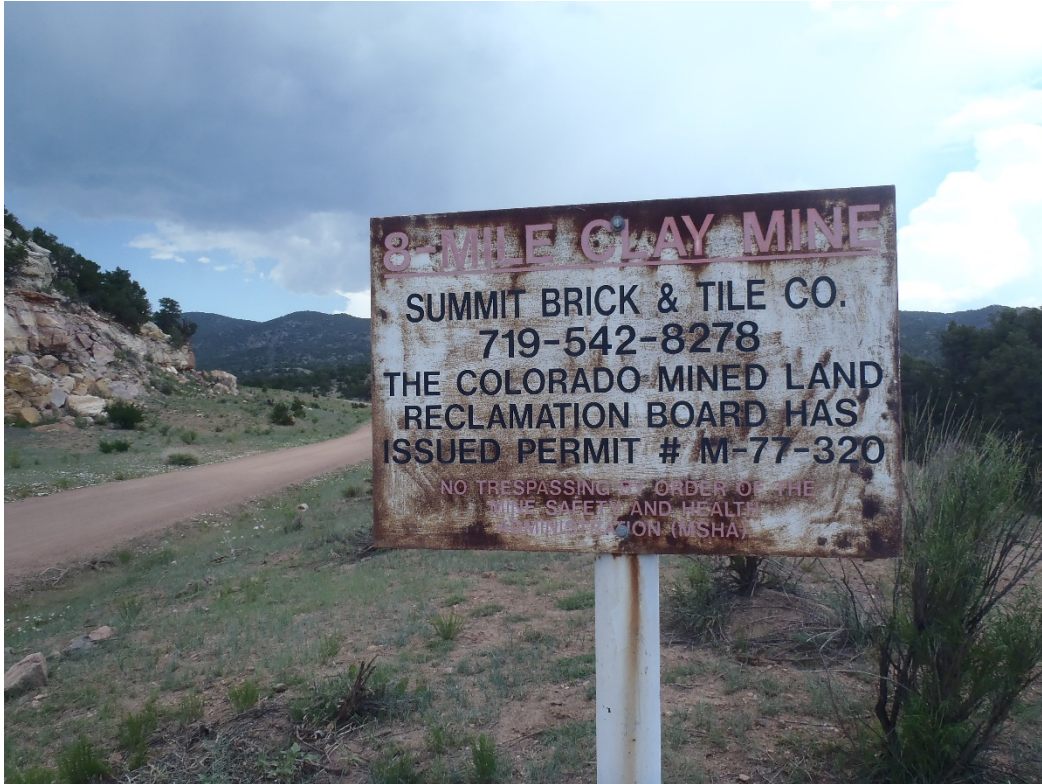
Photo 5. Permit sign (off CR 62 – south of pit).

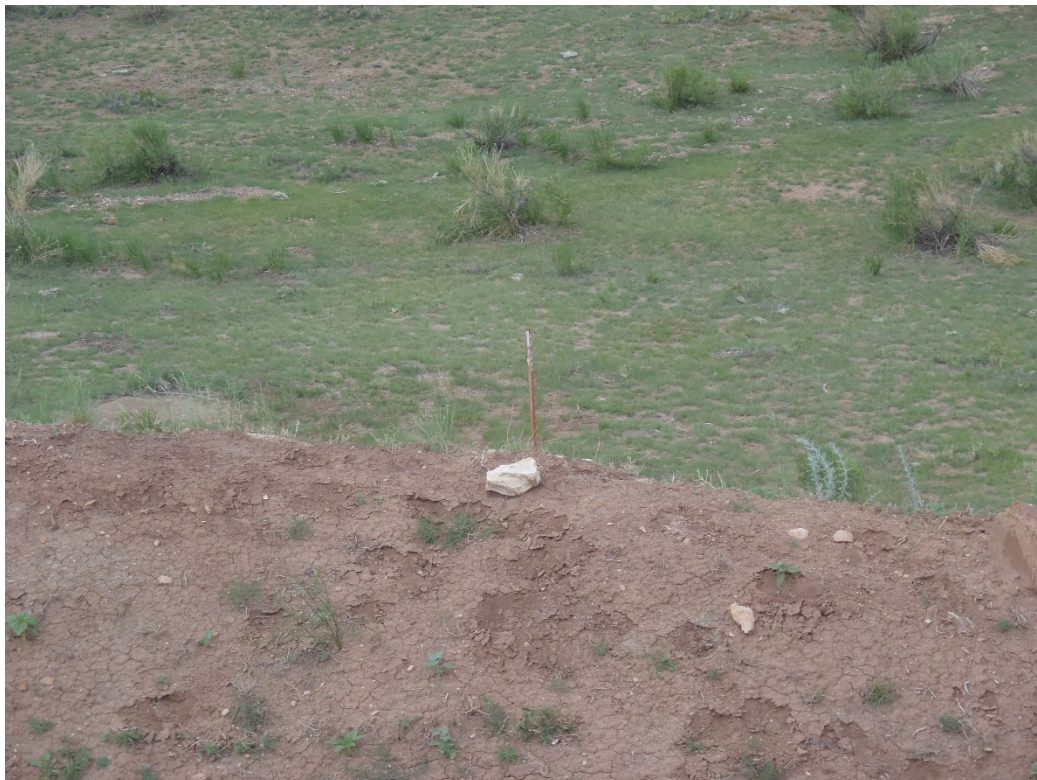
Photo 6. Typical T-post boundary marker.

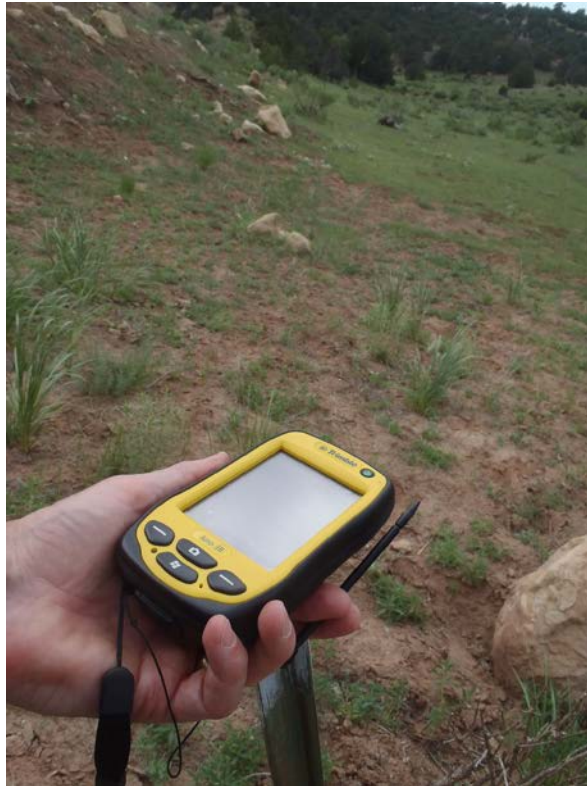
Photo 7. Handheld GPS recording boundary marker location.

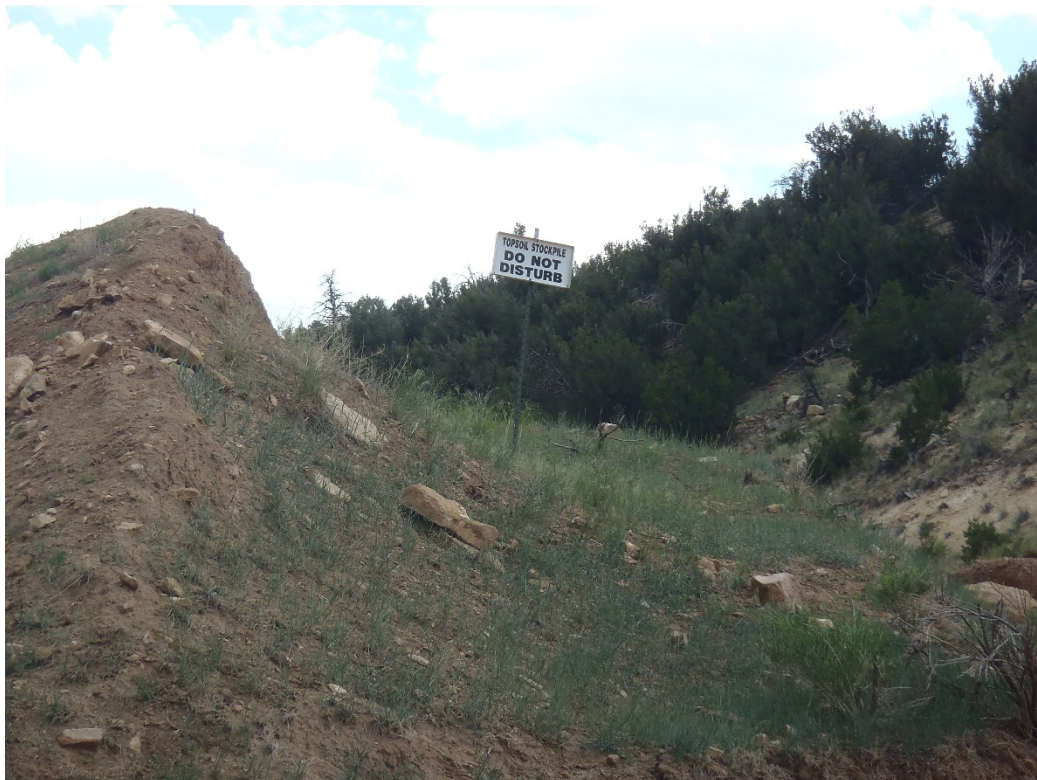
Topsoil: Topsoil stockpiles are labeled as such (see **Photo 8**) and appeared to have sufficient volume for reclamation.

Photo 8. Topsoil stockpile with sign (looking south).
