**MINERALS PROGRAM INSPECTION REPORT**  
**PHONE: (303) 866-3567**

<b>MINE NAME:</b> Dixie Mine	<b>MINE/PROSPECTING ID#:</b> M-2015-028	<b>MINERAL:</b> Silver and gold	<b>COUNTY:</b> Clear Creek
<b>INSPECTION TYPE:</b> Monitoring	<b>INSPECTOR(S):</b> Peter Hays	<b>INSP. DATE:</b> September 9, 2021	<b>INSP. TIME:</b> 10:00
<b>OPERATOR:</b> Teton Drilling Inc.	<b>OPERATOR REPRESENTATIVE:</b> Mike Jones	<b>TYPE OF OPERATION:</b> 110(1) - Hard Rock Limited Impact	
<b>REASON FOR INSPECTION:</b> Priority	<b>BOND CALCULATION TYPE:</b> None	<b>BOND AMOUNT:</b> \$14,500.00	
<b>DATE OF COMPLAINT:</b> NA	<b>POST INSP. CONTACTS:</b> None	<b>JOINT INSP. AGENCY:</b> None	
<b>WEATHER:</b> Clear	<b>INSPECTOR'S SIGNATURE:</b>

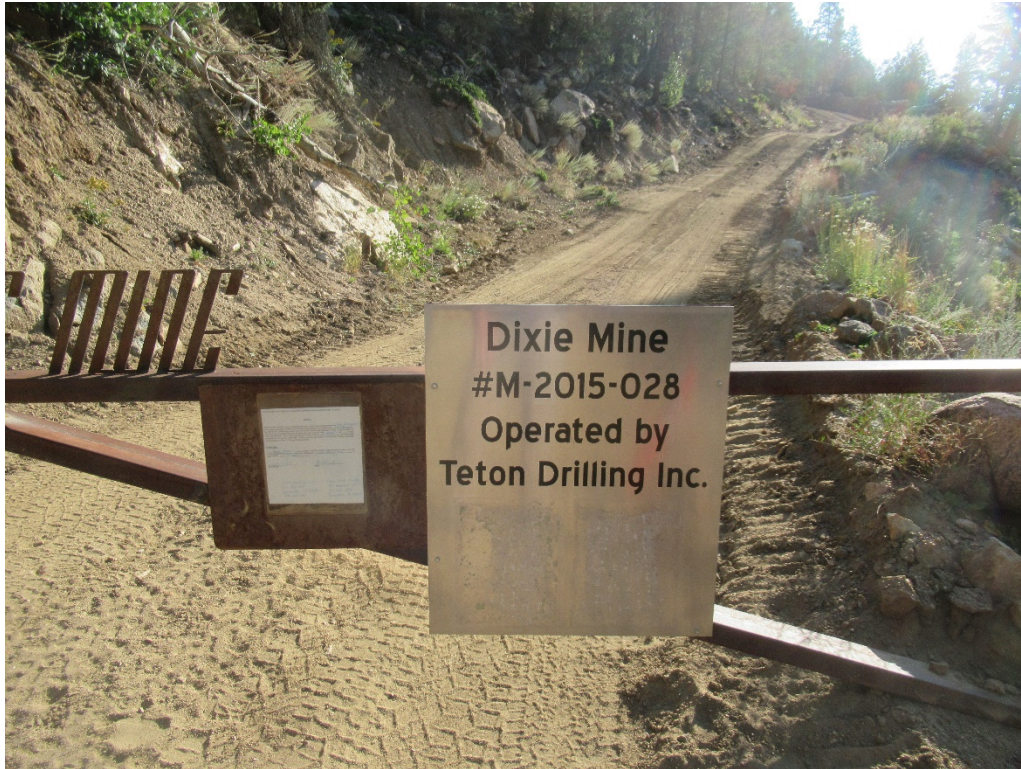
Dixie Mine mine sign

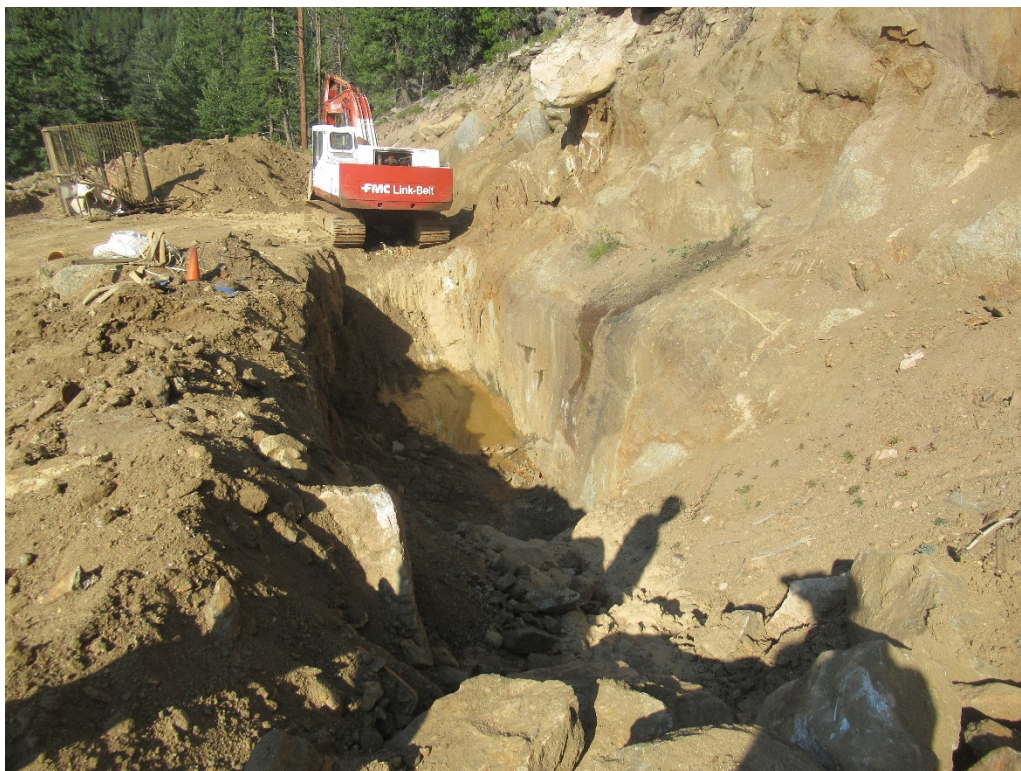
View of the Dixie Mine trench

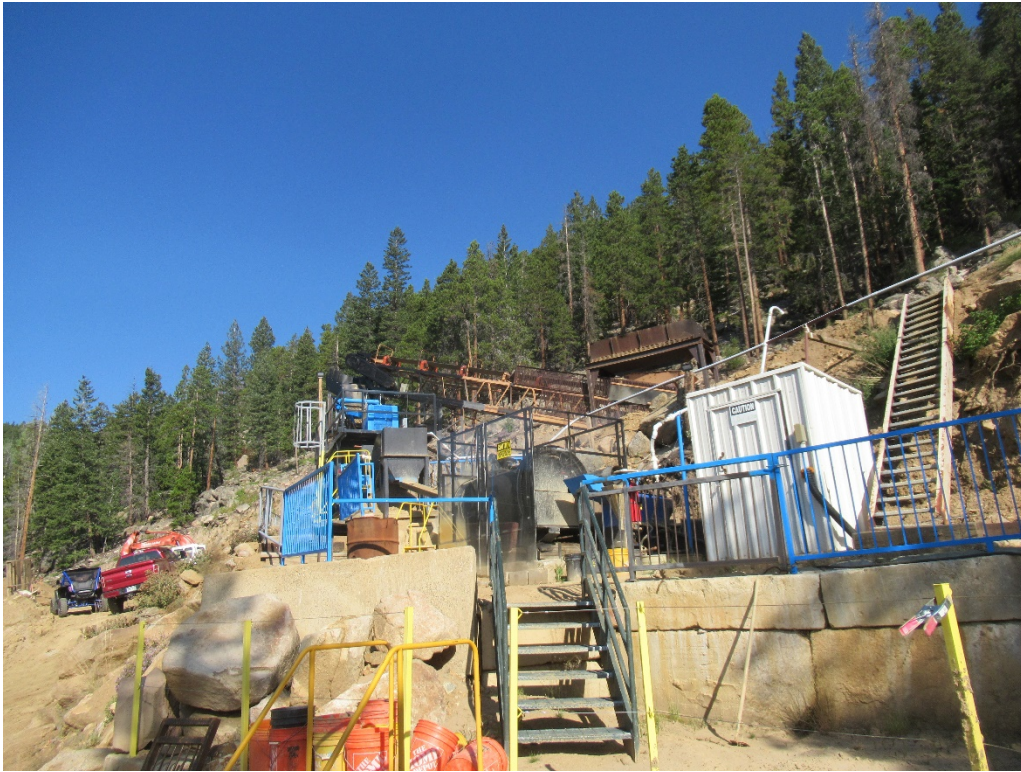
View of the Dixie Mine on-site mill facilities

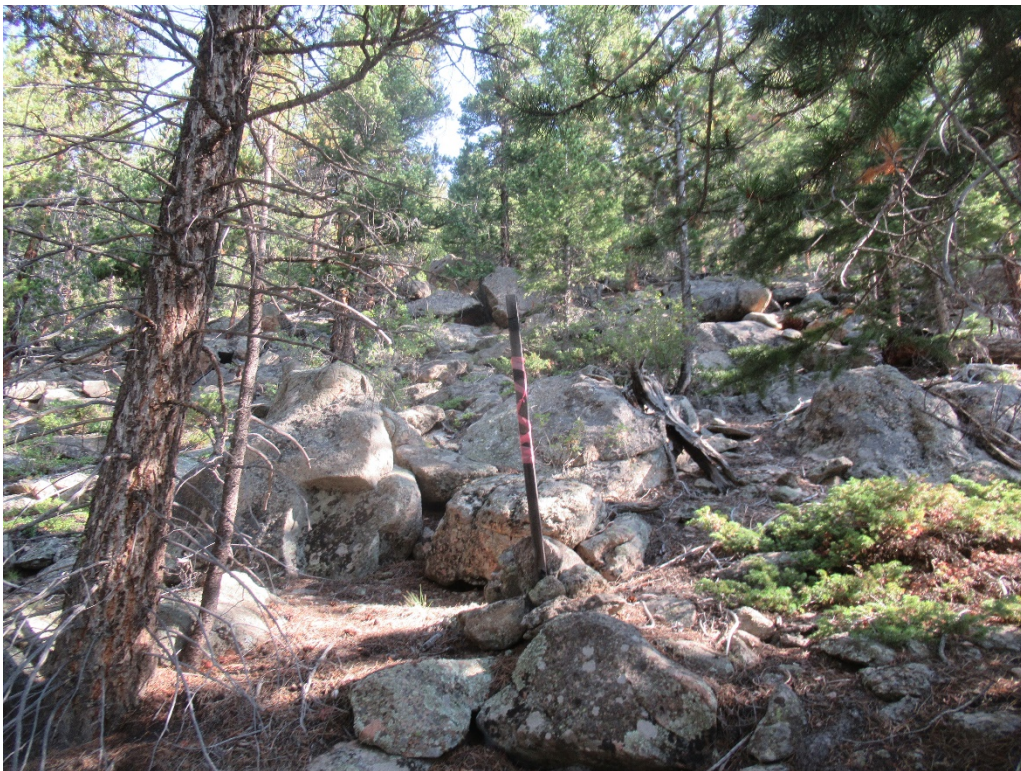
View of typical Dixie Mine boundary marker

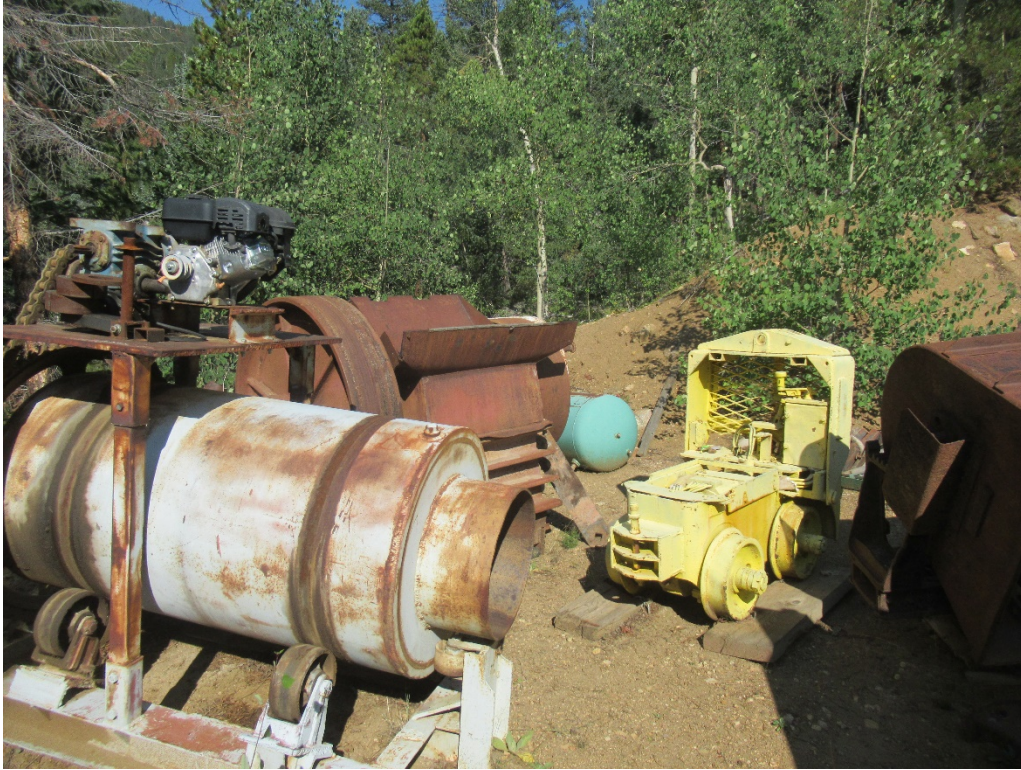
View of equipment storage as shown in the complaint picture

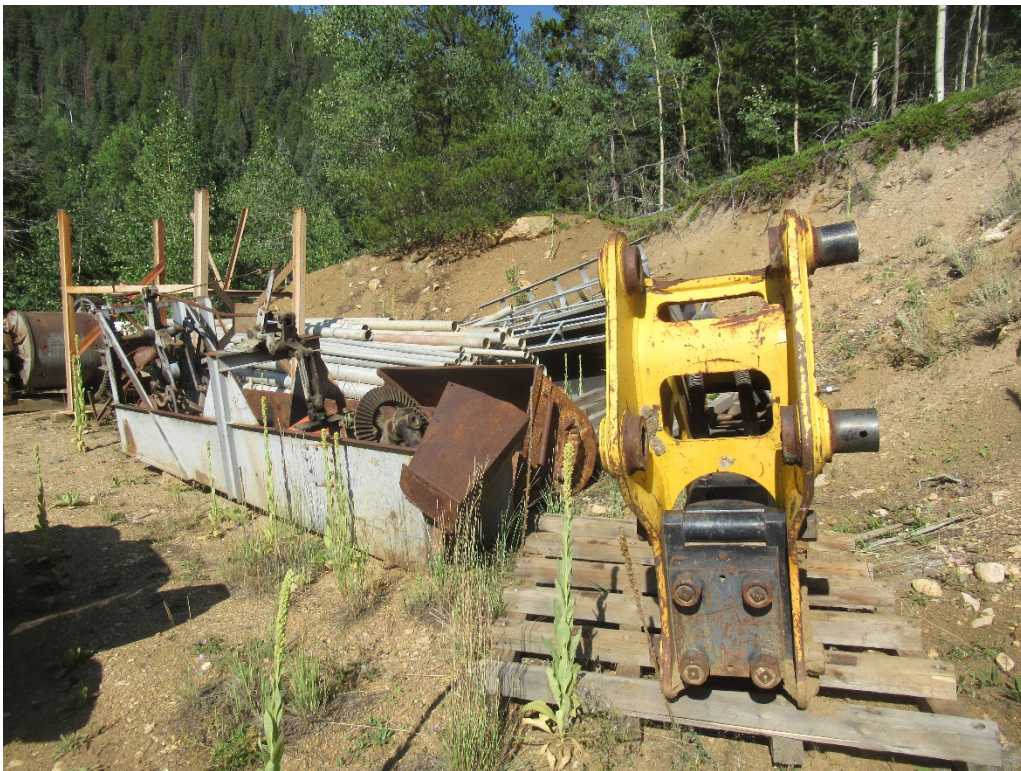
View of equipment storage as shown in the complaint picture

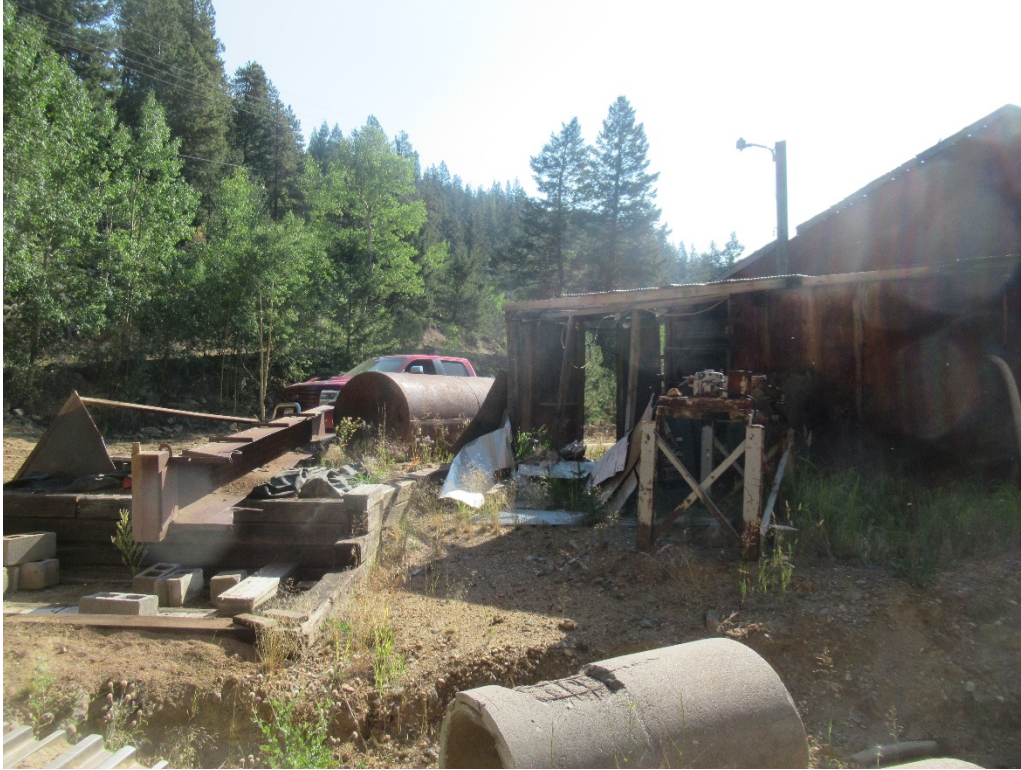
View of equipment storage as shown in the complaint picture, RV removed

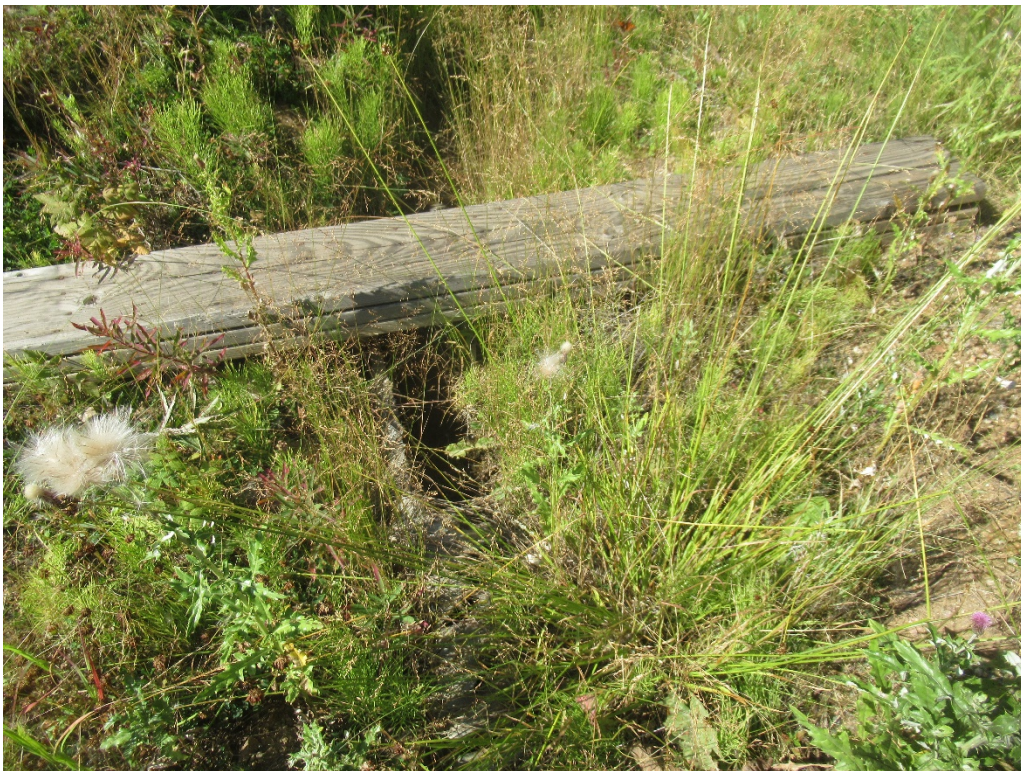
View of the ditch from the adit pool towards Ute Creek

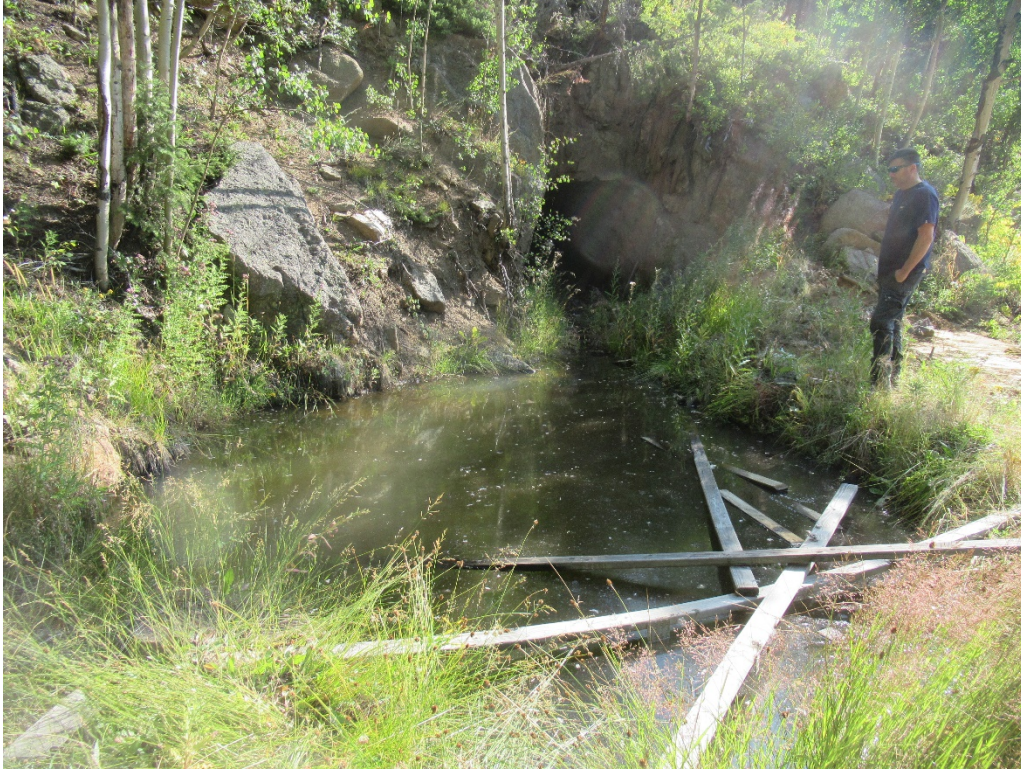
The landowner stated during the inspection they were aware of the requirement to obtain a permit from the Division prior to accessing the Sweet Marie adit for mining activities. The Division reached out to the Inactive Mine Reclamation Program (IMP) program within the Division regarding the adit closure and discharge. The IMP staff stated the adit closure was not installed by the IMP program, however the adit was adequately safeguarded. The IMP staff stated the drainage was very likely historic, since the primary function of old adits in the area was to drain the mine working above.

View of the MM adit and adit pool
