MINERALS PROGRAM INSPECTION REPORT
PHONE: (303) 866-3567

MINE NAME: Hasser Borrow Pit	MINE/PROSPECTING ID#: M-2019-015	MINERAL: Borrow material for construction	COUNTY: Prowers
INSPECTION TYPE: Surety Release Inspection	INSPECTOR(S): Amy Eschberger	INSP. DATE: October 20, 2021	INSP. TIME: 11:45
OPERATOR: Castle Rock Construction Company of Colorado, LLC	OPERATOR REPRESENTATIVE: Darren Janssen	TYPE OF OPERATION: 111 - Construction by Government Agency

REASON FOR INSPECTION: Surety Release Requested	BOND CALCULATION TYPE: None	BOND AMOUNT: \$21,177.00
DATE OF COMPLAINT: NA	POST INSP. CONTACTS: None	JOINT INSP. AGENCY: None
WEATHER: Clear	INSPECTOR'S SIGNATURE:

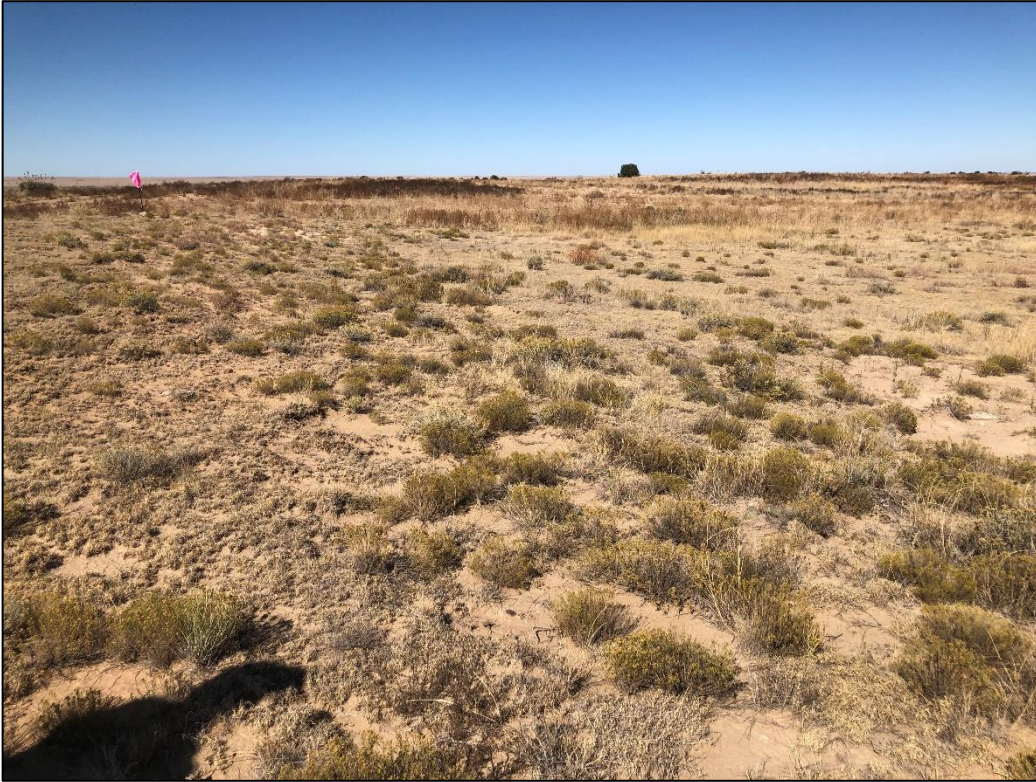
Photo 1. View looking northwest at southeastern edge of permit area showing slopes graded 4H:1V or flatter with good vegetative cover.

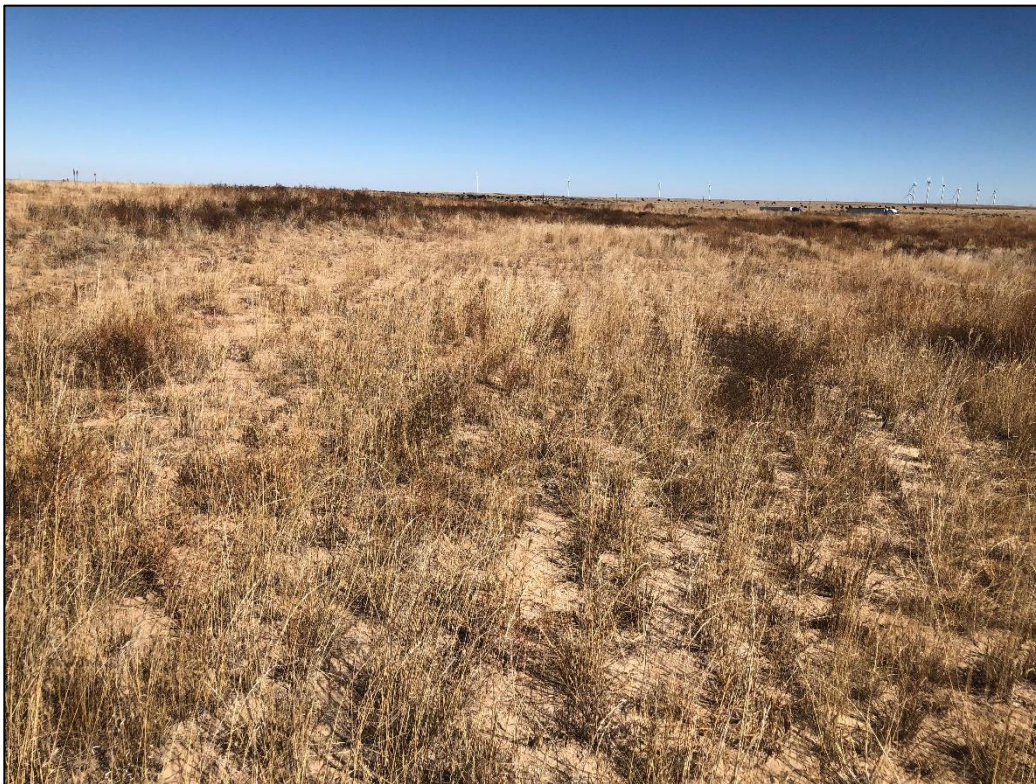
Photo 2. View looking northeast across central portion of permit area, showing slopes graded 4H:1V or flatter with good vegetative cover.

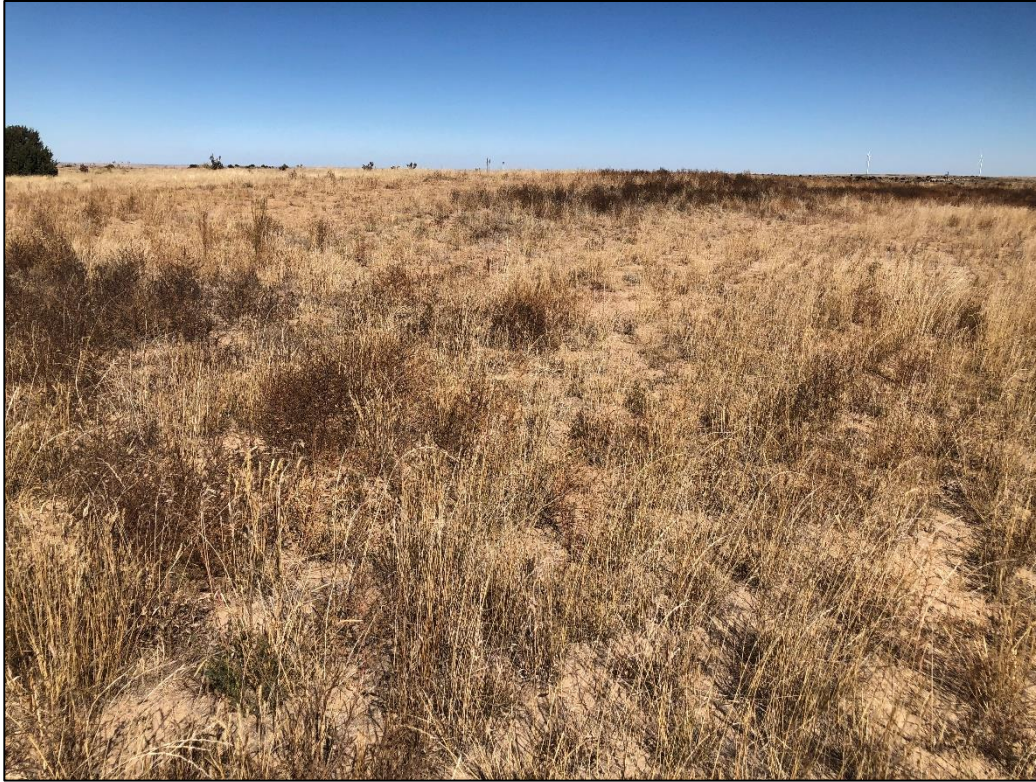
Photo 3. View looking north across northern portion of permit area, showing slopes graded 4H:1V or flatter with good vegetative cover.

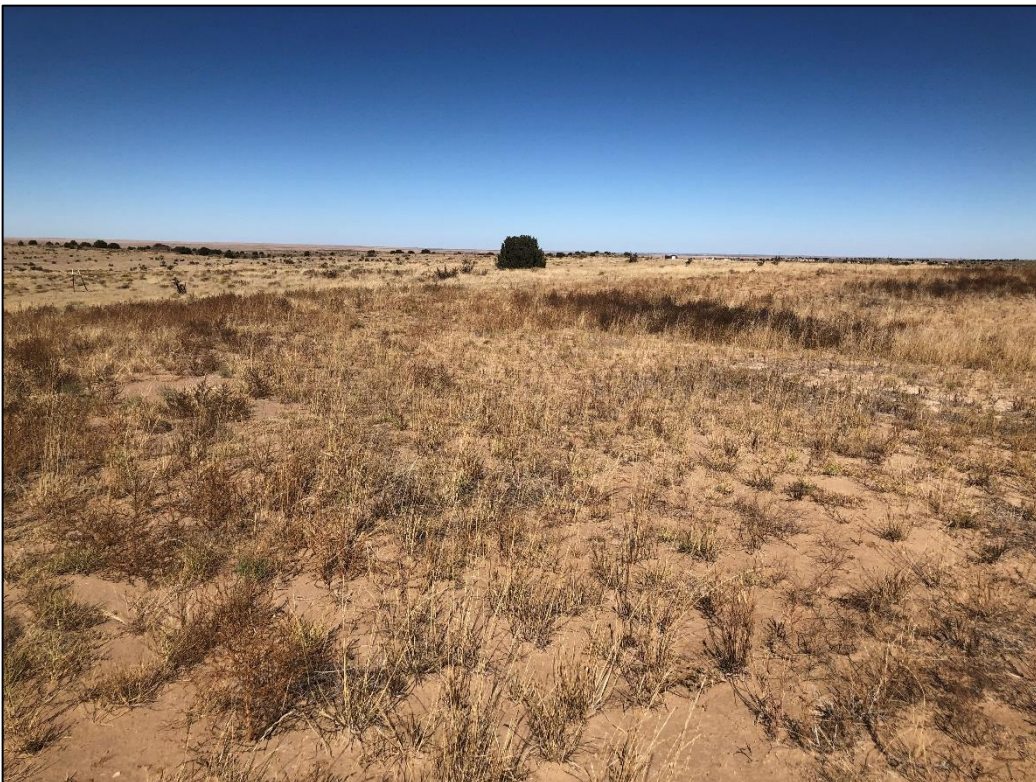
Photo 4. View looking north across northwestern edge of permit area, showing slopes graded 4H:1V or flatter with good vegetative cover.

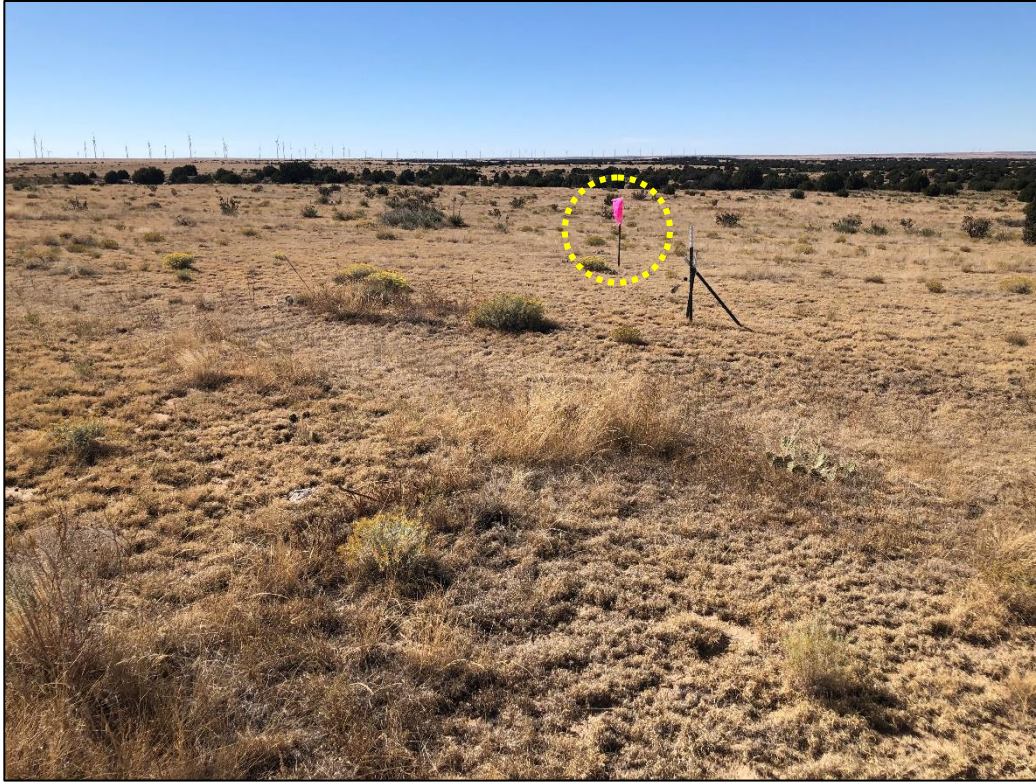
Photo 5. View looking west across northwestern corner of permit area, showing slopes graded 4H:1V or flatter with good vegetative cover. Note t-post with pink flag in background (circled) marking northwestern corner of permit boundary.

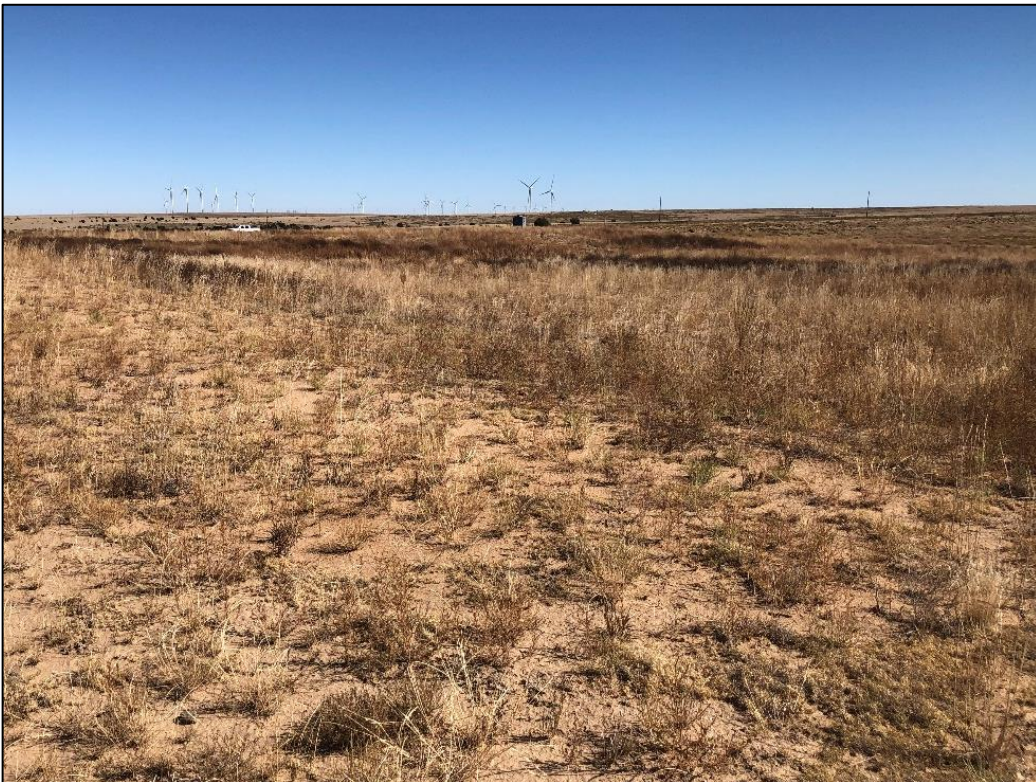
Photo 6. View looking north across northwestern edge of permit area, showing slopes graded 4H:1V or flatter with good vegetative cover.

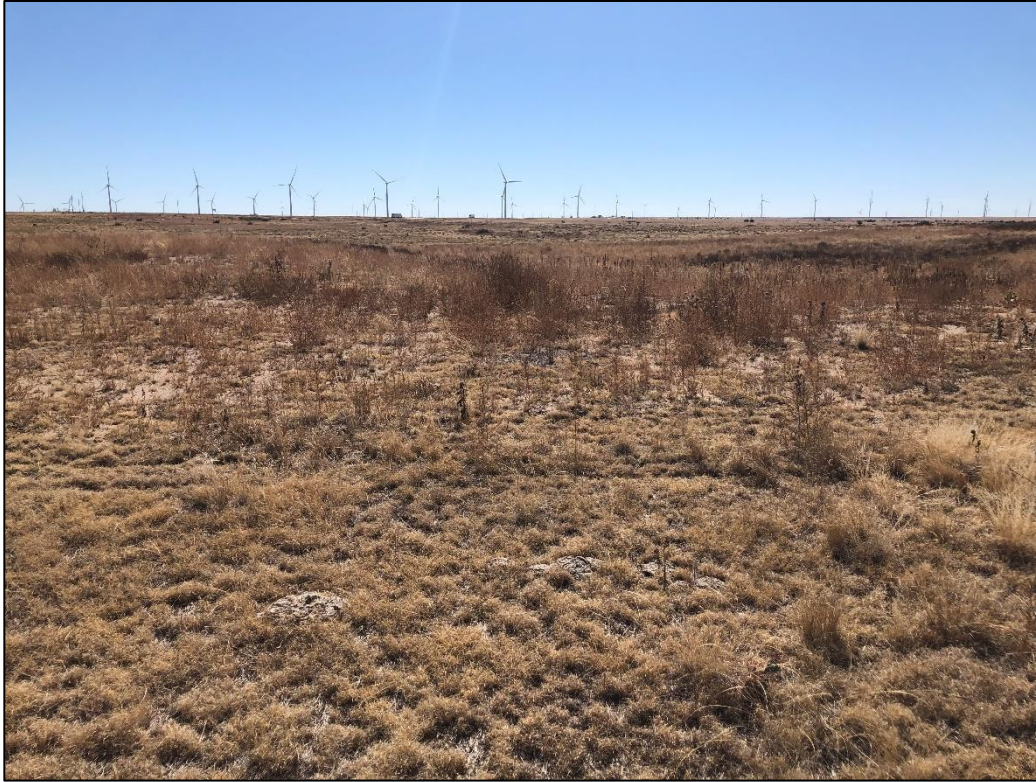
Photo 7. View looking southeast across permit area from its northwestern edge, showing slopes graded 4H:1V or flatter with good vegetative cover.

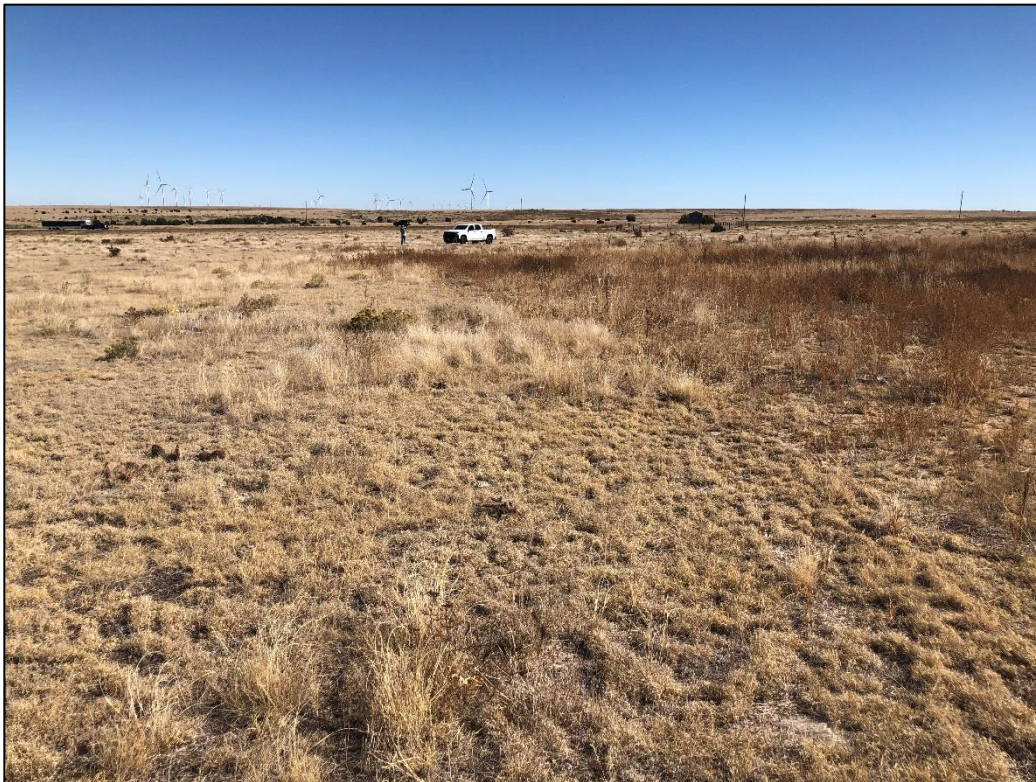
Photo 8. View looking northeast across northeastern corner of permit area, showing slopes graded 4H:1V or flatter with good vegetative cover.

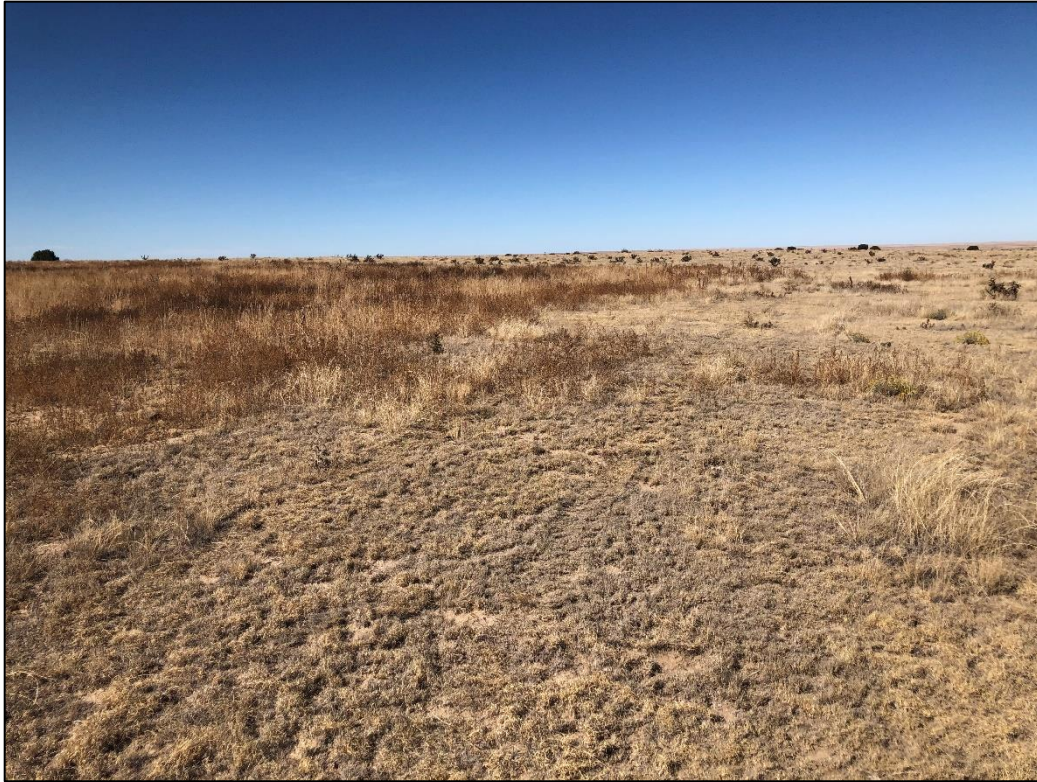
Photo 9. View looking northwest across northeastern edge of permit area, showing slopes graded 4H:1V or flatter with good vegetative cover.

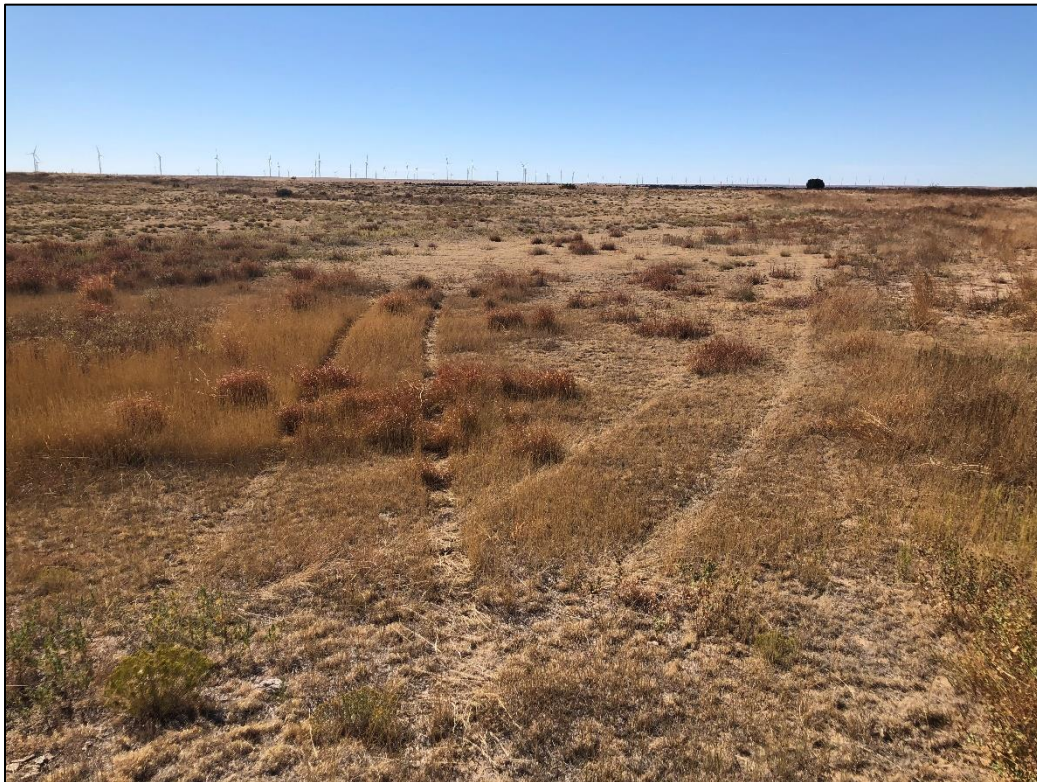
Photo 10. View looking southwest across southeastern edge of permit area, showing slopes graded 4H:1V or flatter with good vegetative cover.
