MINERALS PROGRAM INSPECTION REPORT
PHONE: (303) 866-3567

MINE NAME: Yocam Borrow Pit	MINE/PROSPECTING ID#: M-2018-020	MINERAL: Borrow material for d	COUNTY: Morgan
INSPECTION TYPE: Monitoring	INSPECTOR(S): Brock Bowles	INSP. DATE: October 15, 2021	INSP. TIME: 09:00
OPERATOR: Castle Rock Construction Company of Colorado, LLC	OPERATOR REPRESENTATIVE: Darren Janssen	TYPE OF OPERATION: 111 - Construction by Goverment Agency	
REASON FOR INSPECTION: Normal I&E Program	BOND CALCULATION TYPE: None	BOND AMOUNT: \$42,500.00	
DATE OF COMPLAINT: NA	POST INSP. CONTACTS: None	JOINT INSP. AGENCY: None	
WEATHER: Clear	INSPECTOR'S SIGNATURE:

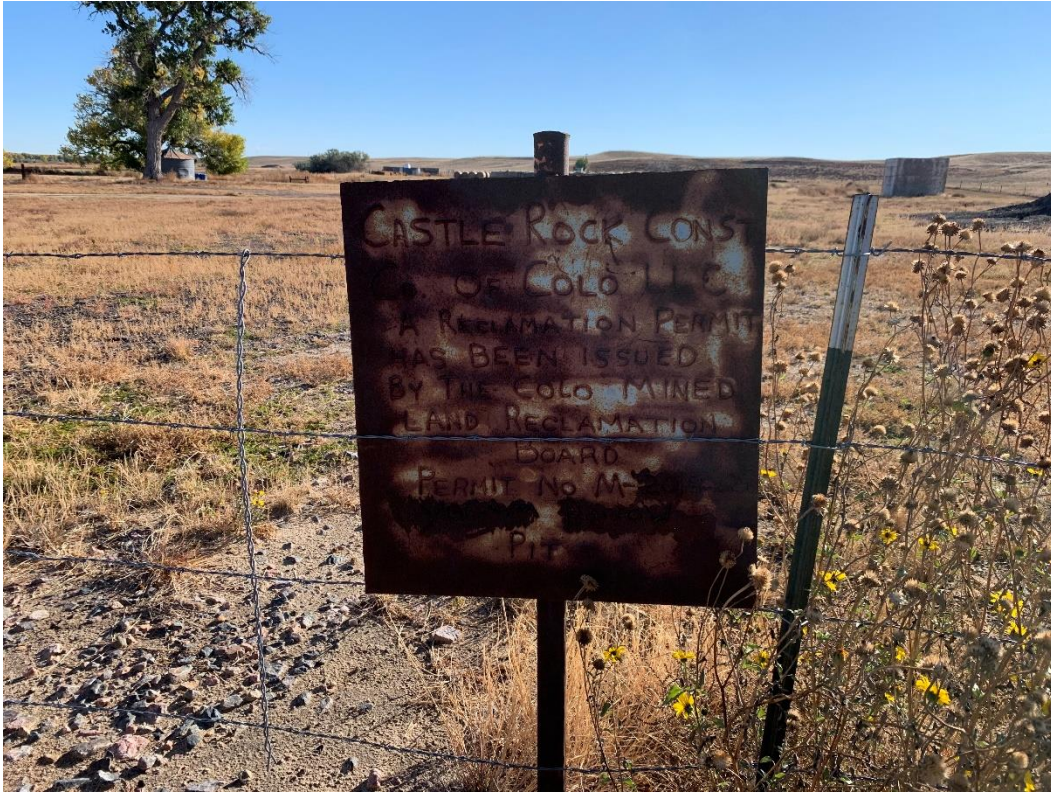
The permit entrance sign was in place (photo 1) and the permit boundary was marked with an electric fence. The fence was open upon arrival.

Photo 1 – Mine entrance sign

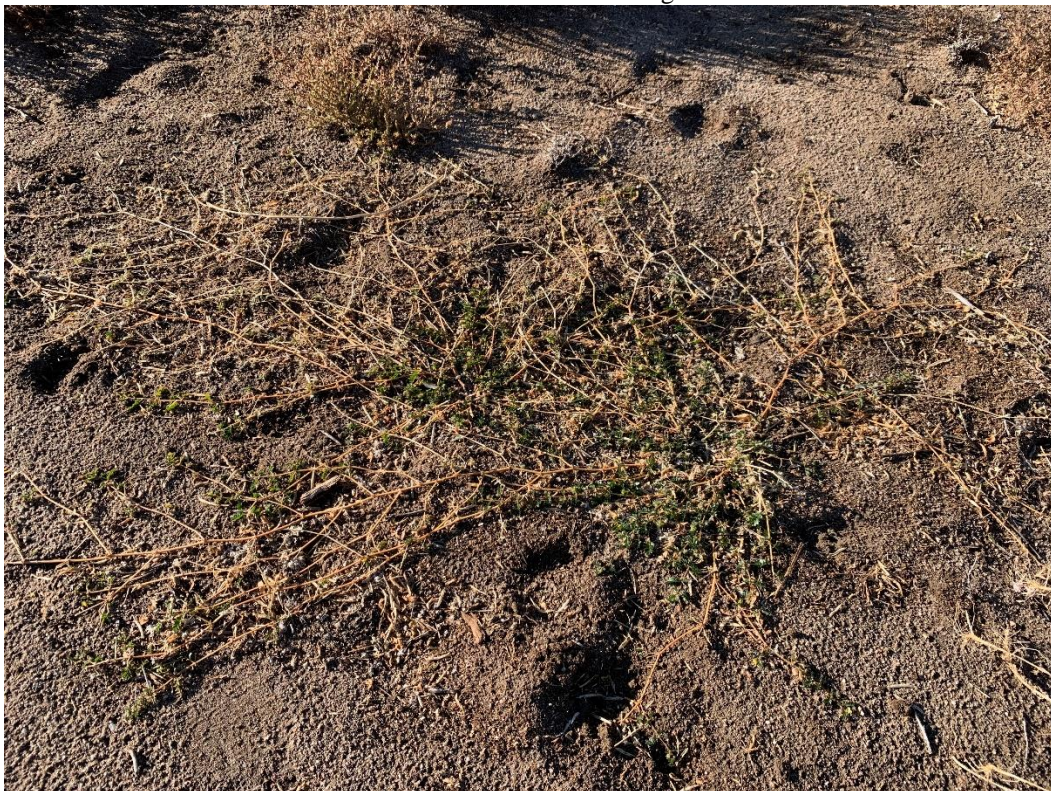
Many puncturevine plants were seen in the reclamation (photo 2). Puncturevine is a List C species on the CO Dept. of Ag Noxious Weed List. The puncturevine needs to be treated.

Photo 2 – Puncturevine plant

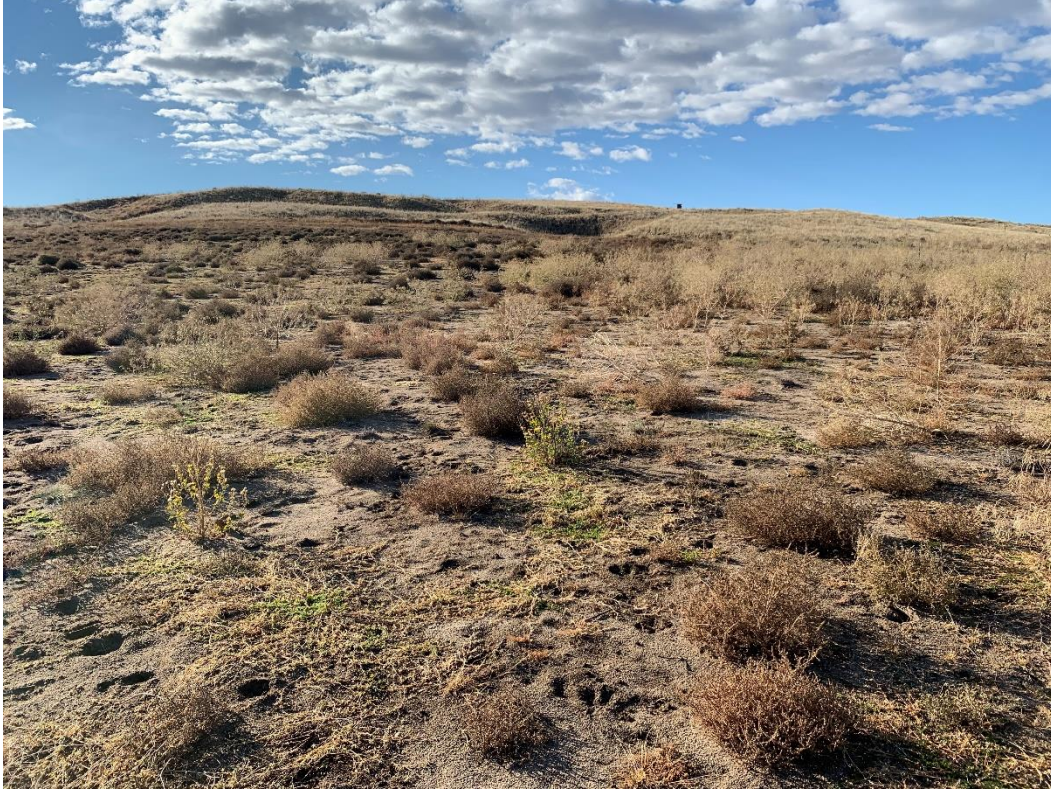
The site is basically in the same condition as it was during the last inspection (photo 3). It appears that cattle have been heavily grazing the site before the vegetation can get established. The Operator should consider re-seeding the site and keep the cattle off the reclaimed area for at least 2-4 years to give the plants time to get established. The length of time is dependent on the amount of precipitation received over the next couple of years and keeping cattle off the reclamation.

Photo 3 – South side of reclamation area
