MINERALS PROGRAM INSPECTION REPORT
PHONE: (303) 866-3567

| MINE NAME: Equity Exploration Project | MINE/PROSPECTING ID#: P-2011-010 | MINERAL: Silver, gold, lead and | COUNTY: Mineral |
| INSPECTION TYPE: Monitoring | INSPECTOR(S): Lucas West | INSP. DATE: October 12, 2021 | INSP. TIME: 08:00 |
| OPERATOR: Rio Grande Silver, Inc. | OPERATOR REPRESENTATIVE: Randy McClure | TYPE OF OPERATION: MP - Mineral Prospecting | |

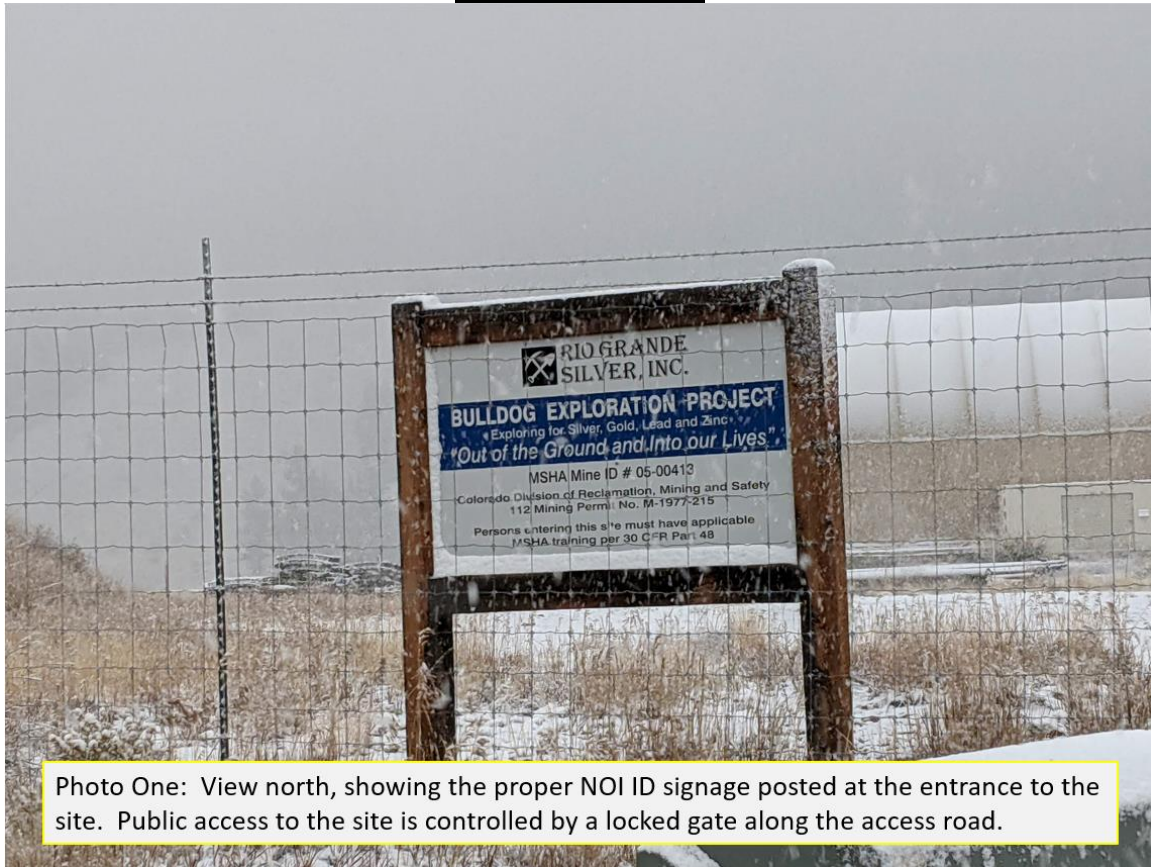
The site was not active the day of the inspection and no exploration equipment was located on site. The Proper NOI Identification sign was posted at the entrance to the site and can be seen in Photo One. The permit boundaries were clearly identifiable by prominent landmarks around the site. Public access to the site is controlled by a locked gate along the access road. The site consists of 3.8 acres, containing a main access portal, ventilation adit and various support facilities located on the portal pad. The main portal was observed with a locking metal gate closure that was verified secure at the time of the inspection. The portal can be seen in Photo Two. The closure is in excellent condition and no evidence of vandalism or attempted unauthorized entry was observed. The portal does not have an associated discharge or water management facilities. The ventilation adit, shown in Photo Three was also observed to be in excellent condition. It is closed off and secured with a locking metal gate closure and similar to the main portal, showed no signs of damage or vandalism.

Photo One: View north, showing the proper NOI ID signage posted at the entrance to the site. Public access to the site is controlled by a locked gate along the access road.

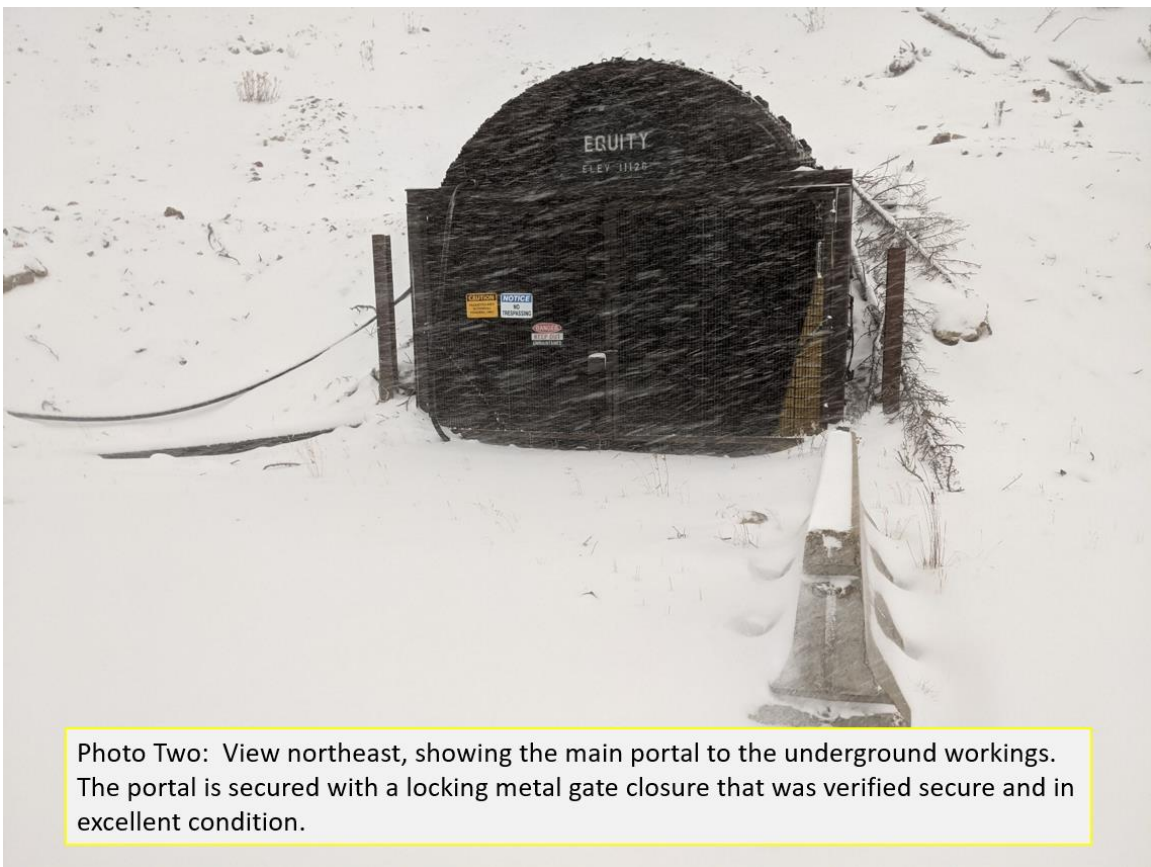
Photo Two: View northeast, showing the main portal to the underground workings. The portal is secured with a locking metal gate closure that was verified secure and in excellent condition.

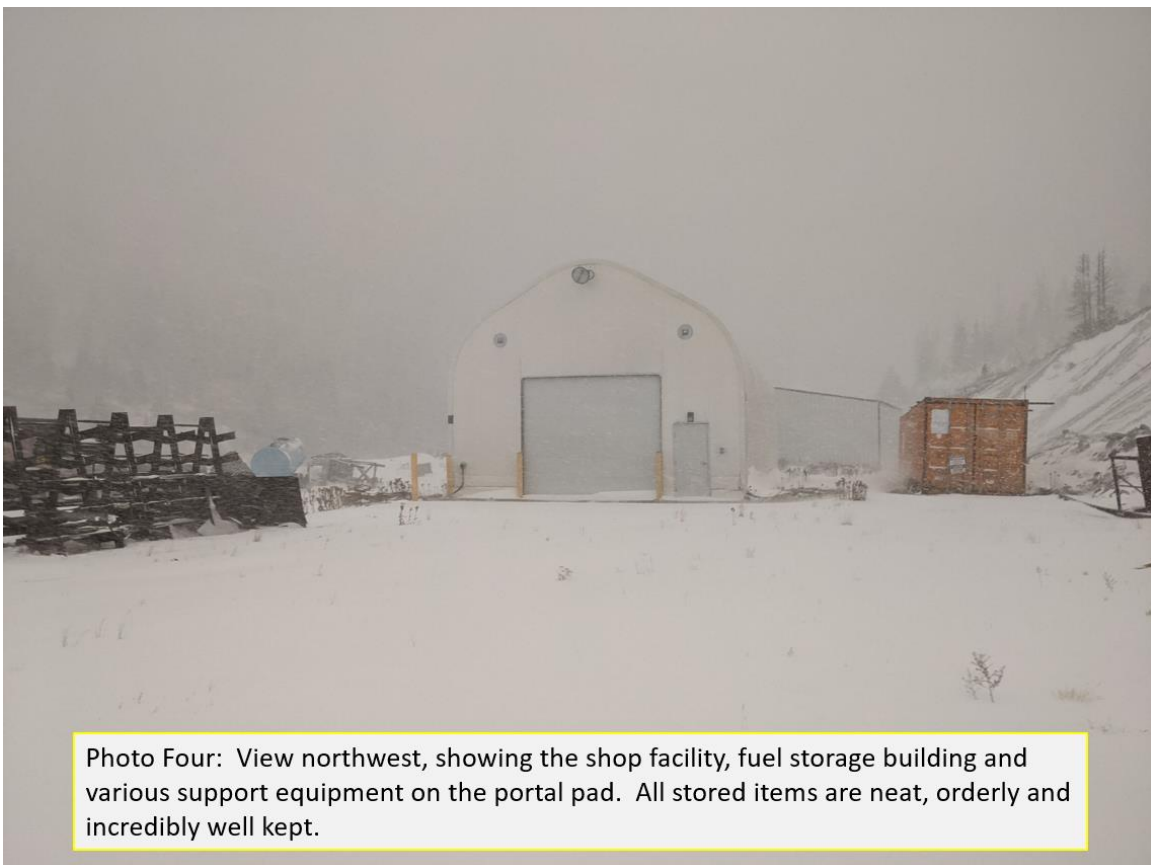
The portal pad contains various support structures for the exploration project including a shop facility, storage containers and fuel storage building. The various structures can be seen in Photo Four. The shop facility was observed to be in excellent condition and mostly empty as exploration activities were not active. The storage container was verified to be secure. Various above ground water storage tanks are located adjacent to the shop and verified to be empty. During active exploration the tanks are used for drilling water underground. On site fuel storage is located just north of the shop building and consists of two large double walled fuel tanks stored within a secure building. The tanks are also stored in a lined secondary containment structure within the building providing for extra spill prevention. An example of the tanks can be seen in Photo Five. The tanks and secondary containment structures are in excellent condition. The tanks were verified to be empty at the time of the inspection.

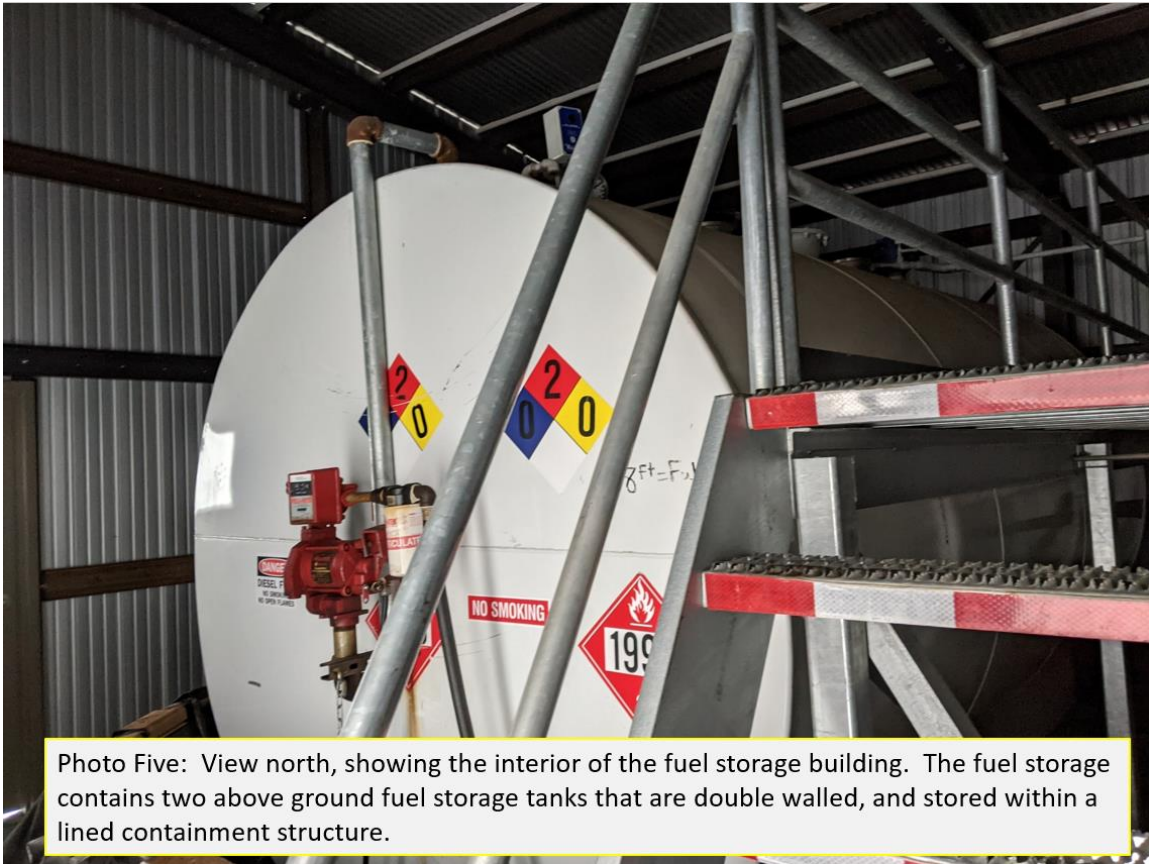
Photo Five: View north, showing the interior of the fuel storage building. The fuel storage contains two above ground fuel storage tanks that are double walled, and stored within a lined containment structure.
