## MINERALS PROGRAM INSPECTION REPORT

<b>MINE NAME:</b> Crystal Pit	<b>MINE/PROSPECTING ID#:</b> M-1989-116	<b>MINERAL:</b> Gravel	<b>COUNTY:</b> Teller
<b>INSPECTION TYPE:</b> Surety Release Inspection	<b>INSPECTOR(S):</b> Timothy Cazier, P.E.	<b>INSP. DATE:</b> September 10, 2021	<b>INSP. TIME:</b> 09:00
<b>OPERATOR:</b> City of Colorado Springs	<b>OPERATOR REPRESENTATIVE:</b> Richard Sebastian-Coleman, Joe Houghton, Kelly Thompson	<b>TYPE OF OPERATION:</b> 110c - Construction Limited Impact	
<b>REASON FOR INSPECTION:</b> Surety Release Requested	<b>BOND CALCULATION TYPE:</b> None	<b>BOND AMOUNT:</b> \$0.00	
<b>DATE OF COMPLAINT:</b> NA	<b>POST INSP. CONTACTS:</b> U.S. Forest Service	<b>JOINT INSP. AGENCY:</b> None	
<b>WEATHER:</b> Clear	<b>INSPECTOR'S SIGNATURE:</b>

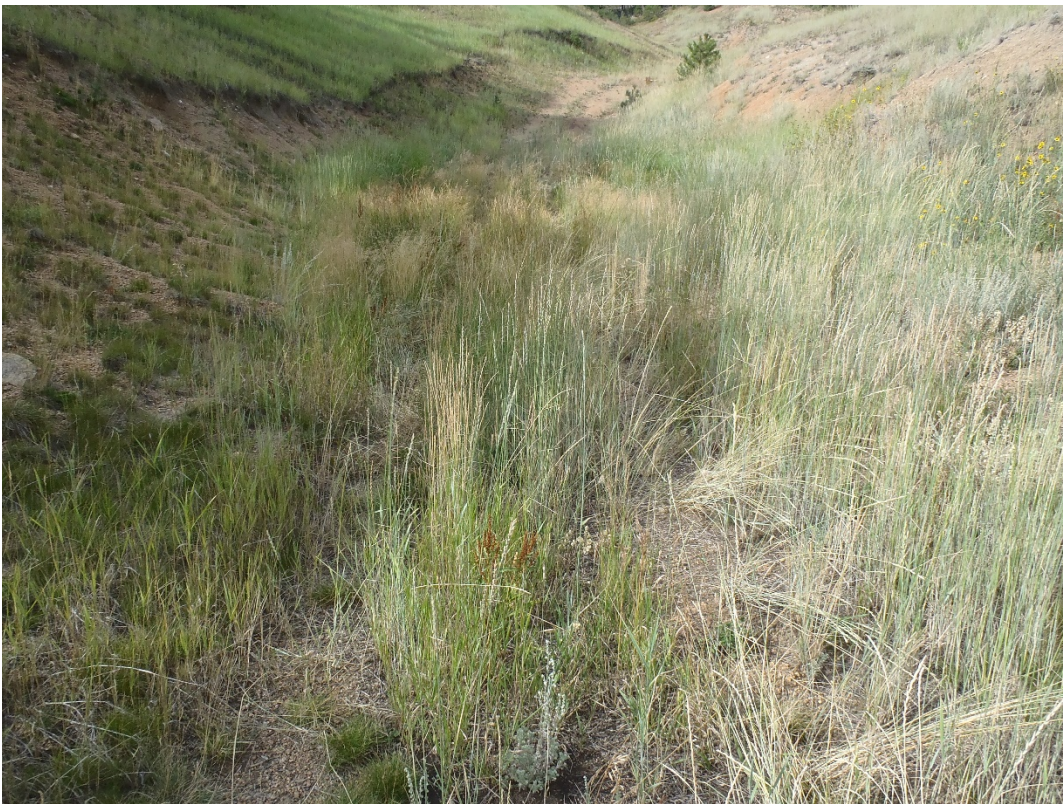
Backfilling and Grading: Backfilling and grading have been completed and appear to be in compliance with the approved reclamation plan (see **Photos 1 and 2**).

Photo 1. East pit – typical finished grading (looking SW from mid-pit area).

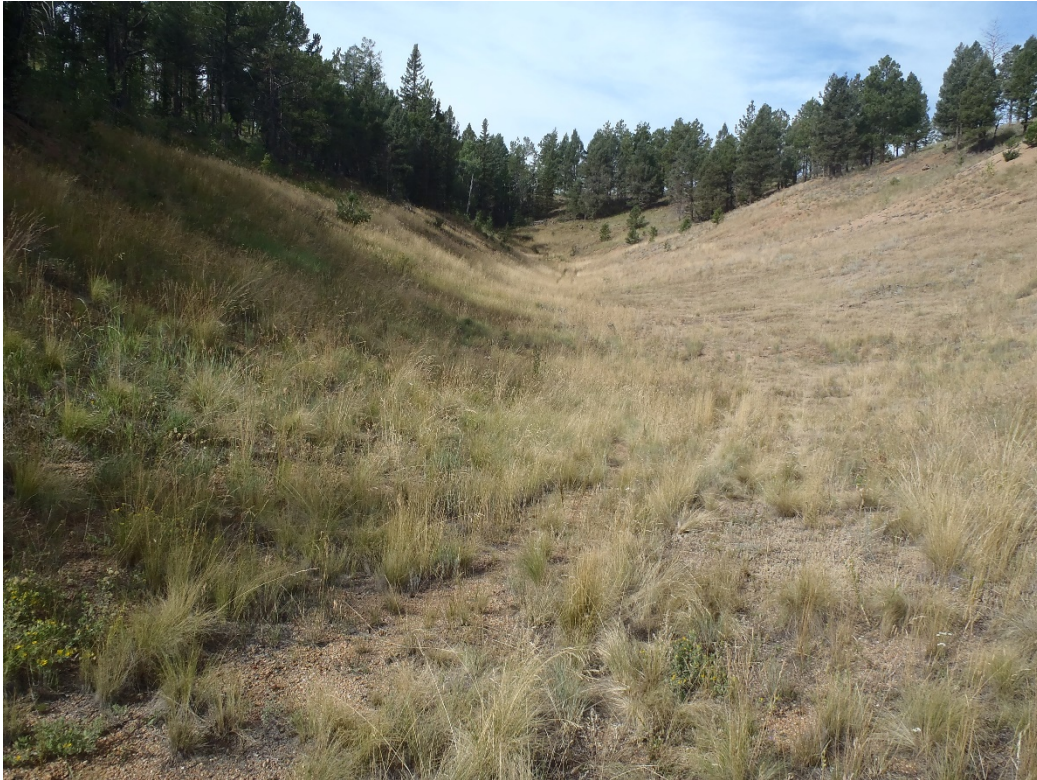
Photo 2. West pit – typical finished grading (looking west from upper pit area).

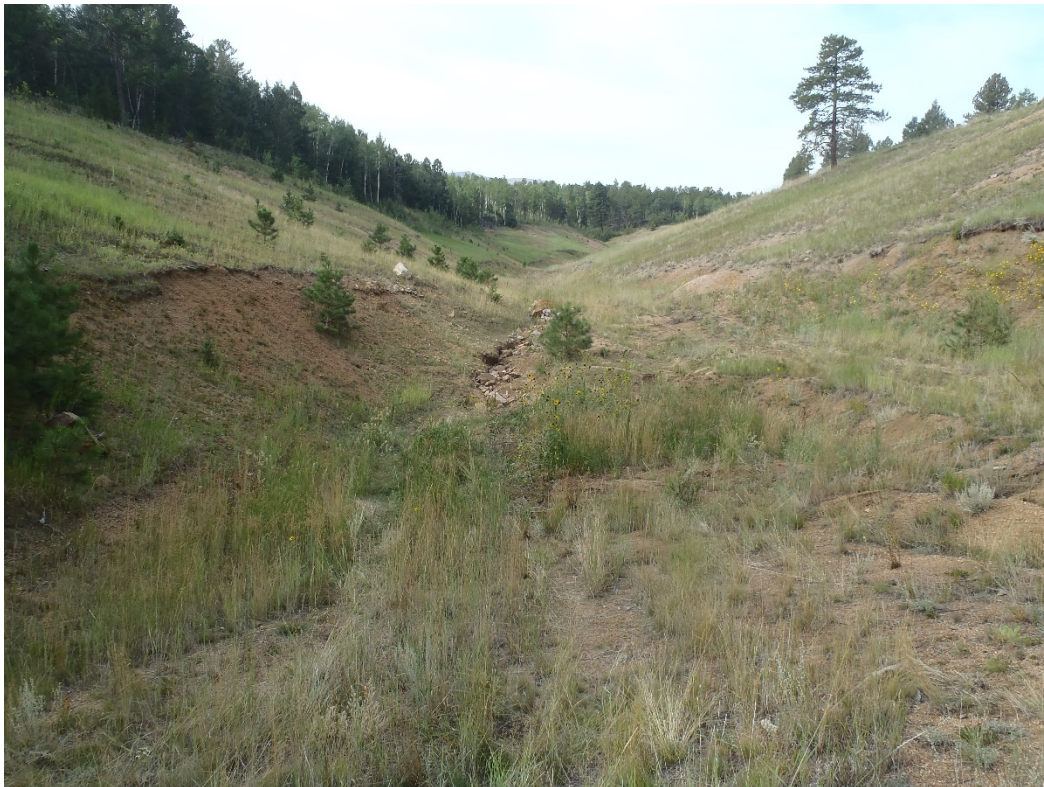
Roads: Haul and access roads were observed to have been reclaimed in both pits (see **Photos 3 and 4**).

Photo 3. East pit reclaimed haul road (looking SW from stormwater basin).

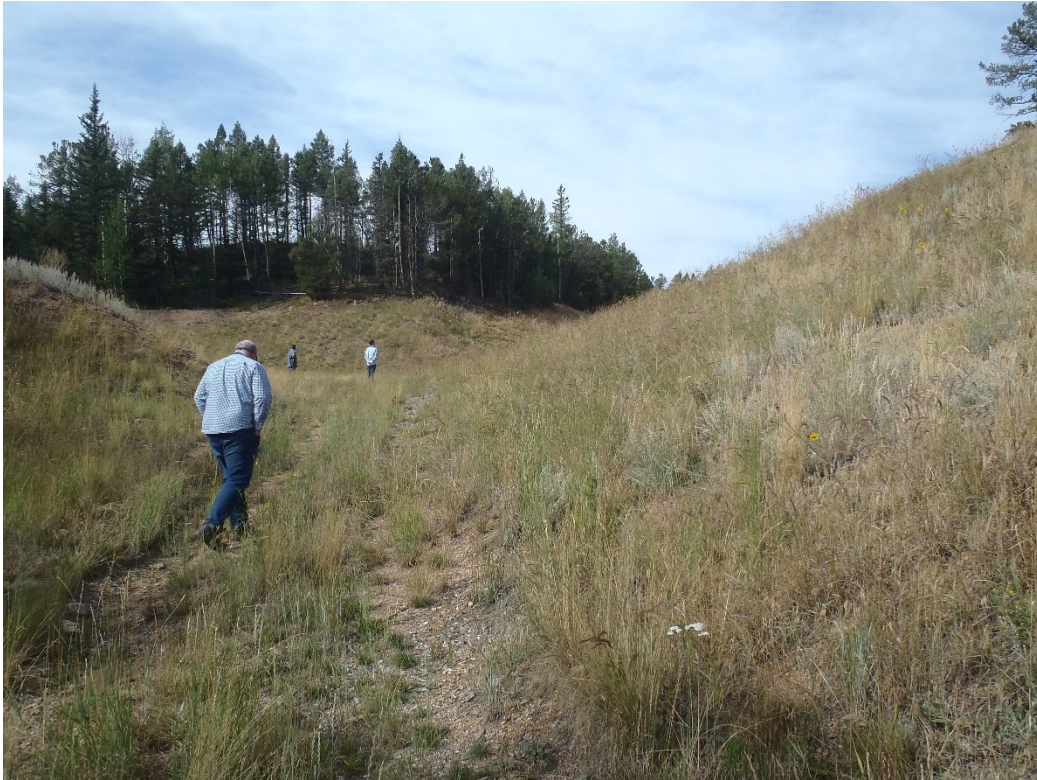
Photo 4. West pit reclaimed haul road (looking west from mid-pit).

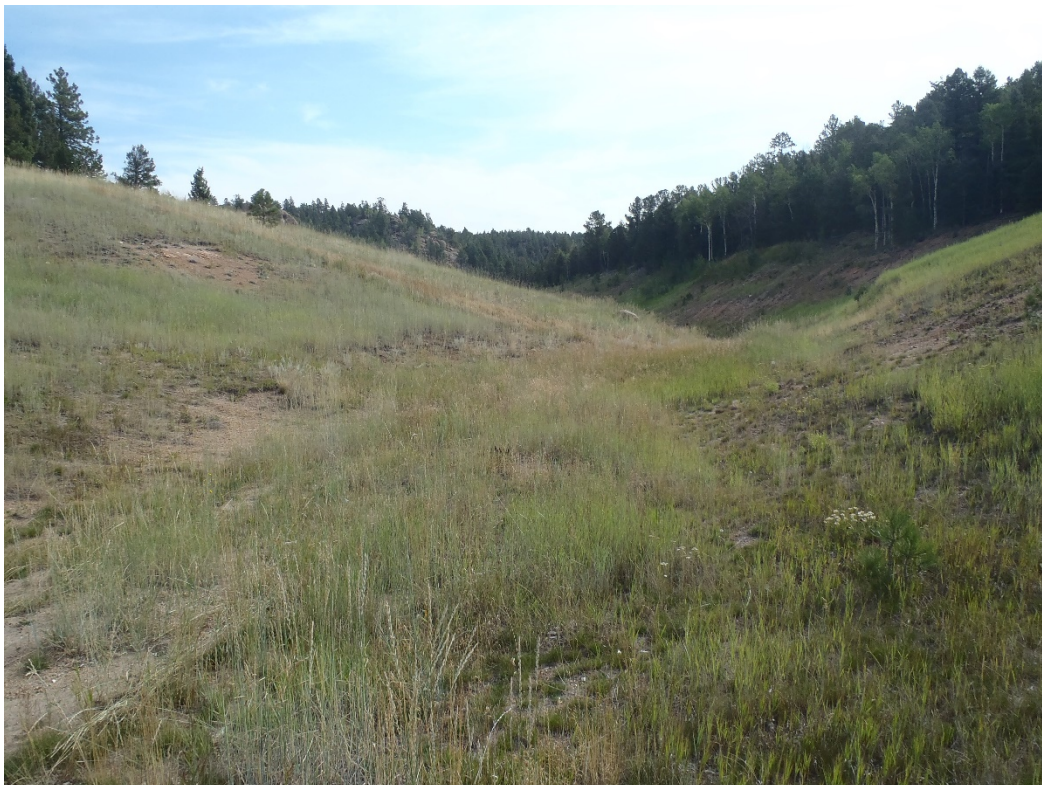
Revegetation: A couple of knapweed plants were observed in the East pit, but not enough to be problematic. Site representatives state Habitat Management had been on site twice this year to treat noxious weeds. The observed vegetation appeared to be diverse and well established in both pits (see **Photos 5 and 6**).

Photo 5. East pit – typical diverse established vegetation (looking NE).

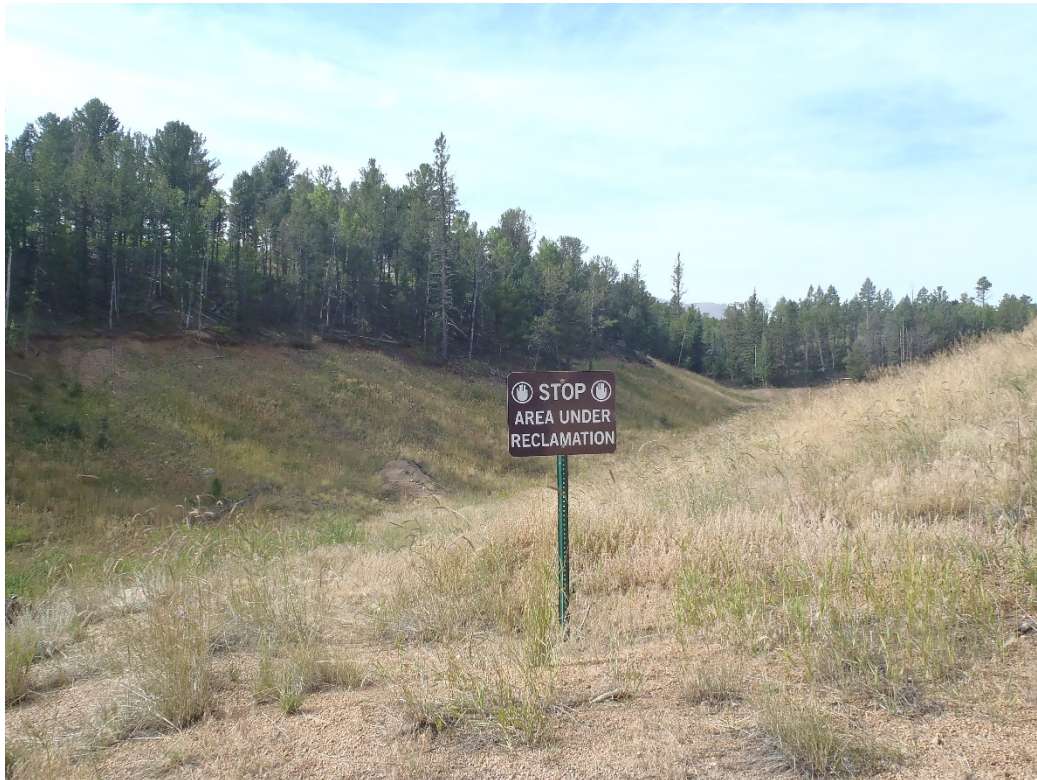
Photo 6. West pit – typical diverse established vegetation (looking SW).

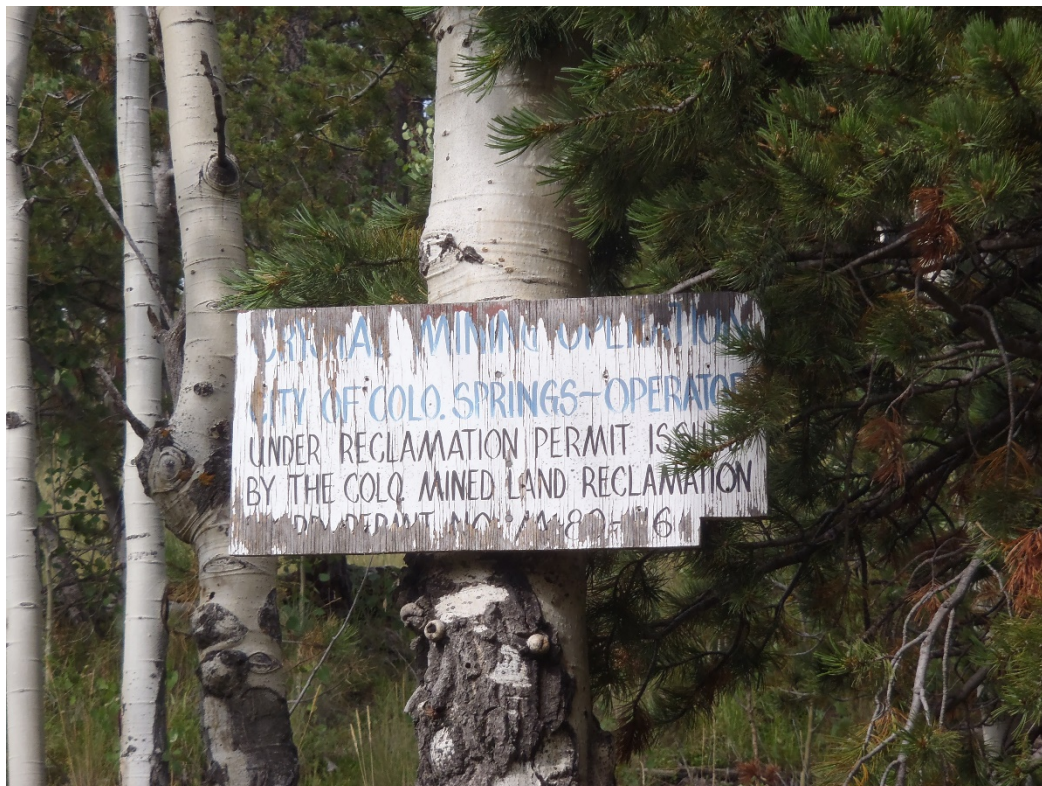
Signs and Markers: The permit sign was properly posted (see **Photo 7**).

Photo 7. Permit sign (near east pit).

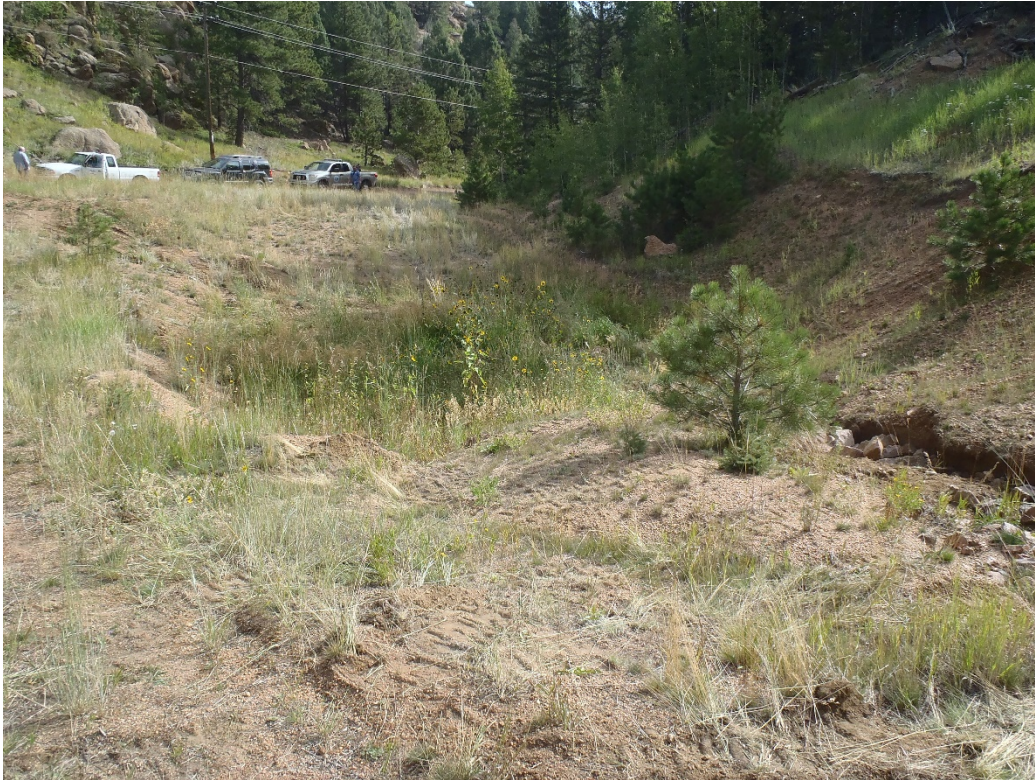
Storm Water MGT Plan: No oil or fuel spills observed. Stormwater basins were observed at the downgradient end of both pits (see **Photos 8** and **9**). Both basins were well vegetated and had outlet points to allow excess flows to discharge offsite.

Photo 8. East pit stormwater basin (looking NE & downgradient).

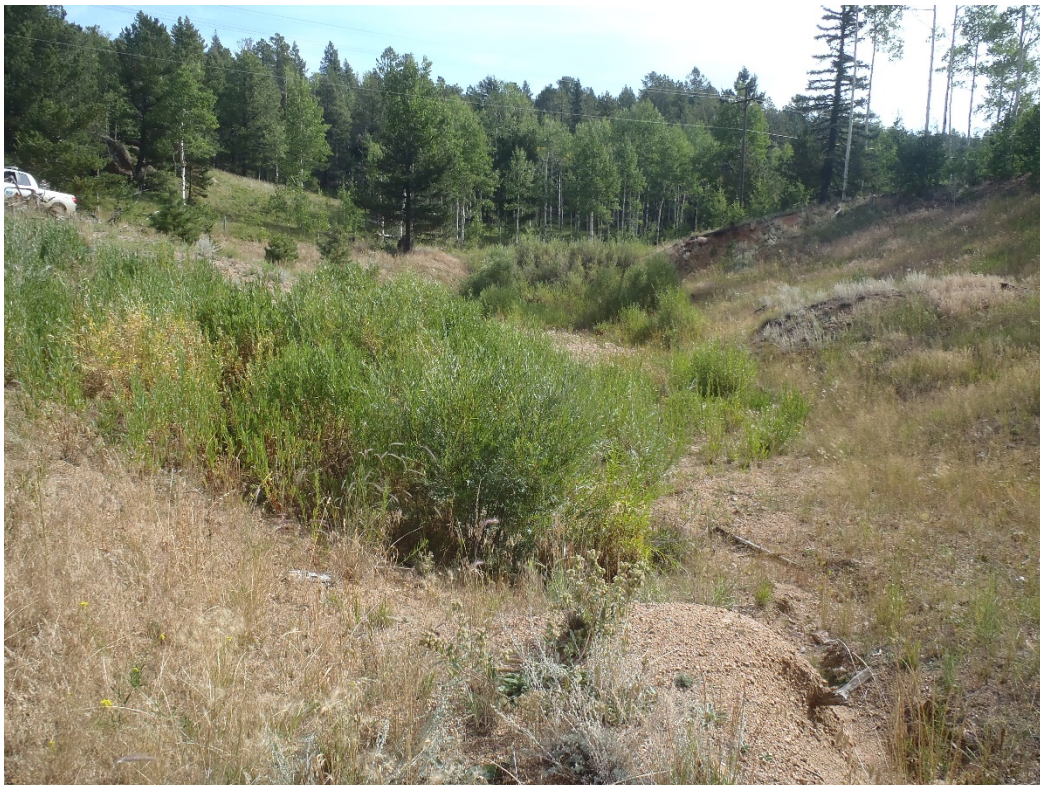
Photo 9. West pit stormwater basin (looking NE & downgradient).
