MINERALS PROGRAM INSPECTION REPORT
PHONE: (303) 866-3567

MINE NAME: Bulldog Mine Operation	MINE/PROSPECTING ID#: M-1977-215	MINERAL: Lead and silver	COUNTY: Mineral
INSPECTION TYPE: Monitoring	INSPECTOR(S): Lucas West	INSP. DATE: October 12, 2021	INSP. TIME: 07:35
OPERATOR: Rio Grande Silver, Inc.	OPERATOR REPRESENTATIVE: Randy McClure	TYPE OF OPERATION: 112d-2 - Designated Mining Operation	
REASON FOR INSPECTION: Normal I&E Program	BOND CALCULATION TYPE: None	BOND AMOUNT: \$163,228.13	
DATE OF COMPLAINT: NA	POST INSP. CONTACTS: None	JOINT INSP. AGENCY: None	
WEATHER: Snowing	INSPECTOR'S SIGNATURE:

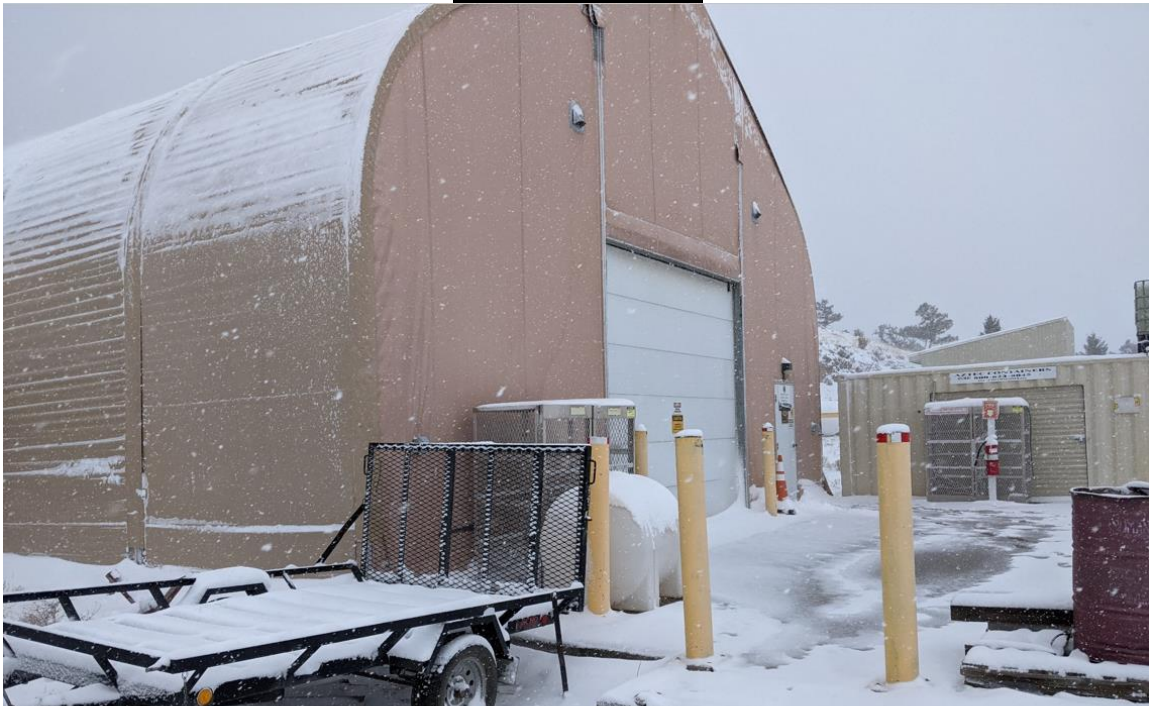
The main facilities adjacent to the office area contains the maintenance shop, shotcrete batch plant building, fuel storage building and materials storage. The shop, shown in Photo One, is a semi-permanent Quonset style building. The building itself is in excellent condition and has had roof repairs done in the recent past. The maintenance shop is currently being utilized by the Mineral County Weed and Pest Department for storage of equipment during county operations, these areas are segregated and extremely well kept in the shop facility. The interior of the shop is in excellent condition and very well kept. The shotcrete batch plant is also being used as an equipment and storage area to keep items out of the elements. The building, similar to the shop is in excellent condition and very well kept. The batch plant building can be seen in Photo Two. On site fuel storage is contained within an enclosed building near the maintenance shop. Within the fuel storage building is a single above ground diesel tank. The tank is double walled, and set within a lined containment structure providing tertiary spill containment. An example of the lined containment system can be seen in Photo Three. The tank and containment structure were in excellent condition at the time of the inspection and the tank was verified to be empty. Various areas around the facilities area are being utilized for mining related materials storage. Materials stored in these areas are well organized and orderly. An example of the storage areas can be seen in Photo Four.

Photo One: View northeast, showing the maintenance shop located at the facilities area. The shop is in excellent condition, despite the semi-permanent building nearing the end of its design life.

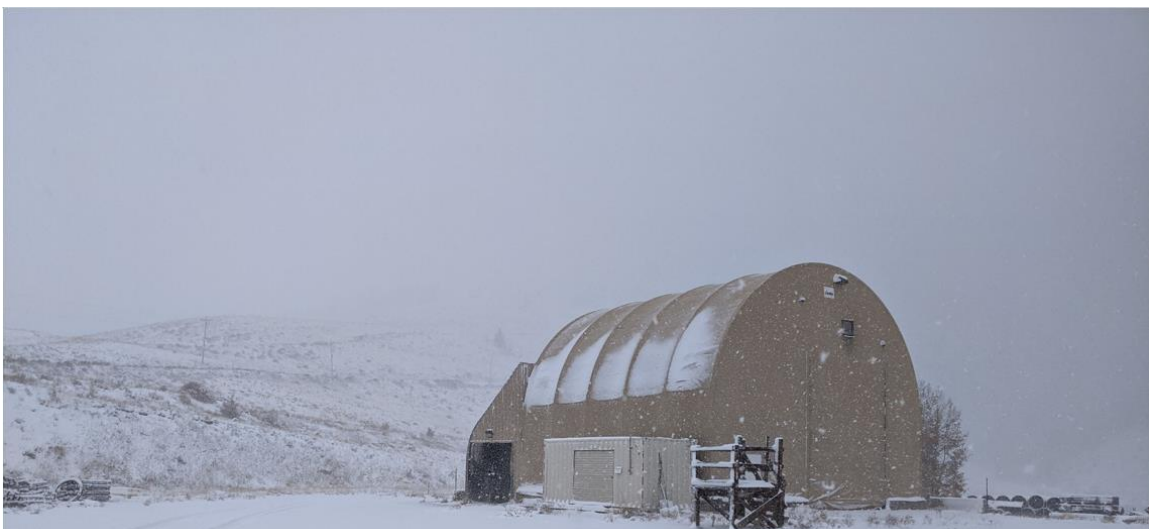
Photo Two: View northwest, showing the shotcrete batch plant building. During operations this facility is used for the production of shotcrete to be used in stabilizing the underground workings. Currently it is being used for equipment storage.

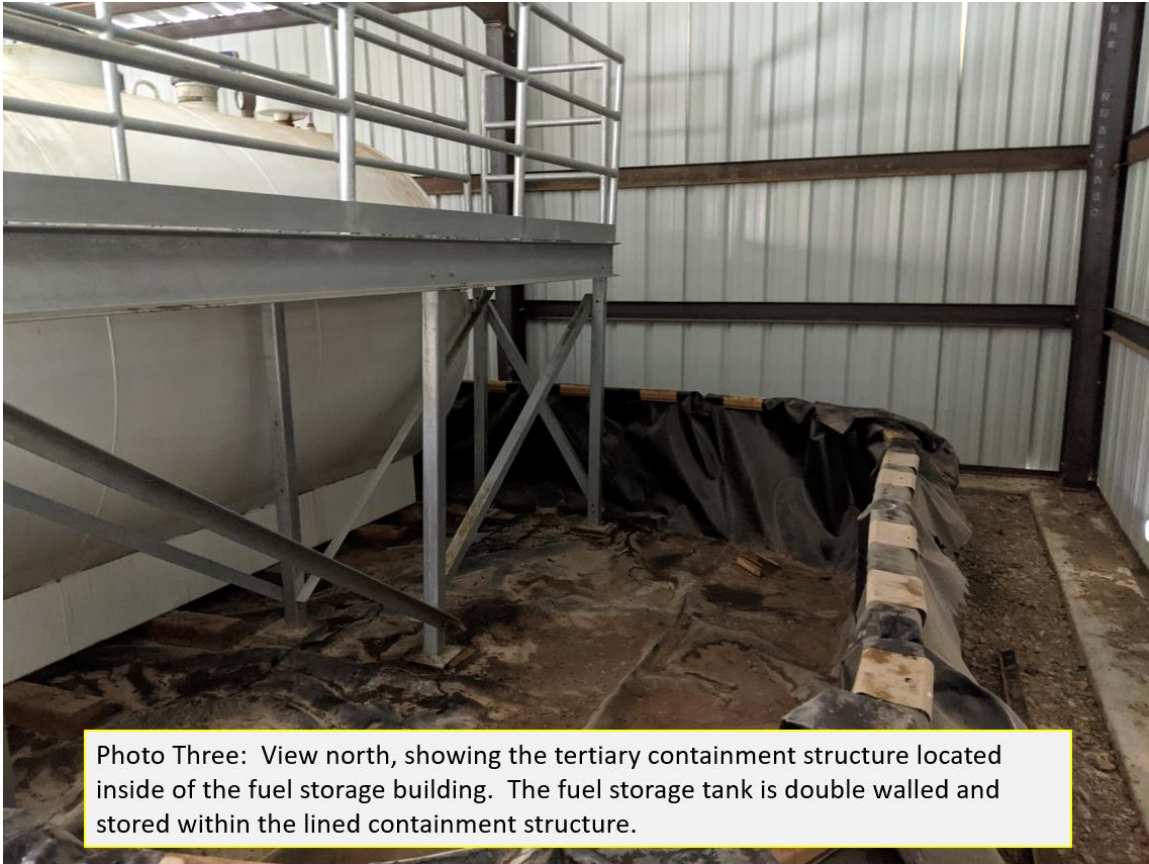
Photo Three: View north, showing the tertiary containment structure located inside of the fuel storage building. The fuel storage tank is double walled and stored within the lined containment structure.

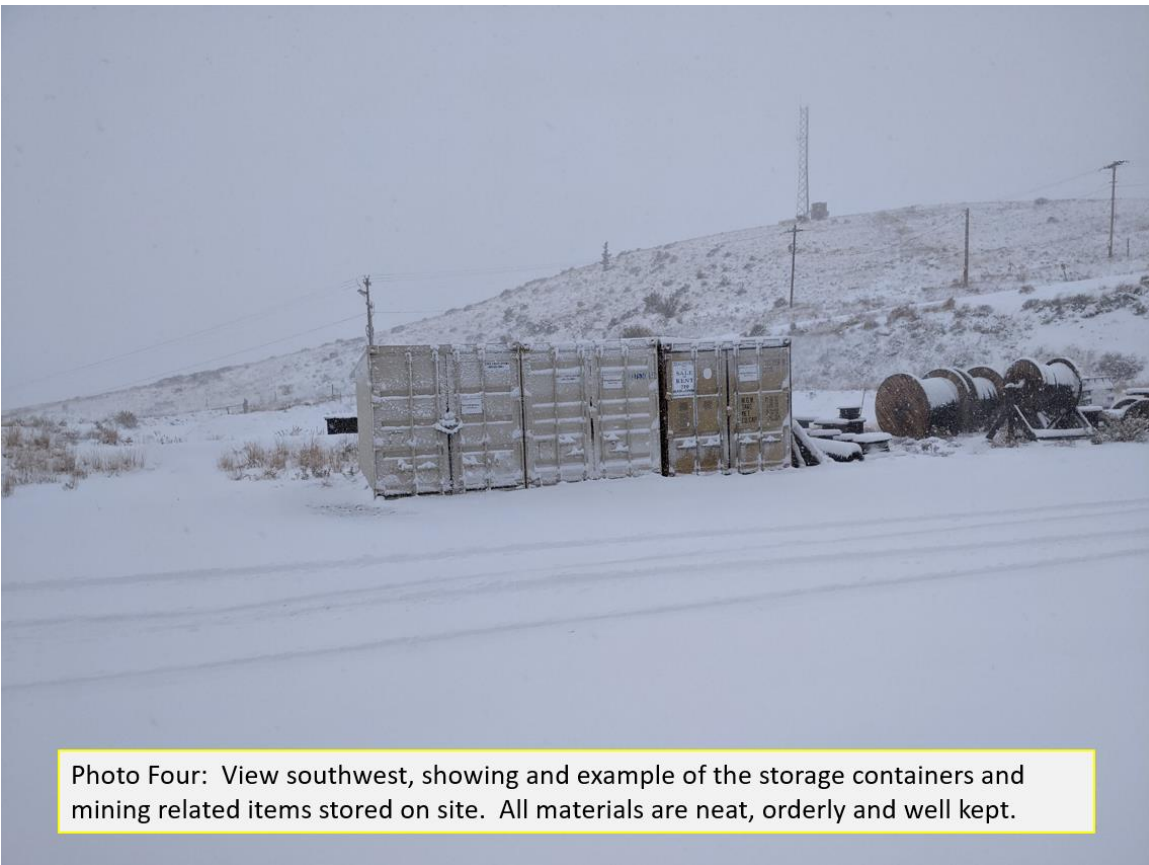
Photo Four: View southwest, showing an example of the storage containers and mining related items stored on site. All materials are neat, orderly and well kept.

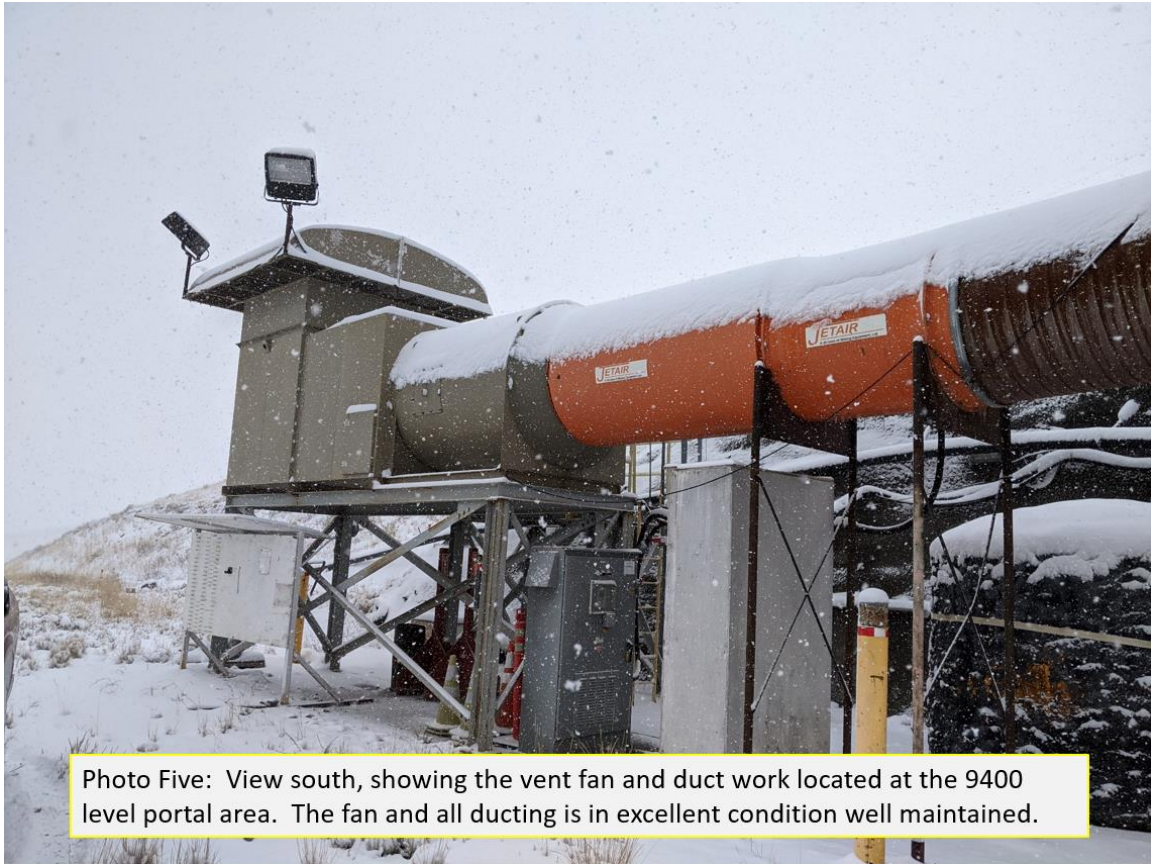
shotcrete. The inspected portion was stable at the time of inspection and in immaculate condition. Various support structures are located on the portal pad area including a ventilation fan with duct work, shown in Photo Five, air compressor and supply lines shown in Photo Six and an electrical power transformer station shown in Photo Seven. All support structures are in excellent working condition. The portal pad and access road were stable at the time of the inspection and no evidence of settling, slumping or significant erosion was noted.

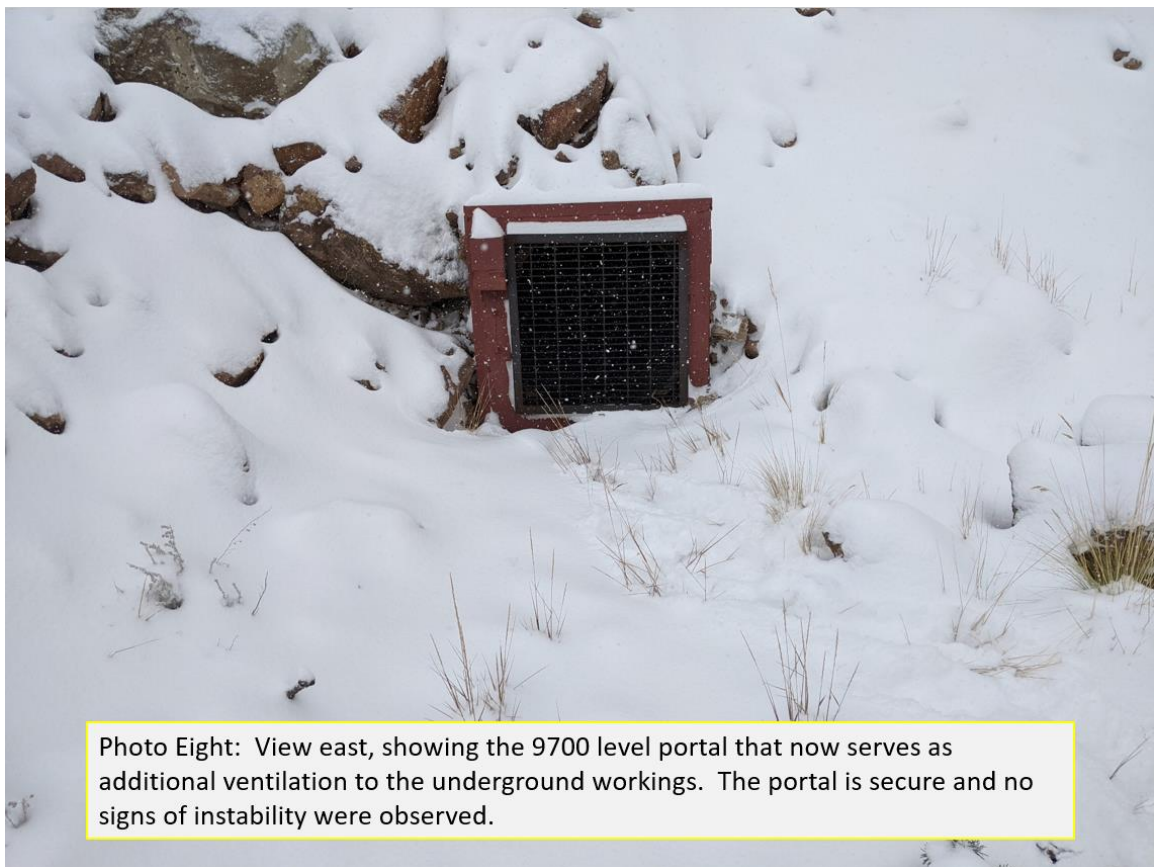
The 9700 level portal, located just up gradient from the 9400 level portal serves as additional ventilation to the underground workings. The portal, shown in Photo Eight, was secure at the time of inspection with a locking steel gated closure. The Closure is in excellent condition and shows no signs of damage or vandalism. The portal pad area was stable at the time, and showed no signs of settling, slumping or erosion. The portal is located in the windy gulch area which is an ephemeral stream system, only flowing in response to runoff or precipitation events. Proper water controls area installed to prevent impact to the affected lands.

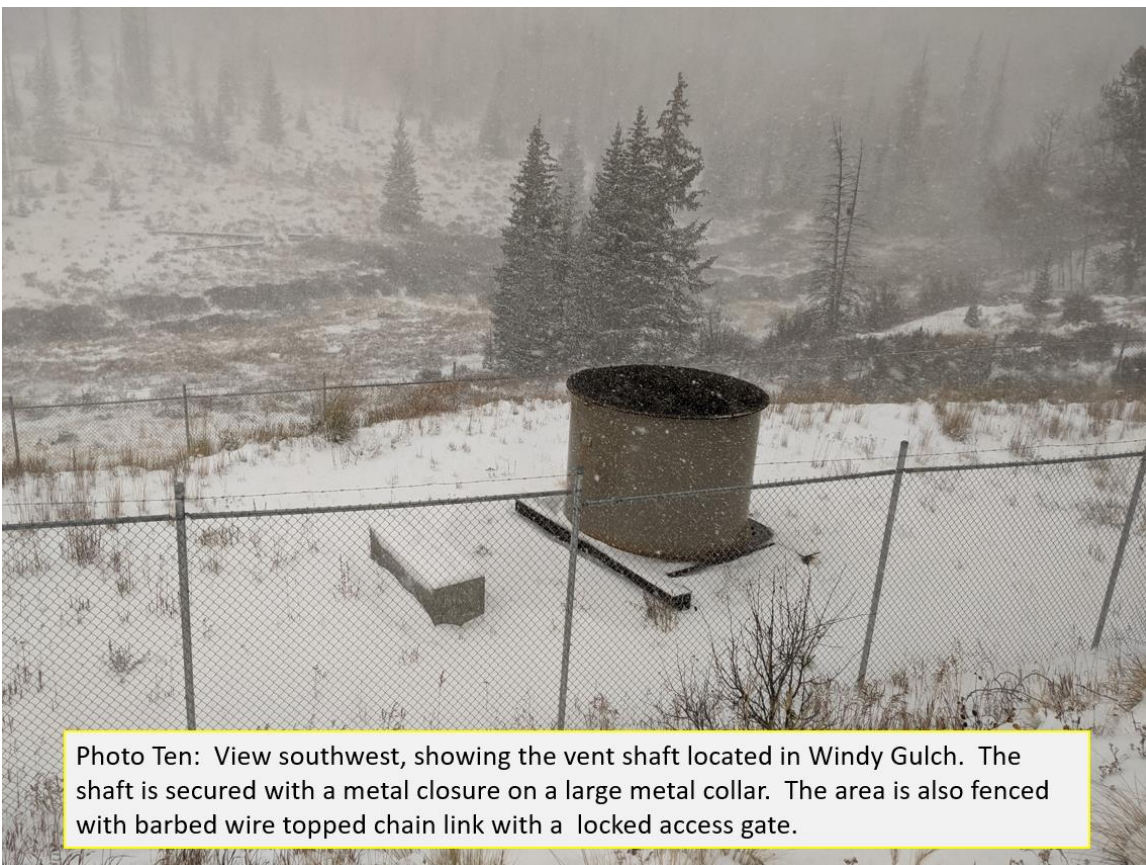
During inspection of the ancillary facilities, the vent shaft located in windy gulch was observed. The vent shaft, shown in Photo Ten, is surrounded by chain link fence with a locking gate to prevent unauthorized entry. The shaft is secured with a large collar and locking closure. The collar and closure are in excellent condition and show no signs of damage or vandalism.
