MINERALS PROGRAM INSPECTION REPORT

MINE NAME: Parkdale Quarry	MINE/PROSPECTING ID#: M-1997-054	MINERAL: Sandstone (silica, stone quartzite), gravel and granite, granite gneiss	COUNTY: Fremont
INSPECTION TYPE: Preoperation Inspection	INSPECTOR(S): Timothy Cazier, P.E.	INSP. DATE: August 9, 2021	INSP. TIME: 11:15
OPERATOR: Front Range Aggregates, LLC	OPERATOR REPRESENTATIVE: Dave Bieber, Phil Courtney, Josh Esquivel	TYPE OF OPERATION: 112c - Construction Regular Operation	
REASON FOR INSPECTION: Surety Related	BOND CALCULATION TYPE: Partial Bond	BOND AMOUNT: \$1,174,724.00	
DATE OF COMPLAINT: NA	POST INSP. CONTACTS: None	JOINT INSP. AGENCY: None	
WEATHER: Clear	INSPECTOR'S SIGNATURE:

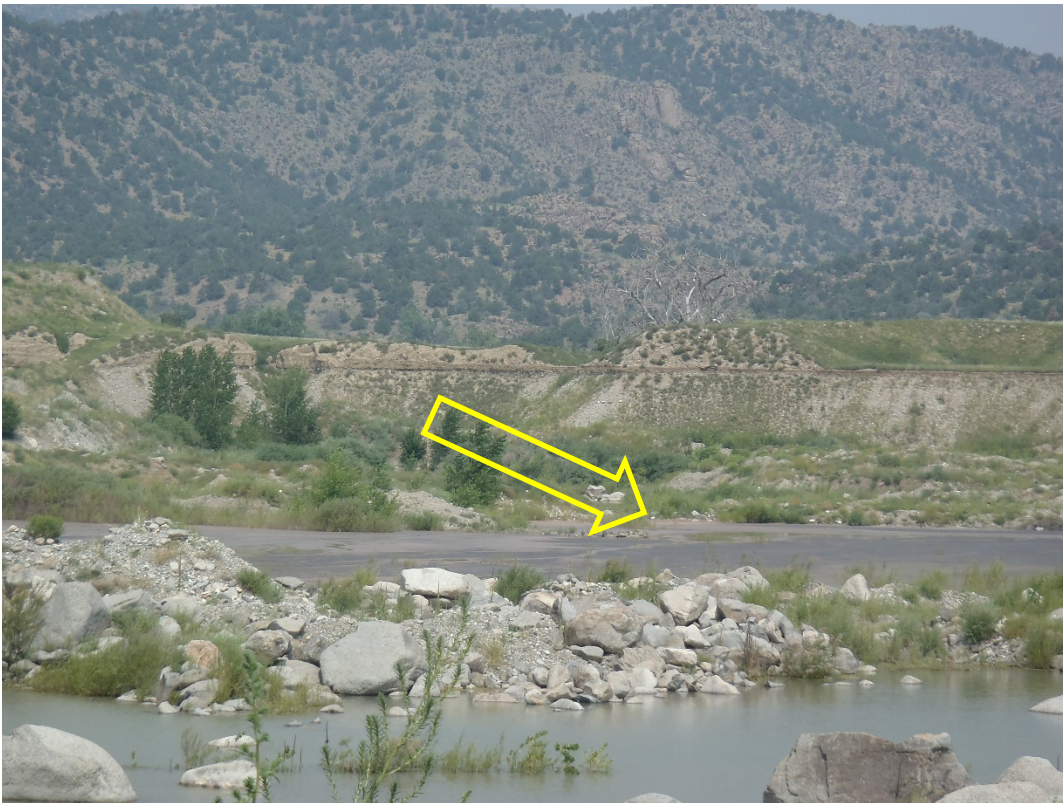
Alluvial Quarry Reclamation Status: Mr. Bieber confirmed the AM2 reclamation plan in to backfill the alluvial pit with the exception of a 15-acre (Reference Exhibit L) water storage area in the northwest corner. The alluvial quarry was observed to have backfill placed both via discharged wash fines (see **Image 1**) and combination of solid crusher fines and oversize rock (see **Image 2**). Based on site observations and Google Earth measurements, the DRMS estimates a little more than 40 acres of the alluvial pit requires backfill. The average 15-foot depth of fill stated in Exhibit L is acceptable. The Permittee is required to backfill at least two feet above the seasonal high groundwater elevation. Mr. Bieber indicated MMM plans to fill the alluvial quarry to at or near the surrounding area elevation.

Image 1. NW area of Alluvial Pit with washer fines discharge/backfill (looking NW).

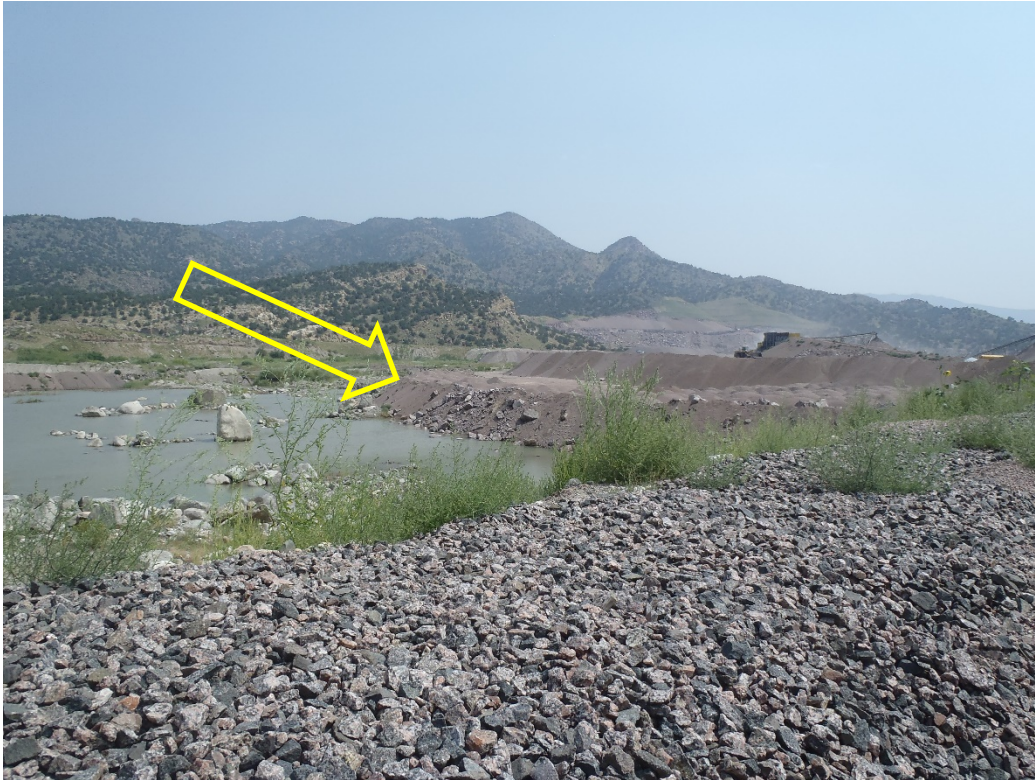
Image 2. SE area of Alluvial Pit with crusher fines/oversize backfill (looking NE).

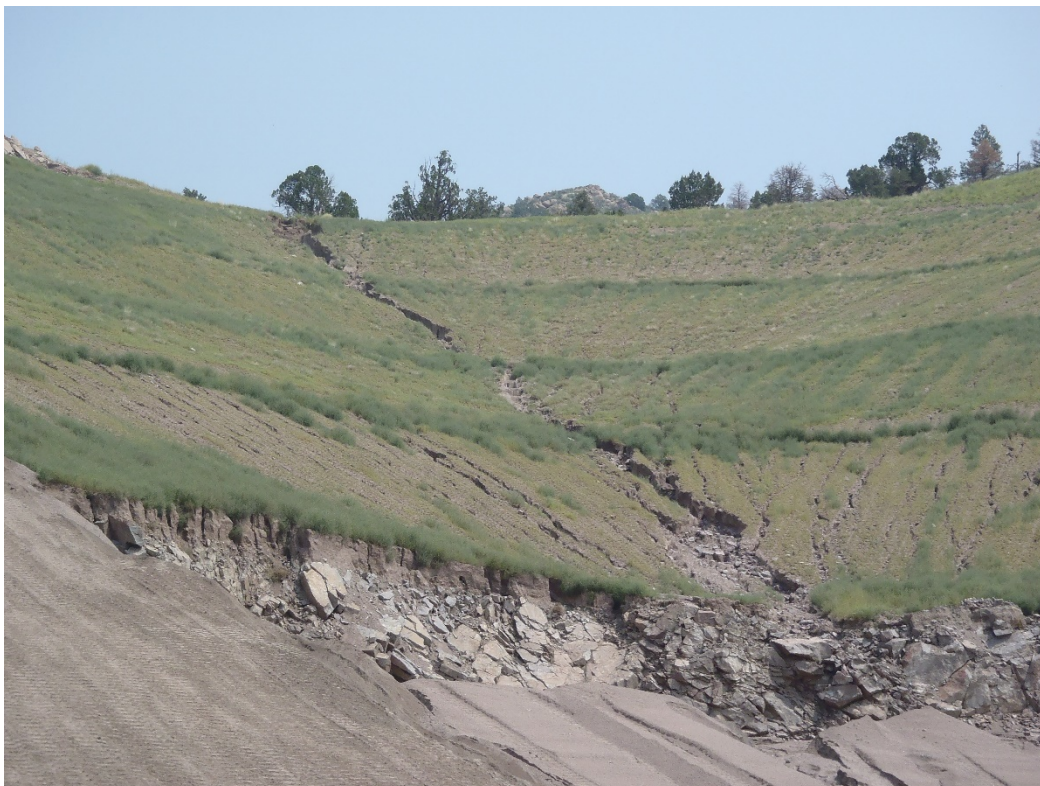
Existing Granite Quarry Reclamation Status: The DRMS was concerned about erosion on the reclaimed portion of the highwall (see **Image 3**). Mr. Bieber explained this area is under temporary reclamation as Phase 6 of the proposed AM2 mine plan will re-disturb this area. As this area is not under final reclamation and MMM is onsite to perform maintenance as necessary, the erosion (from which no offsite impact was observed) was not cited as a problem. [The DRMS recommends MMM recover any eroded growth media and stockpile it for future reclamation.](#)

Image 3. Erosion in reclaimed existing Granite Quarry (Looking NE).

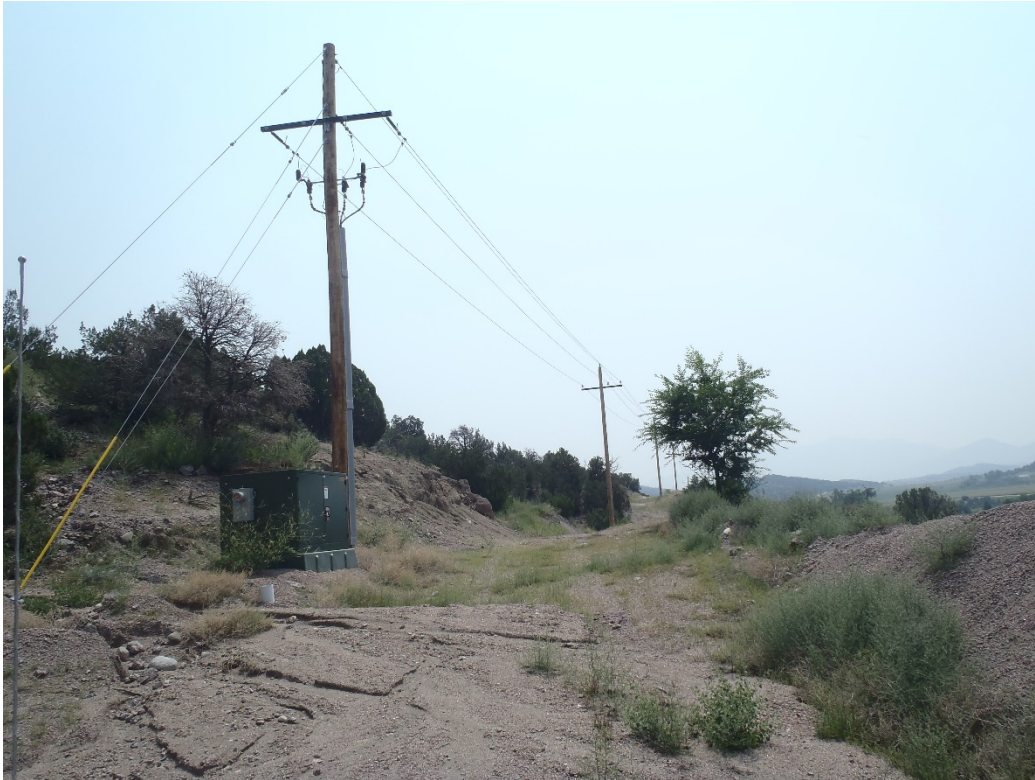
Additional Structures: Southeast of the existing Granite Quarry, Black Hills Energy has extended a power line (see **Image 4**). MMM is currently in the process of addressing this structure in accordance with Rule 6.4.19.

Image 4. New Black Hills power line SE of existing Granite Quarry (looking SW).

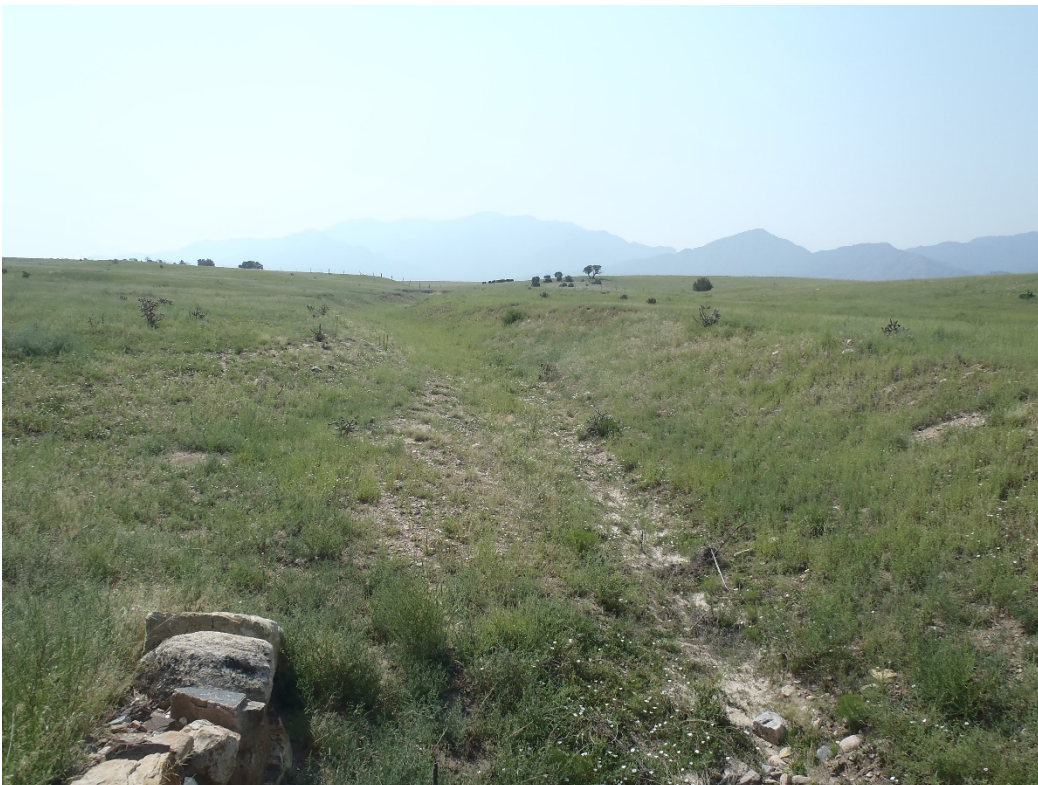
Webster Park Drainages: Photos of the drainages in Webster Park near the intersection of FCR 3 and FCR 3 were taken prior to the inspection (see **Image 5**). Site representatives pointed out Webster Park drainages just south of the Arkansas River and Hwy 50, after the inspection (see **Image 6**).

Image 5. Webster Park drainage south of FCR 3 & ~1/4 mile west of FCR 3A (looking south).

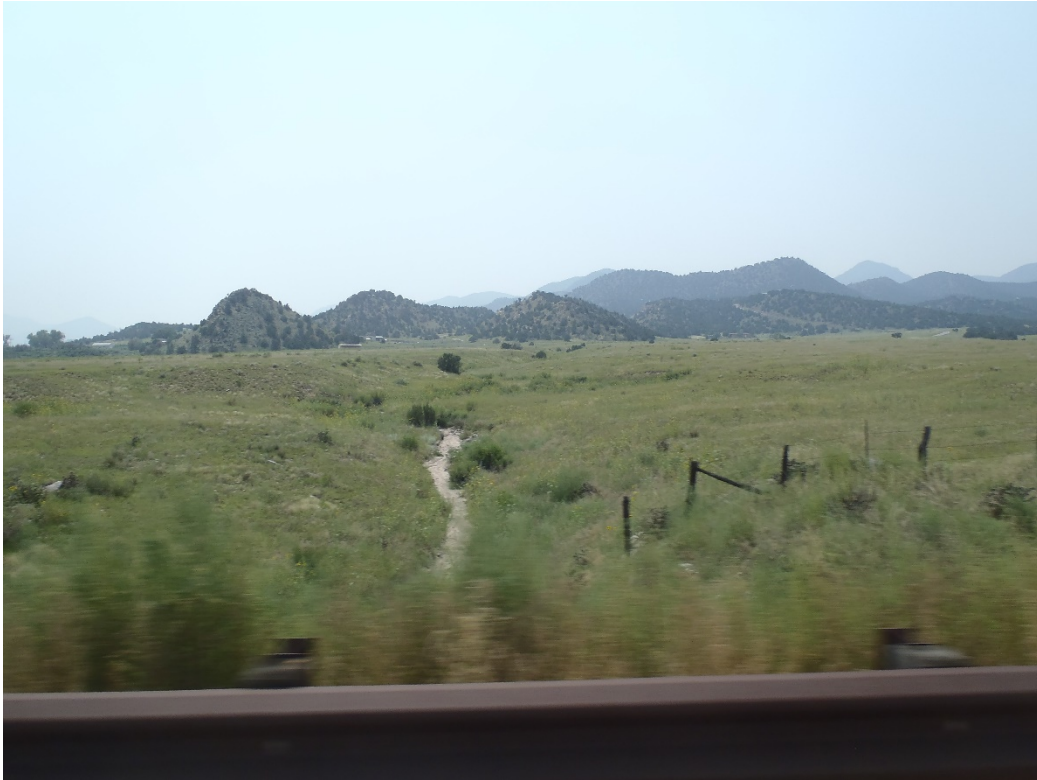
Image 6. Webster Park drainage south of HWY 50, ~3/4 mile east of FCR 157 (looking south).

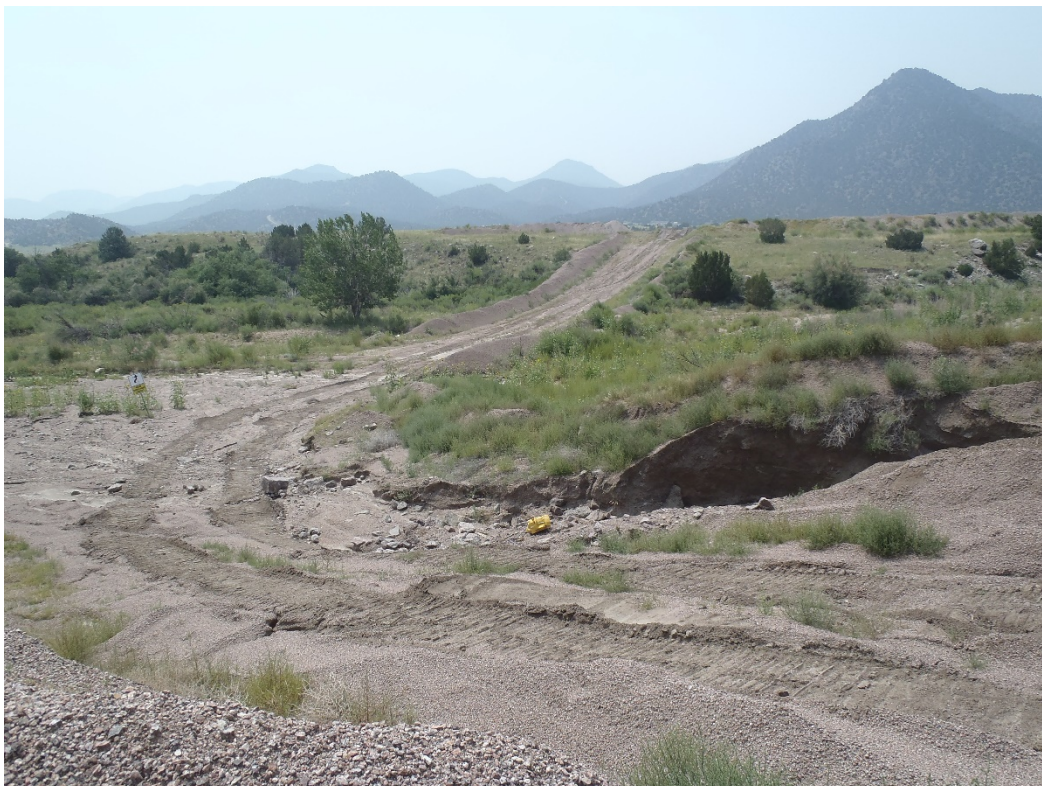
Affected Area Boundary Discrepancy: There are two access roads to the existing Granite Quarry: one over a bridge crossing Tallahassee Creek; the other is a low water crossing through Tallahassee Creek (see **Image 7**). Based on mapping from Amendment 1 (AM1), and carried over to AM2, the segment north of Tallahassee Creek and the segment immediately south of the Creek does not appear to be constructed where perhaps intended in AM1 (see **Image 8**). [Current AM2 maps \(Exhibit C6, D1 through D7, and F\) will need to be revised to show the entire length of the low water crossing is affected area.](#)

Image 7. Low water crossing near existing Granite Quarry (looking south).

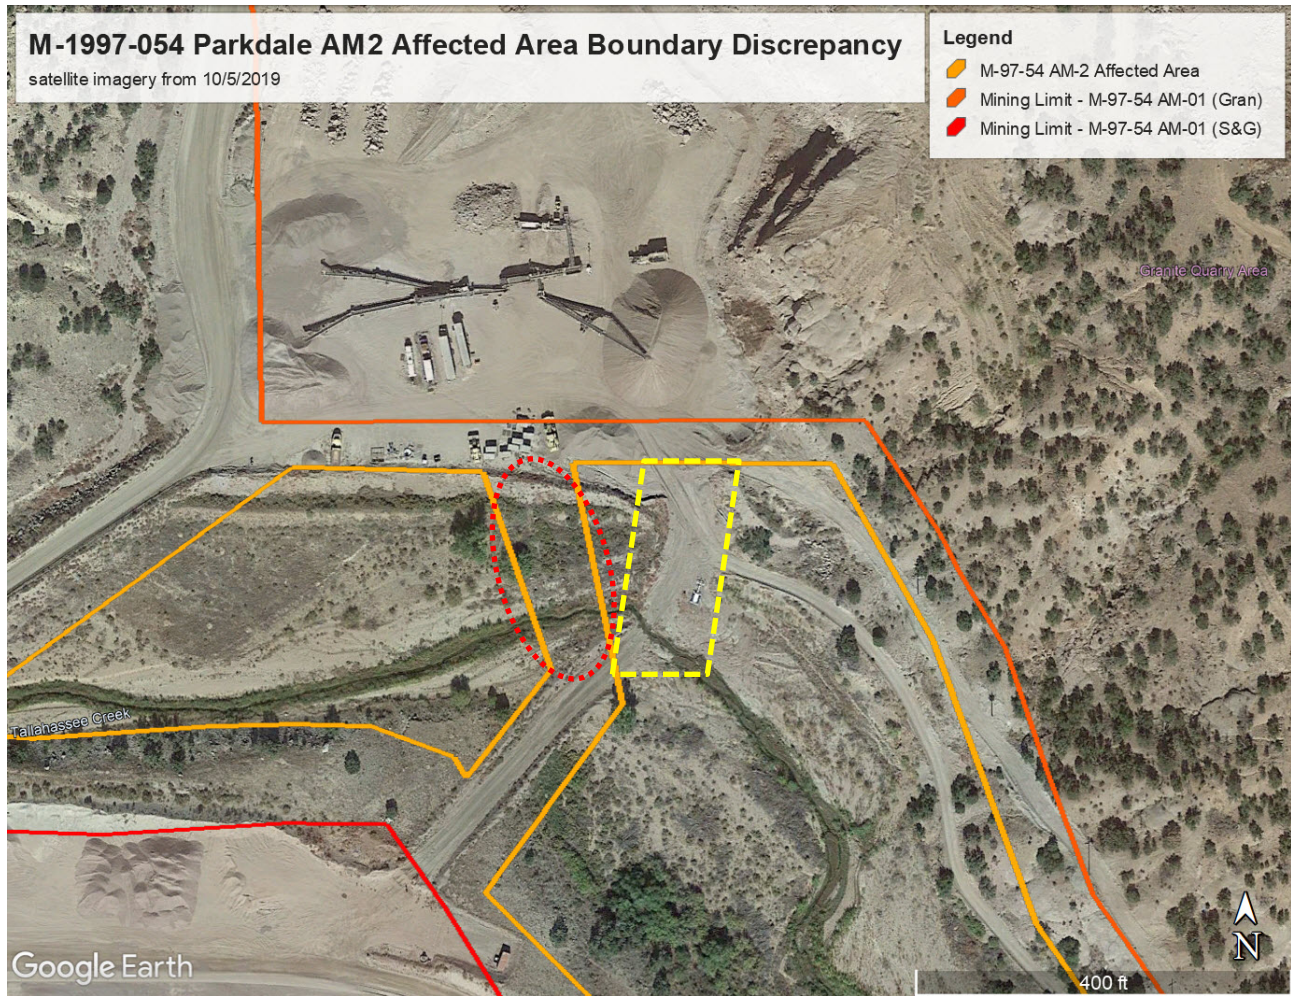
Image 8. Low water crossing segments requiring inclusion in affected area boundary (outlined by yellow dashed line). {red dotted line outlines unaffected area included in affected area boundary}

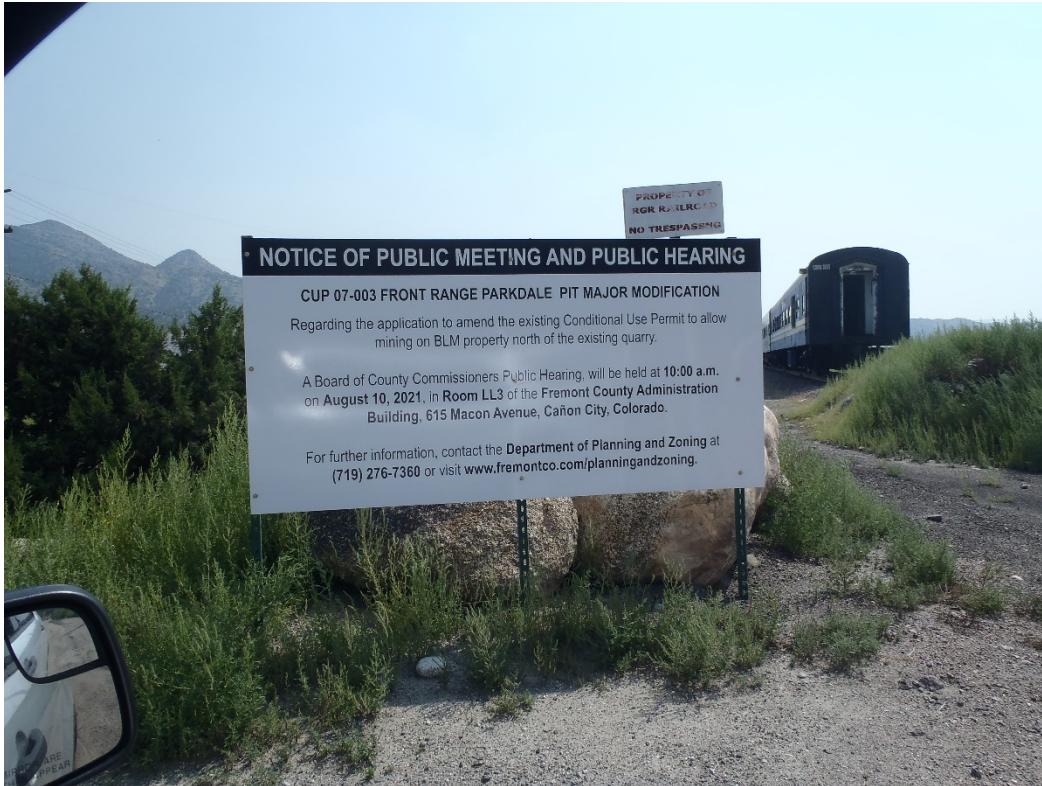
Signs and Markers: The required site public notice was properly posted (see **Image 9**).

Image 9. Posted site public notice (north side of railroad tracks).
