MINERALS PROGRAM INSPECTION REPORT
PHONE: (303) 866-3567

MINE NAME: Revenue Mine	MINE/PROSPECTING ID#: M-2012-032	MINERAL: Lead, silver and gold	COUNTY: Ouray
INSPECTION TYPE: Monitoring	INSPECTOR(S): Lucas West	INSP. DATE: October 19, 2021	INSP. TIME: 10:10
OPERATOR: Ouray Silver Mines Inc.	OPERATOR REPRESENTATIVE: Todd Jesse	TYPE OF OPERATION: 112d-1 - Designated Mining Operation	
REASON FOR INSPECTION: Normal I&E Program	BOND CALCULATION TYPE: None	BOND AMOUNT: \$517,219.00	
DATE OF COMPLAINT: NA	POST INSP. CONTACTS: None	JOINT INSP. AGENCY: None	
WEATHER: Clear	INSPECTOR'S SIGNATURE:

Reagent Room Inspection

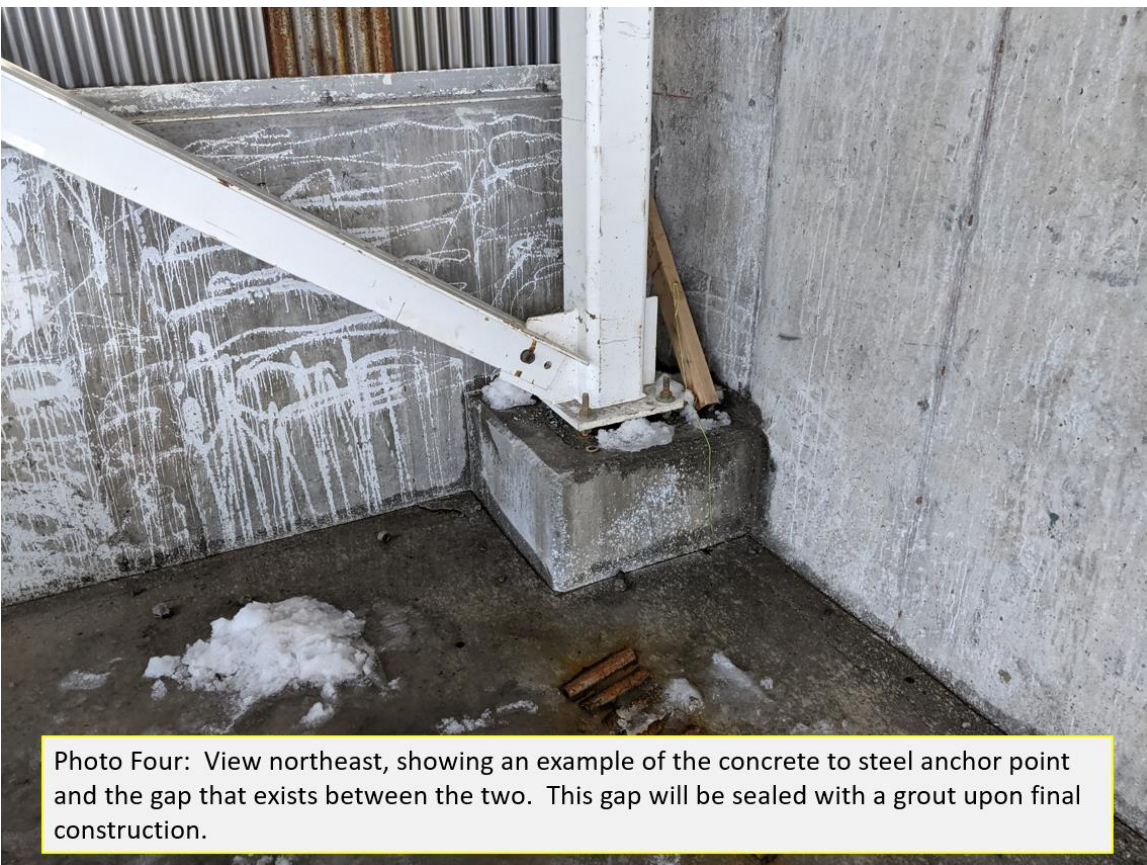
The main focus of this inspection was to serve as the fourth incremental inspection during the construction of the EPF focused on the structural steel of the building. At this point in the construction all concrete work including floors, exterior walls and partitions for secondary containment structures have been completed. All structural steel elements have been installed and crews were actively installing the metal sheeting of the building. The structural steel appears to be installed in compliance with the approved designs, all pillars, load bearing beams and cross bracing has been installed and secured. Photos One through Three show examples of the structural steel. Where the pillars are anchored to the concrete foundations, a gap exists which will be grouted and sealed upon final completion. An example of this can be seen in Photo Four.

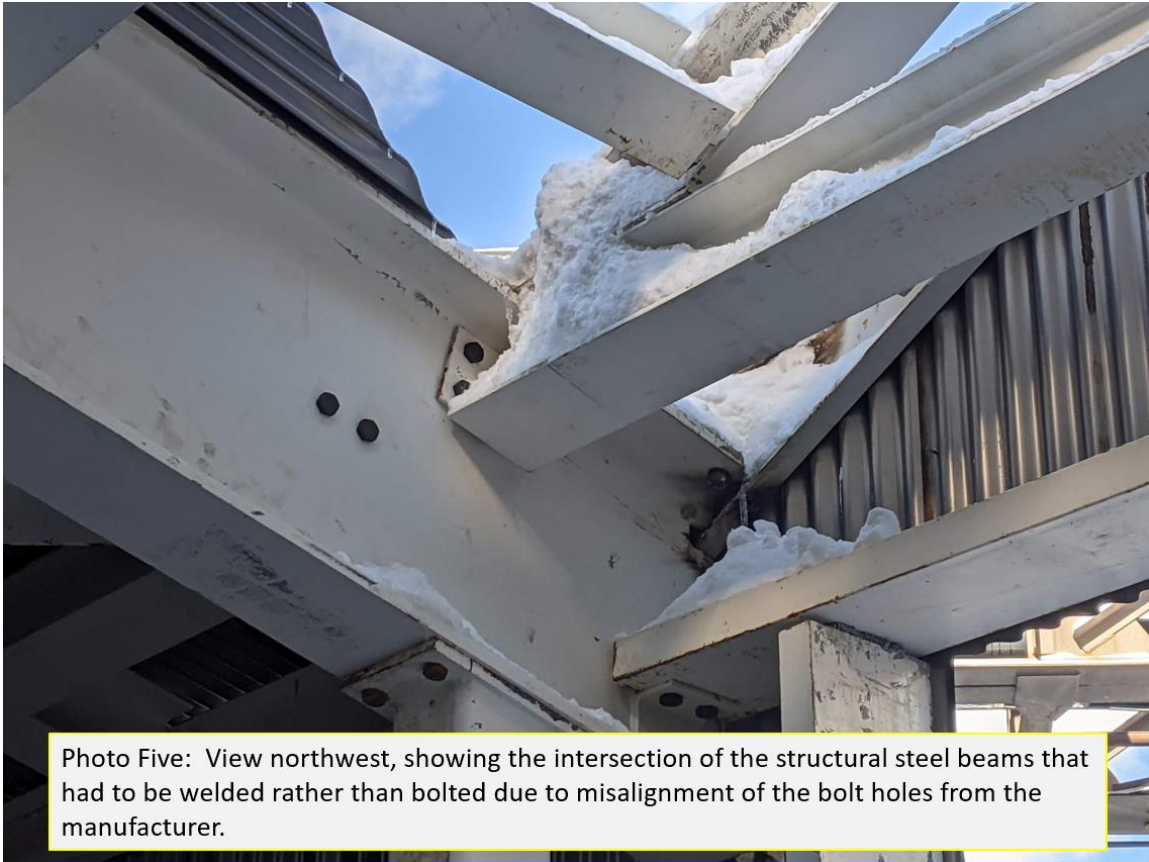
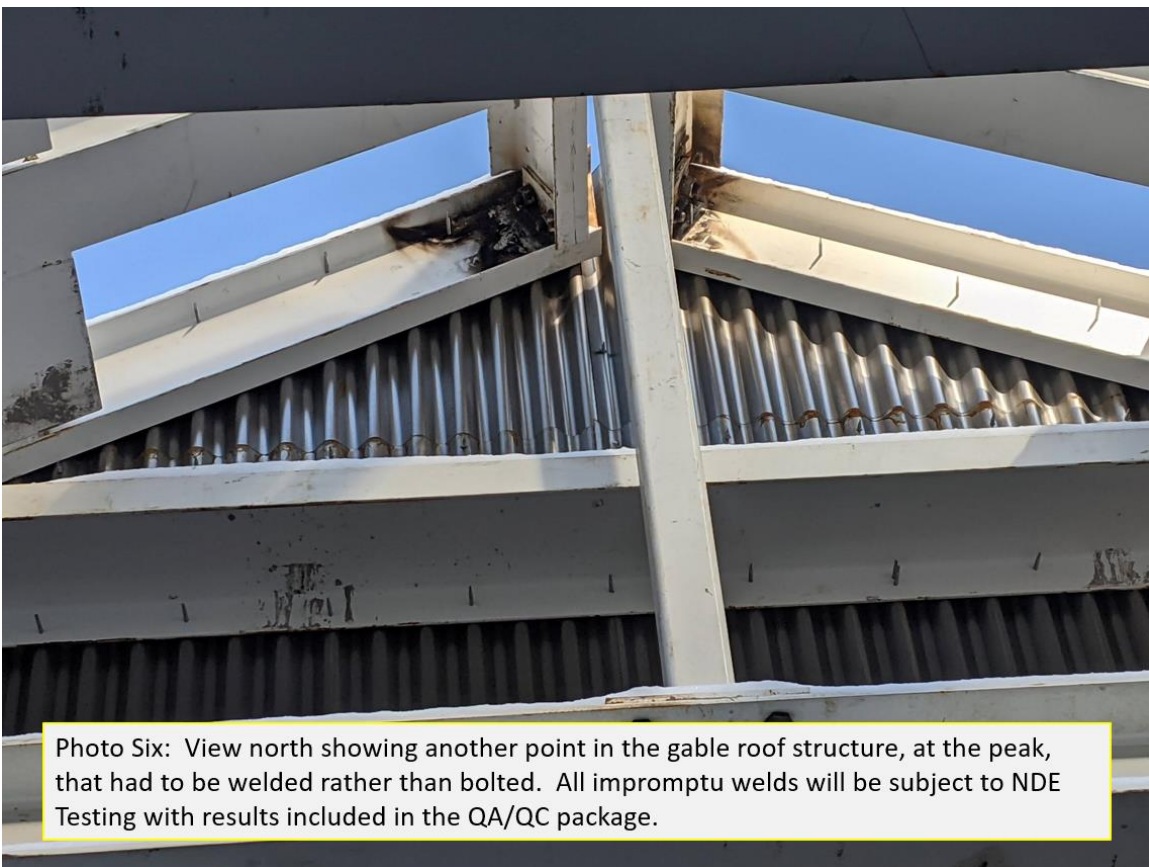
A slight deviation from the plans was encountered in the raised gable portion of the roof, located just above the access doors. Upon installation, crews found the pre-drilled bolt holes of the gable section did not line up with the approved bolt hole design. These junction points were welded, and conversation with the contractor indicate these welds will be subject to NDE testing to ensure proper strength. The NDE weld tests for these points and all other inspected welds will be incorporated into the QA/QC package submitted to the Division. This deviation does not comprise the design strength of the building and is not considered a problem. The weld points, can be seen in Photos Five and Six.

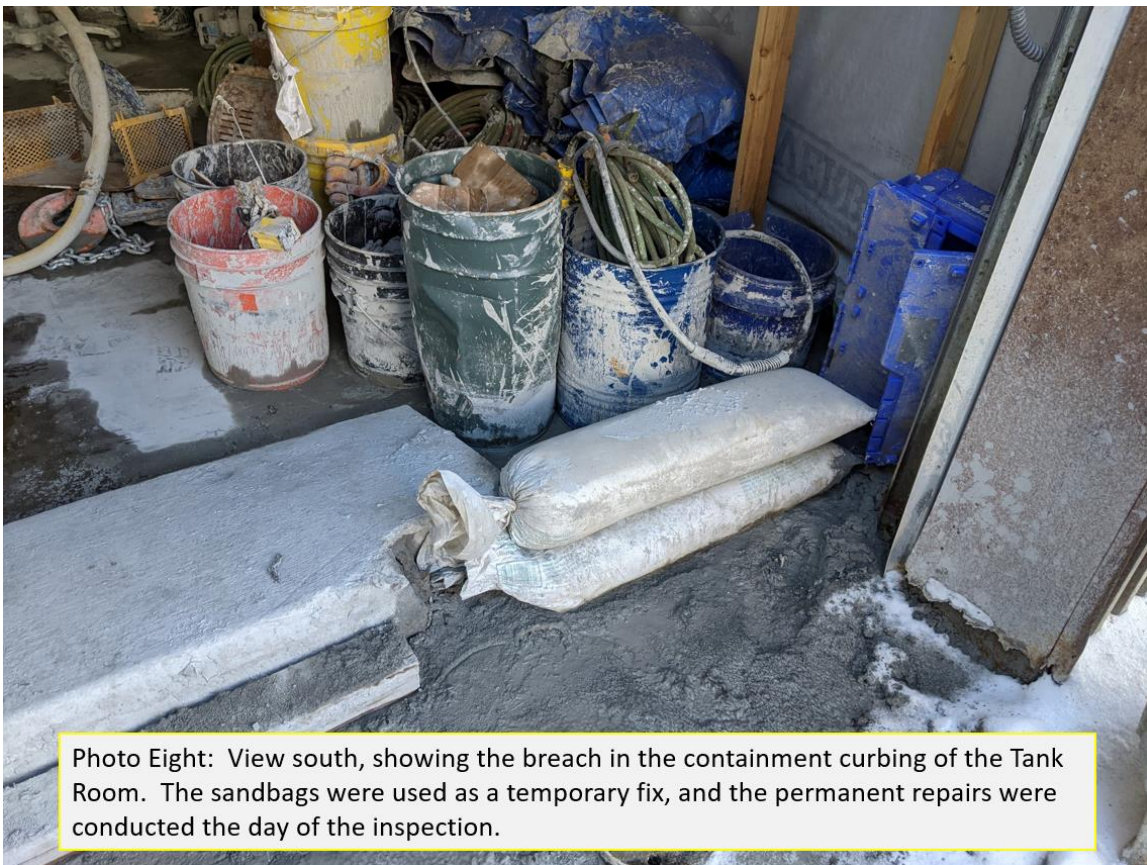
On October 6 and 11, 2021 the Division received two spill notifications for separate events that occurred from the same area, the Process Water and Tailings Filter Water Tank room. Both spills were small, and response and cleanup was conducted immediately by the Operator. The root cause of the spills has been determined and investigated by the Operator. The first event was caused by an overflow of tailings in the tailings thickener, which was caught by secondary containment structures associated with the tailings thickener. That material was then pumped back to the Tailings Filter Water tank, however a runaway pump and faulty tank

level sensor caused the tank to overtop into the secondary containment of that area. The Tailings Filter Water Tank can be seen in Photo Seven. A breach in the secondary containment structure located adjacent to the access door of that area, allowed the material to flow out of the containment structure to the exterior pad and a small area outside the pad. The breach in the containment structure can be seen in Photo Eight. Immediate action by the Operator shut down the pumps eliminating the source of flow. Immediately following, the Operator cleaned up the spilled material as well as the impacted waste rock surrounding the exterior pad, collected a sample for analysis and placed the material within the compacted clay liner of the Revenue Tailings Storage Facility.

Photo Seven: View southeast, showing the Tailings Filter Water Tank which was the spill point of the first spill event. Evidence of tailings flow down the walls of the tank was observed.

Since the time of both events, the Operator has installed measures to prevent future release. The measures include automation of the pump and tank level controls that are tied back to the Mill Control Room for monitoring. In addition the sump pump located in the Process Water and Tailings Filter Water tank room has been repaired and also automated for monitoring. The breach in the containment of the room was temporarily repaired with sandbags, and the day of the inspection, permanent concrete curbing was installed. As of October 22, 2021 the Division has received written notification of the corrective action, and the problem has been resolved. Mill commissioning and testing has resumed and no further action is necessary.

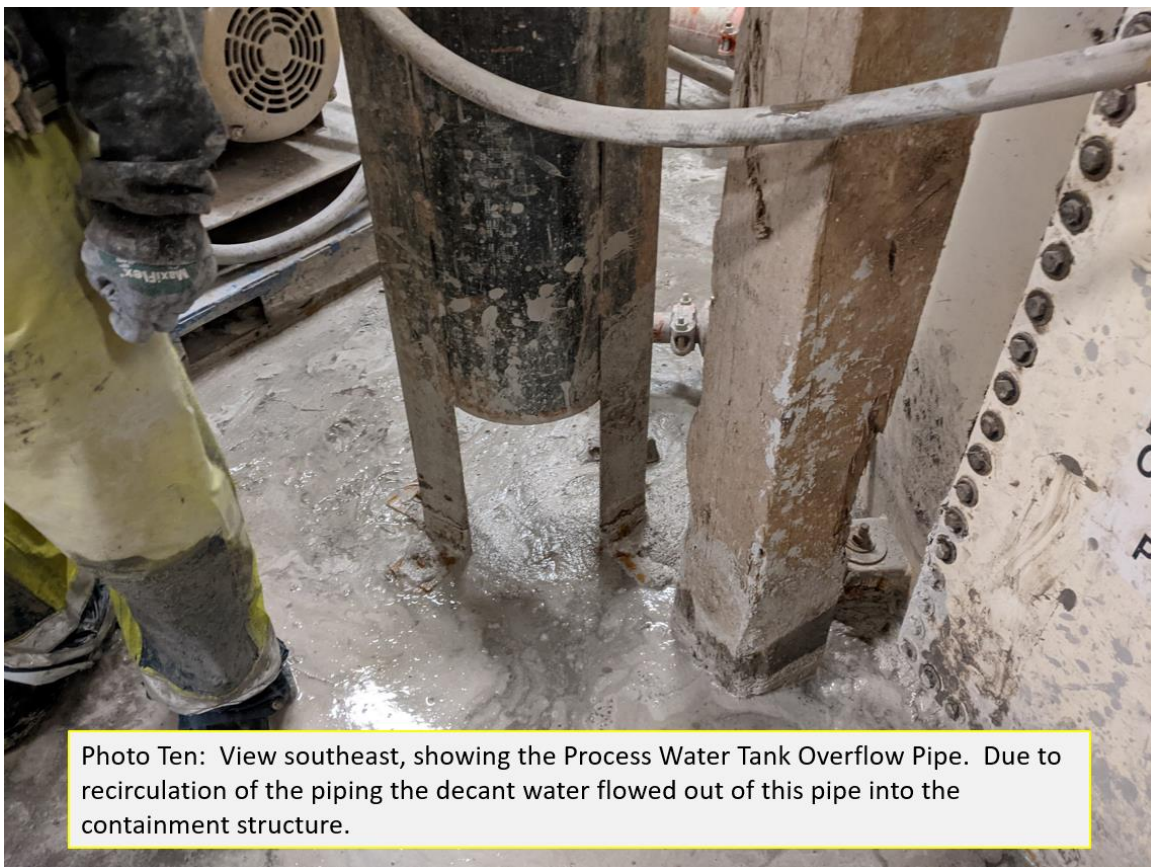
The second event, occurring days later was caused by decant water from the Tailings Thickener being manually pumped back to the Process Water Tank. The Process Water Tank can be seen in Photo Nine. Due to an inadvertent oversight, the piping system was set to recirculate, causing that decant water to be released from the overflow pipe, shown in Photo Ten, and into the secondary containment structure of that room. As was the case with the first event, that water flowed out of the breach in the containment structure and onto the pad and exterior area immediately in front of the tank area. The source of the spill was immediately eliminated and the water was pumped back to the Process Water Tank. In addition, the Operator took samples of the water to understand its makeup and the impacted waste rock was excavated and stored in the temporarily lined portion of the Revenue Tailings Storage Facility. The storage location of all impacted materials can be seen in Photo Eleven.

Photo Nine: View southeast, showing the Process Water Tank. The Process Water Tank was the intended storage location of the spilled decant water of the second spill however the recirculation of the piping caused the tank to be bypassed.
