MINERALS PROGRAM INSPECTION REPORT
PHONE: (303) 866-3567

MINE NAME: Vondy Pit	MINE/PROSPECTING ID#: M-1986-105	MINERAL: Sand and gravel and commodity	COUNTY: Morgan
INSPECTION TYPE: Monitoring	INSPECTOR(S): Brock Bowles	INSP. DATE: October 15, 2021	INSP. TIME: 13:00
OPERATOR: Dilley's Sand & Gravel	OPERATOR REPRESENTATIVE: Chris Monahan	TYPE OF OPERATION: 110c - Construction Limited Impact	
REASON FOR INSPECTION: Normal I&E Program	BOND CALCULATION TYPE:	BOND AMOUNT: \$12,140.00	
DATE OF COMPLAINT: NA	POST INSP. CONTACTS: None	JOINT INSP. AGENCY: None	
WEATHER: Clear	INSPECTOR'S SIGNATURE:

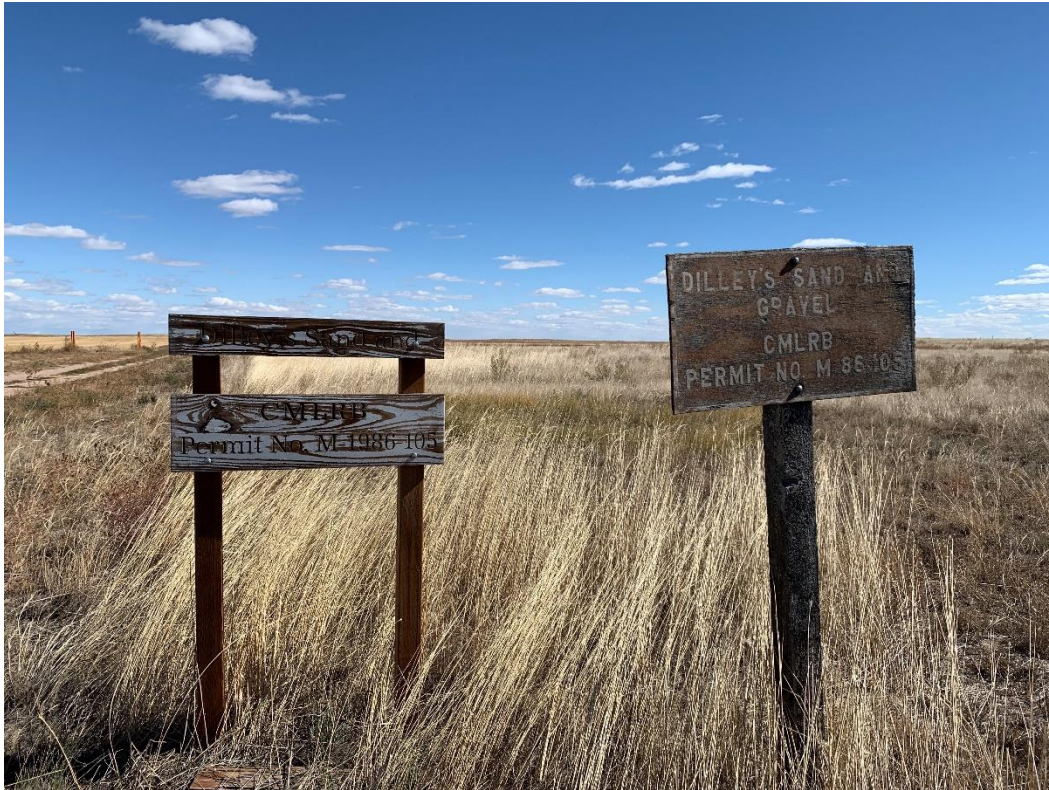
The permit entrance sign was in place (photo 1) and the permit boundary was marked with t-posts (photo 2).

Photo 1 – Mine entrance sign facing Hwy 71

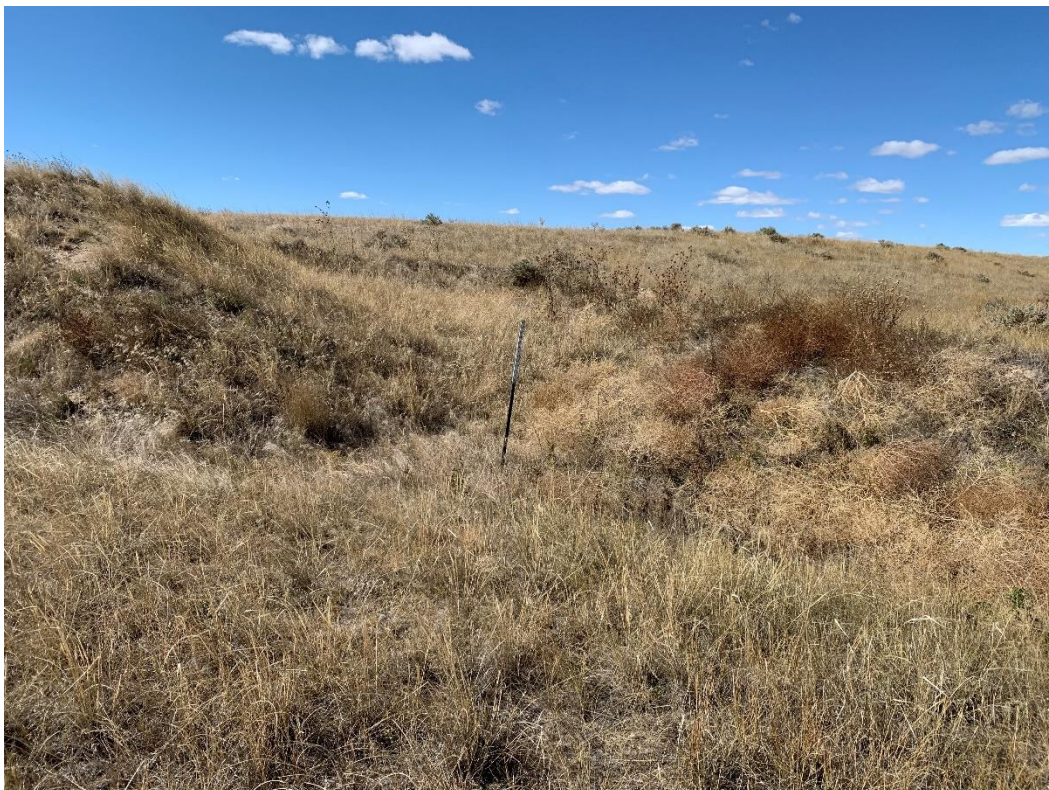
Photo 2 – corner post

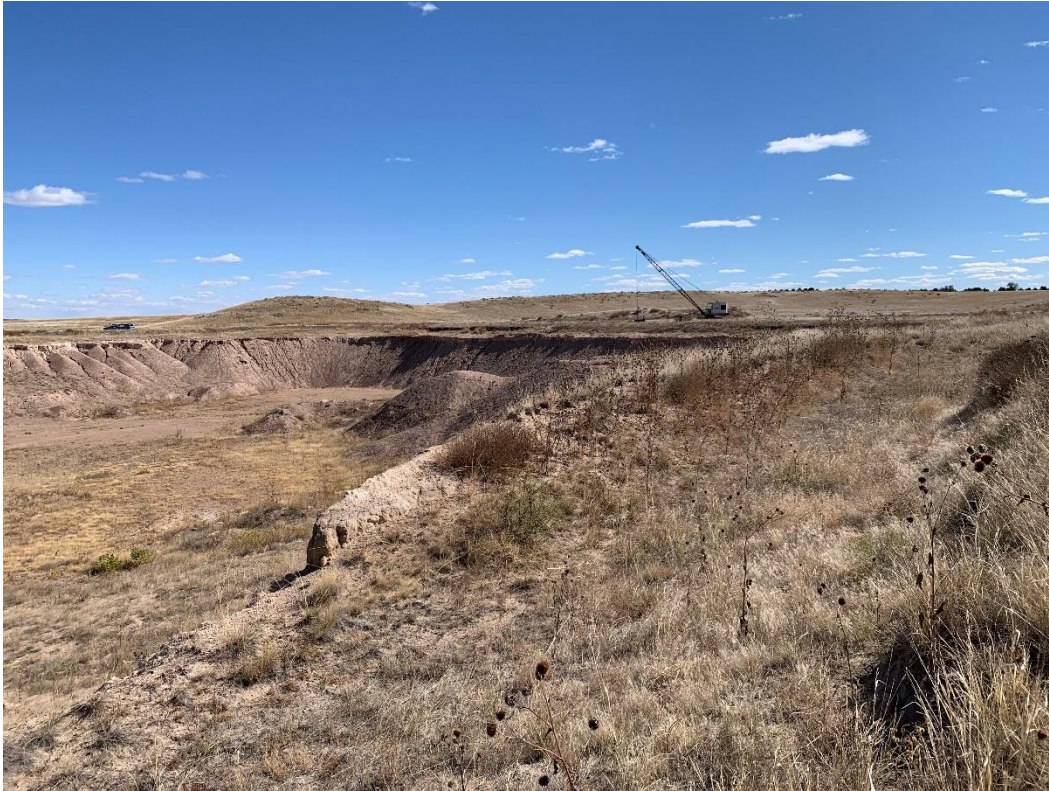
An old drag line was on site but it appeared inoperable. No other mining equipment was on site and no mining was taking place during the inspection (photo 3). There was a lot of vegetation on the pit floor and the stockpiles indicating that it has been a while since mining has taken place. The annual report states that the last activity was in Feb 2020, which is consistent with the observed conditions.

Photo 3 – Pit area, facing southeast
